# Grouting Treatment and Parameters Optimization in Watery Karst Areas of High Speed Railway Tunnel Based on Comprehensive Geological Forecast: A Case Study

Based on the failure of the initial grouting scheme in tunnel engineering, an integrated geological forecasting system incorporating an industrial endoscope was used to detect watery karst areas in this tunnel. Numerical simulations were used to analyze the change patterns of arch top settlement, arch bottom bulge, and water surge in the tunnel under different grouting thicknesses. Compared to the displacement of the support structure, curtain grouting thickness is mainly reflected in reducing the amount of water surge. When the grouting thickness exceeds 5 m, the water-stopping effect of the tunnel is almost unchanged. Finally, a grout thickness of 5 m and a grout length of 25 m were selected as the grouting range for this project. During grouting, the combination of the three grouting techniques can effectively solve the problems of high water surges and difficult hole formation. The principle of “combination of exploration and injection” was followed to obtain real-time geological information and optimize the subsequent gro

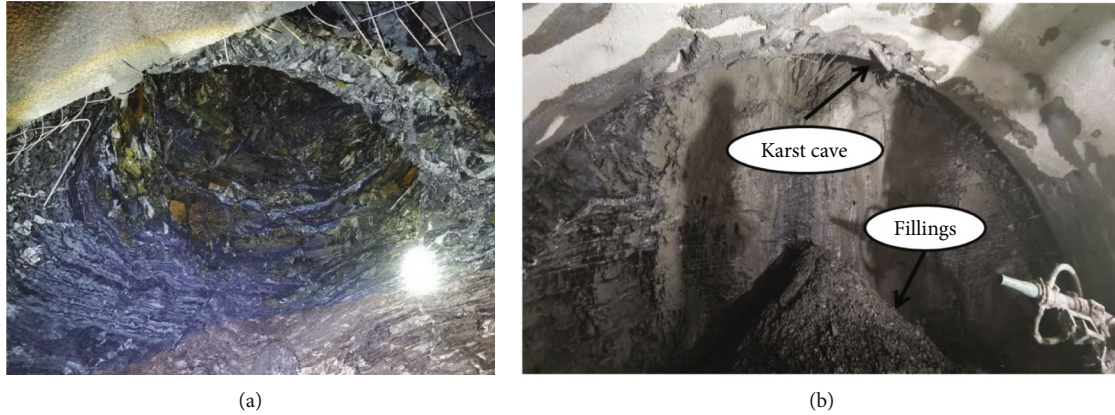
FIGURE 1: The condition of the palm surface at DK114+070: (a) karst cave and (b) fillings from the karst cave.

When the tunnel was excavated to DK114+070, a semi-filled cave developed in the vault of the palm face. After the filling collapsed, a vertical cylindrical cave with a diameter of 2~3 m and a height of 4~5 m was formed at the top of

the tunnel arch (Figure 1). The excavation revealed that the lithology is weakly weathered striped tuff. The lithology is nearly horizontal, thin to medium laminated. The interlayer is filled with white calcite powder, which is poorly bound and soft. The rock is fragmented and the joints and fissures are developed due to tectonic compression.

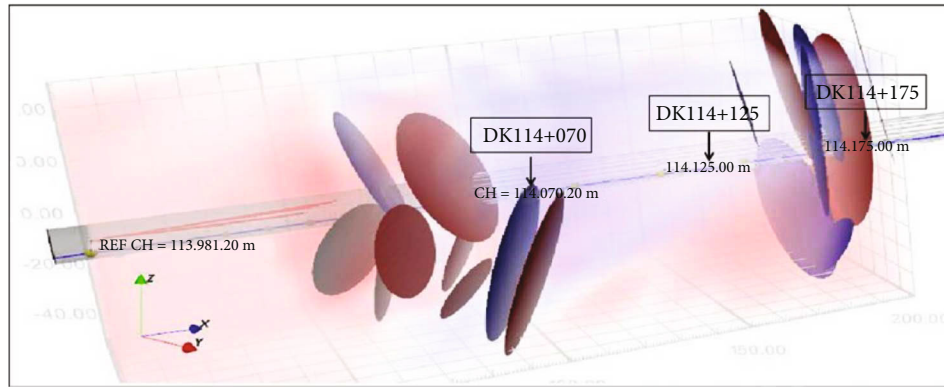
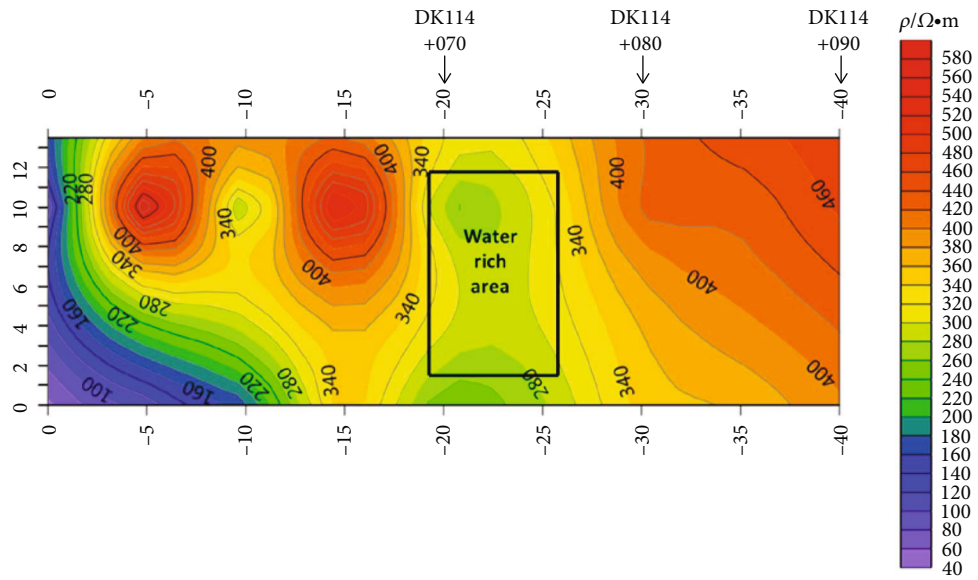
FIGURE 3: Integrated geological forecast results: (a) physical and mechanical parameters; (b)  $V_p$  and  $V_s$  decomposition of 3D seismic model; (c) results of geological radar; (d) results of transient electromagnetic method.

**2.2.1. Tunnel Seismic Prediction.** The TSP303PLUS tunnel geological forecasting system developed and produced in Switzerland was used. The detection range is DK114+070~DK114+190. The detection results are shown in Figures 3(a) and 3(b). The longitudinal velocity ( $V_s$ ) and transverse velocity ( $V_p$ ) of DK114+070~DK114+078 remain almost the same. The value of  $V_p/V_s$  has a large increase,

and its value is  $>1.73$ . There is a sudden change in Poisson's ratio, and there is an obvious reflection interface between DK114+076~DK114+078. There is a sudden change in Poisson's ratio, and there is an obvious reflection interface between DK114+076 and DK114+078. It is assumed that the surrounding rocks in this section basically continue the

2.2.2. *Geological Radar*. SIR-4000 geological radar was used. The detection range is DK114+070~DK114+100. The detection results are shown in Figure 3(c). The electromagnetic wave energy group in the DK114+070~DK114+095 section is not uniformly distributed. The waveform is more disordered. Reflected waves are locally misplaced in the same phase axis. It is presumed that the surrounding rock of this section basically continues the current geological situation

of the palm face. Near the white area, the electromagnetic wave frequency changes drastically from high frequency to low frequency. The pulse period increases significantly. The electromagnetic wave energy decays rapidly. Uneven distribution of energy clusters. The automatic gain gradient is large. And the reflected wave has good continuity in the

+090. The resistivity inversion cross-section of the lateral line is shown in Figure 3(d). According to the results of this completed detection, there is an obvious low resistance anomaly area in the range of DK114+070~DK114+075. It is presumed that the rock in this area is broken and watery, and there may be some scale of cave occurrence.

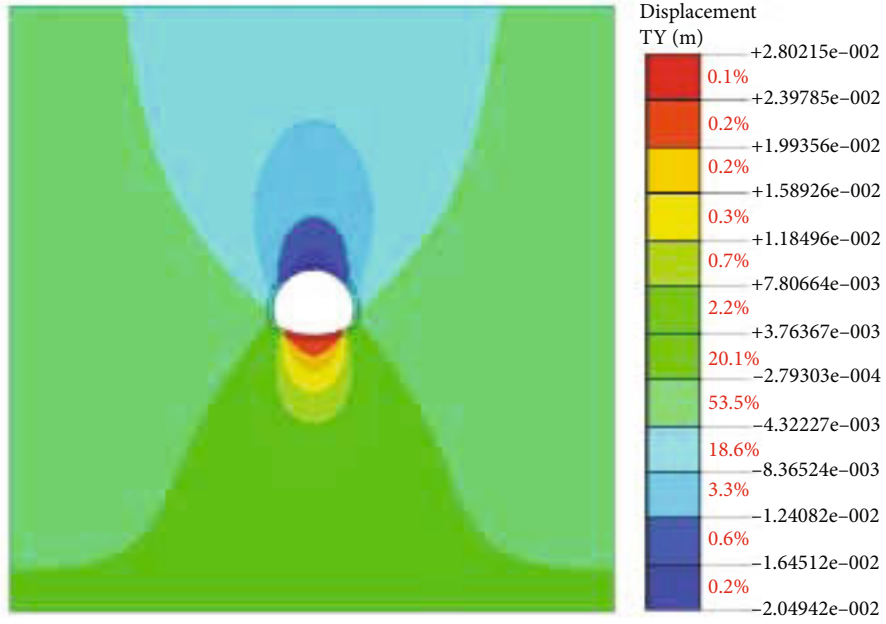
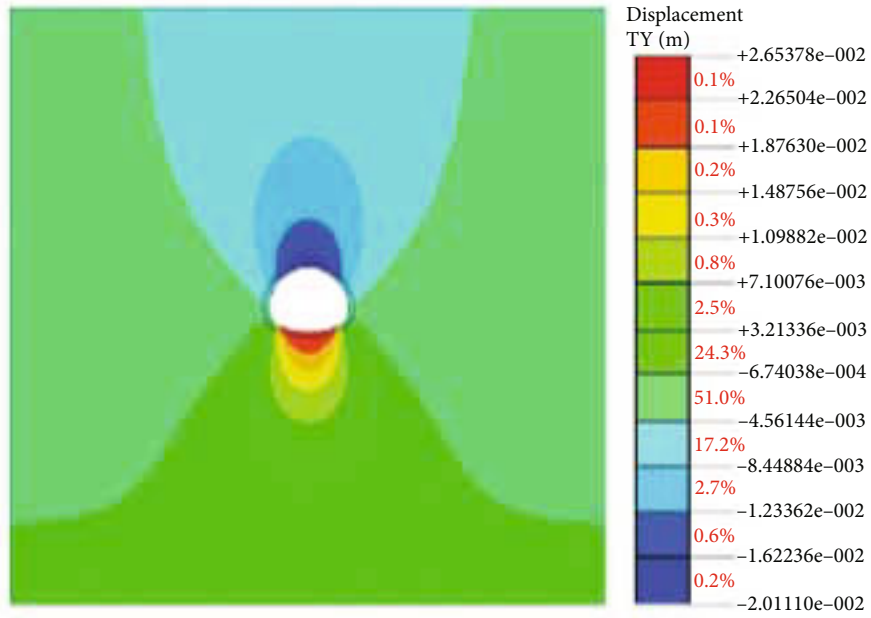
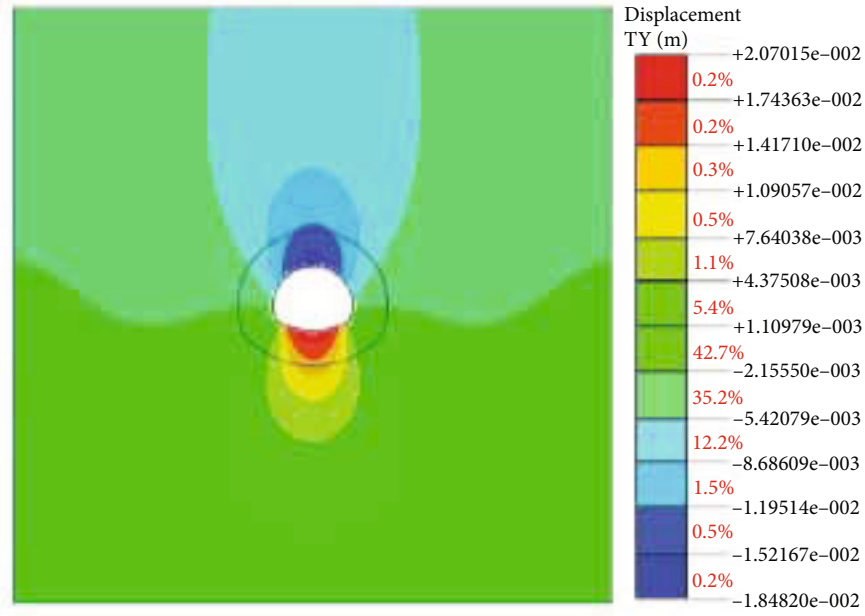
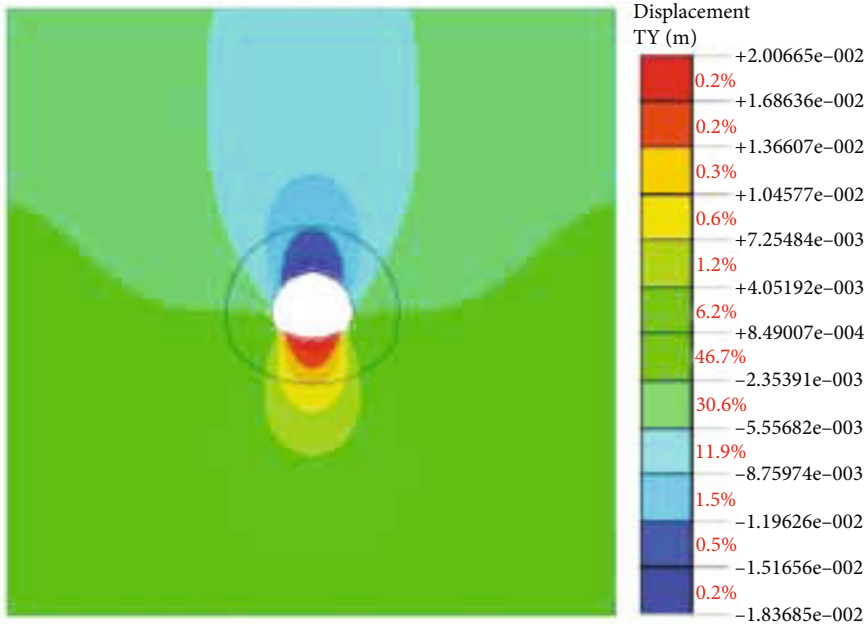
FIGURE 7: Vertical displacement cloud of the tunnel: (a) no grouting, (b) grout 1 m, (c) grout 3 m, (d) grout 5 m, (e) grout 7 m, and (f) grout 9 m.

**3.3.1. The Effect of Grout Circle Thickness on Tunnel Deformation.** The arch top settlement displacement and arch bottom bulge displacement are important to control indicators during tunnel excavation. After the construction is completed, the vertical displacement cloud of the tunnel is shown in Figure 7.

For the arch top settlement, the value without grouting is 20.49 mm. During the process of increasing the grouting thickness from 1 m to 9 m, the arch top settlements are 20.11 mm, 19.28 mm, 18.74 mm, 18.48 mm, and 18.37 mm, which are reduced by 1.85%, 5.91%, 8.54%, 9.81%, and 10.35%, respectively. For the arch bottom bulge, the value without grouting is 28.02 mm. During the increase of grouting thickness from 1 m to 9 m, the arch top settlements are 26.54 mm, 23.29 mm, 21.54 mm, 20.70 mm, and 20.07 mm, which are reduced by 5.28%, 16.88%, 23.13%, 26.12%, and 28.37%, respectively.

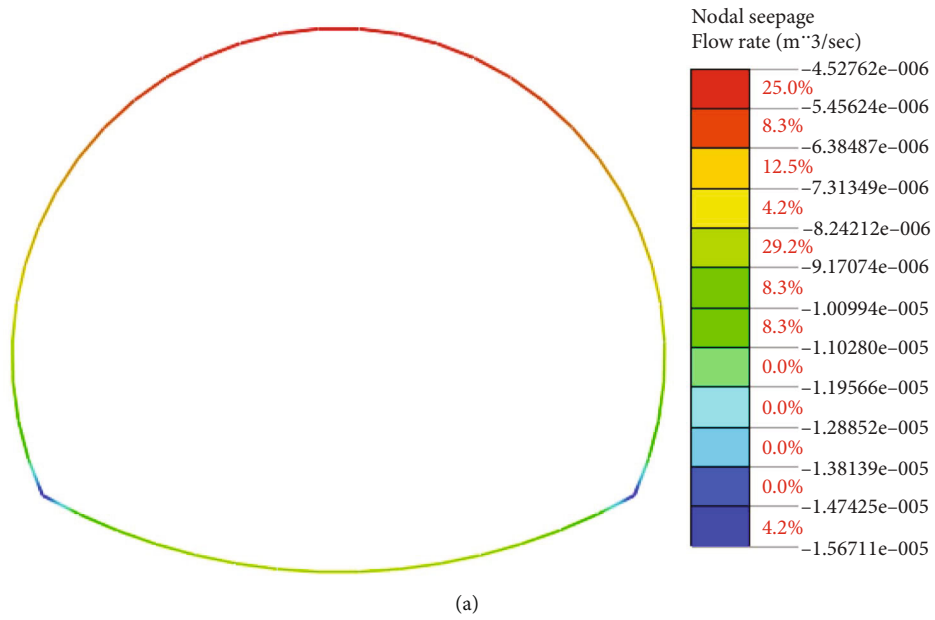
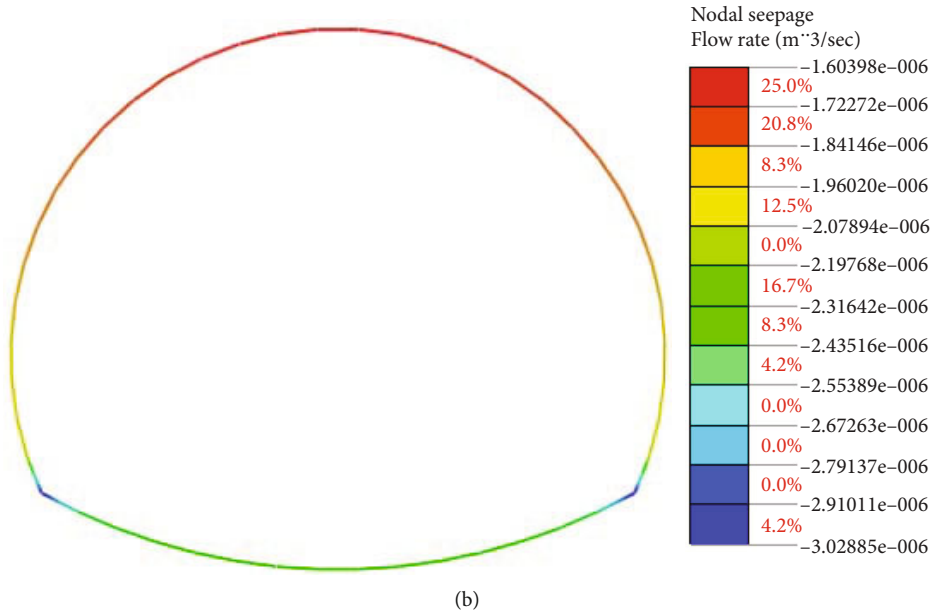
FIGURE 8: Cloud map of water surges: (a) no grouting, (b) grout 1 m, (c) grout 3 m, (d) grout 5 m, (e) grout 7 m, and (f) grout 9 m.

tunnel. Most importantly, it can limit the gushing of water from the surrounding rock into the tunnel. Different grouting thicknesses of the case of the tunnel surge water cloud map are shown in Figure 8. From Figure 8, it can be found that in the absence of grouting and full-section curtain grouting, the maximum amount of water surge in the tunnel is found at the foot of the arch. The tunnel contour line on all nodes of the water surge summation and the tunnel unit length of the water surge can be attained, as shown in Table 3. The water surge without grouting is 22.14L/(m•min). During the process of increasing the grouting thickness from 1 m to 9 m, the water surge is 5.74L/

(m•min), 2.51 L/(m•min), 1.71 L/(m•min), 1.35 L/(m•min), and 1.14 L/(m•min), which are reduced by 74.06%, 88.68%, 92.29%, 93.91%, and 94.87%, respectively.

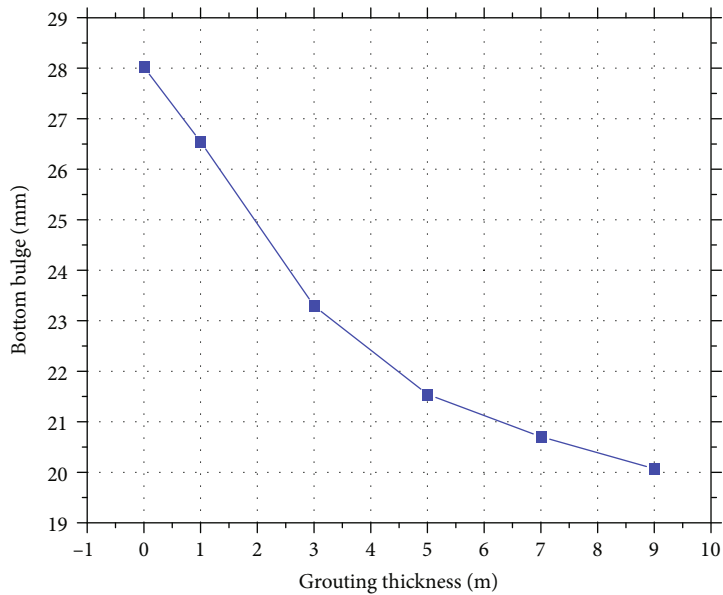
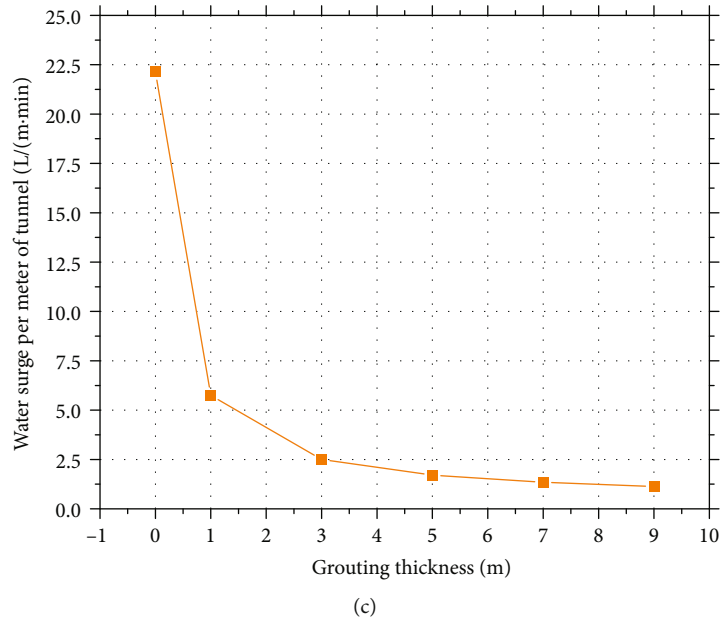
FIGURE 9: The control indicators of the tunnel: (a) arch top settlement, (b) bottom bulge, and (c) water surge per meter of the tunnel.

3.3.3. *Grouting Ring Thickness Selection.* The numerical simulation results are plotted as dotted line plots, as shown in Figure 9. It is not difficult to find that with the enhancement of the grouting thickness, the deformation and water surge of the tunnel can be effectively limited, especially the water surge of the tunnel. It can be seen that the grouting has a very obvious effect on reducing the water surge of the tunnel. However, the thickness of the grouting is not as large as possible.

From Figures 9(a) and 9(b), after the grouting thickness exceeds 5 m, it can be found that the curve starts to become flat. This indicates that the effect of grouting on limiting tunnel deformation is weakening. Mechanistically speaking, after the tunnel is excavated, the main influence is on the rock body within a certain area around the tunnel. After the tunnel is supported, the support structure and the rock surrounding the tunnel form the support system of the tunnel. The better this part of the rock mass around the tunnel, the smaller the force borne by the support structure. When the grouting range exceeds this part, the remaining rock mass has less influence on the force of the support structure. Therefore, improving the parameters of rock masses outside this part has little significance to the force of the support structure.

From Figure 9(c), after the grouting thickness exceeds 3 m, the curve starts to become flat. This indicates that the water-stopping effect of grouting on the tunnel is decreasing rapidly. After the grouting thickness exceeds 5 m, the water-stopping effect of the tunnel almost stops increasing. At this point, it can be considered that the increase in grouting thickness is no longer meaningful to improving the water-stopping effect.

Comparison of the displacement limitation effect and water-stopping effect, the curtain grouting thickness is mainly reflected in reducing the amount of water surge, while the improvement of the displacement of the tunnel support structure is slightly weaker. Therefore, when determining the thickness of grouting, the water seepage should be the main reference basis. When the grouting thickness exceeds 5 m, the water-stopping effect of the tunnel is almost unchanged. Considering the cost, the grouting thickness of 5 m is recommended as a reference value for this project. At this point, the numerical simulation result of the water surge is  $1.71 \text{ L}/(\text{m}\cdot\text{min})$ , which meets the design of the tunnel ( $2 \text{ L}/(\text{m}\cdot\text{min})$ ).

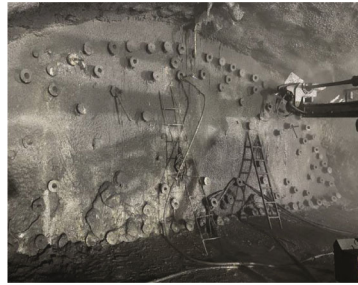
FIGURE 12: Grouting technology: (a) Forward Segmental Grouting, (b) Backward Segmental Grouting, and (c) Cluster Cuff Tube Grouting.

*Backward Segmental Grouting.* As shown in Figure 12(b), after the initial consolidation of forwarding grouting with hole formation conditions, grouting is carried out in segments from the bottom of the hole for the holes prone to collapse. After drilling to the designed hole depth with the integrated drilling and injection machine, the slurry is injected and the drilling rod is removed section by section (the length of each section is 2~4 m) until the grouting is pushed from the bottom of the hole to the hole entrance. This applies to silty strata and powdery clay that are prone to hole collapse.

*Cluster Cuff Tube Grouting.* As shown in Figure 12(c), the discount of the grouting consolidation effect in watery areas is considered, and the grouting is controlled and reinforced by cluster cuff tube grouting. It avoids the problem of running slurry caused by the traditional grouting technology in loose strata and the problem of difficulty in compacting in dense strata. Drill holes to design depth using a  $\Phi 130$  mm drill bit. One to three  $\Phi 25$  mm rigid cuff pipes can be installed in each hole according to the geological conditions.

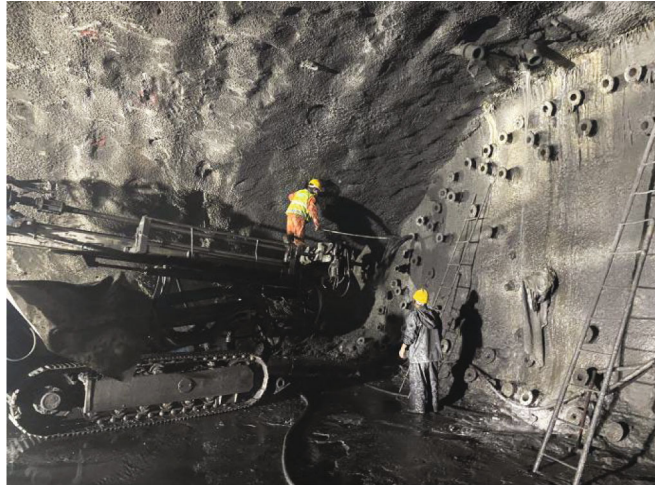
FIGURE 13: Use sulfoaluminate cement for grouting hole B28.
