Research Article

Research on Internal Structure and Mechanism of Landslide Based on Hydrogeophysical Investigation (Quan'an Landslide, Southwest China)

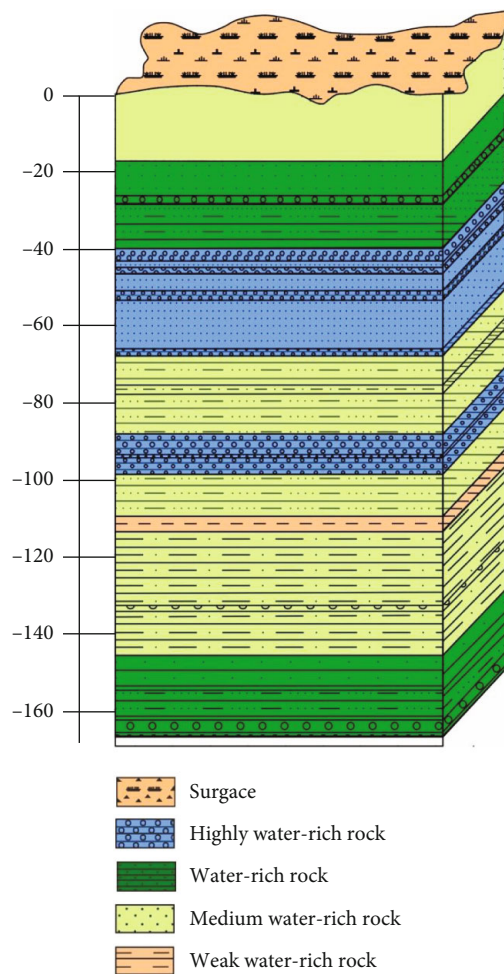
FIGURE 1: The hydrogeological structure in the study area [23].

The study area is located in Longquan Mountain, and the hydrogeological structure of the red layer in the study area (Figure 1). In the early morning of August 17, 2020, a landslide, largely due to a rainstorm, occurred in Group 5 of Quan'an Village, Eastern New District of Chengdu, resulting in the collapse of six houses. Specifically, the length, width, buried depth, and volume of this landslide were approximately 210 m, 180 m, 35 m, and $13.23 \text{ m} \times 105 \text{ m}^3$, respectively. At present, investigation and follow-up monitoring have been carried out. One year after the landslide, many surface plants died, and due to timely warnings and the relocation of villagers to safe areas, no deaths or injuries occurred. However, multiple secondary disasters were

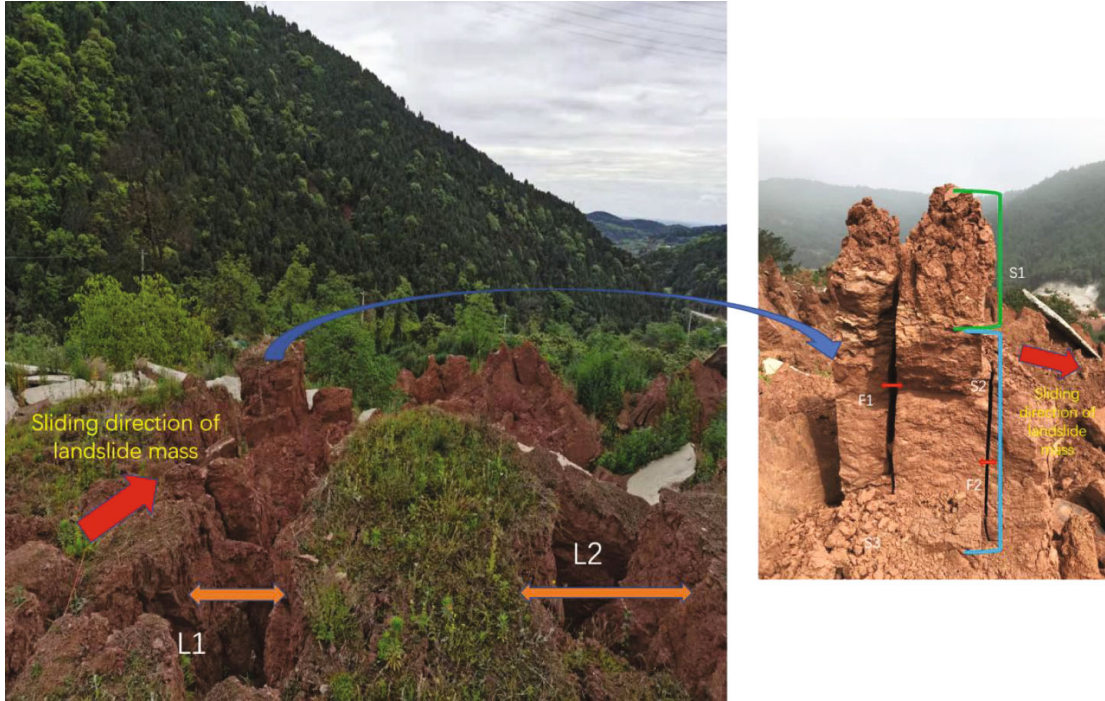
FIGURE 2: Landslide area surface photographed in different seasons. The picture on the left was taken on September 1, 2020. The picture on the right was taken on March 2, 2021. L represents the almost north–south fracture, F represents the almost east–west fracture, and S represents weathered red-bed soft rock.

Figure 2 shows the process of surface fissure development within the landslide mass, with substantial weathering evident throughout the "red layer." Surface fissures were formed in different directions, which predominantly caused the occurrence of landslides twice, in different directions. After a landslide, the rock stratum at the crack was exposed. After erosion during the rainy season and a freeze-thaw cycle in winter, the rock stratum weathered further and broke down. S2 shows a relatively complete rock section, whereas S3 and S1 show broken sections. S3 was developed from the same layer as S1. This highlights various characteristics of the "red layer," including softening in water and poor freeze-thaw resistance (poor freeze-thaw resistance accelerates rock fragmentation, reduces rock strength, and finally makes landslide easier to occur).

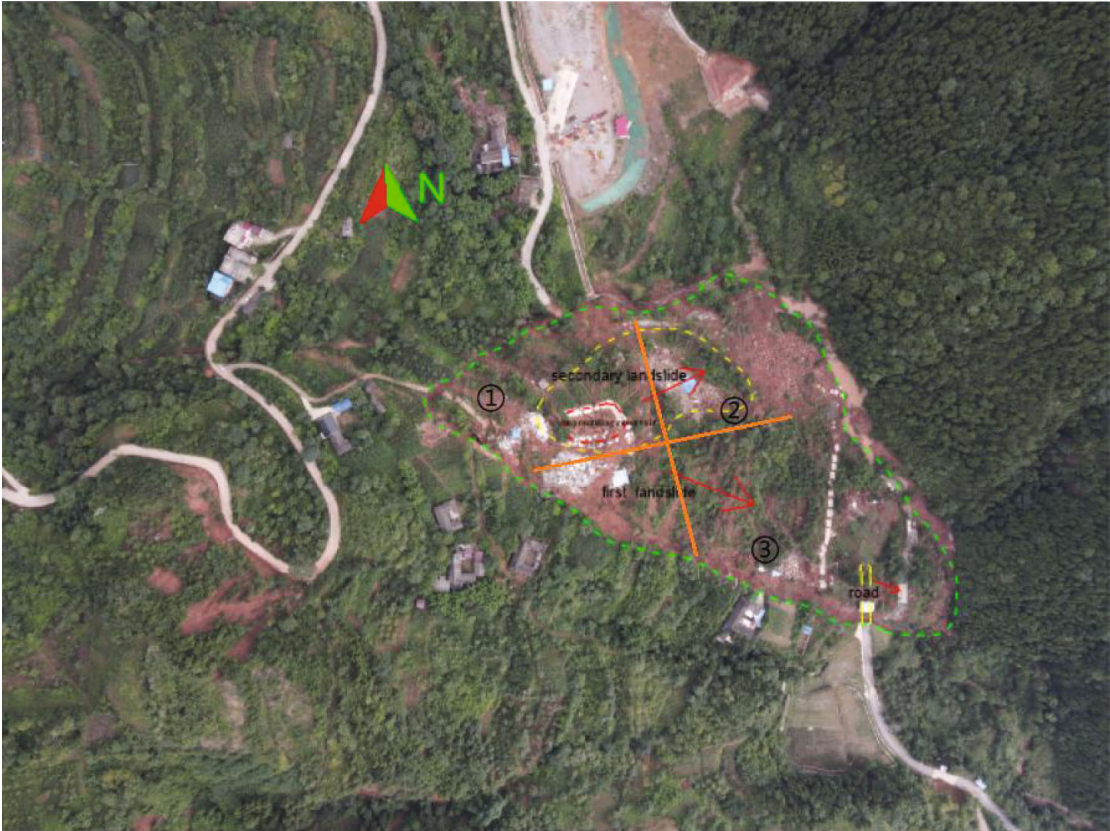
FIGURE 3: Aerial photo taken by drone. The yellow dotted line indicates the secondary landslide caused by pool collapse, and the red arrow indicates the sliding direction of landslide.

The landslide body, along with the secondary landslide, was extremely large (the slope range is shown in Figure 3). The first slip occurred on the southeast side, and its distance was approximately 11.2 m. As shown in Figure 3, after the initial landslide, the geological body was loosened. A further increase in rainfall resulted in increased water within the artificial pool (red dotted line area), and the cracks in the pool that were caused by the first slip further increased. This led to the collapse of the pool and resulted in the second landslide (yellow dotted line area in Figure 3). The impact of the secondary landslide on surface vegetation can be clearly observed in Figure 6. Specifically, the trees on the left side of the image are not inclined, whereas the trees on the right side are substantially inclined. As the trees had grown along the back edge of the artificial pool, the positioning of the trees indicates that trees on the right side of the image were affected by the secondary sliding mass, whereas the

trees on the left side of the image were affected by the primary sliding mass but not by the secondary sliding mass. The field survey revealed that the trees on the right side of the image were approximately 3.6 m from the artificial pool. The straight-line distance between the trees on the left and right sides was approximately 4.2 m. The slope development and vegetation were similar to those indicated by the arrows in Figure 3.

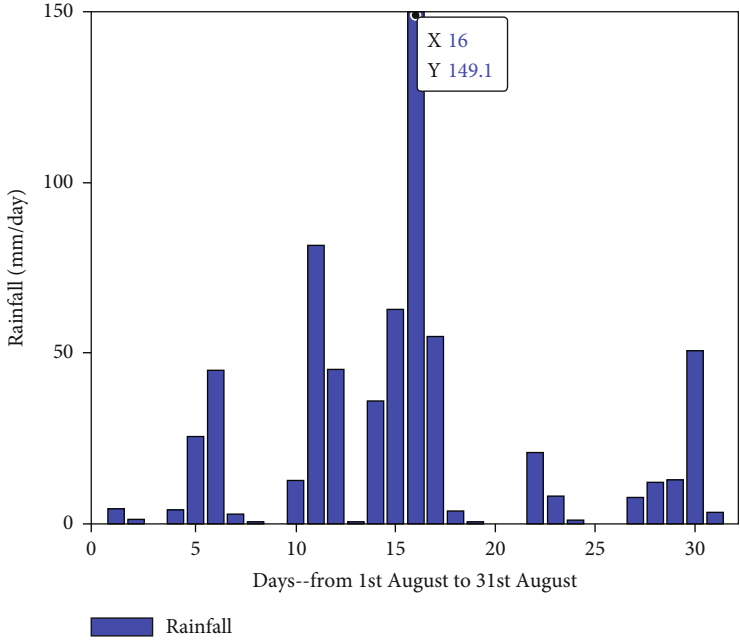
FIGURE 4: The precipitation data provided by Geoenvironment Monitoring Institute in Chengdu.

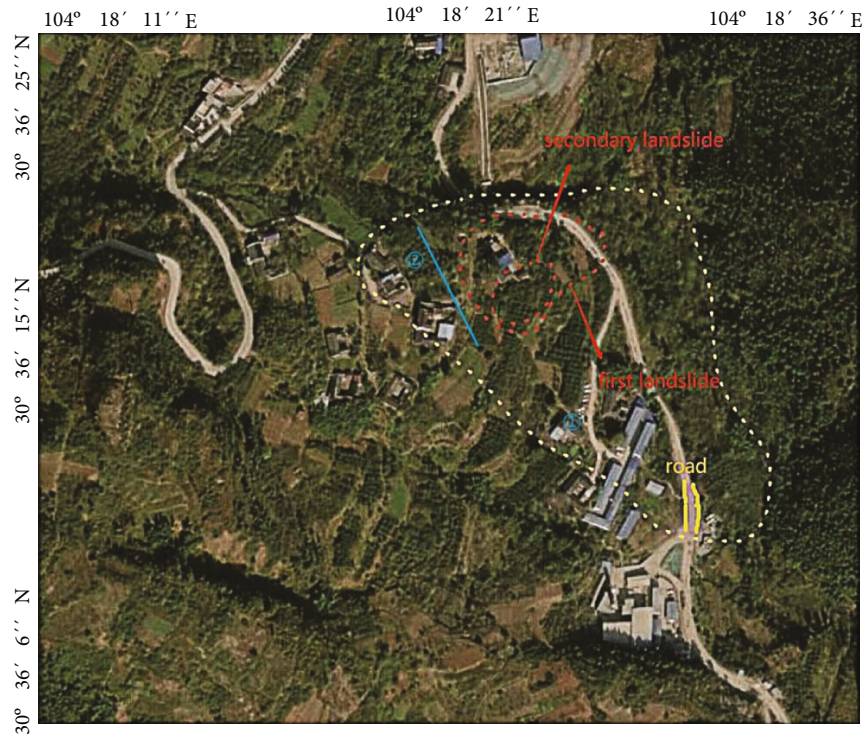
FIGURE 5: Satellite image before the landslide. The red dotted line indicates the area of the first landslide and the second landslide. The yellow dotted line indicates the entire study area.

2.3. Human Activity. As shown in Figure 5, a highway crossed the front edge of the landslide, forming an overhead strong stress load zone (the yellow solid line in the figure is shown). Due to road-related construction activities, the distribution of the slope rock mass was changed, leading to increased erosion and changes in groundwater movement [37, 38]. The middle area of the slope was cultivated land and economic crop forest. The southeast corner of the slope was occupied by various factory buildings. Five houses and artificial reservoirs were distributed throughout the northern and southeastern corners of the slope (① in the figure). The degree of damage to surface vegetation and subsequent

5.2. Geological Hazard Monitoring. The location of the surface monitoring meter is shown in Figure 5, and the monitoring results are shown in Figure 22, from the horizontal and vertical displacement data of on-site geological disaster monitoring points, it can be seen that the horizontal and vertical displacements of monitoring point GJ01 near

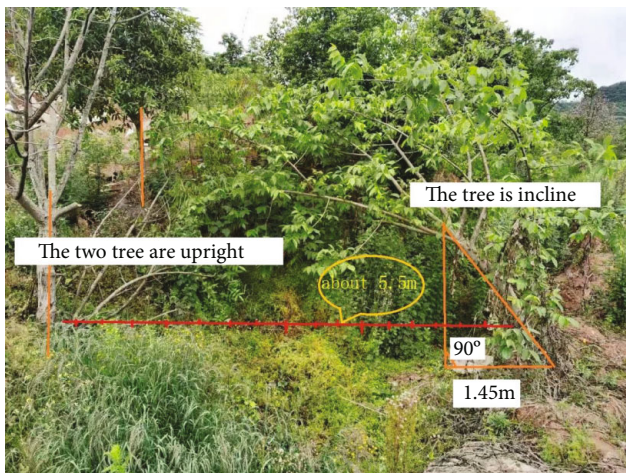
FIGURE 6: Vegetation indicating the occurrence of the secondary landslide. Trees on the left and right sides were approximately 4.2 m apart. Vegetation on the right side was affected by the secondary sliding body, and vegetation on the left side was affected by the primary sliding body but not by the secondary sliding body.

The surface vegetation and direction of the slope cracks shown in the aerial photograph indicate the overall shape of the landslide. As shown in Figure 6, the first landslide occurred on the southeastern side of the slope, whereas the

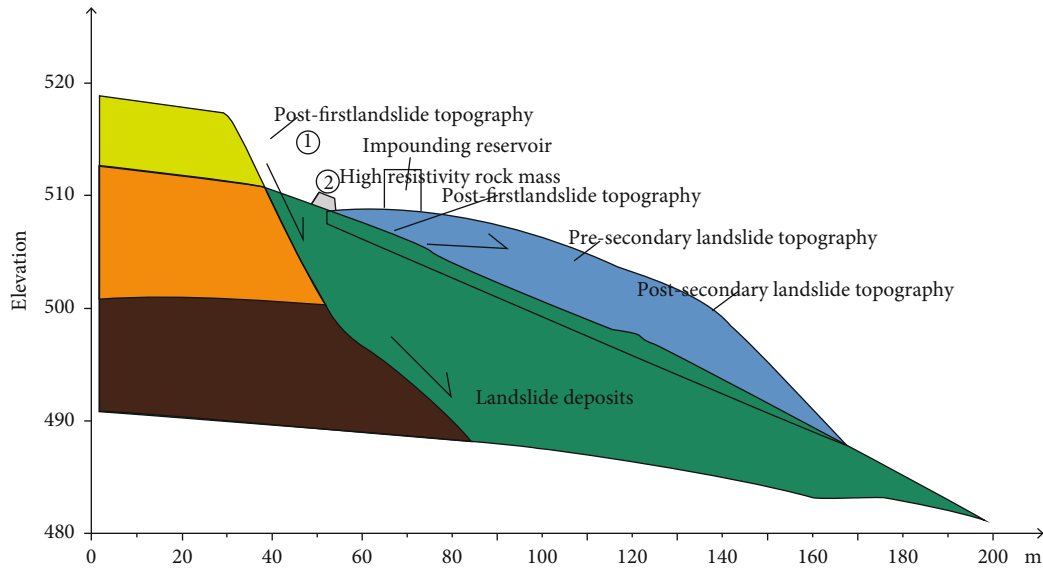
FIGURE 7: Landslide pattern, showing the west-east section of the landslide. The ordinate indicates the altitude, abscissa indicates the horizontal distance of the landslide, arrow indicates the slip direction, and different colors represent different strata information. ① indicates the trailing edge of the landslide mass, and ② indicates a hard rock mass within the landslide mass. Vegetation here is not inclined.

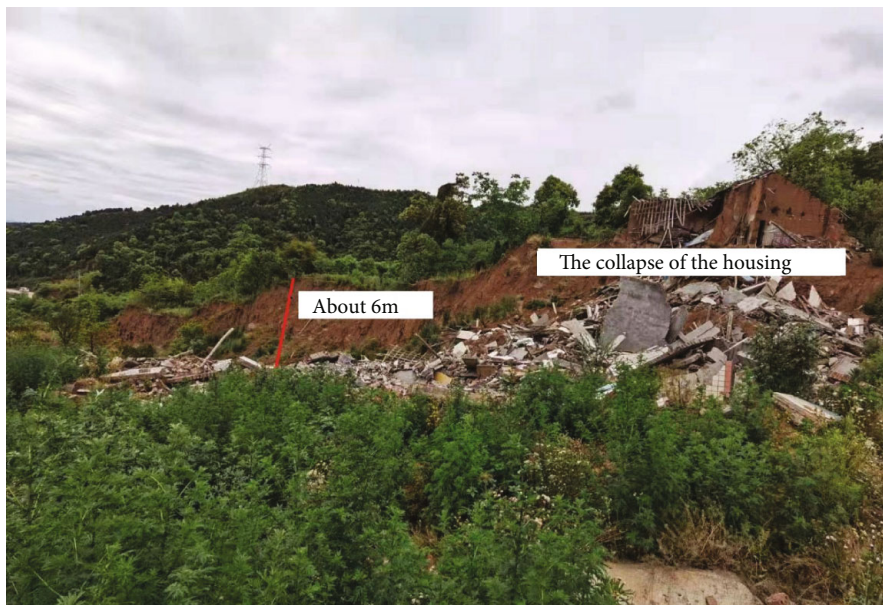
FIGURE 8: Fault zone at the back edge of the landslide. The trailing edge of the collapse zone extends from north to southwest, with a maximum depth of 6 m and a total length of approximately 210 m.

secondary landslide occurred on the eastern slope. The two landslides were related. Secondary landslides occur after the primary landslide and have a different volume and surface exposure compared to the primary landslide. The box in Figure 7 represents the location of the artificial reservoir. The continuous rainfall led to an expansion of the fissures at the trailing edge of the sliding body, and finally, tensile collapse occurred. Figure 8 shows the fracture of the trailing edge of the slope.

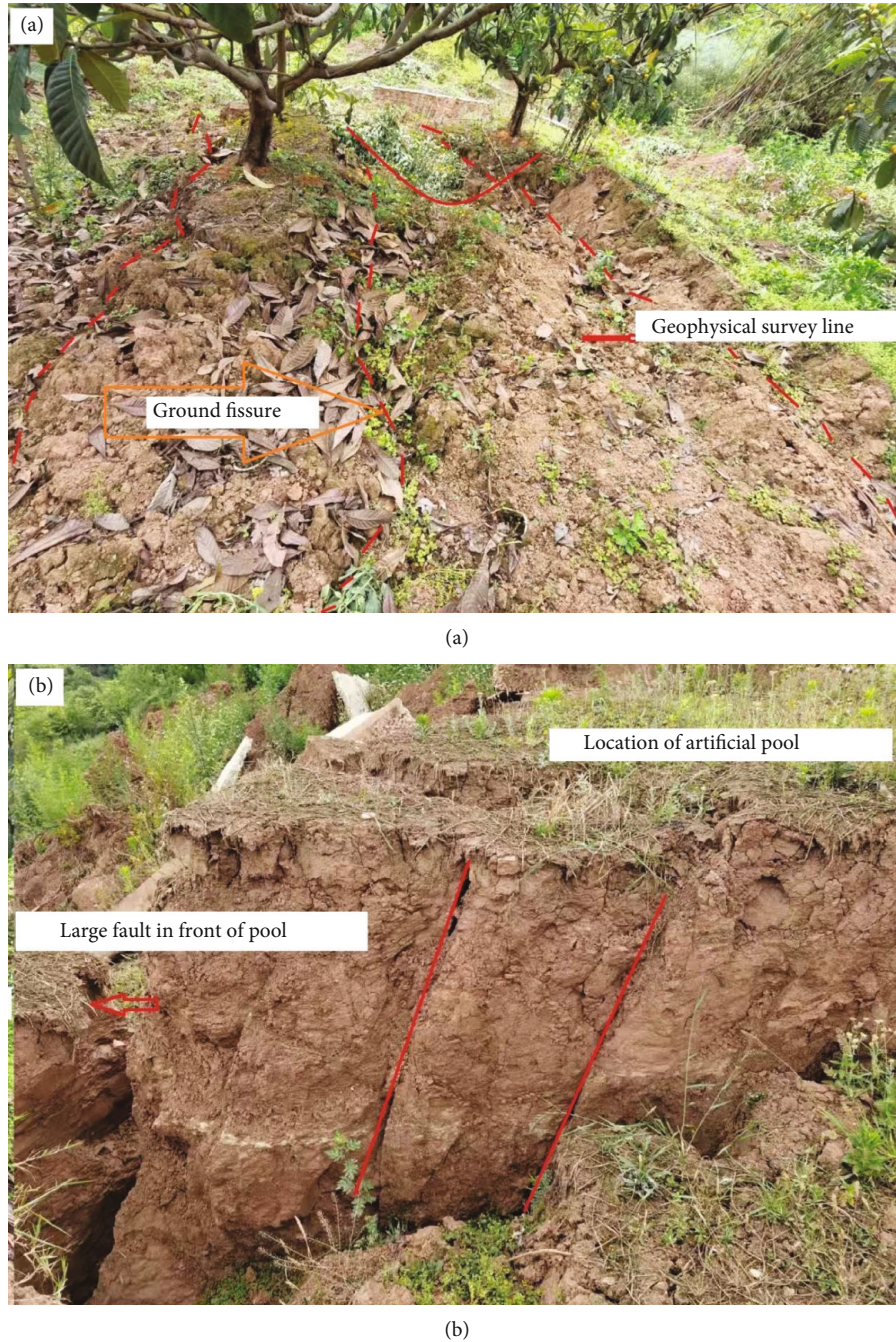
FIGURE 9: Land subsidence and cracks. (a) A large number of settlement and fissure areas throughout the loquat forest land on the northeast side of the landslide. (b) An inclined fissure at the bottom of the reservoir.

observed in Figure 9. On the northeast side of the sliding mass, a large number of settlement and fracture areas appeared in the loquat plum forests, with the widths and lengths of the fractures ranged from 2 to 19 cm and from 1.2 to 13.0 m, respectively. The minimum and maximum diameters of the irregular settlement areas were 40 cm and 2.3 m, respectively. As shown on the right-hand side of Figure 9, a large eastward fracture collapse occurred on the east side of the reservoir, and an inclined fracture appeared at the bottom of the reservoir. The fracture was approximately 1.3 m. From the vergence and collapse directions of

the fracture, it can be observed that the formation of the fracture was affected by the primary stratum slip [49]. The collapse was caused by water flow after the reservoir rupture, which is consistent with previous findings regarding the cause of the secondary landslide [50]. A large collapse zone at the rear edge of the slope is shown in Figure 8. Five houses located either at the rear edge or within 10 m of the right-hand side of the landslide.

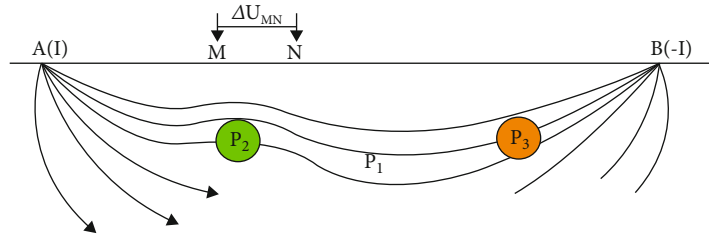
FIGURE 10: Working principle of the electric resistivity tomography. When the current propagates through underground, due to different lithology and fracture development in the underground space, the formation resistivity at different locations in the underground space is as shown by ρ_1 , ρ_2 , and ρ_3 . The current density is also different, as shown in the dense and sparse distribution of current schematic lines. The resistivity value was calculated through the collected potential difference (ΔU_{MN}), after which the geological anomaly was divided through the resistivity value to realize the spatial display of geological information.

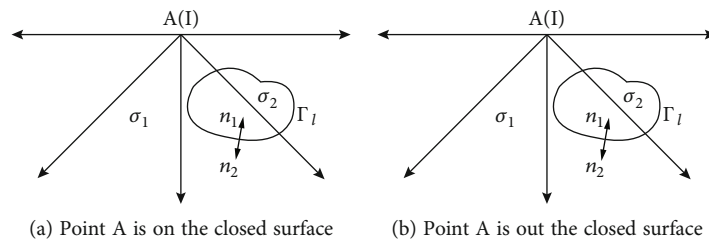
FIGURE 11: Point source 2-D electric field sketch map.

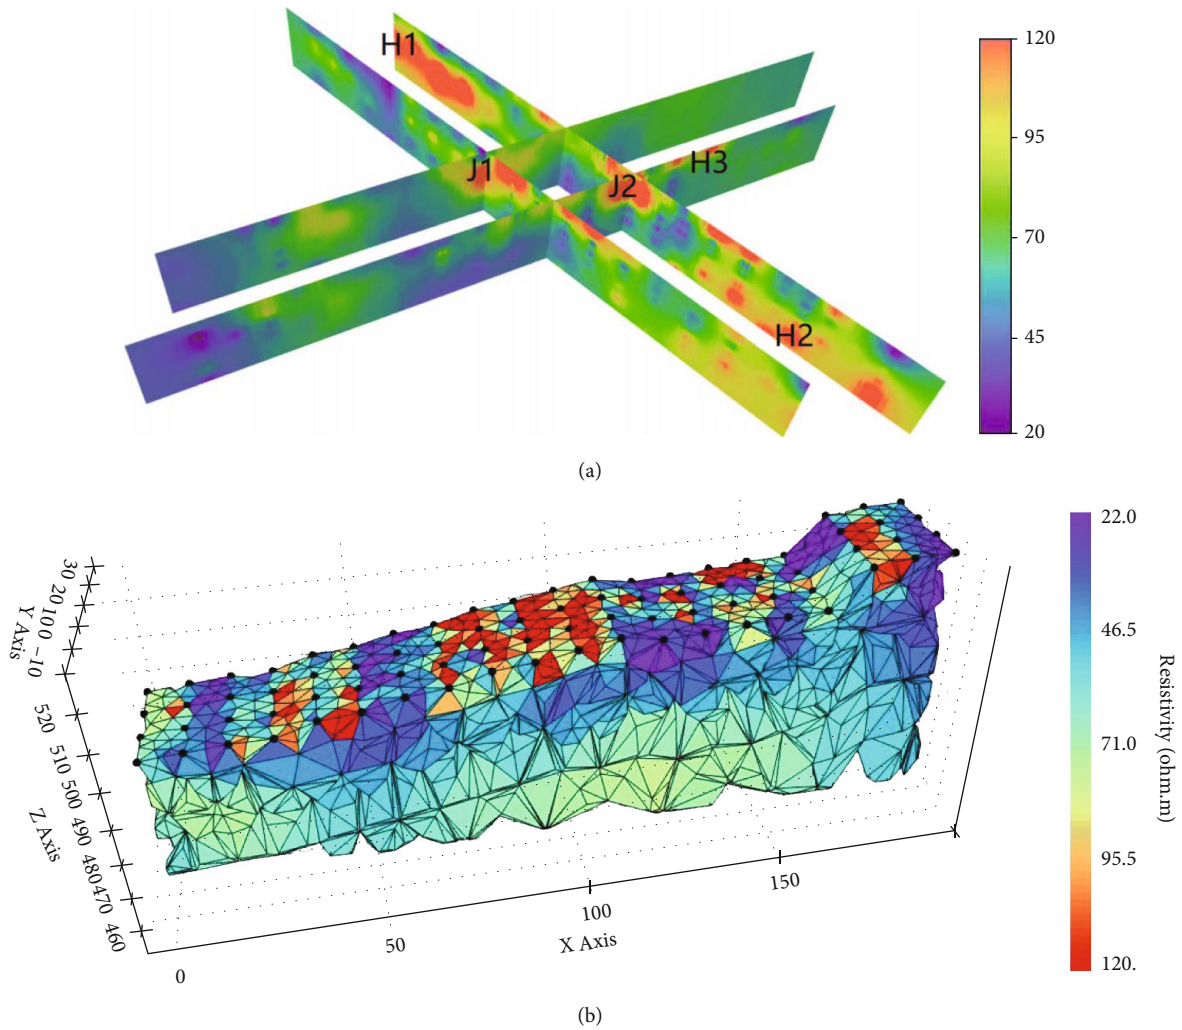
FIGURE 19: Three-dimensional electric resistivity tomography imaging. (a) shows J1 corresponds to the abnormal position of high resistivity of cross-section E and H; H1 largely corresponds to the position of M; H2 indicates the deep extension direction of H, showing high-resistivity anomaly. H3 shows the longitudinal section of the high resistivity of area D, that is, the area where the initial and secondary landslides did not move the hard rock mass. (b) shows the three-dimensional inversion results with grid lines, corresponding to the two-dimensional section, indicating the abnormal position of high-resistivity landslide mass. This is convenient for disaster evaluation and analysis.

4.6. Three-Dimensional Imaging. Several measuring lines were simultaneously arranged across the landslide mass. Each line had a function of electrical sounding. The lines intersected at fixed points, and three-dimensional mapping was conducted to show the differences in the spatial electrical characteristics of the landslide [56]. As shown in Figure 19, the north–south line indicates a relatively low resistivity, whereas the west–east line shows a relatively high

resistance. This is consistent with the results from the vertical and horizontal sections of the landslide from different seasons. J1 corresponds to the abnormal position of E and

H high resistivity in the west-east section; H1 and M are basically in the same position; H2 is basically in the deep extension direction of H, showing a high-resistivity

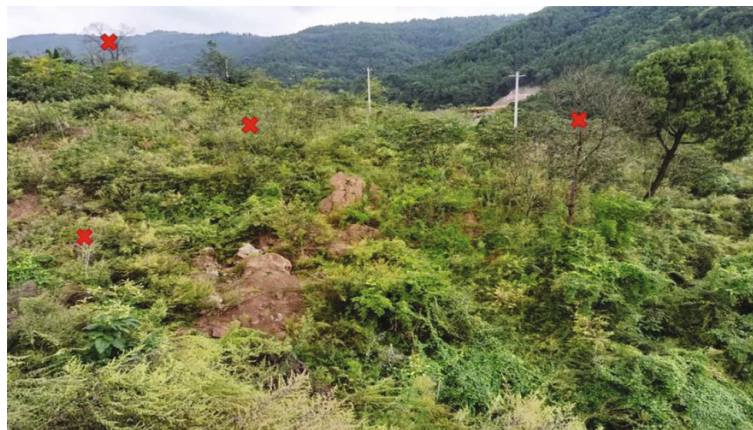
FIGURE 20: The investigation on vegetation death. X shows the plants have died.

5.1. Surface Vegetation Survey. After the landslide, the porosity and moisture content of soil change, which directly affects the growth of plants. As shown in Figure 20, the survival rate of surface vegetation on which plants are taller than 1.5 meters was investigated immediately one year after the landslide. Located in the middle of the Sichuan Basin with a humid climate, the landslide area was clothed with a thick growth of plants. In the vicinity of the landslide mass, there are approximately 215 plants (natural plants and artificially planted plants combined) taller than 1.5 meters, among which 78 have died, with a mortality rate close to 27.6%. Twenty-three plants taller than 4 meters were recorded, of which 12 have died, with a mortality rate of

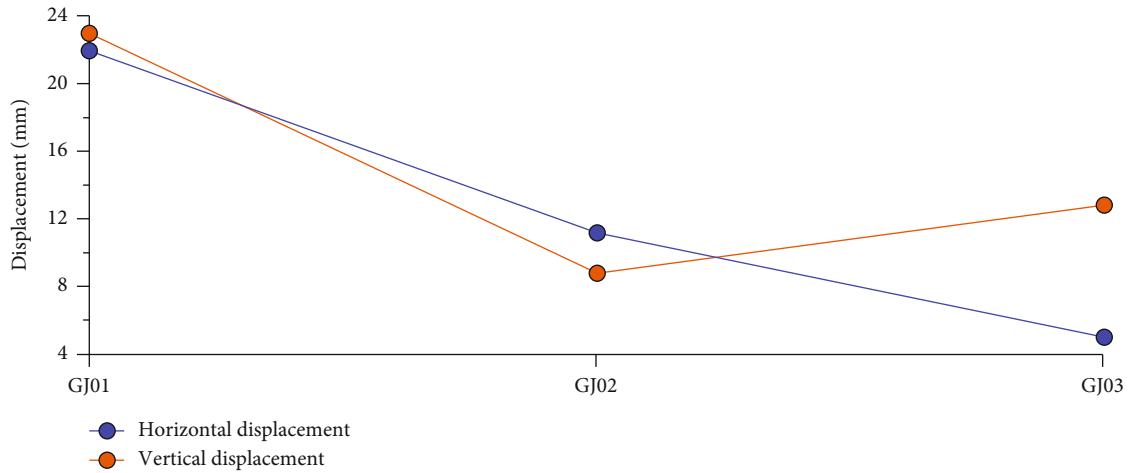
FIGURE 21: Electrical property anomaly and displacement of the surface monitoring station location.

As shown in Figures 21 and 23, rainfall triggered the deformation of the landslide mass. In terms of the geophysics, the anomaly with a high resistance had a large displacement change, while the anomaly with a low resistance had a small displacement change. Through observation of the surface displacements and the utilization of the direct current, the upper fissure change and stability of the landslide will be accurately predicted.

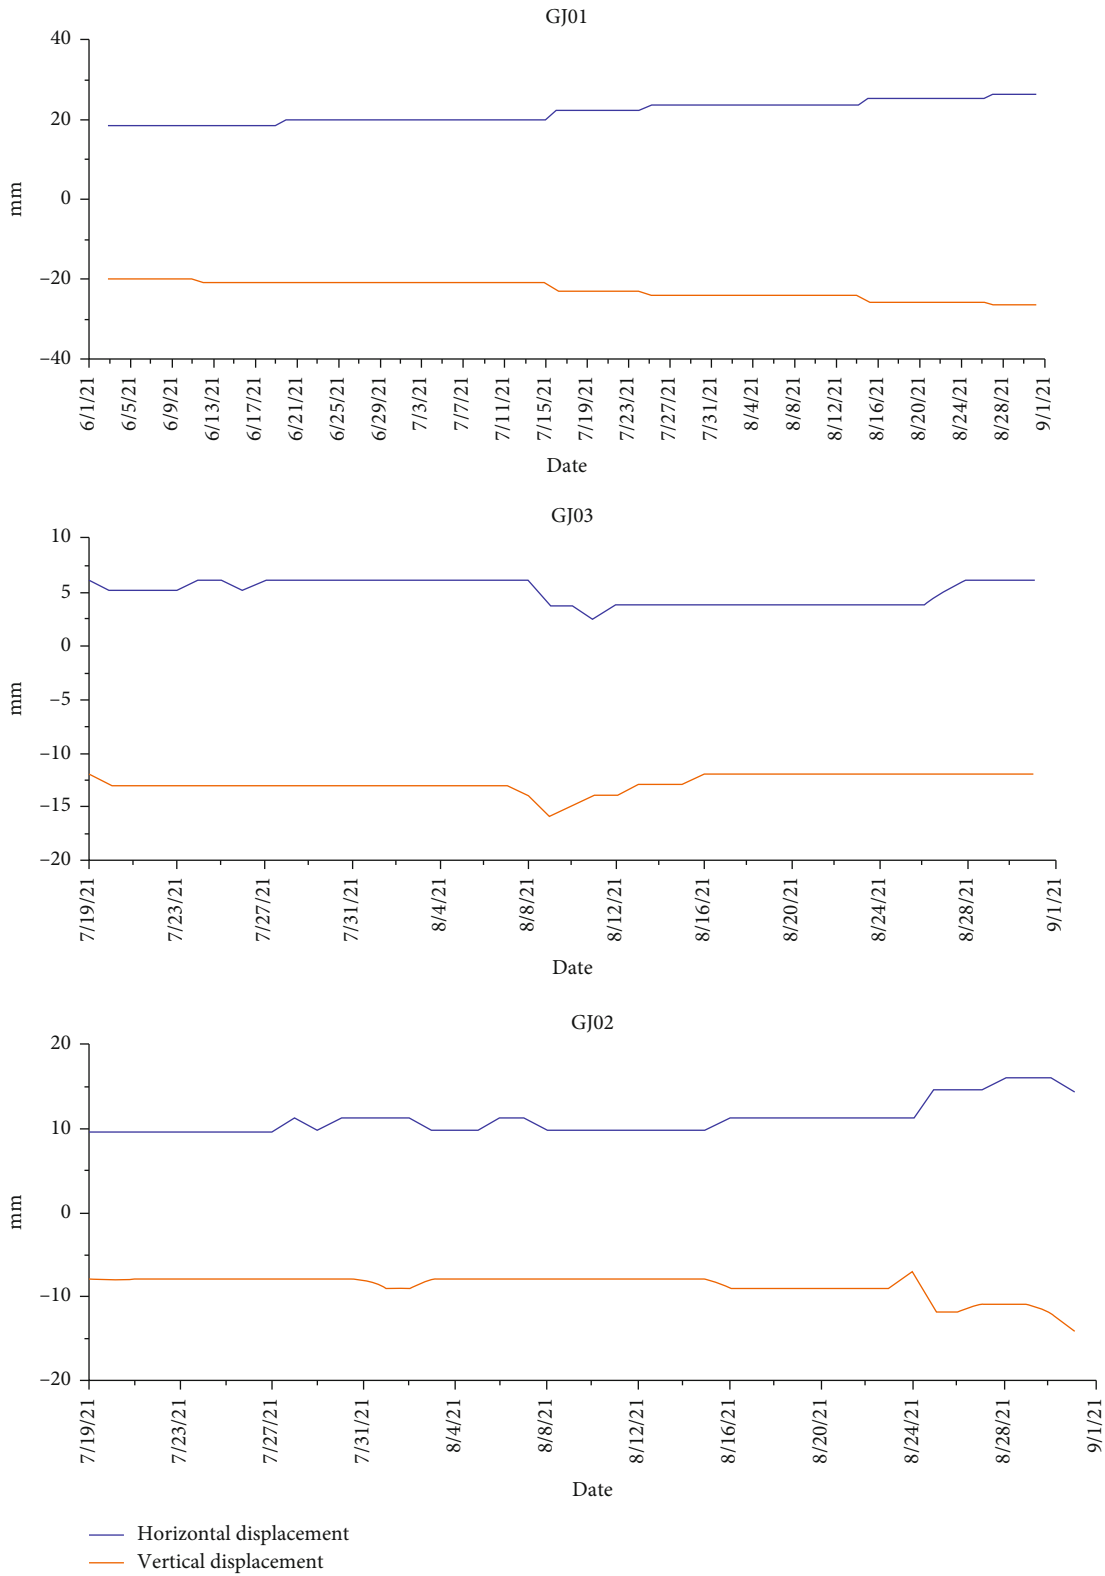
FIGURE 22: Geological Hazard Monitoring: Monitoring point GJ01 is at the rear edge of the landslide mass; monitoring point GJ02 is north of the landslide mass; monitoring point GJ03 is south of the middle of the landslide mass.

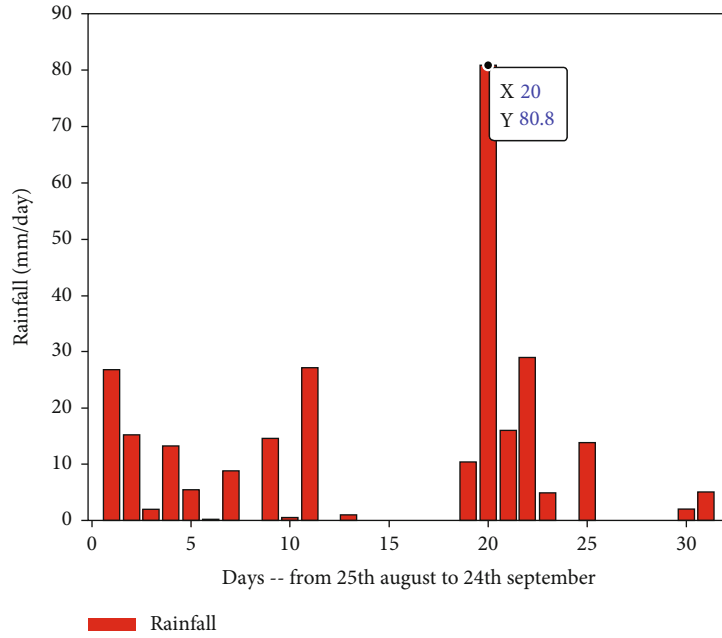
FIGURE 23: Rainfall monitoring results.

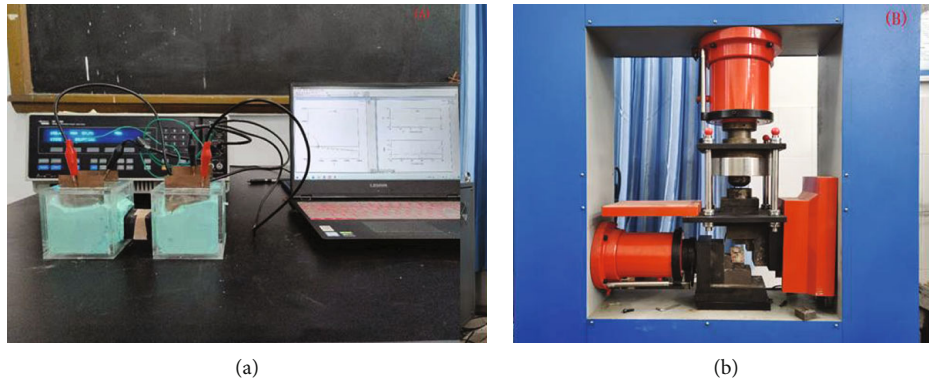
FIGURE 24: The sample test in the lab. (a) is the measurement of electrical characteristic. (b) is the measurement of rock mechanical parameters.
