Research Article

Roadway Instability Mechanism of Weakly Consolidated Soft Rocks and Support Technologies

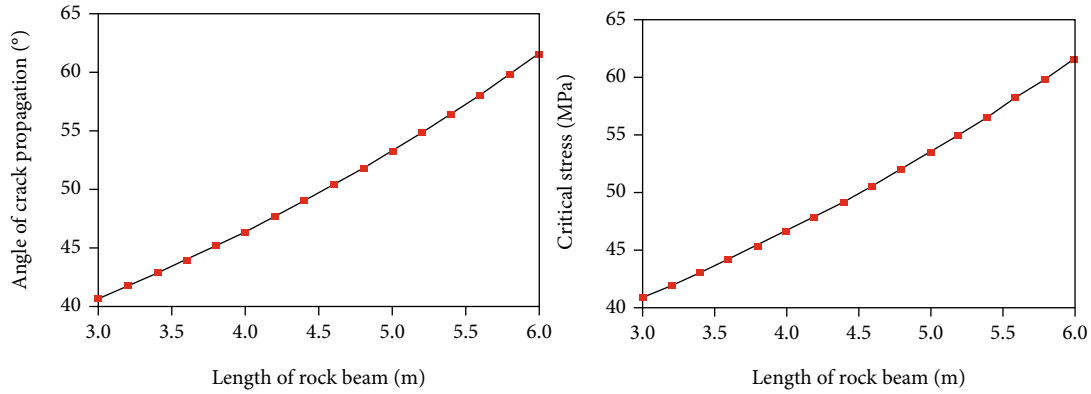
FIGURE 11: Analysis of crack propagation angle and critical stress and length of rock beam.

Figure 11 shows that with the increase of distance to the ends of rock beams, the fracture propagation angle decreases and the critical stress increases. In other words, fractures at the ends of the rock beam are easier to propagate toward large angles. Thus, an inclined anchor rod or cable has to be applied at two ends of the roadway roof to prevent crack propagation.

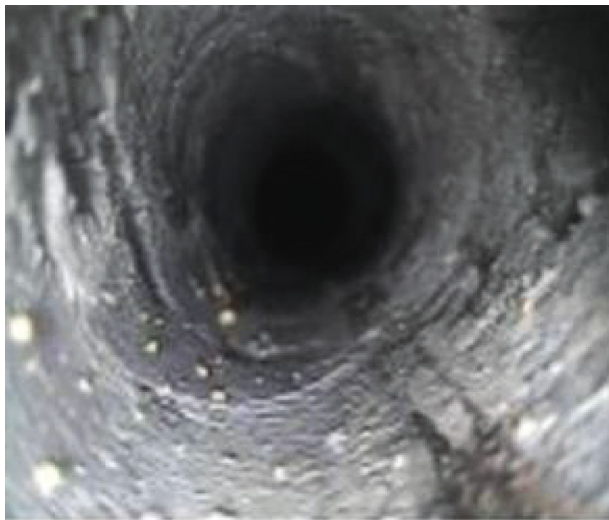
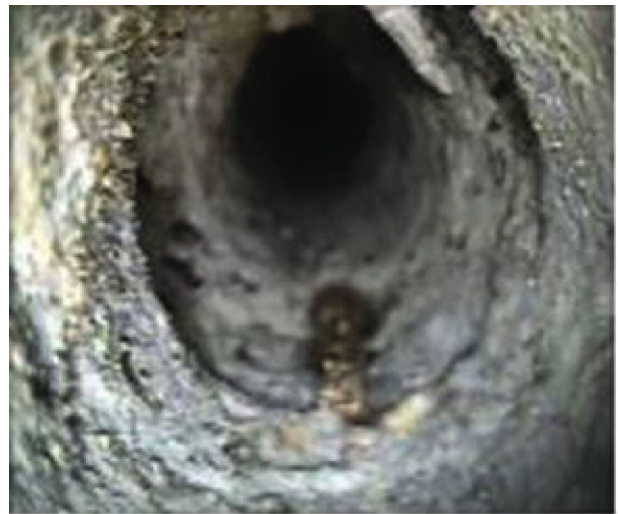
FIGURE 16: Roof borehole peep view: (a) 1.6 m; (b) 6.2 m.

5.2. Engineering Applications. To verify the reliability of supporting technology after the optimization, this study examines the applications of this technology during field experiment in the return roadway of working face #113102 in coal seam #3-1. To further elaborate the effects of optimized supporting scheme in the separation and deflection control of the roof, the internal structure of the roadway roof was studied by using a TS-C0601 drill imager after the roadway was advanced for 10 months. Results are shown in Figure 16.

Through the drill imaging, white cracks were detected near 1.6 m in the upper position of the roof, which were separation layers. The separation layer size was approximately 6–7 mm. Furthermore, an annular black zone within a certain scope occurred on the porous wall, which is 6.2 m near the upper position of the roof, and the separation layer size

was approximately 7–10 mm. In the experimental section, surrounding rocks on the roadway roof were relatively integrals, without evident opening bedding and the separation value of the roof was small. Cracks were not connected yet, which further proved that the optimized supporting structure could effectively control the separation layers, fracture development, and roof connection, thereby improving the overall structure of the roof.
