Failure Mode Analysis and Maintenance of Railway Overhead Line Rigid Stainless Steel Droppers and Multi-Strand Copper Jumpers

¹Electrification & Plant Maintenance, East Coast Route, Eastern Region, Network Rail, London, UK

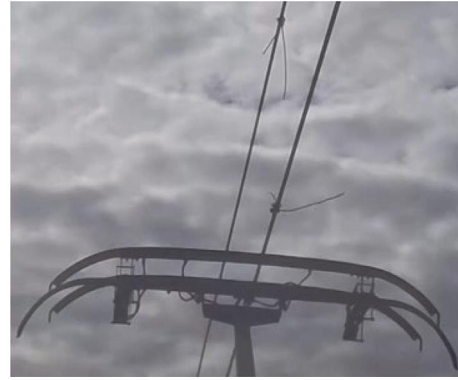
FIGURE 1: Broken dropper wire that could affect pantograph operation.

Outstanding corrective and preventive maintenance both require condition monitoring and dynamic risk assessment [11]. The monitoring used to be, and is still commonly, achieved by placing a watch person at a high-risk location so that any failed equipment will be reported immediately, with mitigation being implemented promptly. Recent advanced sensing technologies and the development of the Internet of Things make remote, labour-free, continuous, and detailed monitoring increasingly cost-efficient, and maintenance records can be stored electronically and accurately for failure investigation and risk analyses [12, 13]. In recent years, published solutions have included fitting sensors to railway overhead line equipment and remotely monitoring overhead line leaning stanchions [14], tension [15, 16], temperature [17], vibration [18], and neutral sections [19]. Because of the droppers’ and jumpers’ small size, substantial quantity, and wide distribution, infrastructure-borne monitoring solutions are likely to incur extremely high capital expenditures and operating expenses. More likely, train-borne cameras and advanced image processing techniques (e.g., [20–23]) will be the approach to monitoring dropper and jumper failures and their deterioration. This monitoring is discontinuous—and sometimes too late, as after a fast-running train identifies a service-affecting failure, the train is very unlikely to have a sufficient response time. Figure 1 shows a typical example of a broken dropper being captured by a fast-running train’s pantograph camera. The train could not slow down sufficiently at such short notice to reduce the risk of the pantograph being hit by the broken dropper wire.

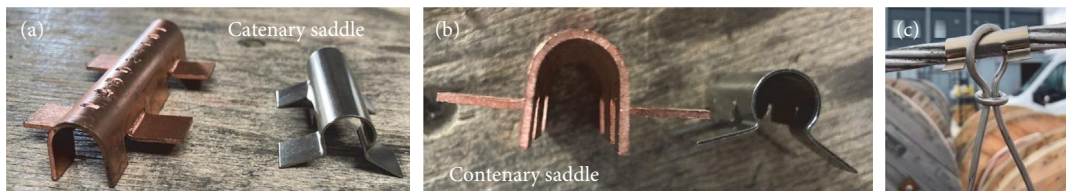
FIGURE 8: (a) and (b) View of contenary and catenary saddle and (c) dropper top fits around catenary saddle.

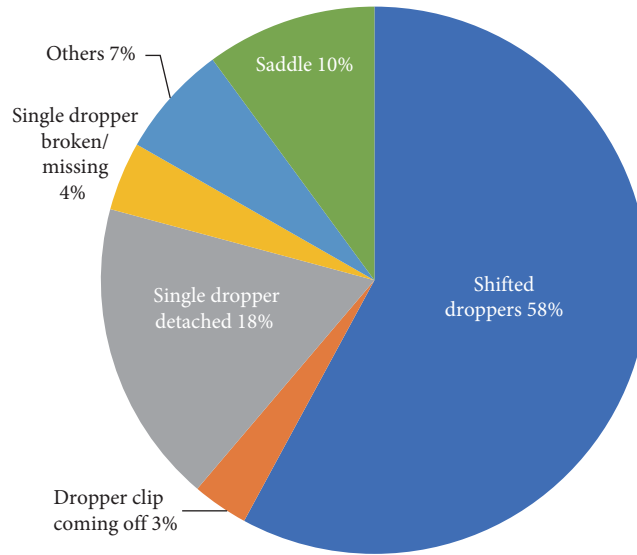
FIGURE 13: Dropper failure modes' proportion in 4 years' maintenance record, 4,050 entries in total.

The above-mentioned dropper failure modes, causes, and effects are summarised in Table 2. Four years’ maintenance

records of 4,050 dropper-related work orders on the ~100 km railway between Cambridge Junction and Stoke Junction have been analysed in this paper. The area includes two fast lines in the centre with ~125 pantographs passing per direction per day at more than 100 mph and two slow lines on the outer having ~85 pantographs passing per direction per day at 75–80 mph. The proportions represented by the various dropper failure modes are presented in Figure 13. The occurrence of the four most common modes shows no distinction between pantograph travelling directions and has been very unlikely on the slower lines (Table 3).

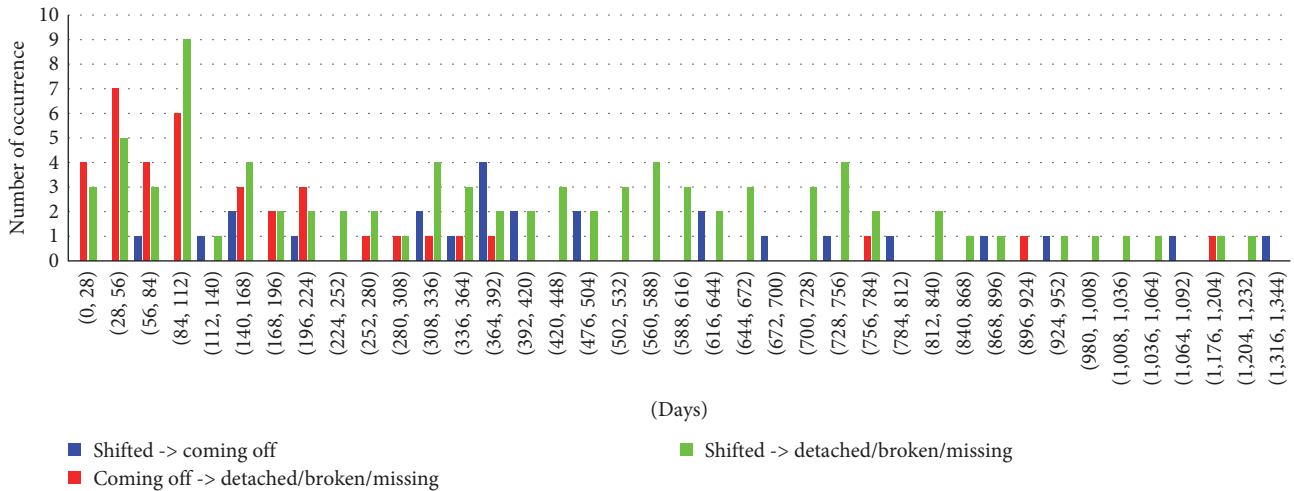
FIGURE 14: Histogram of dropper failures' state transition.

The data includes 146 transitions between single-dropper failure modes, and 84 of the transitions are shifted droppers deteriorating. The transition time is presented in a histogram (Figure 14). The failure modes' identification and transition show no surge in a specific year or quarter in the 4-year period. Many failure modes are also applicable to flexible droppers, though their rate of occurrence is much less than that of the rigid stainless steel type. The following subsections analyse each of the failure modes in Table 2 in detail.

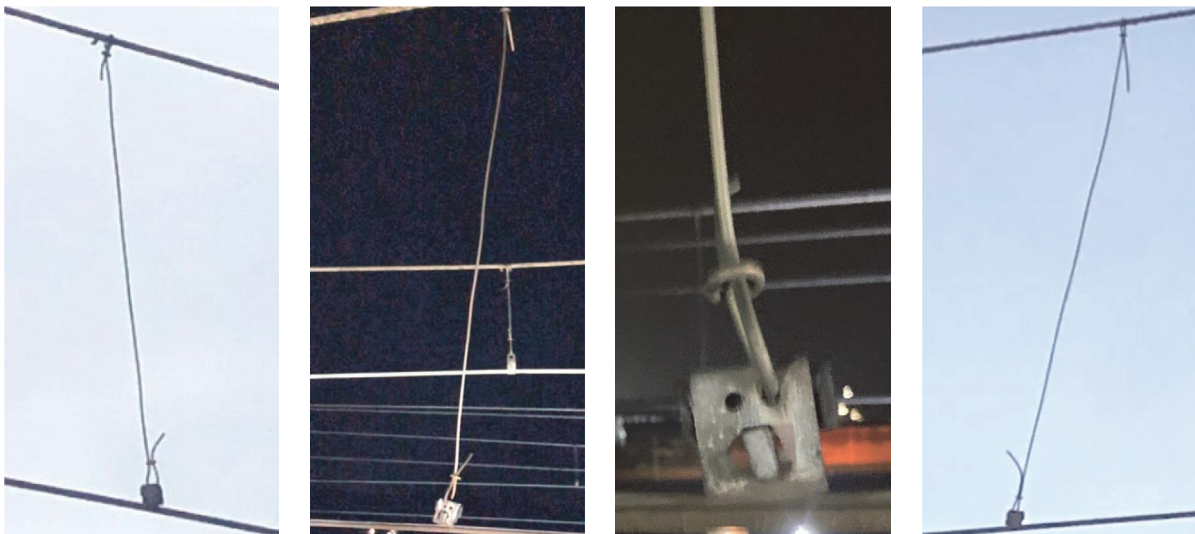
FIGURE 15: Droppers coming off contact wire.

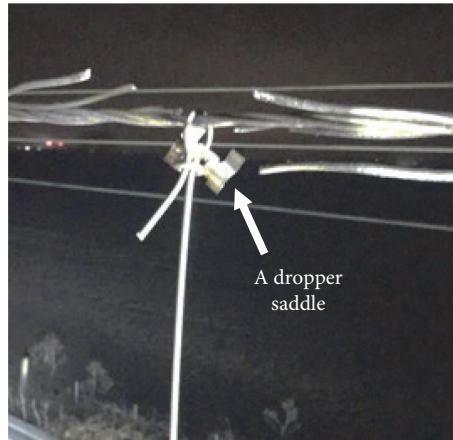
FIGURE 28: Dropper's top loop cuts into aluminium–steel catenary wire.

For contenary wires, the saddle’s protection is also not risk-free. Investigation of the previously mentioned incident (Figures 19 and 20) found that the stainless steel dropper wire wore into its saddle and contenary assembly (Figure 29). This is very hard to spot from the ground. This makes regular high-level inspection important and necessary to identify and prevent wires being severely worn.

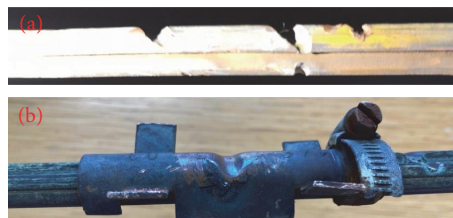
FIGURE 29: Catenary wire (a) and saddle (b) having been worn by stainless steel dropper loop.

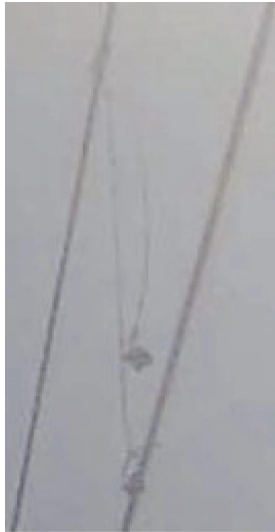
FIGURE 32: Detached dropper runs away.

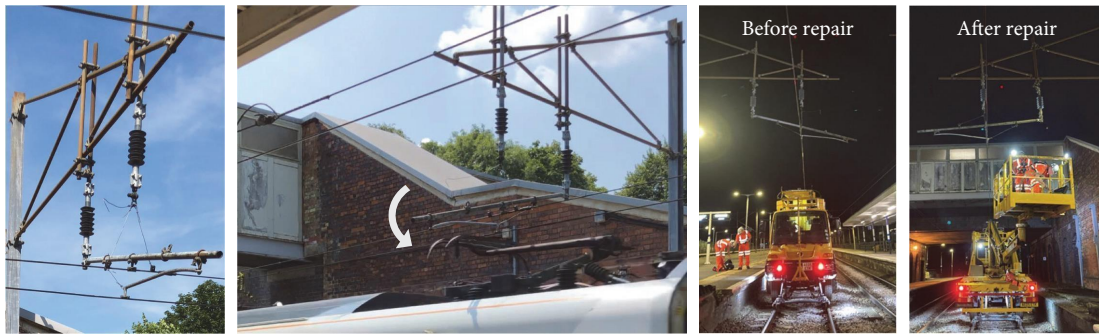
FIGURE 34: Detached nose dropper leads to registration tube falling at far end.

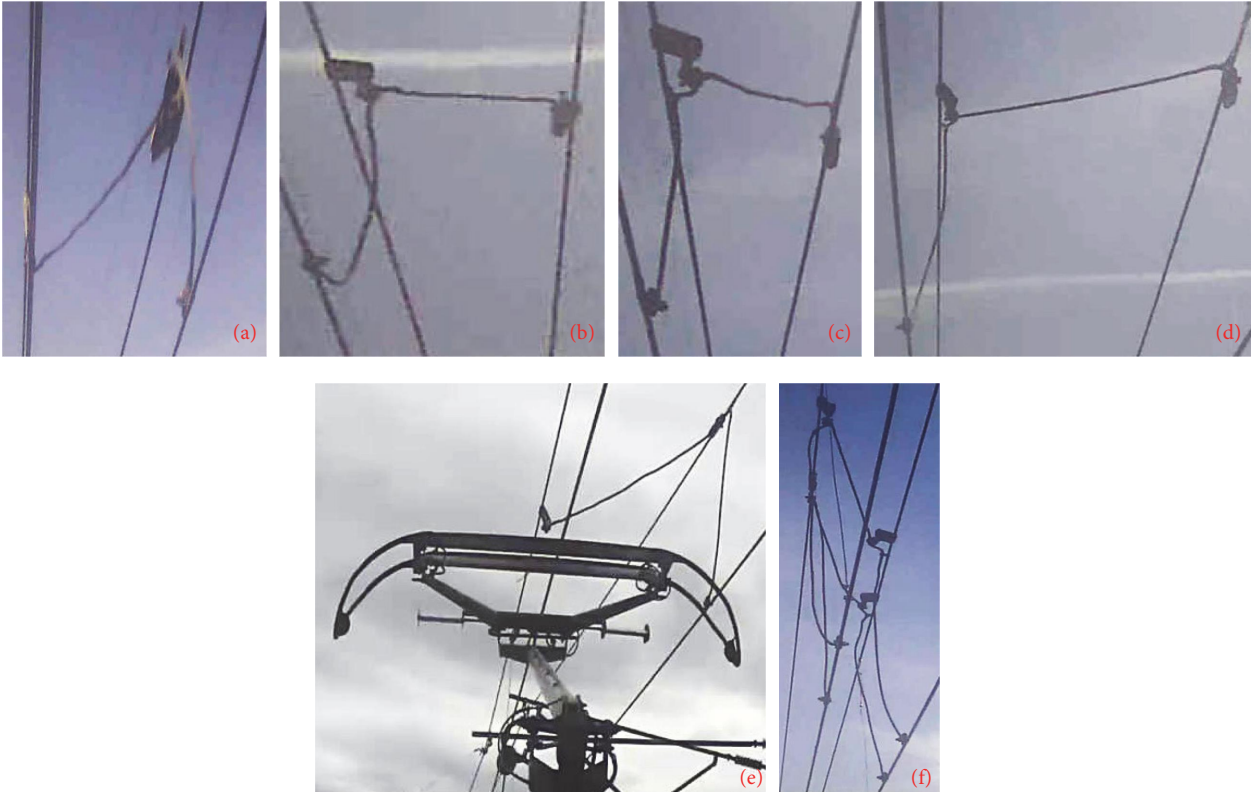
Second, the relative movements of the two wire runs can pull the jumpers tight (Figure 42) or push them sagging (Figures 43 and 44). The former does not affect train services in the short term. The latter shows the importance of checking jumper condition and maintaining a mechanical clearance (on the ECML, the clearance needs to be minimum 300 mm) between the jumper's belly and the lower contact

FIGURE 42: Tight potential-equalising (a–e) and full-drape (f) jumpers.

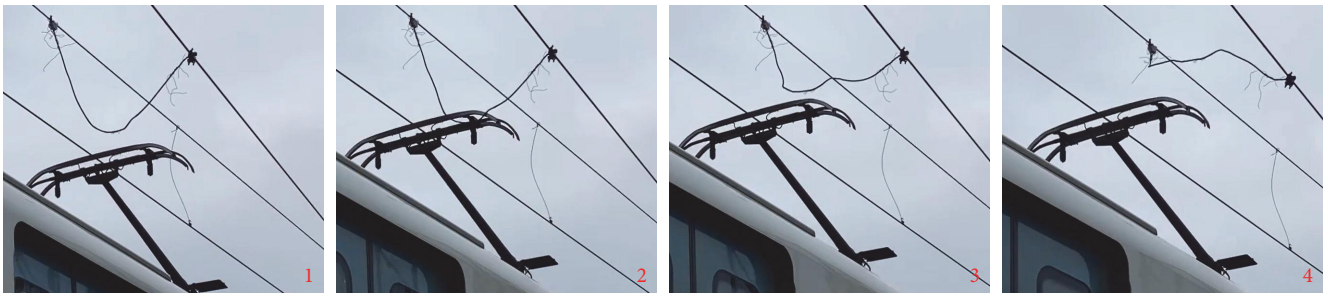
FIGURE 44: Loose jumper hits passing pantograph, 1 → 2 → 3 → 4.

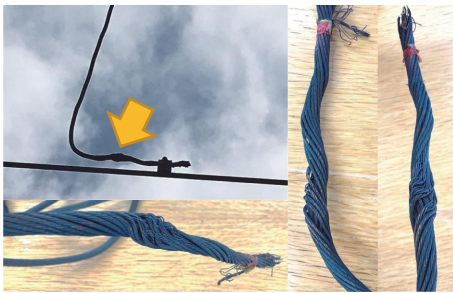
FIGURE 46: Caged jumper near overhead line neutral section.

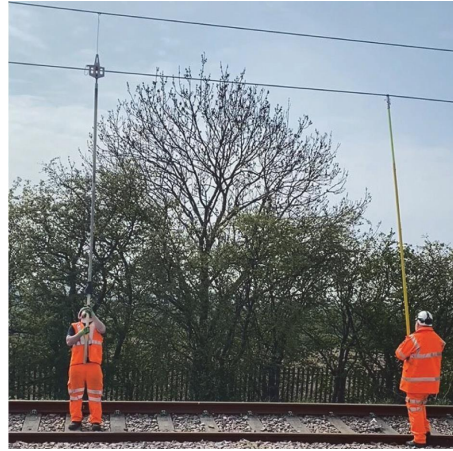
FIGURE 49: Staff installing a rigid stainless steel dropper on the ground that the left staff is installing while the right staff is pushing up the wire.

6.1. Failure Repair. The installation and removal of a "key" clip dropper can be completed on the ground by a set of live line dropper tools on the end of insulated poles (Figure 49) or at a high level with staff in the basket of a MEWP (Figure 50) with the overhead line being earthed. The former is often considered a temporary repair. A black or red plastic tag is usually attached to the middle of the dropper's wire to ease the installation. This can be used as a reminder of the droppers being replaced in this way. When the time of track access is insufficient for repair, staff may cut away the bottom

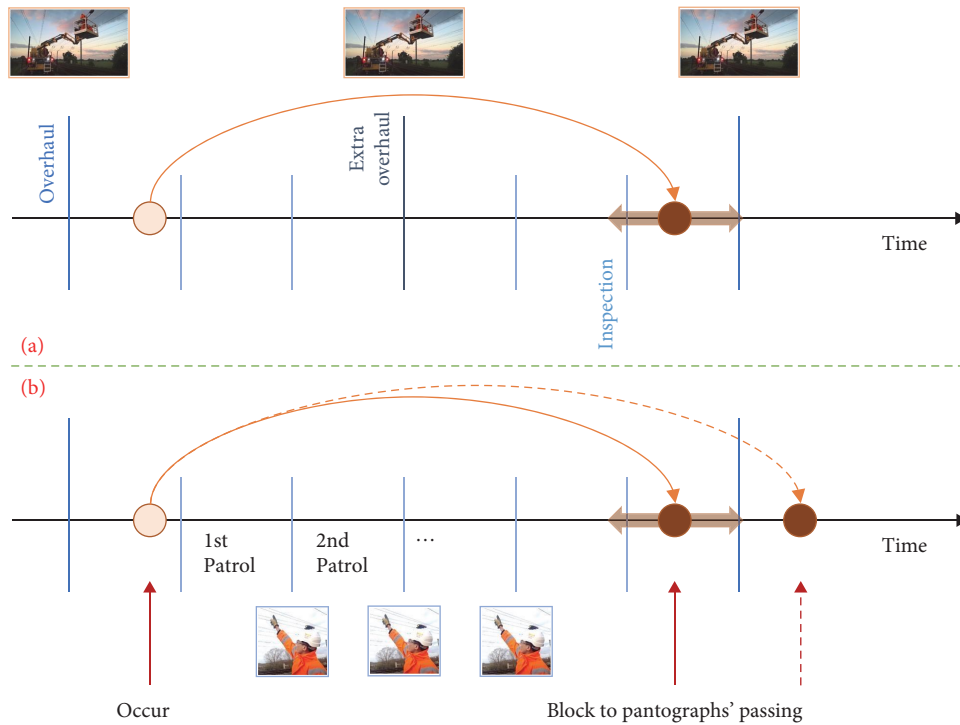
FIGURE 51: Prevent failure causing significant service disruptions in schedule-based maintenance: (a) double the overhaul’s frequency to repair the failure earlier and (b) implement special arrangements to slow down the deterioration.

Maintenance staff can plan inspection every 12 weeks, a cab ride every week, and overhaul every 4 years where the speed is more than 100 mph or 6 years where the speed is less (although nearly all of the dropper failures occur on the fast lines, the slow railway lines are mentioned here because they are next to the fast lines on the ECML and the planned access on slow lines can sometimes be amended at short notice and used to rectify the droppers on their adjacent fast lines). Each ground-level inspection may cover 2–6 km, depending on signalling capacity and access availability, and the majority of the inspections may be carried out at night to minimise the impact on train operations. Overhauls may need to be planned half a year in advance; access involves earthing the overhead line equipment, which is much more complicated and time-consuming than access for ground-level inspection. In such a situation, overhauls can be scheduled and distributed evenly on the time and the geographical horizon (Figure 52) so that when an urgent dropper or jumper failure is identified, instead of staff

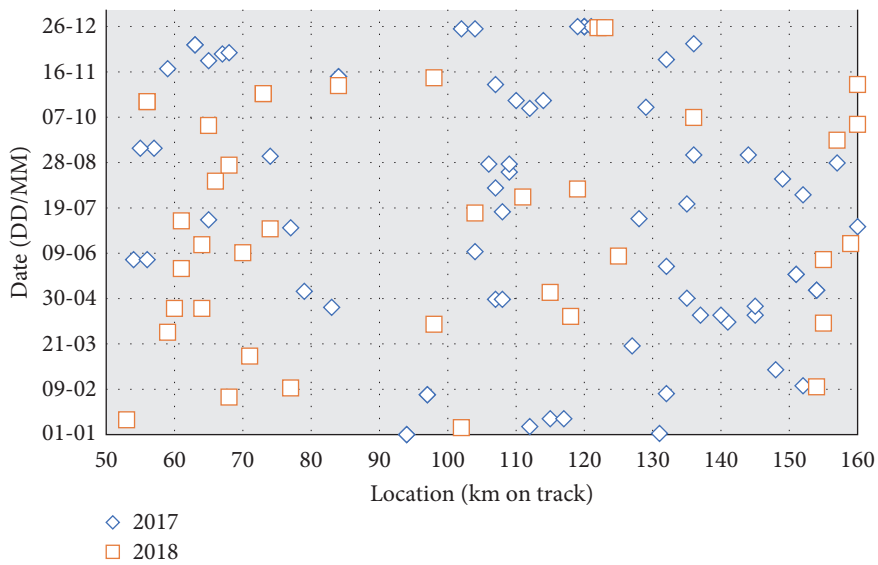
FIGURE 52: Overhauls are scheduled and distributed evenly on the time and geographical horizon, 2017 and 2018’s maintenance records.
