Research Article

Laboratory Assessment of Select Methods of Corrosion Control and Repair in Reinforced Concrete Bridges

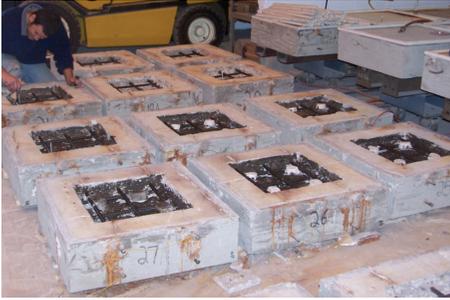
FIGURE 6: Patch repairs of laboratory specimens.

chloride ingress. Patch repairs were then performed (Figure 6) and the various treatments were applied. The patch repair consisted of saw-cutting the perimeter of the square patch area (16 in. (40.6 cm) \times 16 in. (40.6 cm)), chipping out the concrete, cleaning the exposed reinforcing steel bar with a drill and wire wheel accessory, applying an epoxy coating to the steel bar, applying a bonding agent to the concrete substrate, and placing the patch repair material. The coating of the steel bar and the application of bonding agent within the patch area were based on patch material manufacturer's instructions and in accordance with conventional patch repair practices. Following anode installation directions, care was taken not to coat the points of electrical continuity (locations where the bars intersect), the connections of the anodes to the reinforcing steel, or the anodes themselves.

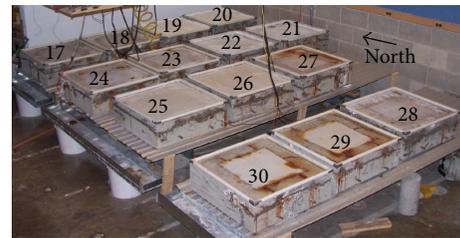
FIGURE 10: Surface staining on laboratory CoC specimens after 6 months.

3.4. Surface Staining and Steel Corrosion. To provide a quantitative measure of the condition of the specimens after exposure to accelerated corrosion testing, a visual examination of the rust staining on the concrete surface and exposed reinforcing steel was performed, so that a numerical rating could be assigned to each specimen. The condition of the CoC specimens after 6 months of exposure and dissection is shown in Figures 10 and 11, respectively.

Based on a rating scale of 0 to 4, with 0 being the best condition and 4 being the worst condition, rust staining on the surface of the specimens as well as the level of section loss in the reinforcing steel was evaluated. The rating scale for staining was based purely on visual examination; the more severe the staining, the higher the grade. The rating scale for the condition of the reinforcing steel was based on the loss

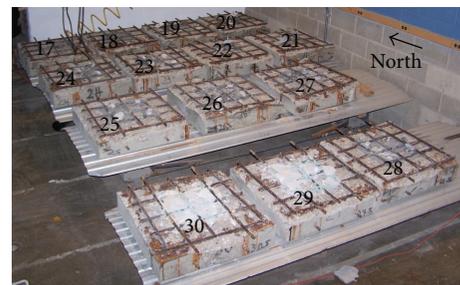
FIGURE 11: Dissected laboratory CoC specimens.

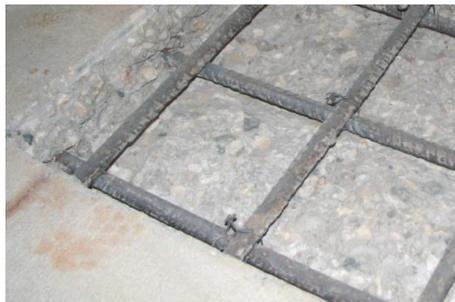
FIGURE 12: Steel rating of 2 and 3 (close-up of exposed Rebar of control after 3 months).

of ribs (Figures 12 and 13). If no corrosion by-products were present, a rating of 0 was given. If it appeared that all of the ribs were lost, a rating of 4 was given. If, on average, 1/4, 1/2, or 3/4 of the ribs were lost, ratings of 1, 2, and 3 were given, respectively. This rating was given to each of the top-layer bars in each specimen. The ratings were then averaged for each specimen. The two separate ratings (staining and loss of steel section) were then added together, for a maximum value of 8, to determine a combined rating.

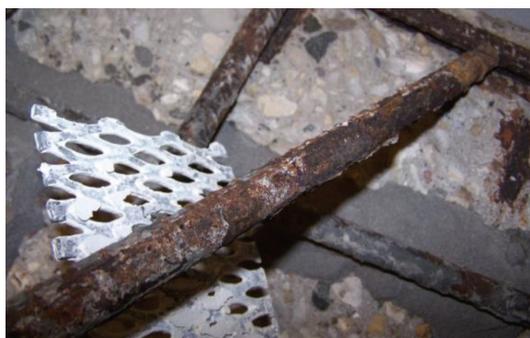
FIGURE 13: Steel rating of 4 (close-up of exposed Rebar of TSZ w/EP-C after 6 months).
