Research Article

Corrosive Environment Assessment and Corrosion-Induced Rockbolt Failure Analysis in a Costal Underground Mine

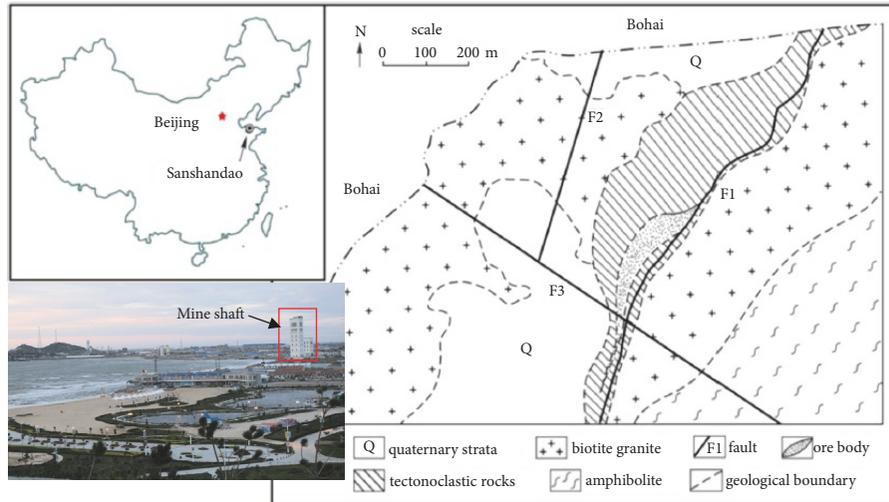
FIGURE 1: Hydrogeological sketch of the Sanshandao Gold mine.

Sanshandao mine is an underground gold mine located in Jiaodong Peninsula where the largest gold resources in China exist. As shown in Figure 1, the mine is a coastal mine and

a part of the deposit is under the sea. The hydrogeology of the mine is complex because three faults with a range of thickness 1~10 m exist in the mine area. Moreover, the fault F2 develops into the Bohai sea, which results in a powerful water conductivity. For evaluating the groundwater condition, a groundwater gushing survey is first carried out.

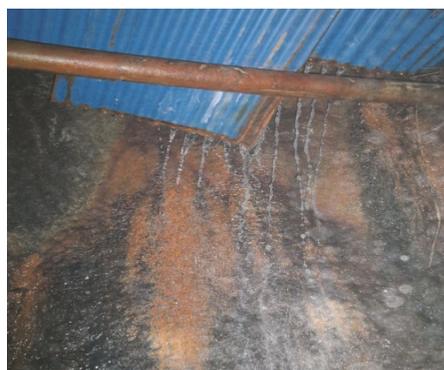
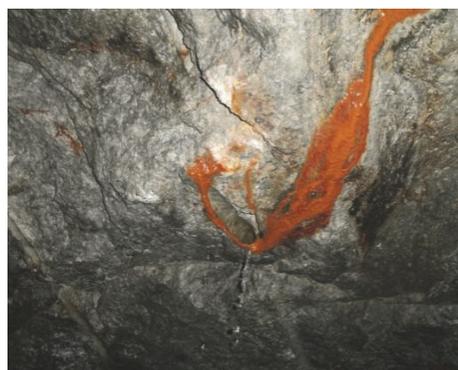
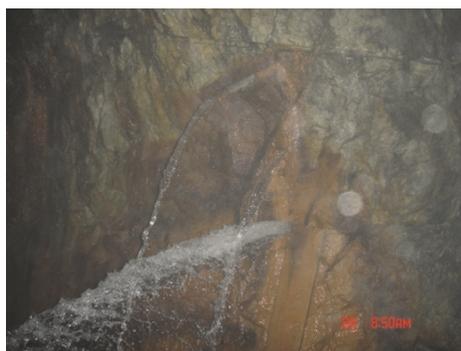
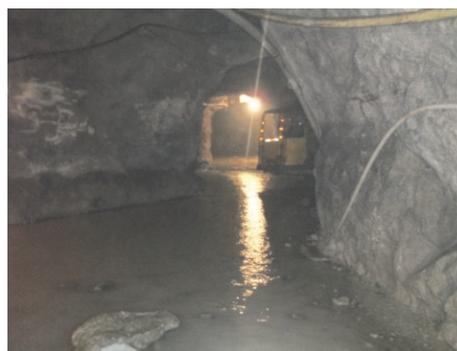
(a) Water gushing from the roof

(b) Water seepage from the roof

(c) Water gushing from the sides

(d) Water accumulation at the floor

FIGURE 2: Groundwater condition in the Sanshandao Gold mine.

The groundwater inflow in the roadways of the mine is shown in Figure 2. It can be seen that the groundwater is very rich in the mine. The water gushes and seeps out from the surrounding rock. According to the metallogenic and geological condition, probably the groundwater comes from the ancient seawater stored in the rock. Figure 2(a) illustrates that the support steel has been corroded. Figure 2(b) shows that the rock surface has been dissolved at the roof of the roadway. The red-brown substance is corrosion products of minerals in the rock. The total water inflow of the Sanshandao Gold mine is approximately 14,000 m³/day.

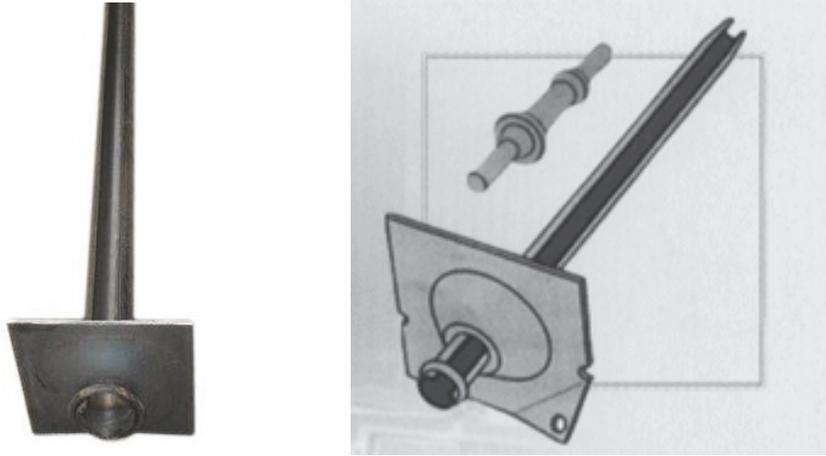
FIGURE 3: Slotted rockbolts used in Sanshandao gold mine.

m level where the ground stress is very high. To ensure that roadways are stable and safe, a large amount of rockbolt is used to support rock. In consideration of mining cost, rockbolts used in the mine are the slotted metal bolt as shown in Figure 3. After the excavation of roadways, boreholes are drilled and then the slotted bolts are installed into the boreholes. The diameter of boreholes is smaller than that

of the rockbolt. A radial spring force is created by the compression of the C-shaped steel tube and a tight friction contact between the rock and the bolt is generated. There are many faults and fractures around the rock of roadways, which can be passes of the groundwater. As illustrated in Figure 4, the groundwater flows from the fault and fractures into roadways and reaches to attack the rockbolt. Because of the high content of chloride ion and low pH value of the groundwater, the electrochemical corrosion cells form and then the rockbolt gradually corrodes. Hassell concluded corrosion rates of rockbolt under several underground mines in Australia [15]. The corrosion rate and working conditions of rockbolts are introduced in Table 2. It can be seen that the corrosion rate in different corrosive environment ranges from 0.08 mm/a to 1.32 mm/a. And the temperature has a significant influence on the corrosion rate. According to the theory of reinforcement corrosion in concrete, the higher the temperature is, the larger the corrosion rate of steel bar is [18, 19]. The temperature of groundwater in Sanshandao gold mine varies from 35°C to 45°C. The deeper the mining depth is, the higher the temperature is. The average chloride ion content of the groundwater in Sanshandao mine is about seven times larger than that in Enterprise mine. Moreover, the pH value of the groundwater in Sanshandao mine is lower than that of mines in Table 2. It can be estimated that the corrosion rate of rockbolts in Sanshandao gold mine is higher than or similar to that of mines in Table 2. It should be mentioned that the corrosion rate of rockbolt

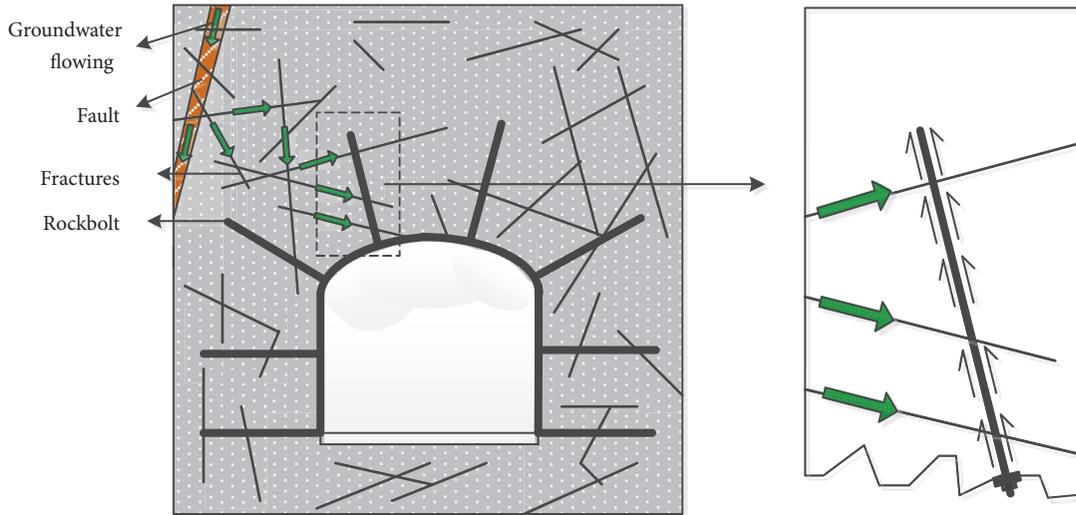
FIGURE 4: Rockbolt attacked by the groundwater.

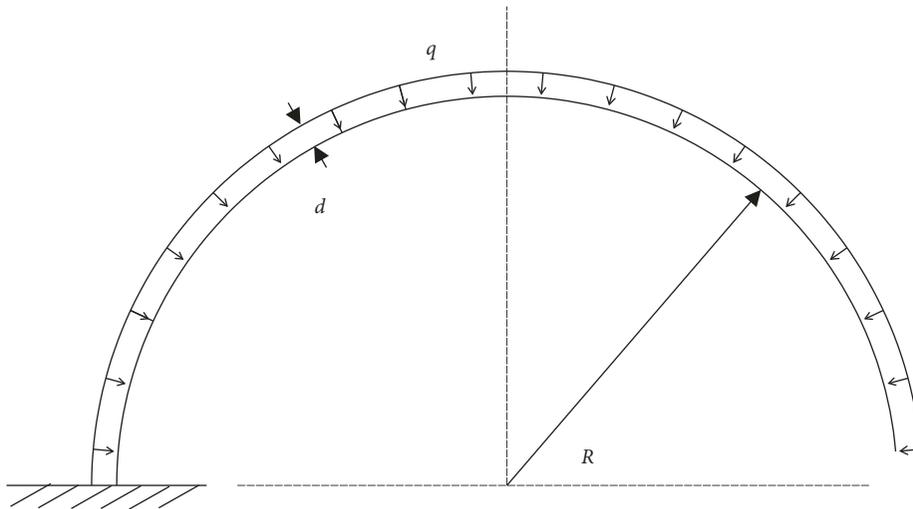
FIGURE 5: Mechanical model of the slotted rockbolt.

3.2. Anchoring Force Degradation Induced by Rockbolt Corrosion. The anchoring force of rockbolt is the maximum force when pulling out the rockbolt from the rock, which is the most important parameter for assessing the effect of support. Most researches on rockbolt supporting did not consider the corrosion of rockbolt. The mechanical model of slotted rockbolt is shown in Figure 5.

The model describes a two-dimensional plain strain problem. The load between the rock and the rockbolt is assumed as uniform. The maximum stress of circular tube can be expressed as

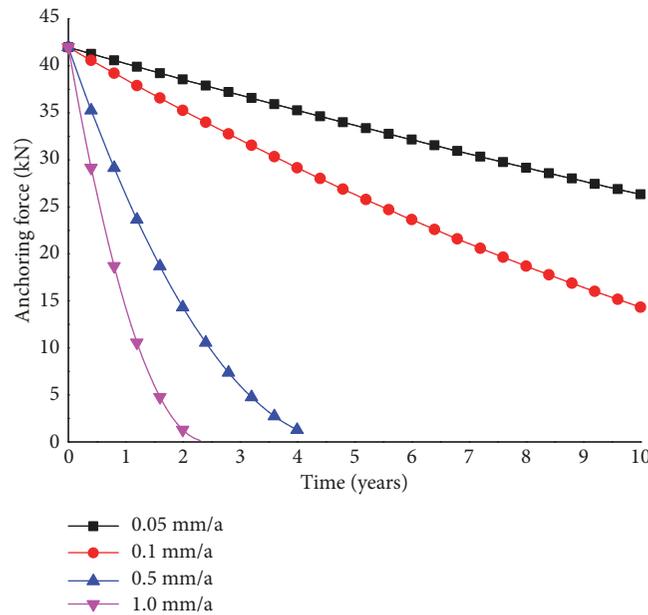
FIGURE 6: Anchoring force degradation induced by rockbolts corrosion.

Figure 6 illustrates the time-dependent anchoring force under different corrosion rates. It can be seen that the original anchoring force of the rockbolt is about 42 kN which has a good agreement with the design value. The initial anchoring force can ensure the stability of roadways in Sanshandao gold mine. With the service time increasing, the anchoring

force is gradually decreasing. It is because corrosion reduces the effective thickness of the slotted rockbolt. The larger the corrosion rate is, the faster the anchoring force decreases. When the corrosion rate is 1 mm/a, the anchoring force decreases to half of initial value at first year, while when the corrosion rate is 0.05 mm/a, the anchoring force decreases to about 60% of the initial value at tenth year. Therefore, corrosion of the rockbolt has great significant influence on the anchoring force. If the corrosion has not been considered when designing or using the rockbolt, the roadways may be unstable in the serving period. It should be noted that the analysis on the anchoring force only considers the thickness reduction of the slotted rockbolt. The effects of corrosion products on frictional coefficient and stress corrosion cracking of rockbolts are not considered. In fact, with the corrosion degree increasing of rockbolt, the corrosion products will be washed away by the flowing groundwater. The strength of rockbolt would be reduced because of corrosion. Moreover, the stress corrosion of rockbolt may occur under high stress conditions. However, the effects of corrosion on the frictional

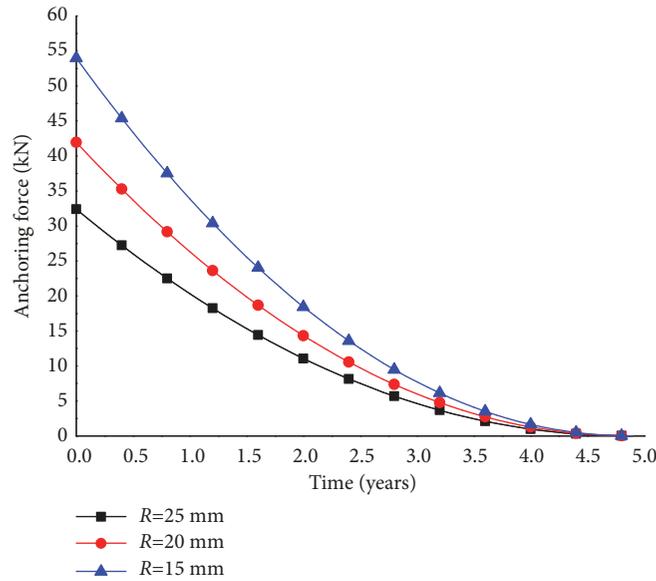
FIGURE 7: Anchoring force degradation under different radius of rockbolts.

3.3. Parametric Studies of the Rockbolt on Anchoring Force Degradation. The radius, thickness, and length of the slotted rockbolt are three important parameters when designing a rockbolt. Taking corrosion rate 0.5 mm/a as examples, the effects of radius, thickness, and length of slotted rockbolt on anchoring force are discussed. Figure 7 shows the anchoring force degradation under different radius of the rockbolt. The smaller the rockbolt radius is, the larger the anchoring force is. With the increasing of corrosion time, the anchoring force is smaller and smaller. The radius of rockbolt has little effect on the final failure time. However, in the effective service period of rockbolts, a smaller value of rockbolt radius has a better anchoring ability for roadways. Figure 8 illustrates the anchoring force under different thicknesses of slotted rockbolts. It can be found that the thicker the rockbolt is, the larger the anchoring force is. For a slotted rockbolt with

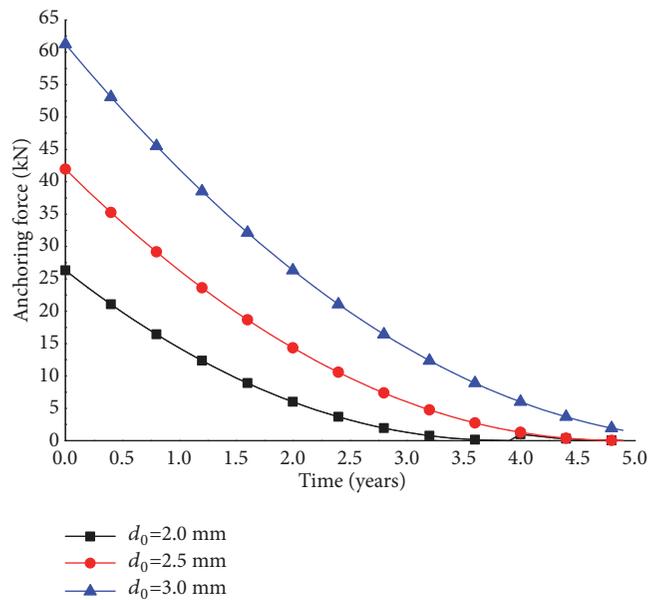
FIGURE 8: Anchoring force degradation under different thicknesses of rockbolts.

thickness 2.0 mm, the anchoring force reduces to 10 kN at about 1.5 years when the anchoring force for thickness 3.0 mm is about 35 kN. Therefore, for roadways under a corrosive environment, it is necessary to use a thicker slotted rockbolt. The effect of lengths of rockbolts on anchoring force is shown in Figure 9. It can be seen that the longer the rockbolt is, the larger the anchoring force is, while for long-term service time of rockbolt, the anchoring forces are similar for different lengths of rockbolts.

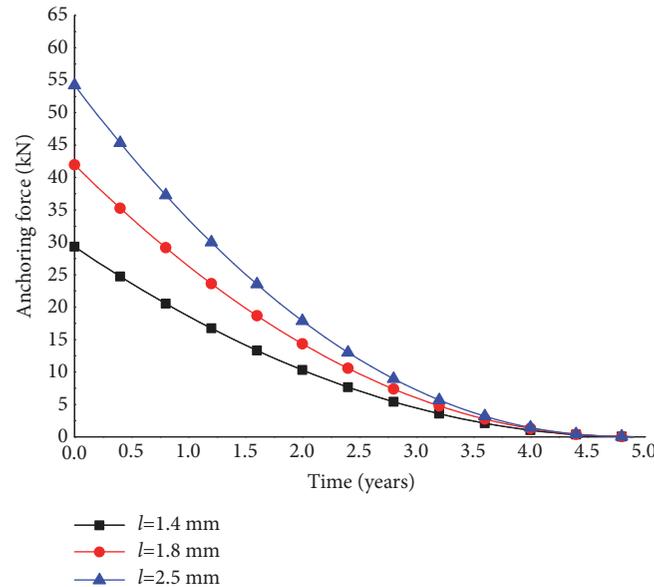
FIGURE 9: Anchoring force degradation under different lengths of rockbolts.
