Research Article

Study on Susceptibility and Mechanism of Reheat Cracking in Welded Joint of Type 347 Austenitic Stainless Steel

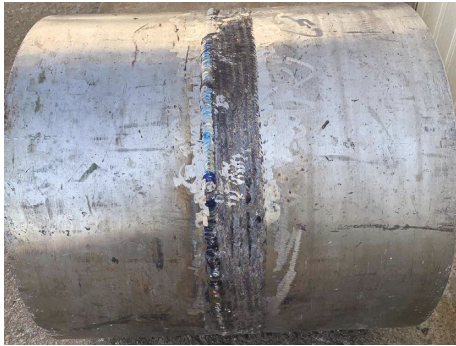
The completed welding specimen *M* is shown in Figure 2. After welding, the as-welded condition was maintained, welding specimen *M* was visually checked to find that the weld surface was uniform, the overlap between weld passes was even and grooveless, the transition to base material at weld toe was smooth, and the surface was free of defects such as pore, undercut, and slag inclusion. After the satisfactory visual inspection, the specimen passed RT and PT.

FIGURE 2: Welding specimen M.

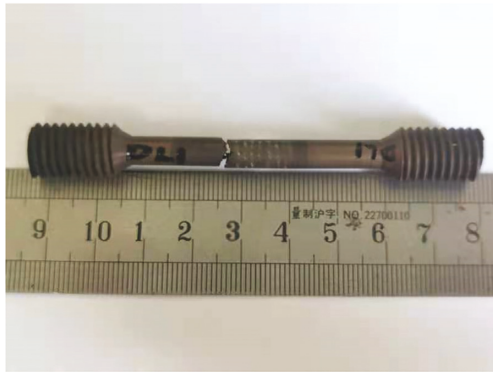
3.1. High-Temperature Constant Load Test Result and Analysis. See Figure 5 for the specimen fracture appearance in the high-temperature constant load test. See Table 4 and Figure 6 for test result.

All fractures occurred in the weld zone, and this means the strength of the weld zone is lower than that of HAZ and base material. There was no visible necking on the specimen, and this means the plasticity of the welded joint is low.

FIGURE 5: Appearance of fractured constant load test specimen.
