Research Article

Effect of Incisal Porcelain Veneering Thickness on the Fracture Resistance of CAD/CAM Zirconia All-Ceramic Anterior Crowns

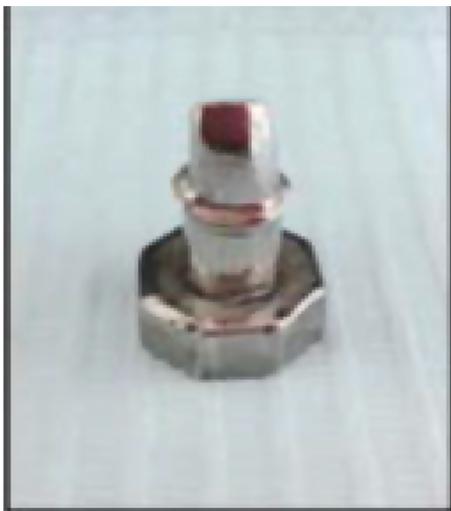
FIGURE 1: Stainless steel master die.

2.2.1. Preparation of Master Die. A specially designed stainless steel metal master die was milled to simulate the maxillary central incisor crown prepared to receive metal ceramic and all-ceramic full coverage crowns (Figure 1). The apico-coronal height of the prepared metallic die was 6 mm, with a mesiodistal dimension at the cervix of 5 mm, while the labiolingual dimension at the cervix was 4 mm and the width of the incisal edge was approximately 4 mm mesiodistally and 1.5 mm labiolingually. The axial wall taper was approximately 6 degrees on each side and 12 degrees total convergence angle. All transitions from the axial to the incisal edge were rounded and smooth.

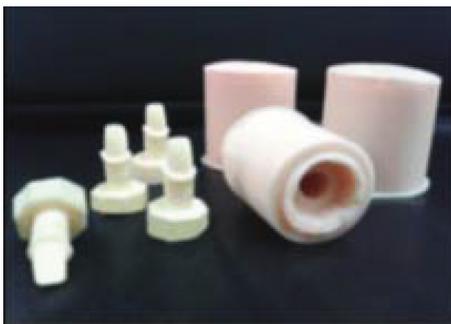
FIGURE 2: Epoxy resin replicas of master die.

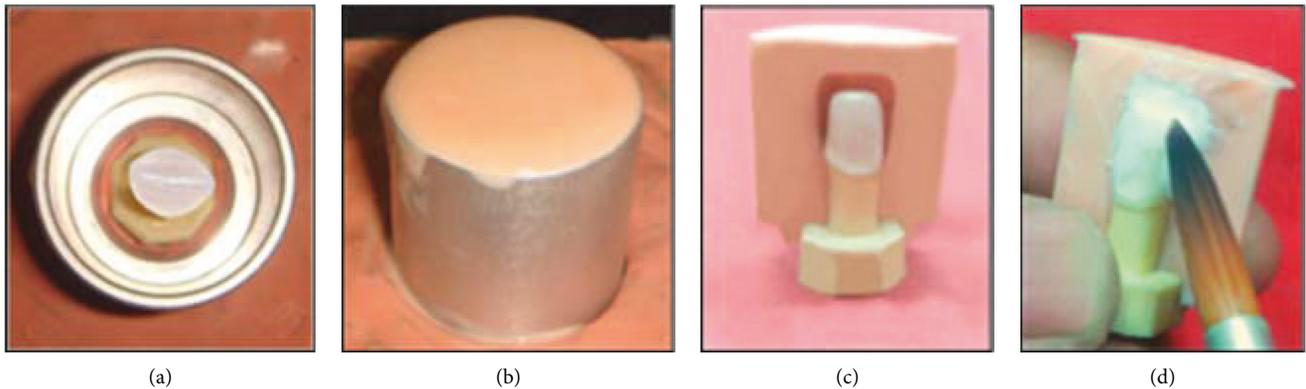
FIGURE 3: Making impression of full contoured CAD/CAM zirconia crown: (a) CAD/CAM zirconia coping inside the metal ring; (b) metal ring filled with the duplicating material; (c) split mold adapted on lined zirconia coping; (d) application of body porcelain and condensation.

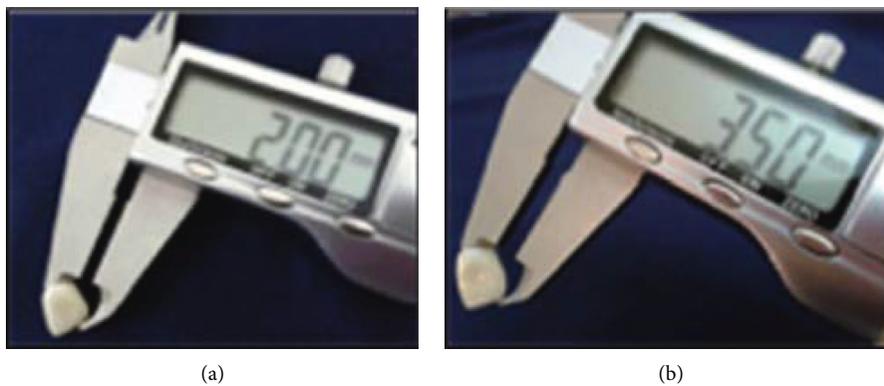
FIGURE 4: Checking thickness of the finished CAD/CAM zirconia all-ceramic crown: (a) all-ceramic crown of 2 mm incisal thickness; (b) all-ceramic crown of 3.5 mm incisal thickness.

only difference was in the incisal edge thickness. One of the specimen had 2 mm incisal edge thickness (0.5 mm core, 1.5 mm veneer), and the other had 3.5 mm incisal edge thickness (0.5 mm core, 3 mm veneer); the thickness of both was checked using the Iwanson gauge. Two impressions were made for the full contoured crowns from duplicating addition silicon with the aid of a metal ring to reproduce two silicon molds (mold #1 and mold #2) which were then split along the long axis to be used as guidance during building of the porcelain veneering, and then all the specimens were

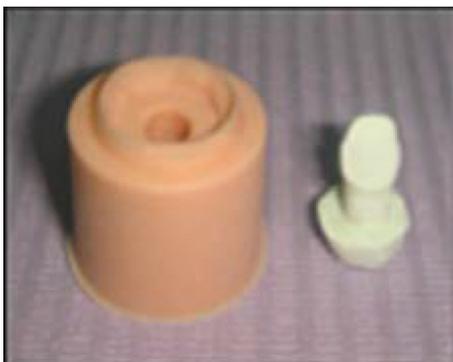
FIGURE 5: Poured stone die.

2.2.5. Fabrication of Group II (Metal Ceramic Crowns). For standardization of the metal coping thickness and contour with that of CAD/CAM zirconia coping, duplicating addition silicon was used to make an impression for one of the zirconia copings; then, hard stone type IV was poured, and the stone die (Figure 5) was trimmed. And with the aid of the vacuum forming machine, a transparent template was fabricated on the stone die using 0.02 inch thickness under vacuum pressure and was trimmed after cooling with a scissor to a level approximately 2 mm cervical to the finish line to act as a vertical stop and vented to get a coping former that will be used later for resin pattern fabrication from self-curing acrylic resin (PATTERN RESIN™LS) (Figures 6 and 7).

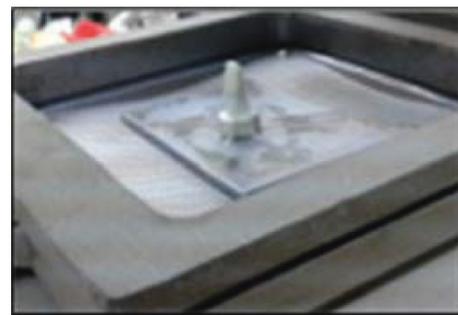
FIGURE 6: Vacuum formed resin template.

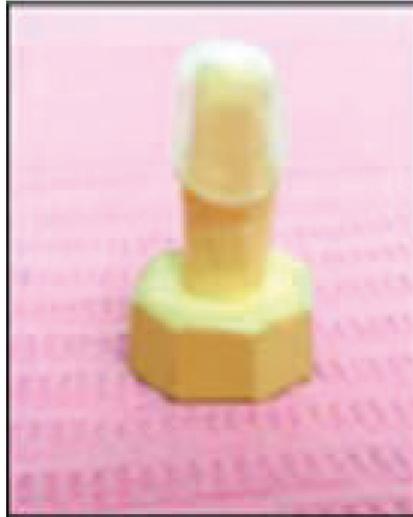
FIGURE 7: Coping former.

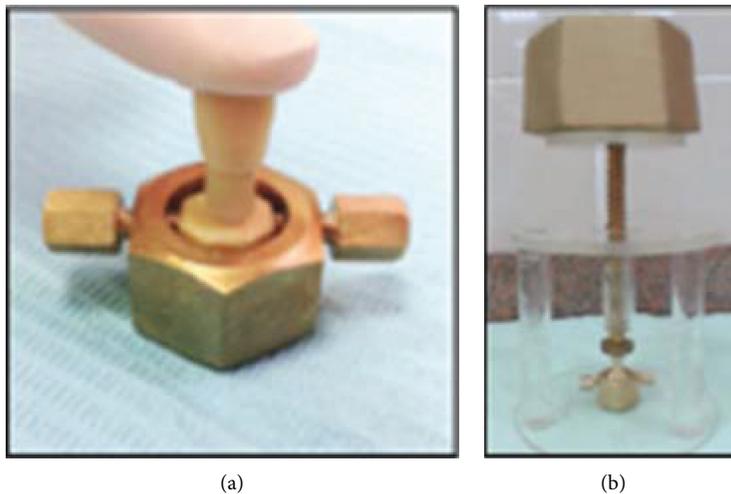
FIGURE 8: Seating the crown after cementation (a) under finger pressure and (b) under static load of 5 kg.

instructions, and the restoration was seated in place and fixed by finger pressure for 15 seconds and then under static load of 5 kg for 10 minutes [15] (Figures 8(a) and 8(b)). Excess resin cement was removed immediately with a scaler, and light curing (quarter technique) was used; all margins were light cured again for 20 seconds per each surface under the static load device. Finishing and polishing of the cement at the crown margins were carried out using both silicon rubbers and discs.

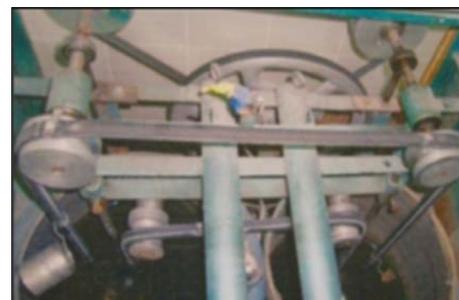
FIGURE 9: Specimens inside the thermal cycling machine.

placed into a specially designed tray suspended from the arm of a thermal cycling machine. The specimens were subjected to 300 thermal cycles corresponding to six months of clinical service [16, 17]; thermal cycles were performed mechanically with a machine that transfers the specimens between two temperature-controlled water bath (the bath temperatures were adjusted at 5°C and 55°C with a dwell time of one minute in each bath and relaxation period of 30 seconds in air between the two baths) (Figure 9).

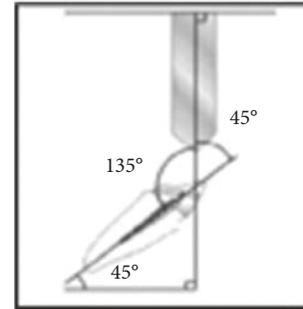
FIGURE 10: Schematic representation of load at an angle of 135° to the root long axis (45° to the horizontal plane).

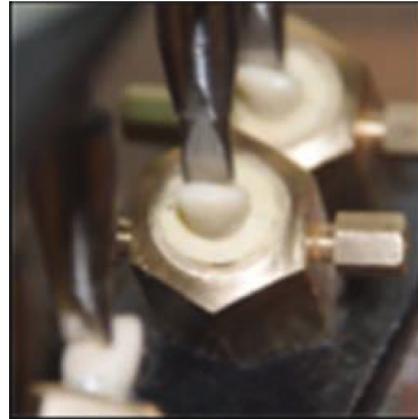
FIGURE 11: Loading stylus applying load onto the palatal surface of the crown 135° to the long axis of the tooth during the cyclic loading test.

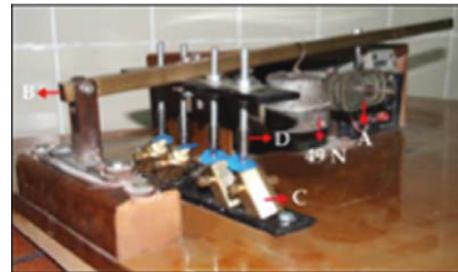
FIGURE 12: Specimens subjected to cyclic load. A, motor drive connected to an oval-shaped acrylic block with a metal rod; B, the metal arm fixed to the base of the machine from the one end and the other end carrying a metal block 49 N; C, four custom-made copper molds, carrying the specimens; D, four metal stylus, each one ended with 7 mm × 2 mm diameter beveled metal rod.

Cycling loads in this study were corresponding to 6 months of clinical service. Accordingly, samples were exposed to 120,000 mechanical cycles [23]. The load cycle was estimated by movement of a small metal projection attached to the upper metal arm within a groove in the oval-

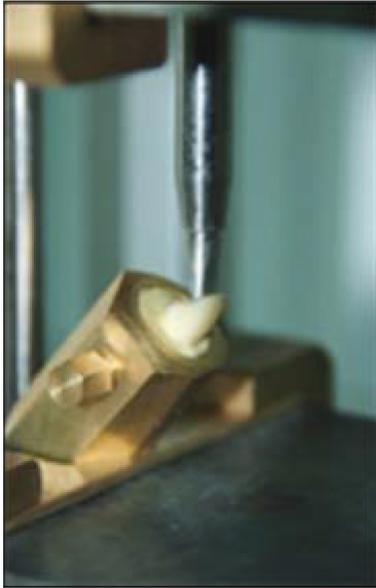
FIGURE 13: Loading stylus applying load onto the palatal surface of the crown 135° to the long axis of the tooth during the fracture resistance test.

(3) *Fracture Resistance Test.* To determine the fracture resistance of the specimens, a universal testing machine was used (Figure 13). Each embedded specimen was inserted into a copper mold of the lower jaw of the testing machine which was fixed at 45° degrees to the horizontal plane. A vertical compressive load was applied with a cross-head speed of 0.5 mm/min [25, 26] by means of a 7 mm × 2 mm beveled metal rod attached to the upper jaw of the testing machine, adjusted at 135° to the long axis of the tooth, and directed toward the palatal surface of the crown 2.5 mm from the incisal edge to simulate class I occlusion relationship with the antagonist tooth, and a rubber sheet was placed in between [18–22].

The load was applied on each specimen until catastrophic failure occurred. Catastrophic failure was defined as exhibition of visible cracks and events of chipping or fracture [27]. The failure load was recorded in newton on a reading monitor for each sample, and the fractured crowns were examined under the stereomicroscope to determine the fracture mode of each sample which was classified as following [18, 27, 28]:

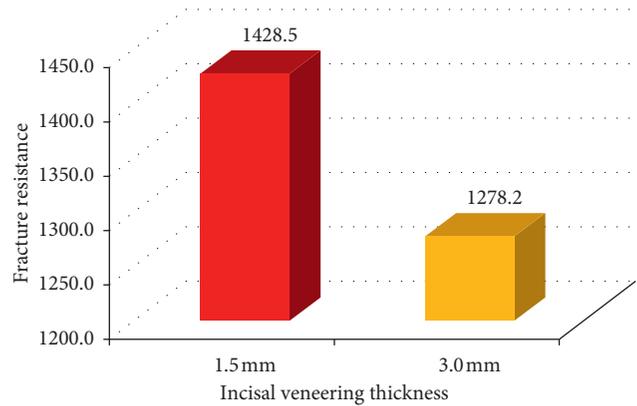
FIGURE 14: Bar chart showing fracture resistance of the two incisal veneering thicknesses in CAD/CAM zirconia all-ceramic groups.

3.1. Fracture Resistance. The results revealed that there was a significant difference in the fracture resistance between the two incisal veneering thicknesses in both groups. For CAD/CAM zirconia all-ceramic group, there was a significant difference at ($P < 0.05$) between the fracture resistance of subgroups Ia and Ib where $t = 4.2$. CAD/CAM zirconia ceramic crown specimens with 1.5 mm incisal veneering thickness showed higher mean values (1428 ± 72.2 N) than those with 3 mm thickness (1278.2 ± 33.3 N) (Figure 14).

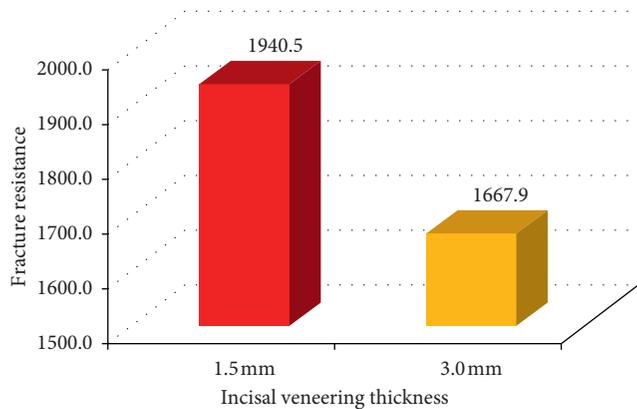
FIGURE 15: Bar chart showing fracture resistance of two incisal veneering thicknesses in the nickel-chromium metal ceramic group.

For the metal ceramic group, a significant difference was also reported at $P < 0.05$ between the fracture resistance of subgroups IIa and IIb where $t = 3.5$. The mean values for specimens with 1.5 mm veneering thickness was 1940.5 ± 153.7 N which is higher than those with 3 mm veneering thickness (1667.9 ± 80.2 N) (Figure 15).

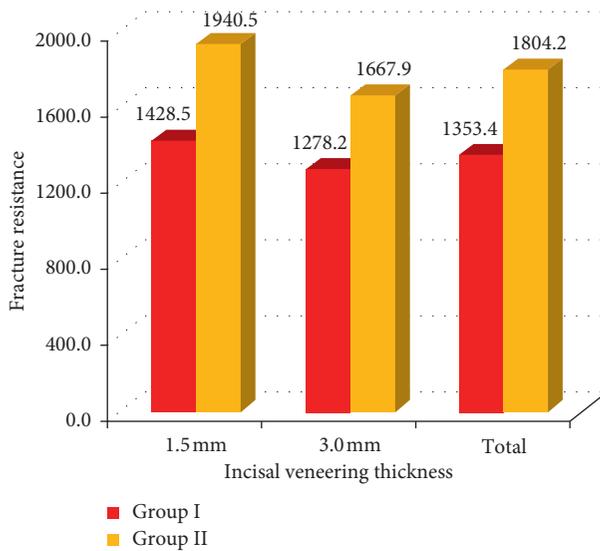
FIGURE 16: Bar chart showing fracture resistance of the two studied groups.

The results revealed that there was a significant difference ($P < 0.05$) in the fracture resistance between the two groups. The metal ceramic group showed a higher mean value (1804.2 ± 184.4) than the mean value of the CAD/CAM zirconia all-ceramic group (1353.4 ± 95.3) (Figure 16) (Table 3).

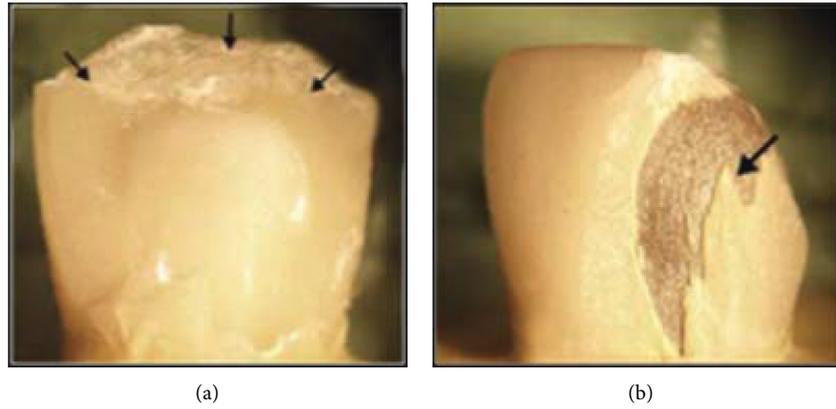
FIGURE 17: Mode II (veneer chipping) under stereomicroscope: (a) all-ceramic; (b) metal ceramic.

leucite reinforcing crystals to improve fracture resistance and to create thermal expansion compatibility with metal substructures. However, for zirconia coping, leucite is not needed in the zirconia veneering ceramic which is a multiphase mixture of glass compositions. Accordingly, the fracture surfaces of the porcelain for zirconia veneer were very flat and glassy in appearance (Figure 17).

The chip size in the current study was much greater with zirconia crowns, creating more unacceptable defects; the surfaces where the veneering porcelain were delaminated from the core appeared smooth with no residual porcelain detected, and these observations were similar to previous studies [30, 43].

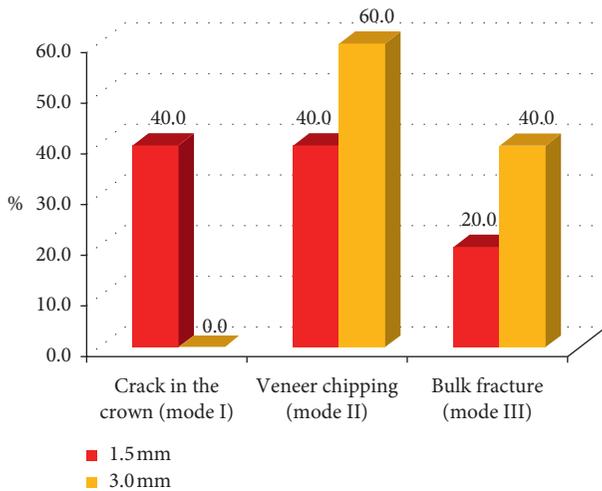
FIGURE 18: Bar chart showing the mode of fracture of each veneering thickness in both groups.

3.2. Modes of Fracture. It was found that there was no significant difference in the modes of fracture demonstrated by the two groups in the two incisal veneering thicknesses since 50% of the total specimens demonstrated Mode II (veneer chipping). However, 35% demonstrated Mode I (visible crack), and only 15% demonstrated Mode III (bulk fracture) (Figure 18) (Table 3).

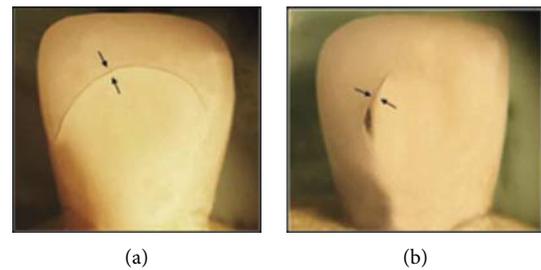
FIGURE 19: Mode I (visible crack) detected under stereomicroscope: (a) all-ceramic; (b) metal ceramic.

studies [44, 45] which reported that cracks, initiating from the loading area, became evident long before the obvious event of fracture in all-ceramic restorations and cone cracking which are vertical planes where shear stresses are revealed. Porcelain cracks have also been ascribed to tensile stresses arising from internal or external flaws and in a fractographic analysis of failed clinical zirconia crowns, and heavy occlusal wear spots were observed at the failure origins [46].

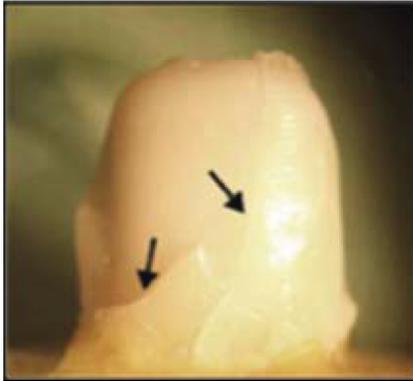
FIGURE 20: Mode III (bulk fracture) in all-ceramic specimen.

Bulk fracture demonstrated by 15% of total specimens and only by the CAD/CAM zirconia all-ceramic specimens (Figure 20), and this finding is similar with Çehreli et al.'s study [47] who reported rarely occurring core fracture of CAD/CAM zirconia crowns which indicate the high strength of the coping material.
