A “Non-Invasive” Technique for Qualifying the Reinforced Concrete Structure

The research objective is to provide new qualitative information on the strength of reinforced concrete structures of a building by using innovative, non-invasive testing techniques. The case of study is the “Centrone” theatre in Gravina in Puglia (Italy).

4. The Case of Study: “Centrone” Theatre in Gravina in Puglia (Italy)

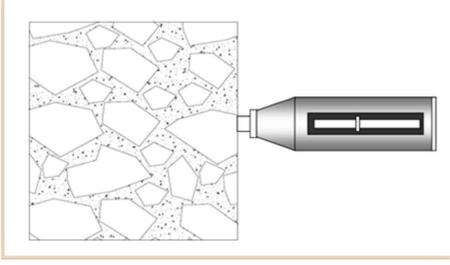
FIGURE 1: Sclerometer beats against a large piece of aggregate.

to the chance nature of the position of aggregates in relation to the external surface of an investigated component; the sclerometer can easily beat against a large piece of aggregate, probably obtaining a higher value of the bounce index S in relation to the one returned when the blow is executed on a homogenous concrete surface (Figure 1).

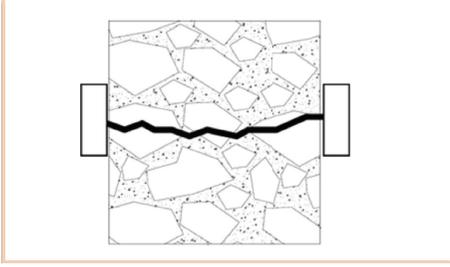
FIGURE 2: Ultrasound equipment: the impulse transmission.

Again as an example, the ultrasound test (Figure 2) can equally be affected by the chance nature of the disposition of aggregates in a cement mix when the gaps between the aggregates are arranged in the way that induces the rise of the void index; in this case, the speed of wave spread V decreases in relation to the value that would be obtained when the wave spreads through an area of “homogenous” concrete.

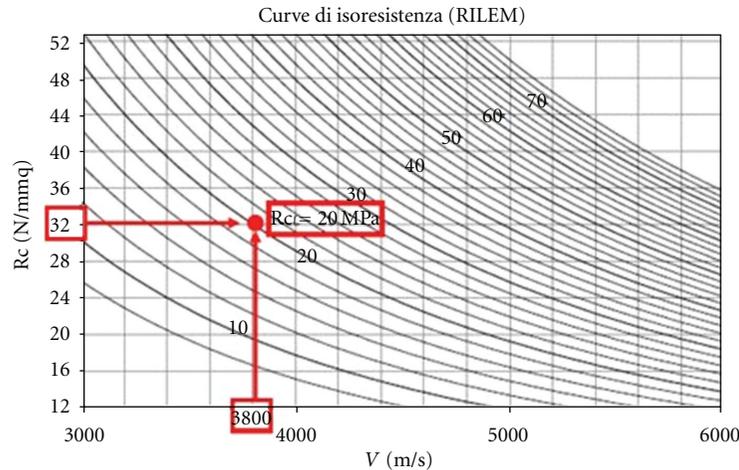
FIGURE 3: Example of iso-resistance curves—RILEM NDT 4 recommendations.

However, a qualitative appraisal of the resistance of concrete can be made even by using the graphs (Figure 3) which show a series of isoresistance curves in the plane V - S (obtained from the above analytic expressions) and which refer to the tests undertaken on standardised samples in a laboratory.

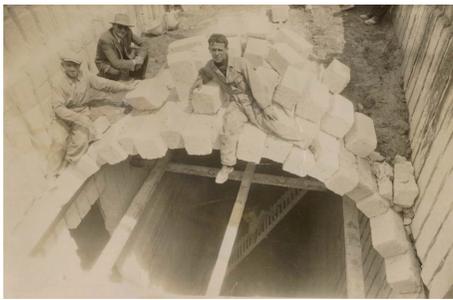
FIGURE 4: Historical image of vault construction.

The building was built between 1946 and 1948; the foundations were built on pillars and vaults (Figure 4) and the pitched roof using iron trusses (Figure 5).

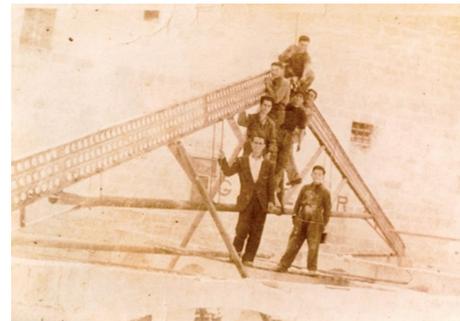
FIGURE 5: Historical image of iron trusses.

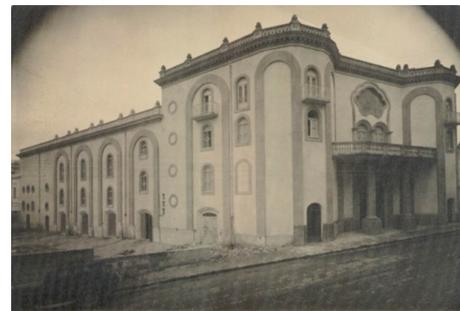
FIGURE 6: The “Centrone” theatre in Gravina in Puglia (Italy).

The building is a rectangular block (Figure 6), developed on three levels and covered using plaster and stone; the main façade is symmetrical, tripartite and follows the ground inclination; in the opposite side, the building shows two projecting polygonal elements realized using the local stone.

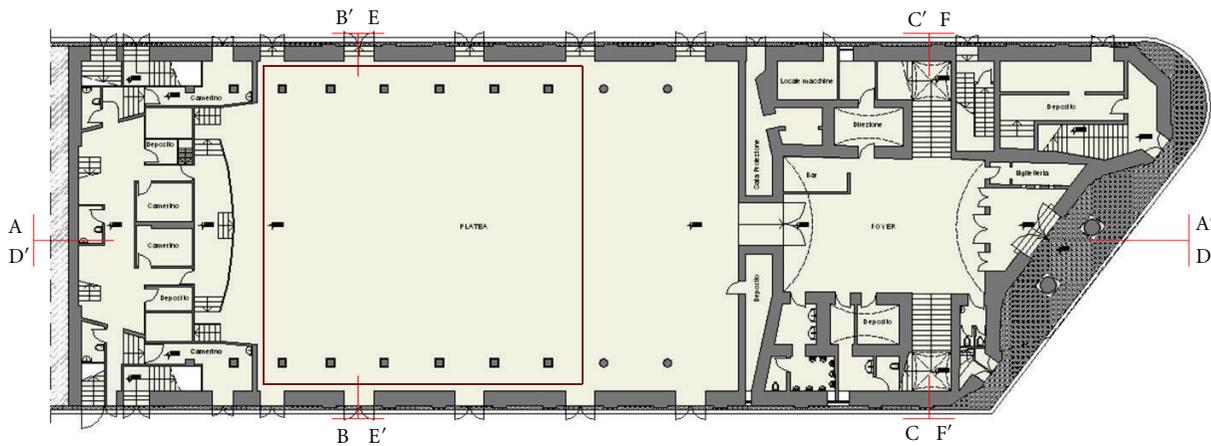
FIGURE 8: The specification of the location of the investigation points.

The selection of the location of the investigation points (Figure 8) was random (with the aim to guarantee the representativeness of the investigation for the entire structure); in addition, “homogenous” areas [1] (which have the same characteristics) were noted and considered by making the obtained results “qualitative” and representative for all the

Three different areas were selected for each investigated component; at 0.70 m, at 1.40 m, and at 2.10 m from the floor. This selection, in fact, was motivated by the need to investigate the columns at the points of major stress (base and middle), having assumed (1) a uniform distribution of
