Research Article

Mechanical Behavior and Chloride Penetration of Precracked Reinforced Concrete Beams with Externally Bonded CFRP Exposed to Marine Environment

Yan Xie, Kunhua Guan, Lei Zhan, and Qichen Wang

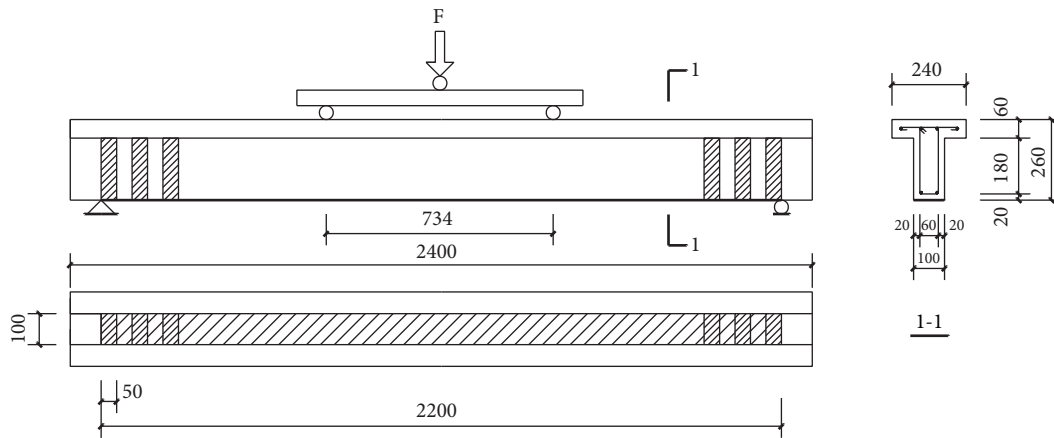
FIGURE 1: Details of the specimen (mm).

2.1. Specimens. All specimens were T cross section beams as shown in Figure 1, reinforced with 2 Φ 14 mm steel bars in tension side and 4 Φ 8 mm steel bars in compression side. They were provided with Φ 6 mm diameter steel stirrups at 100 mm center to center spacing and distributed over the span. The mix proportions used to cast all beams were 1 : 1.81 : 2.77 : 4.51 (water : cement : sand : aggregate). The average 28-day compressive strength of the concrete was 36.62 MPa. The yield and ultimate strengths of steel bars were 397 MPa and 535 MPa, respectively. The elastic modulus is 202 GPa. The CFRP sheet (UT70-30) used was a unidirectional CFRP supplied by Toray Industries, whose nominal thickness is 0.167 mm. The

2.2. Preparation of Strengthened Specimens. All beams were cast from the same batch in the laboratory and thereafter cured for 28 days. The RC beams in the specimen series DF, DFH-3, and DFH-6 were precracked by fatigue overloading before CFRP strengthening. The tensile concrete surface of the strengthened RC beams was ground by a concrete scabblor until exposure of aggregate was achieved, then blown with clean air to remove dust, and cleaned by acetone to ensure a good bond between the concrete surface and adhesive. After mixing, the adhesive was applied to the beam and CFRP sheet. The excess adhesive was squeezed out along the edges of the sheet, assuming complete adhesive coverage. Two layers of CFRP sheet was bonded to the tension face of the strengthened specimens. In order to avoid CFRP sheet debonding at the ends during the testing, they were attached in three U-shapes with 50 mm extension on each side of the beams, as shown in Figure 1.

3.3.1. CFRP Bonding Effect. The chloride contents in the sides of the web (samples L and R) are significantly higher than those in the middle of the web (samples M), which indicates that the CFRP bonding resisted the chloride penetration into the concrete. The chloride contents in the samples close to the ends of the strengthened beams (FH-3 and FH-6), especially in samples M, are obviously higher than those in other locations. This is because the CFRP bonding did not cover the ends of the specimens as shown in Figure 1. Thereby, it has higher chloride permeability.

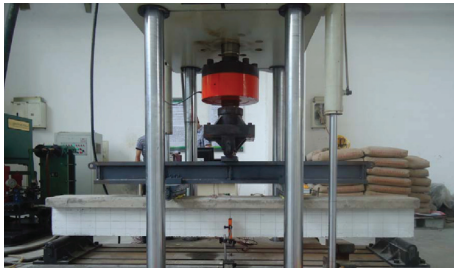
FIGURE 2: Bending test of the beam.

2.4. Bending Test Set-Up and Procedures. The tests were carried out in a servohydraulic SDS500 test machine with a maximum capacity of 500 kN, subjected to a four-point bending set-up as shown in Figure 2. Deflections were measured at middle of the specimens using a potentiometer. All data were automatically recorded by a data logging system (TDS-530). The crack width was observed by a microscope. During loading, the displacements and load were recorded every 1 second.

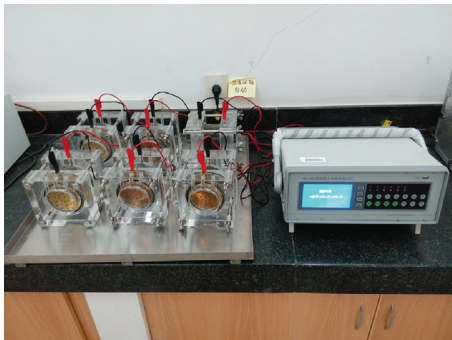
FIGURE 4: NEL-PEU instrument.

2.6. NEL Tests. NEL method [19–21] was employed to study the chloride diffusion coefficients of the concrete using a concrete electric flux measuring instrument (NEL-PEU), as shown in Figure 4. The mix proportions of the concrete in NEL test were 1:2.22:2.89:4.92 (water: cement: sand: aggregate). As shown in Figure 5, 15 concrete cylinders with a diameter of 100 mm and a thickness of 50 mm were casted as the samples. Thereafter, they were cured for 28 days. The concrete cylinders were equally distributed in five series with different crack depth. The series G-0 represents sound concrete. The series G-10, G-15, G-20, and G-25 represent the concrete with a 10 mm, 15 mm, 20 mm, and 25 mm depth crack, respectively. The width of the cracks is 0.2 mm which is the maximum allowed crack width in RC structures in Chinese bridge standard (JTG D60-2004) [24]. To artificially preset the crack, a stainless steel thin plate with 0.2 mm thickness was embedded in the concrete cylinders along a diameter when casting and was moved after 3-day curing. After immersed in a vacuumed instrument filled with water for 24 h, each specimen was fixed in a testing device. One side of the device was fulfilled with 0.3 mol/L NaOH solution and the other side was fulfilled with 3% NaCl

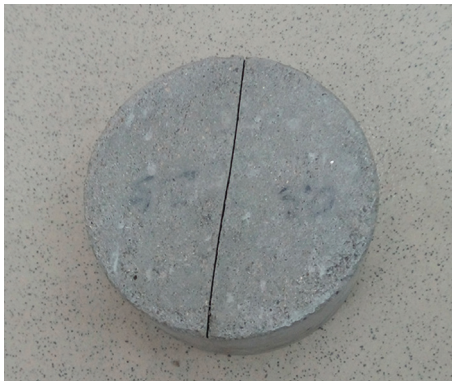
FIGURE 5: Specimen of NEL test.

solution. The electric flux values were recorded after being electrified for 6 h.

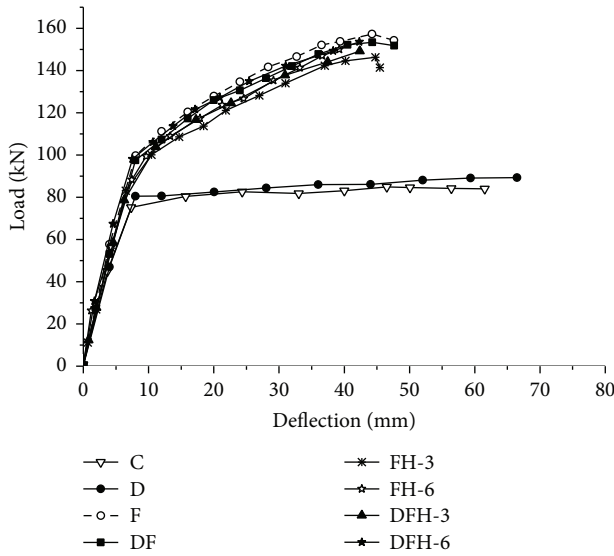
FIGURE 6: Load-deflection curves.

3.2. Flexural Capacity. All specimens were statically tested to determine the ultimate strength and deflections. The test results in the form of load-deflection behavior were presented in Figure 6. Average curves of each series were used to avoid cumbersome presentation. Two aspects were noted from Figure 6. Firstly, all the strengthened beams showed a strength enhancement over the unstrengthened beams, but the strengthened beams have very little enhancement in stiffness prior to the unstrengthened beams yielding. Secondly, the precracking and environmental exposure have only marginal effects on the load-deflection curves.

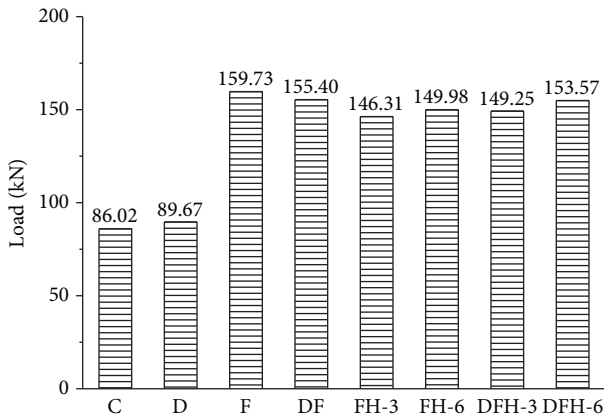
FIGURE 7: Ultimate loads.

The average ultimate loads and deflections of each series are shown in Figures 7 and 8. The load-deflection curves of series C and D are equal, while the ultimate load of D is slightly higher than that of C. The CFRP strengthening increased the ultimate strength of the sound beams in series F by 85.7% and the precracked beams in series DF by 73.3% in comparison with series C and D, respectively. This indicates that the CFRP strengthening was less effective for the precracked RC beams compared to the unprecracked RC beams due to the residual deflection and cracks. In addition, the ultimate deflections of the specimens in series F and DF were decreased by 20.1% and 30.8% in comparison with C and D, respectively, which presents that the CFRP strengthening reduced the ductility of the RC beams. Comparing the specimens in series F and DF, the wetting/drying cycles for 3 and 6

months reduced the ultimate strength of the strengthened RC beams in series FH-3 and DFH-3 by 6.0% and in FH-6 and DFH-6 by 3.7%, respectively. These clarify that the strength of the specimens exposed to wetting/drying cycles decreased in the first 3 months and then slightly increased in the next 3 months. The environmental exposure has clear effect on the mechanical behavior of the CFRP reinforced concrete members for the first 3 months but this effect is marginal for the next 3 months and even longer period [25]. The strength of the concrete, meanwhile, increased during immersing in the water. The deflections of the specimens in series FH-6 and DFH-6 decreased slightly after 6 months of exposure to environmental condition in comparison with series FH and DFH. It showed that the hygrothermal environment has marginal effect on the ductility of the strengthened beams. The main cause of the decreases in the strength and ductility of the specimens under environmental exposure is the deterioration of the adhesive bonding caused by moisture diffusion into the adhesive joint [7, 8].

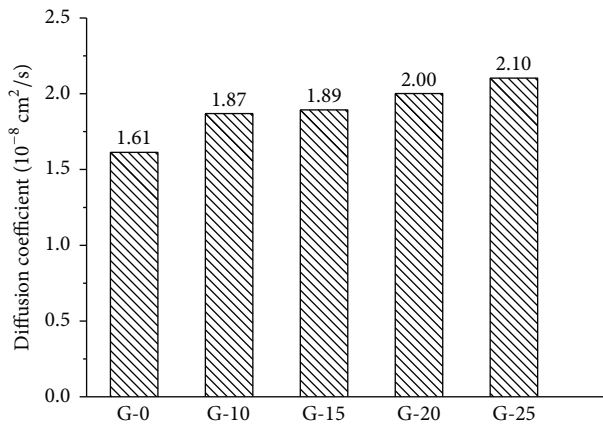
FIGURE 10: Chloride diffusion coefficients.

3.4. Effect of Crack Depth on Chloride Diffusion Coefficients. The electric flux values Q of series G-0, G-10, G-15, G-20, and G-25 obtained by NEL tests were 2755.21C, 3276.17C,

3324.52C, 3543.57C, and 3751.45C, respectively. The chloride diffusion coefficients calculated by equation of Nernst-Einstein [20, 21] were shown in Figure 10.

The chloride diffusion coefficients of the specimens with 0.2 mm width crack (G-10, G-15, G-20, and G-25) were 16%–30% higher than that of the sound specimens (G-0). The chloride diffusion coefficients increased with the depth of the crack; however, the rate of increase was not pronounced. The chloride diffusion coefficient of the specimens with 25 mm depth crack (G-25) was only 12% higher than those with 10 mm depth crack (G-10).

The average width of the residual cracks in the specimens DFH was 0.26 mm. Meanwhile, the average chloride content in specimens DFH is about 18% higher than that in specimens FH without precracks. From the above NEL test results, the increasing rate is in the range of 16%–30%, which validates
