## Research Article

# Experimental Study on Bond Behavior of FRP-Concrete Interface in Hygrothermal Environment

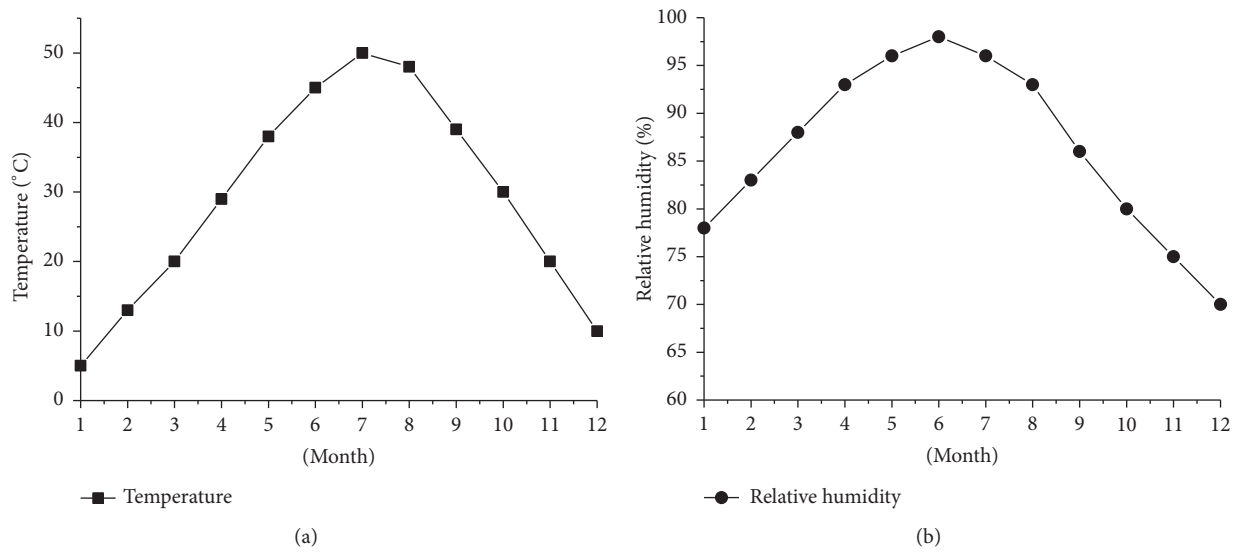
FIGURE 3: Monthly temperature and humidity curves over one year on the bridges in South China.

**2.3. Hygrothermal Environmental Conditions.** In this test, the specimens were moved to pretreatment in an environmental chamber in which temperature and relative humidity (RH) conditions can be preset. The characteristic values of temperature and humidity were chosen according to the measured data of a number of bridges in service in the coastal provinces of South China combined with some relevant codes [24]. The curves of monthly temperature and humidity throughout one year are shown in Figure 3. It indicates that the temperature was from 5°C to 50°C in service and that for humidity is from 70% RH to 95% RH. According to the Chinese guidelines (GB/T1446-2005 [25] and GB/T2573-2008 [26]), the accelerated condition for hygrothermal environment is  $60 \pm 2^\circ\text{C}$ ,  $93 \pm 3\%$ . The prescribed temperature and RH conditions in this test were chosen as 5°C, 25°C, and 60°C and 60% RH, 75% RH, and 95% RH, respectively.

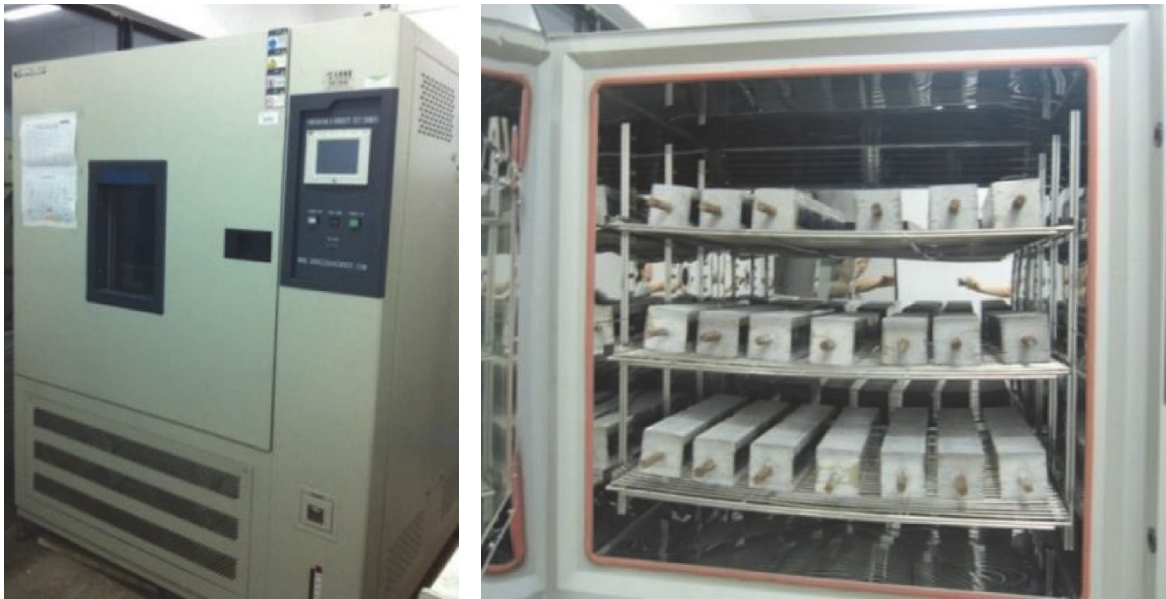
FIGURE 4: Programmable environmental chamber (HP-800U) and specimens.

The temperature and humidity conditions for different groups of specimens are listed in Table 2. The specimens were kept in the environmental chamber as shown in Figure 4 for 14 days in accordance with the Chinese guidelines (GB/T1446-2005 [25] and GB/T2573-2008 [26]). After exposure to the simulated environment, the specimens were taken out from the chamber and dried at air environment in laboratory at an average temperature of 25°C with 80% RH before testing.

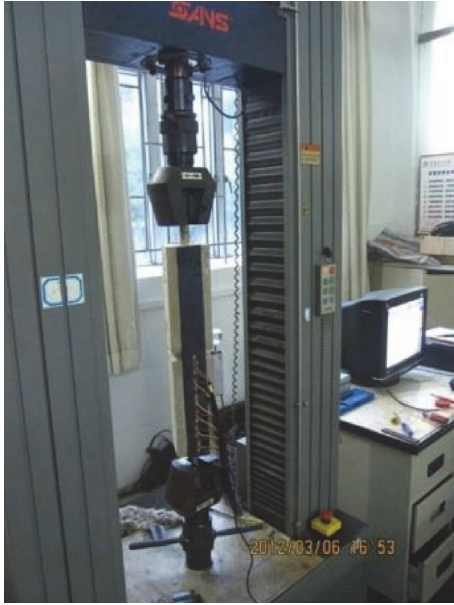
FIGURE 5: Electronic testing machine (type: CMT5105).

All specimens were tested on an electronic universal testing machine (CMT5105) with 100 kN capacity as shown in Figure 5. Loading was controlled in displacement mode at a rate of 0.005 mm/s. Strain gauges were externally bonded on the CFL to measure the strains in CFL. A total of 13 strain gauges were distributed along the bonded length of CFL with a center-to-center spacing of 20 mm as shown in Figure 6(a). During the test, strains were automatically recorded by a data-acquisition system (TMR-211) at 10 Hz

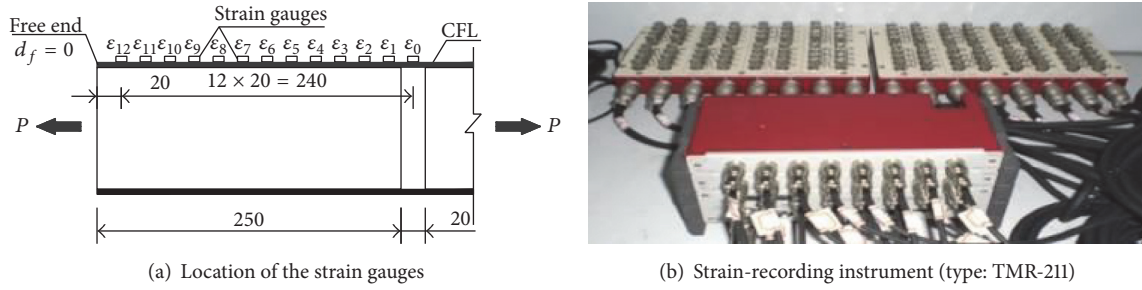
FIGURE 6: Measurement of strain.

as shown in Figure 6(b). The relative slip ( $\Delta\omega$ ) between two concrete blocks was measured by a linear displacement sensor fixed on the surface of concrete block near the middle of the specimens as shown in Figure 7.

**4.2. Strain Distribution in the CFL.** These strains were read from the strain gauges mounted on the upper surface of the CFL as shown in Figure 6. Longitudinal strains in the CFL at various load levels for each specimen are shown in Figure 13, where the horizontal axis  $d_f$  is the distance from the free end of the CFL shown in Figure 6, and the vertical axis is the measured strains of the CFL.

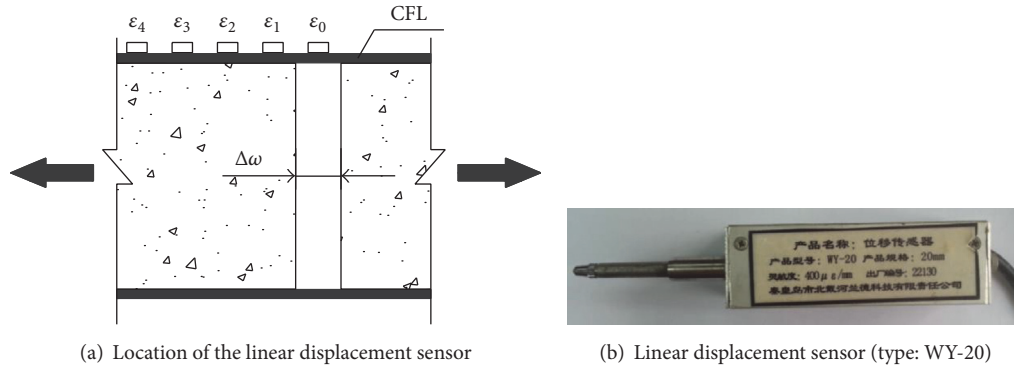
FIGURE 7: Measurement of relative slip between the concrete blocks.

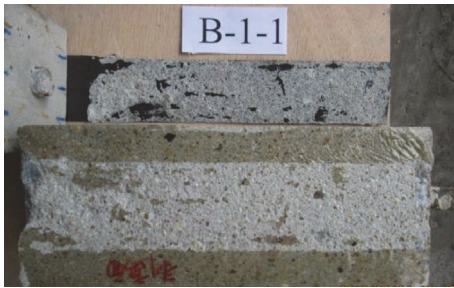
FIGURE 8: Typical bond failure mode.

**3.1. Failure Mode.** Only one typical debonding failure mode was observed in all specimens. As shown in Figure 8, a thin concrete layer attached to the surface of the debonded CFL shows that the debonding failure happened in the substrate concrete. Such failure mode is also widely reported in other resources [17, 18, 20].

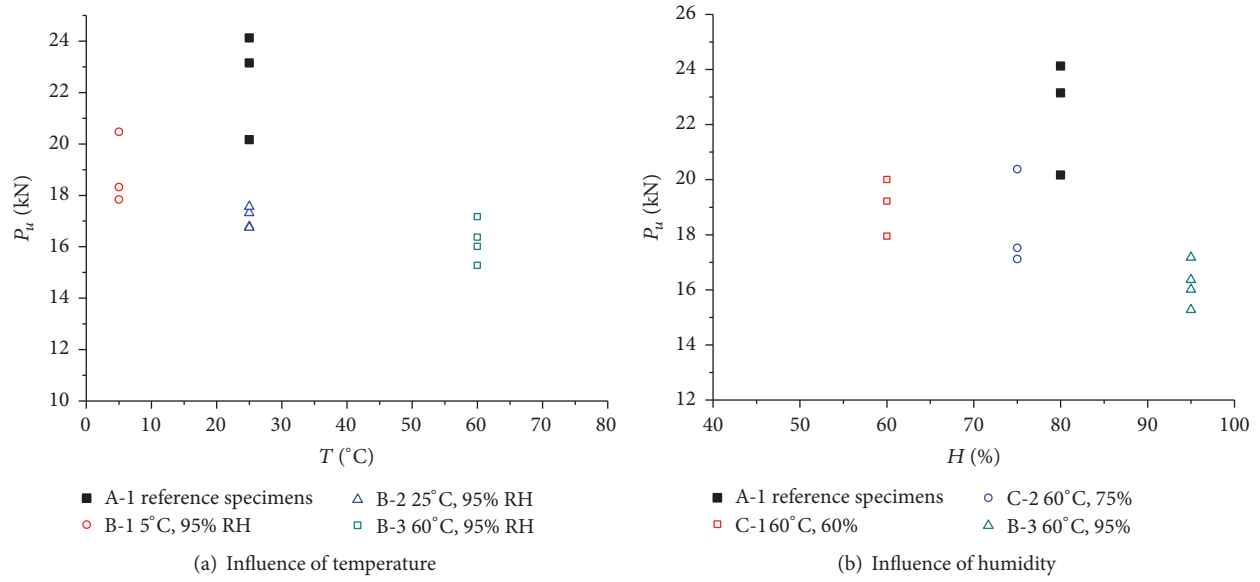
FIGURE 9: Influence of the hygrothermal environment on the ultimate load.

**3.2. Hygrothermal Environment Effect on the Ultimate Load ( $P_u$ ).** Table 3 summarizes the statistics of the ultimate loads for each group of specimens. Hygrothermal environment influence on the ultimate load was obtained by comparing the ultimate loads of the aged specimens with those of reference specimens as shown in Figure 9. In Figure 9(a), results for the reference specimens (A-1, without ageing) and those of group B subjected to different temperature with the same humidity are compared to analyze the temperature effect on

the ultimate load. In Figure 9(b), results for the specimens under different humidity are compared.

A clear decrease of the ultimate load for the specimens exposed in hygrothermal environment can be observed except C-2-1. In general, higher temperature and humidity cause higher reduction in ultimate load.

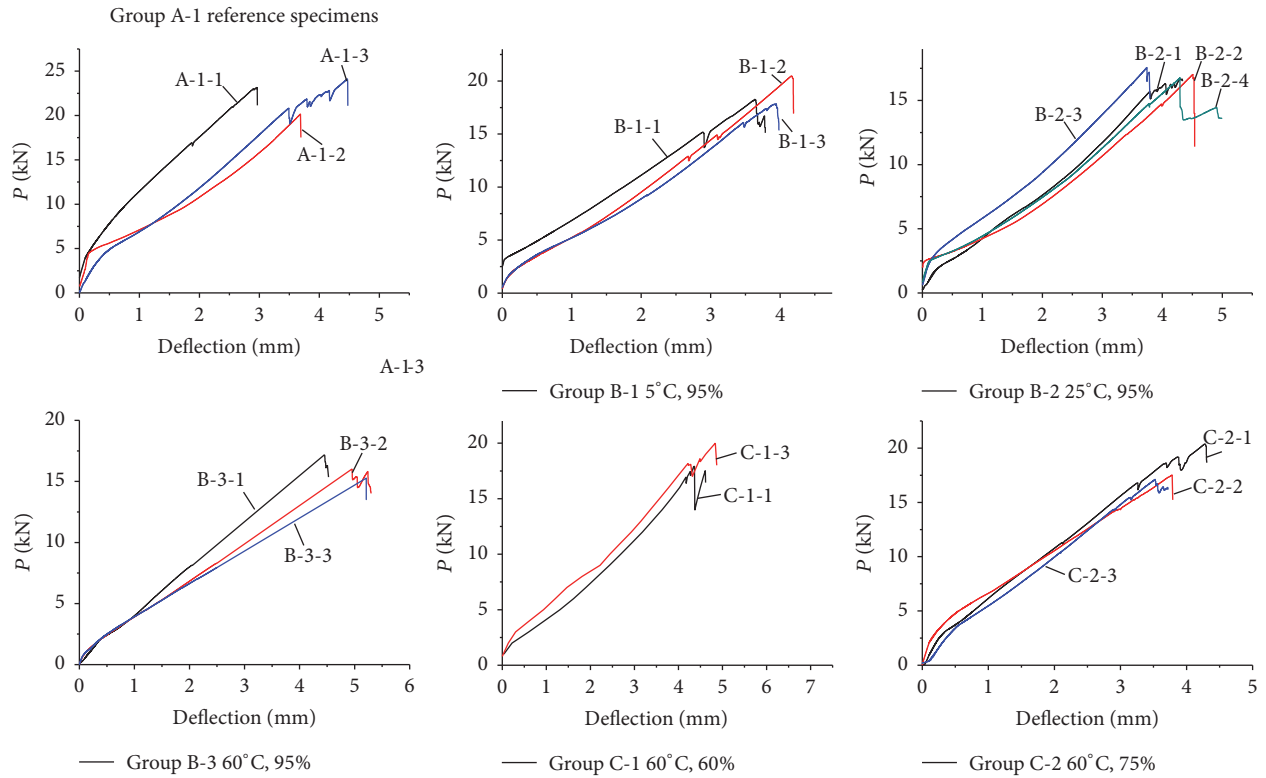
FIGURE 10: Load-deflection curves of all the specimens.

**3.3. Load-Deflection Curves.** Figure 10 shows the total load versus deflection graphs for all the specimens tested. The curves of all the specimens in each group are similar to each other. Load-deflection data for C-1-2 were lost in the test.

The slope of the load-deflection curves reflects the total stiffness of the bond interface. It is steeper at the initial loading stage indicating good bond stiffness and then decreases with the increase of loading. The fluctuations in the curves indicate that local debonding happened on the bond face before the sudden failure.

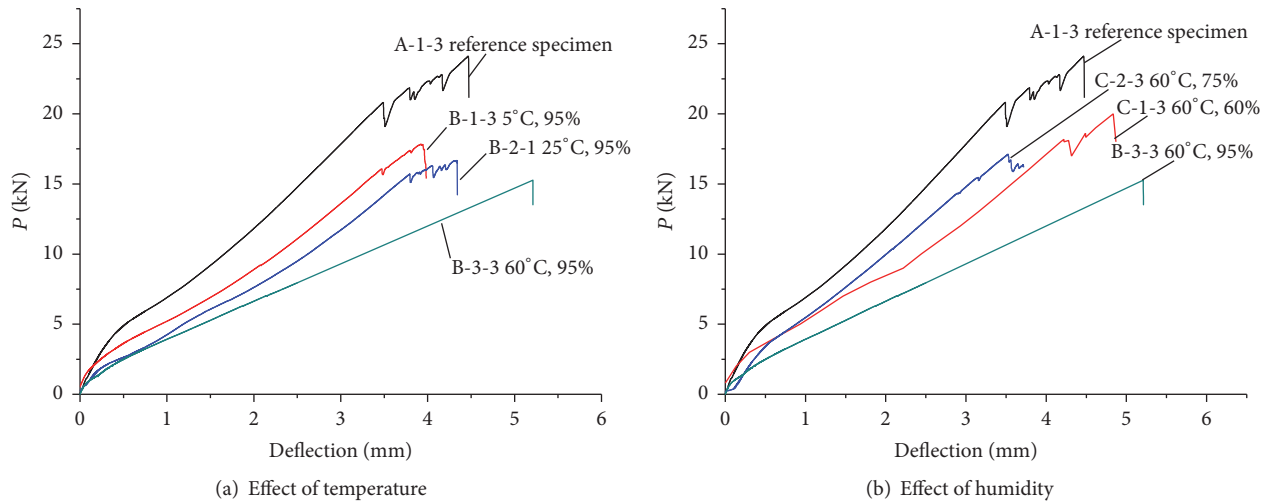
FIGURE 11: Effect of hot-wet environment on the load-deflection curves.

The load-deflection curves of the reference specimens (without ageing) and group B specimens subjected to different temperatures (5°C, 25°C, and 60°C) with the same humidity (95%) are compared in Figure 11(a) to analyze the temperature effect. The comparison between the reference specimens (without ageing) and group C specimens subject to different humidity (60%, 75%, and 95%) with the same temperature (60°C) is shown in Figure 11(b).

The results presented in Figure 11 clearly reveal that noticeable deterioration was caused by exposure in hygrothermal environment. Compared to the reference specimens, the smaller slopes of the curves for the aged specimens mean bond degradation and this becomes more obvious with increasing temperature and humidity.

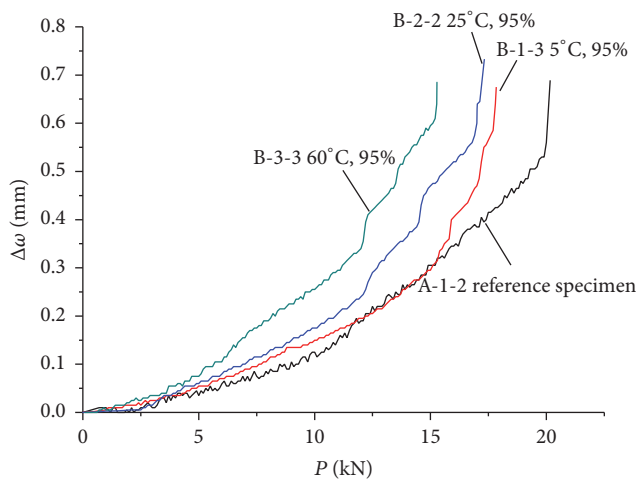
FIGURE 12: Hot-wet pretreatments effect on the relative slips ( $\Delta\omega$ ).

effectively. Figure 12 shows some relative displacement-load curves for specimens with different temperatures. The typical experimental relative slip-load response has a 3-stage characteristic containing an initial linear growth stage, a rapid growth stage, and an instable growth stage. Compared to the reference specimens in group A, the slopes of the relative slip-load curves of group B specimens were higher which indicated faster degradation of the bond behavior. As for group B aged with different temperatures under the same high humidity (95% RH), the higher the ageing temperature was, the faster the speed rate grew. However, the ultimate relative slips of all specimens were not sensitive to temperature and humidity and all were in the range of 0.7 mm and 0.8 mm.

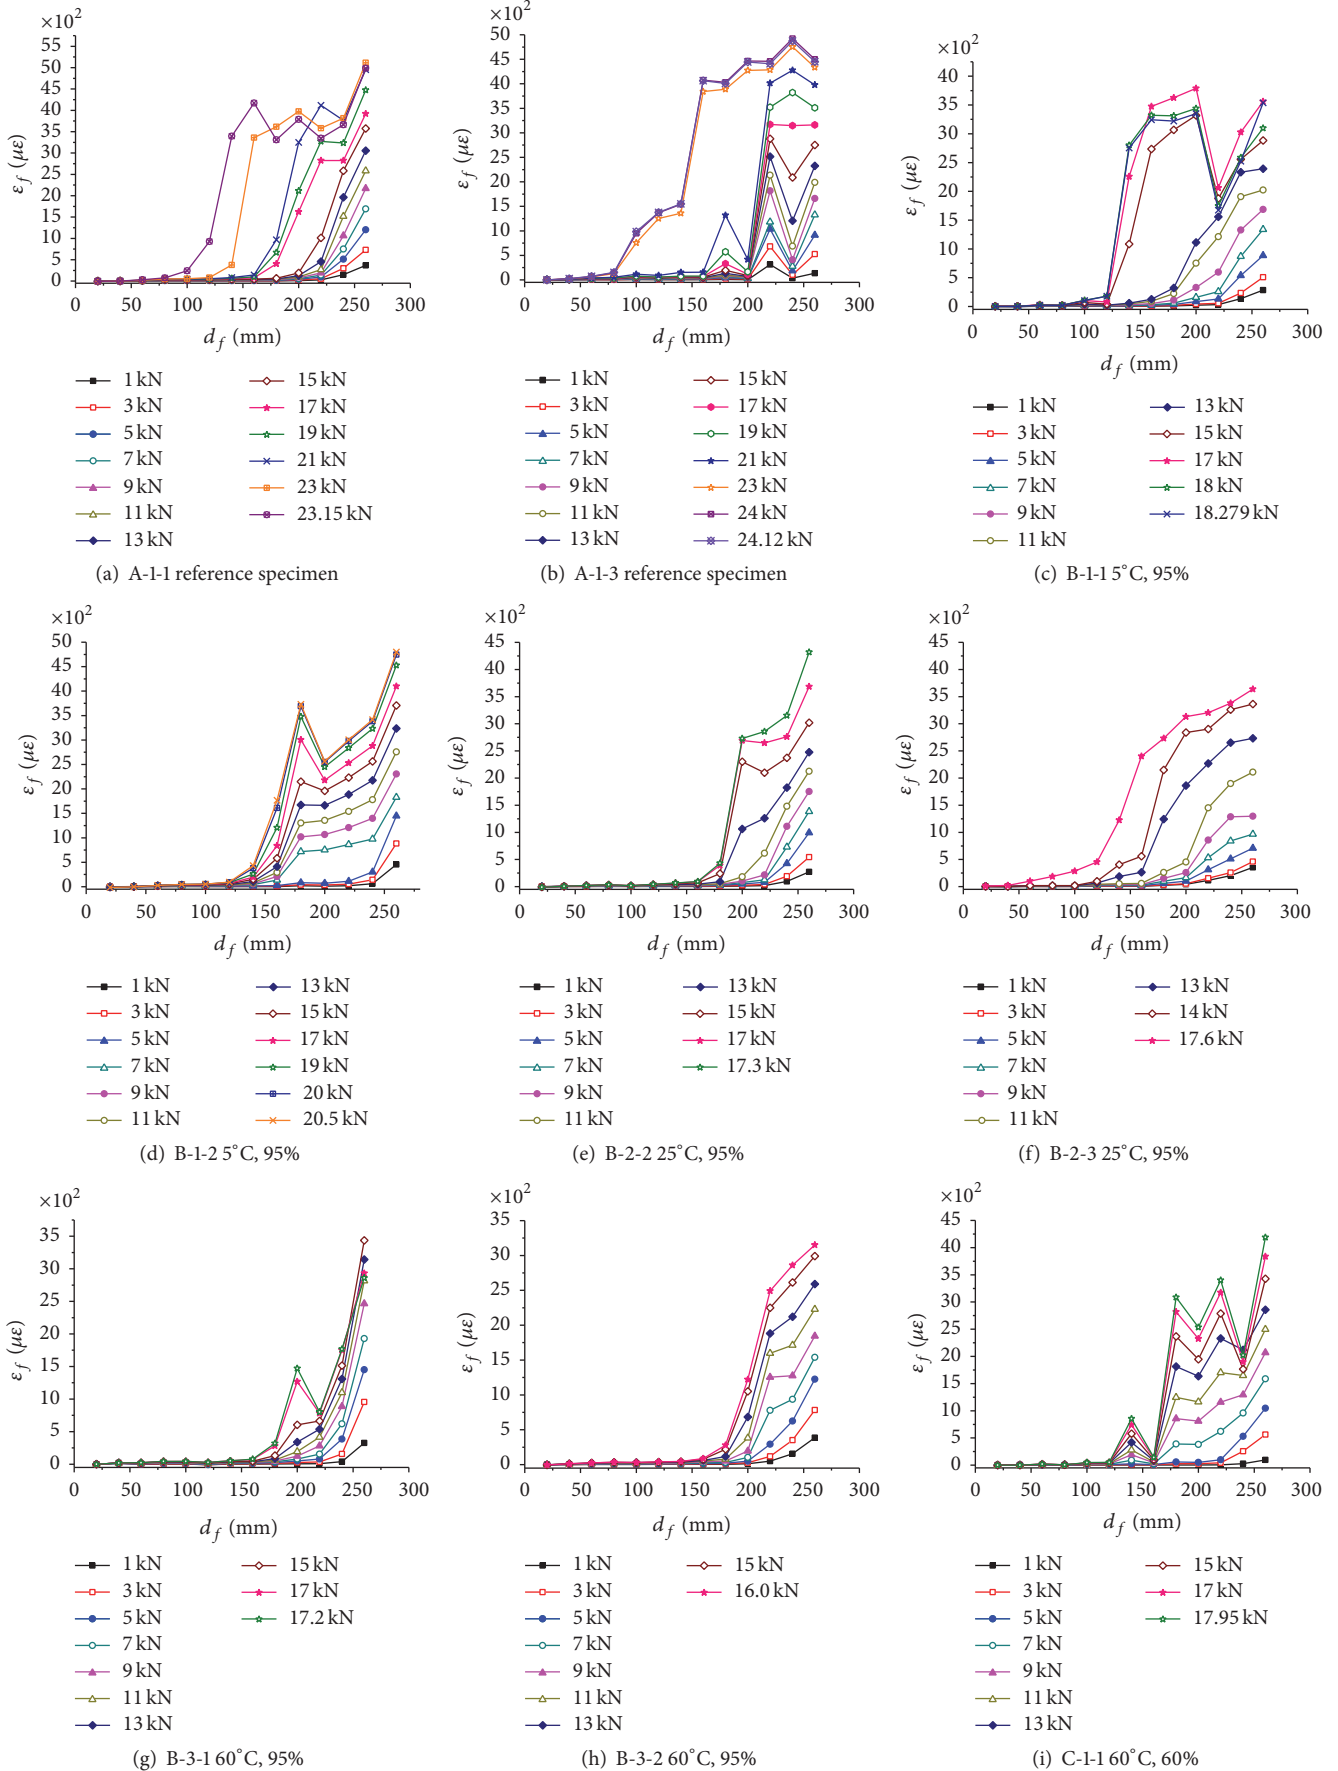
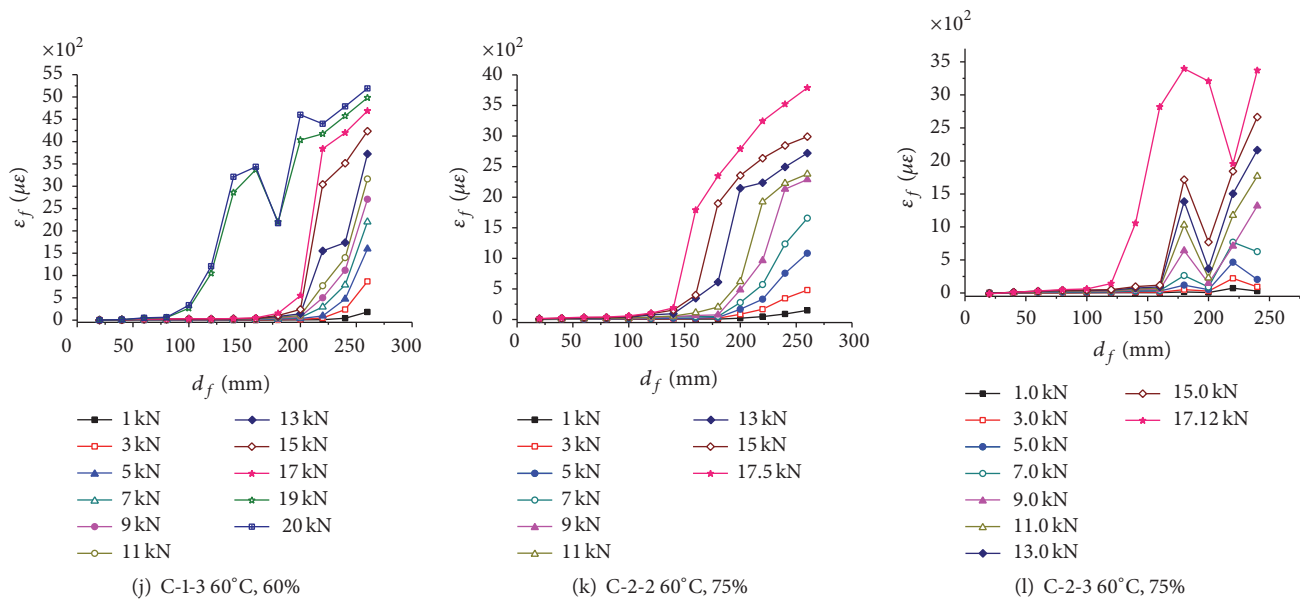
FIGURE 13: Strain distributions for groups A to C specimens.

150 mm at each side of the gap. The strain of the CFL was at maximum at the gap location and reduced at the locations away from the gap. The strains also increased with external loading. It needs to be noted that the strain distribution across the width of the CFL was not uniform due to the imperfection in loading and/or geometry.

Compared with the reference specimens (group A-1), the maximum strains ( $\epsilon_{\max}$ ) of the specimens in groups B and C decreased obviously which indicated decay of the bond behavior after exposure to the hygrothermal environment. The maximum strains were 5500~6000  $\mu\epsilon$ , 3500~4500  $\mu\epsilon$ , and 3500~5000  $\mu\epsilon$  for groups A-1, B-2~3, and C-2, respectively. This means that the aggressive environment caused premature debonding failure along the interface.
