## Research Article

# Application of a Reinforced Self-Compacting Concrete Jacket in Damaged Reinforced Concrete Beams under Monotonic and Repeated Loading

**Constantin E. Chalioris, Constantin P. Papadopoulos, Constantin N. Pourzitidis, Dimitrios Fotis, and Kosmas K. Sideris**

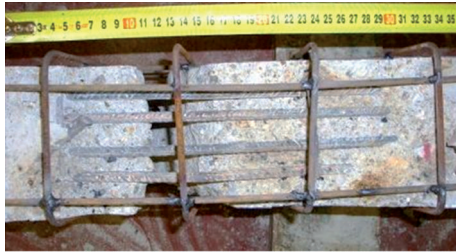
FIGURE 3: Typical installation of the jacketing steel reinforcement (view from the bottom of the original damaged beam).

Further, L-shaped mild steel dowels with 5 mm diameter were installed in the vertical sides of the initial beams in order to support the longitudinal bars of the jacket, as shown in Figure 2. Dowels were bonded by injected epoxy resin into 7 mm holes that were drilled before. The amount of the provided dowels was rather low; every side bar of the jacket had Ø5 dowels per 150 mm. No dowels have been installed at the bottom bars of the jackets. The main reason of the low amount of steel dowels provided is that the original beams suffered severe cracking and the installation of numerous of dowels by drilling may further deteriorate their damages. Steel bars, stirrups, and dowels were all welded together. The installation of the jacketing steel reinforcement is also shown in the photograph of Figure 3.

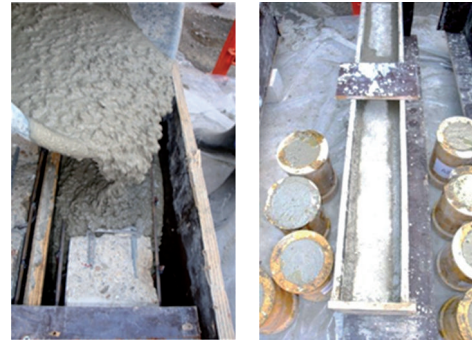
FIGURE 4: Formwork of the jacket and SCC pouring.

**2.3. SCC Characteristics.** Cast-in-place SCC was used to rehabilitate the damaged beams. Pouring of the SCC into the jacketing formwork is shown in the photographs of Figure 4. Mix design composition (in  $\text{kg}/\text{m}^3$ ) and proportions for casting one cubic meter of SCC are summarized in Tables 3 and 4, respectively. The cement content was  $356 \text{ kg}/\text{m}^3$  (305 kg of cement type CEM IV/B (W-P) 32.5 N and 51 kg of cement type CEM II/B-M 42.5 N). Fine aggregates (sand) and coarse aggregates with maximum diameter 8 mm were also used in the SCC mixture. Superplasticizer (Glenium

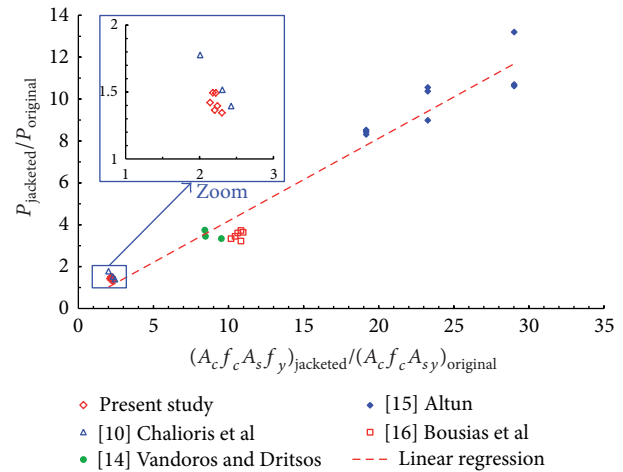
FIGURE 9: Comparisons between the experimental results derived from this study (6 data points) and the literature [10, 13–15] (21 data points).

**3.4. Comparisons with Test Data of the Literature.** The experimental results derived from this study are compared with the available test data of previously published works from the literature [10, 13–15] in Figure 9. Figure 9 illustrates 27 test data points from these experimental researches in terms of the ratio  $P_{\text{jacketed}}/P_{\text{original}}$  and  $(A_c f_c A_s f_y)_{\text{jacketed}}/(A_c f_c A_s f_y)_{\text{original}}$  where  $P_{\text{jacketed}}$  and  $P_{\text{original}}$  are the ultimate load bearing capacity of the jacketed and the original beam, respectively, and  $A_c$ ,  $f_c$ ,  $A_s$ , and  $f_y$  are the area of the cross-section, the concrete compressive strength, the area of the longitudinal steel reinforcement, and the steel yield strength, respectively, of the jacketed and the original beam.

It is noted that the experimental results used in Figure 9 consist of RC jacketed beams (18 data points) and columns (9 data points) under monotonic, repeated, or cyclic imposed deformations that exhibit flexural performance. The comparison of these test data indicates that the measured increase of the load bearing capacity due to the application of RC jacketing seems to be approximately proportional to the ratio  $(A_c f_c A_s f_y)_{\text{jacketed}}/(A_c f_c A_s f_y)_{\text{original}}$ . This ratio is evaluated by the area and the strength of the concrete used and the longitudinal steel provided to the jacketed beam and to the original beam. Therefore, the aforementioned ratio expresses the increase of the cross-sectional dimensions and the amount of the steel bars due to the application of RC jacketing.
