Research Article

An Experimental Study for Quantitative Estimation of Rebar Corrosion in Concrete Using Ground Penetrating Radar

Md Istiaque Hasan and Nur Yazdani

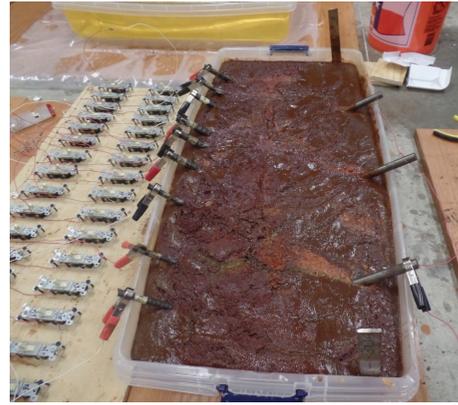
A corrosion tank was prepared to perform the accelerated corrosion of three rebars 16 mm in diameter. The tank was filled with 5% sodium chloride solution, made of regular table salt and tap water. The 300 mm long rebars were submerged in the solution to act as anode of an electrochemical cell. A few extra rebars were also submerged in the salt water solution to act as a cathode. The three rebars were connected in series, ensuring that the first of the three rebars would attract the most electrical current. This was expected to cause most amount of mass loss in the first rebar. The other two rebars, as they were connected in the series connection, would receive less electrical current, resulting in lesser amounts of corrosion. This approach resulted in the varying amounts of corrosion in the three rebars as needed for the experiment. A 15-volt DC current source was used to supply electrical current to the electrochemical cell through the anodes and the cathodes. The experimental setup of the accelerated corrosion of the rebars is shown in Figure 1. The resulting corrosion products can be seen floating on the salt water solution.

FIGURE 1: Tank for accelerated corrosion.

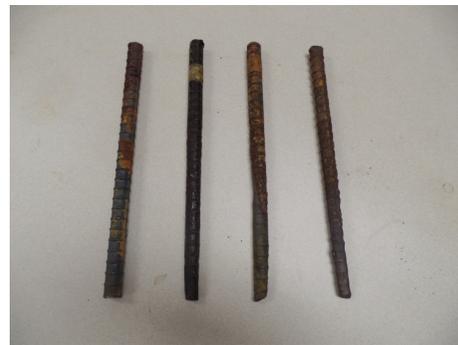
After three days of continuous electrical current through the electrochemical cell, the process was stopped and the anode rebars were taken out of the solution and thoroughly cleaned. The rebars were weighed to determine the amount of weight loss due to corrosion. Some parts of the rebars were outside of the solution tank and did not experience any corrosion, and they were excluded in the calculation of weight loss. It was assumed that the weight loss due to corrosion occurred uniformly along the corroded length of the rebar. Figure 2 shows the three rebars with varying amounts of

FIGURE 2: Rebars with different degrees of corrosion.

corrosion. An uncorroded rebar is shown on the extreme left for comparison. Table 1 presents weight losses for each rebar and the associated rebar cross-sectional area losses. The corrosion loss for rebar areas ranged between 0 and 45%. Active corrosion can reduce the rebar diameter by as much as 0.0039 in (0.1 mm) per year [8]. Therefore, the range of rebar corruptions studied herein is practical for concrete structures.

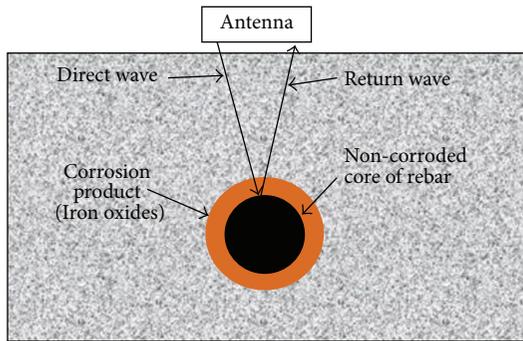
FIGURE 3: GPR scanning of corroded rebar in concrete.

reflects the incident GPR wave. The power of the reflection wave from the interface of two different materials depends on the contrast of the dielectric constants of the two media [10]. If the contrast is high, most of the incident wave gets reflected and a small part of the wave goes through the interface. If the dielectric contrast is low, a small part of the incident wave gets reflected and most of it travels through the interface into the second medium. In this study we assume that the concrete is very severely corroded and the corrosion products got dispersed around the rebar through cracks and interstitial pores. The dielectric constant of iron oxide is 14 [9] which is a little higher than the dielectric constant of concrete. This close difference indicates that a radar wave can penetrate through the corrosion contaminated concrete and the rust and eventually reflect back from the surface of the noncorroded rebar core. Therefore, it is assumed that GPR wave can travel through the corrosion products. The changed environment in the vicinity of a corroded rebar can be monitored with a GPR. The schematic diagram of GPR scanning of a corroded rebar in concrete is shown in Figure 3. The dielectric constant of the concrete between the GPR antenna and the noncorroded core of the rebar increases due to the contamination of the concrete by external corrosion agents and the internal development of corrosion products. The reduction of the rebar area and the increase of the dielectric constant of rust contaminated concrete are the two major factors that can differentiate the GPR response from a corroded rebar and that from a noncorroded rebar. It was expected in the study reported herein that the increase of dielectric constant and decrease of the rebar size would result in a decrease in the maximum amplitude of the returning radar wave from the rebar. It is worth mentioning that the

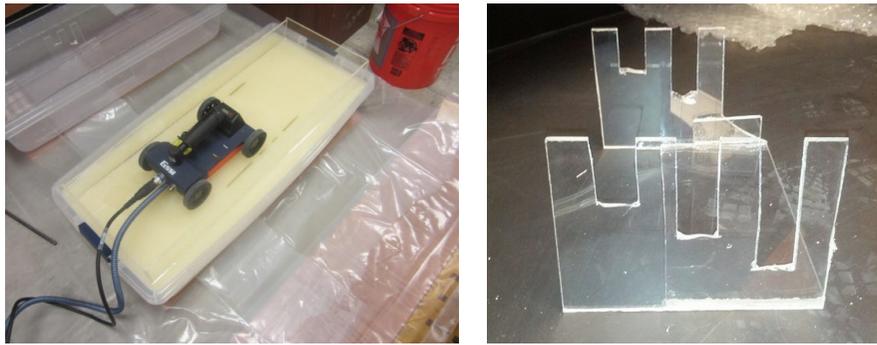
(a) Antenna supported by Plexiglas cover (b) Rebar supporting arrangement

FIGURE 4: Rebar and antenna supporting system in the emulsion tank.

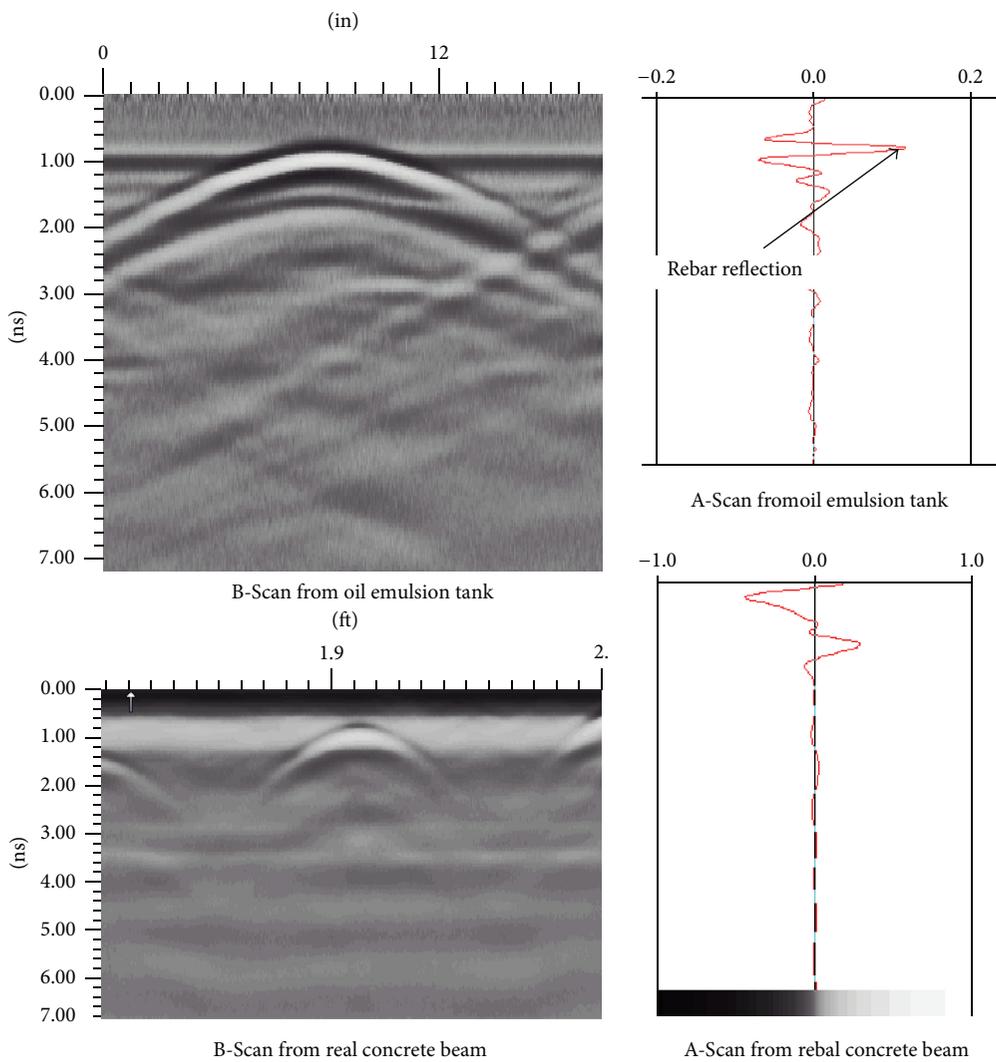
According to existing research knowledge, water oil emulsions can be used as a substitute of concrete in geophysical investigation using GPR [11]. This emulsion can be made with appropriate proportioning of water and oil to match the dielectric constant of concrete. In this study, three different water oil emulsion tanks were prepared to simulate concrete dielectric constants for embedding the corroded rebars in these solutions. Sodium lauryl sulphate was used as an emulsifying agent to assure proper mixture of oil and water in the emulsions. The simulated dielectric constants of the three tanks were measured as 2.73, 5.47, and 9.3 using the two-way travel time (TWTT) of a GPR scan by placing a steel plate under the tank. These values fall within the range of dielectric constants of most concrete. GPR is very sensitive to presence of moisture because of the very high dielectric constant of water. The dielectric constant of concrete mainly depends on the presence of moisture in the interstitial spaces in concrete. Very dry concrete has a low dielectric constant and fresh concrete or concrete with a high moisture content shows higher value of dielectric constant. A system was designed and made to hang the rebars at particular depth in the oil water emulsion tanks. The rebar hanging arrangement was supporting the Plexiglas cover over the emulsion as shown in Figure 4. A thin Plexiglas cover was placed over the emulsion tank to facilitate the movement of the antenna over the liquid surface. The dielectric property of Plexiglas is similar to the oil used in the emulsion. So the GPR wave is assumed to be unaffected by the layer of Plexiglas at the top of the emulsion. Figure 5 shows comparison between GPR data collected from the oil emulsion tank and a real concrete beam. It is obvious from Figure 5 that the B-Scan and A-Scan from both the sources are compatible.

FIGURE 5: Comparison between the emulsion tank and a real concrete beam.

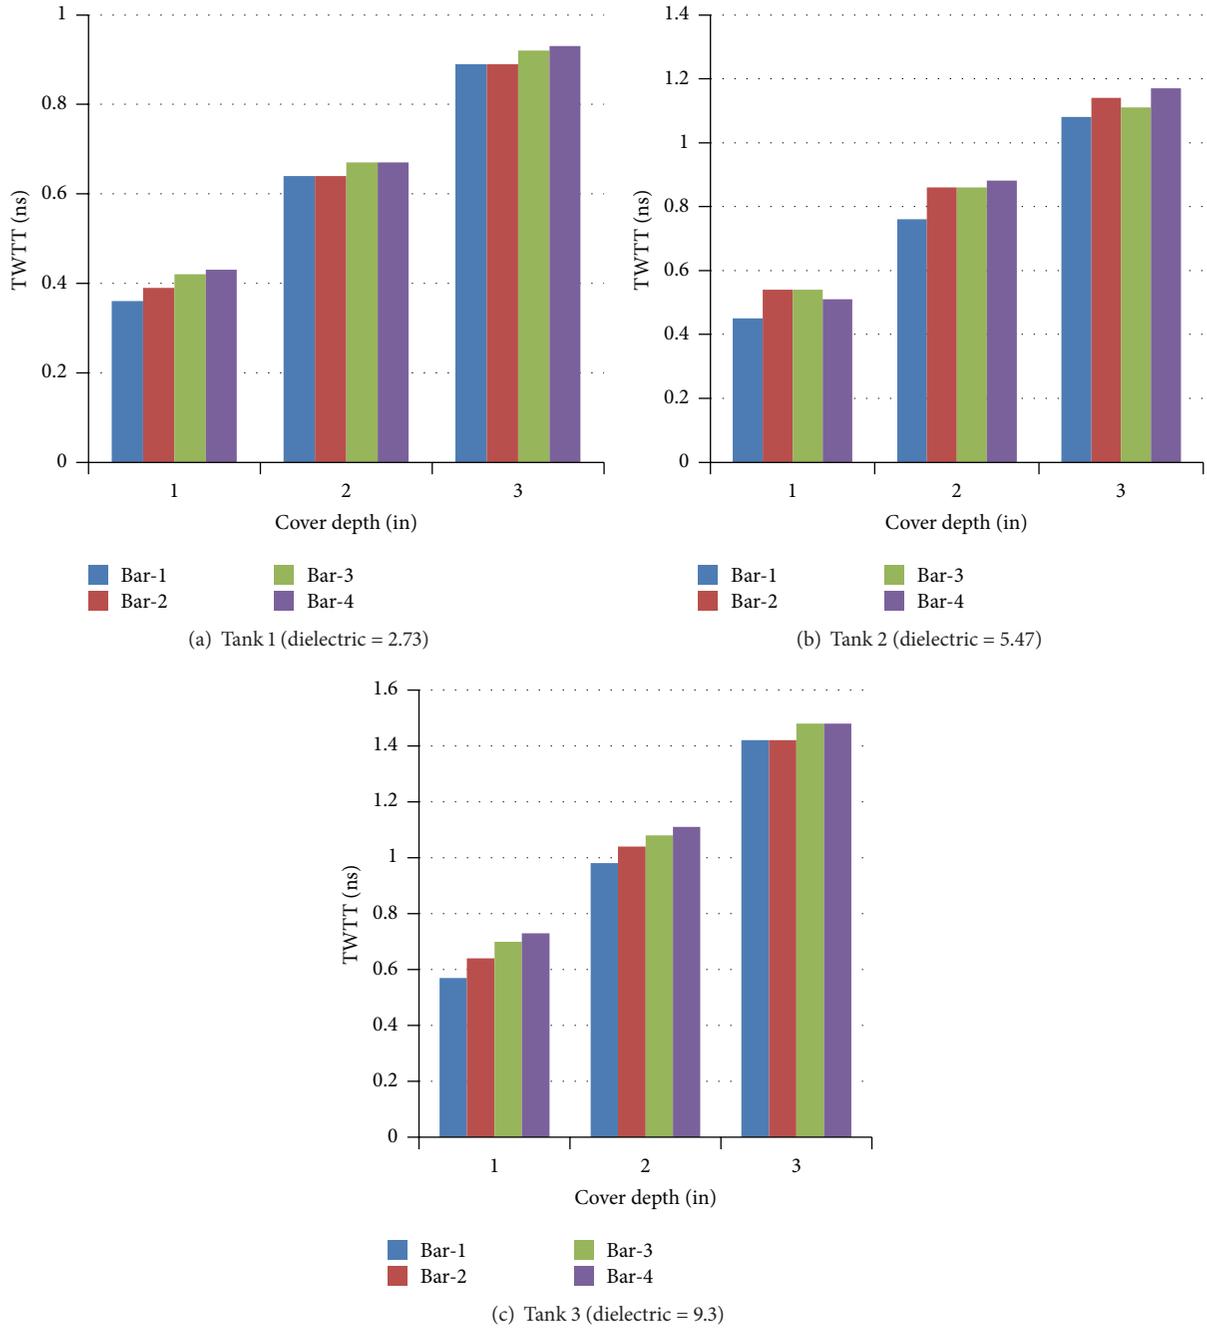
FIGURE 6: Change of TWTT with cover depth for varying corrosion levels. Note: 1 in = 25 mm.

Two GPR parameters were chosen to relate with the extent of rebar corrosion. They are two-way travel time (TWTT) from the rebar and the maximum positive reflective amplitude from the rebar. Two-way travel times were plotted against the rebar depth in the corrosion tanks, as seen in Figure 6. It may be observed that the TWTT is increasing with the increase of the corrosion rate. The reduced rebar diameter due to corrosion created a longer travel path for the GPR

signal and the extra distance traveled was reflected in the increase of TWTT. Figure 6 shows that the TWTT increased with increasing cover depths. Similar behavior was observed in all three tanks. However, the TWTT for a particular cover depth and rebar corrosion is increasing with the increase of the dielectric constant.

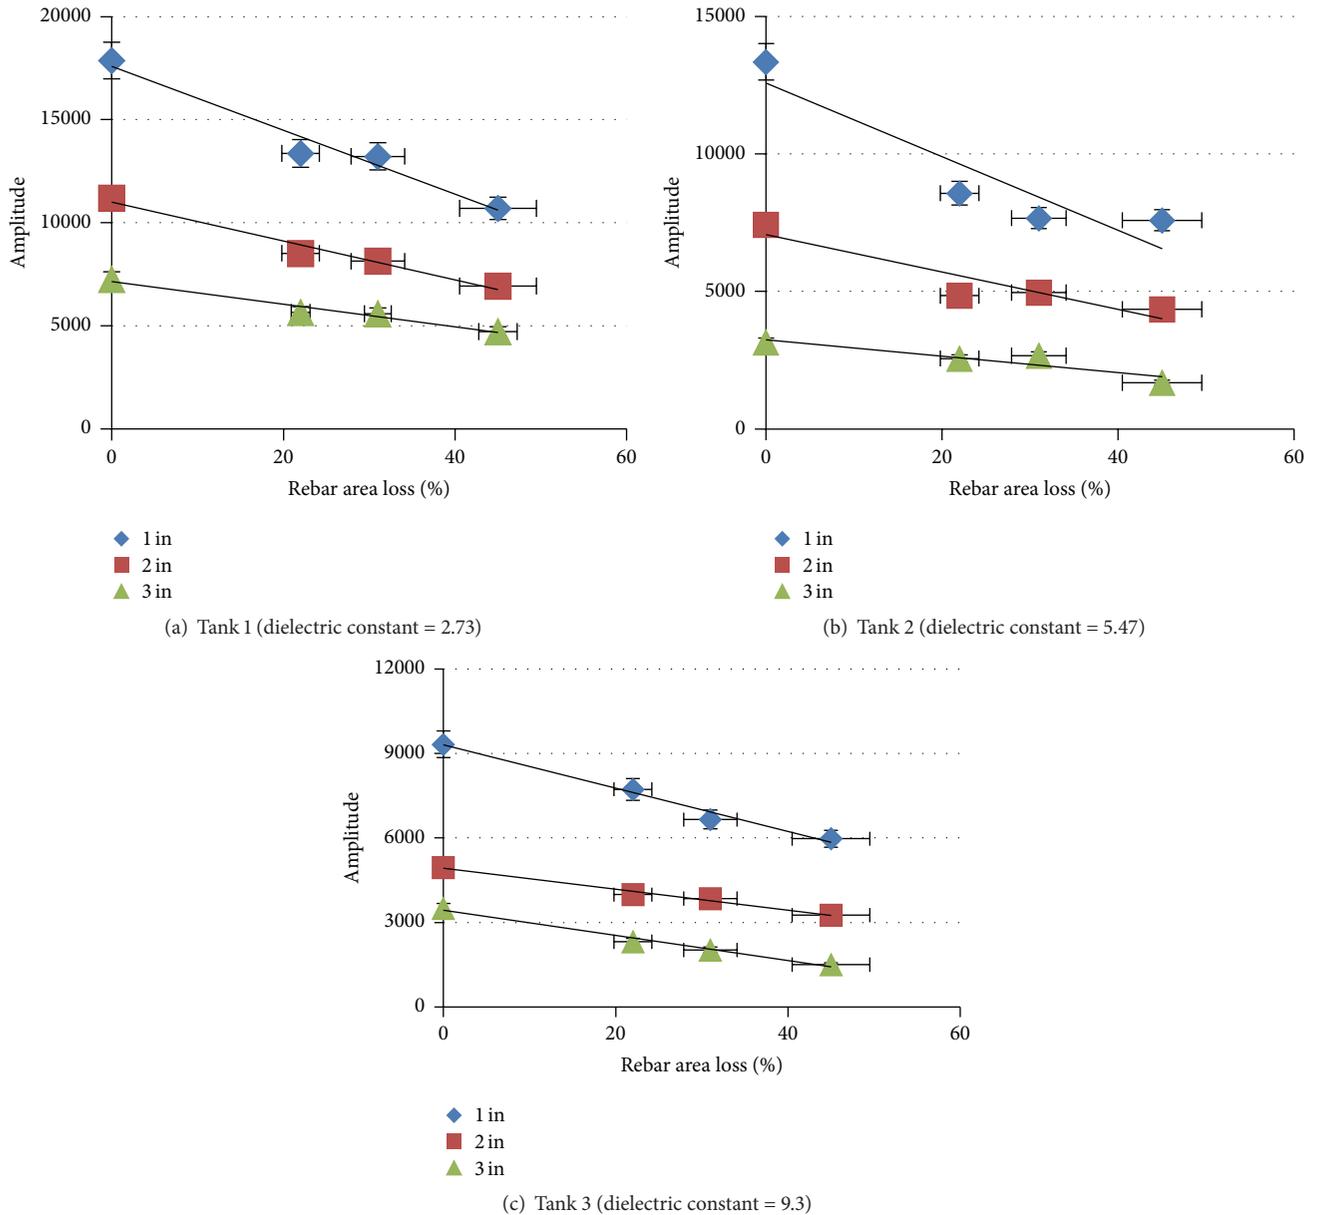
FIGURE 7: Maximum amplitude versus rebar area loss.

Figure 7 shows the plot of maximum amplitudes versus cover depths for the three tanks having three different dielectric constants. It is observed that the maximum amplitude decreased with the increase of rebar area loss due to corrosion in all three tanks with varying dielectric constants and for all cover depths. In order to develop predictive models for rebar corrosion estimation, regression equations for the best fit trend lines (shown in Figure 6) were

generated herein. The best fit equations and the corresponding correlation coefficients are presented in Table 2. The correlations coefficients are very high, ranging from 0.85 to 0.99, indicating high levels of accuracy of the corrosion models. It is also observed that the relationship between the GPR maximum amplitude from the corroded rebars and the amount of corrosion is almost linear. Figure 6 shows that the rate of change in GPR amplitudes is greater at lower cover depths which means that the changes in GPR signal due to corrosion at lower depths are more prominent. The models from Table 2 show that a relationship exists between the maximum positive amplitude and the amount of corrosion if the dielectric constant and the concrete cover are known.
