## Research Article

# Utilization of 3D Laser Scanning for Stability Evaluation and Deformation Monitoring of Landslides

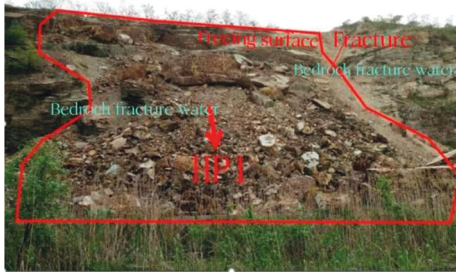
FIGURE 2: Scene of landslide 1.

The lithology of the slope is mainly Silurian Maoshan Formation Middle Series quartz sandstone mixed with silty mudstone. The ground angle of the slope is trapezoidal. Landslide 1 (HP1) (see Figures 2 and 3) is located on the southeast side of the survey area. The length along the slope is about 60 m, the elevation of the top of the slope is  $+47\sim+54$  m, the elevation of the bottom of the slope is  $+4$  m  $\sim+6$  m, the height difference is  $40\sim52$  m, and the slope is  $34^{\circ}\sim42^{\circ}$ .

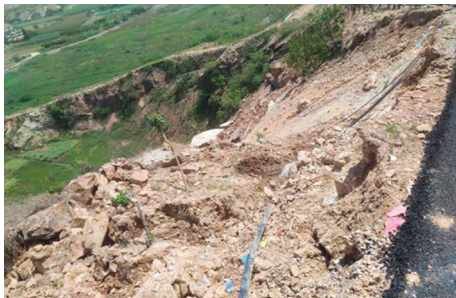
FIGURE 3: The trailing edge of the top of the landslide.

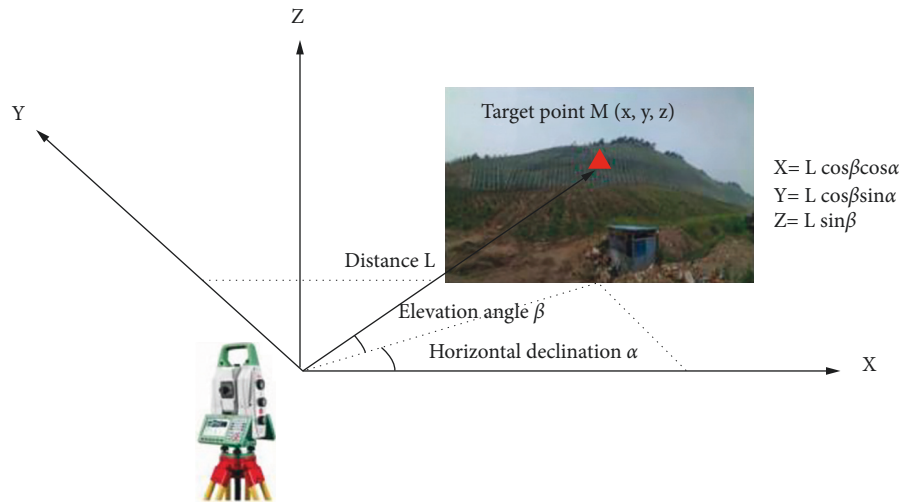
FIGURE 4: Principle of 3D laser scanning positioning.

*3.1. Principle of 3D Laser Scanning.* The 3D laser scanner adopts active laser scanning technology to detect the monitoring target in all directions to obtain precise positioning. The distance  $L$  is calculated by measuring the phase difference or time difference required for the first laser pulse to travel from the instrument to the monitored landslide surface and return and to measure the horizontal declination angle  $\alpha$  and elevation angle  $\beta$  at the same time. The positioning principle is shown in Figure 4.

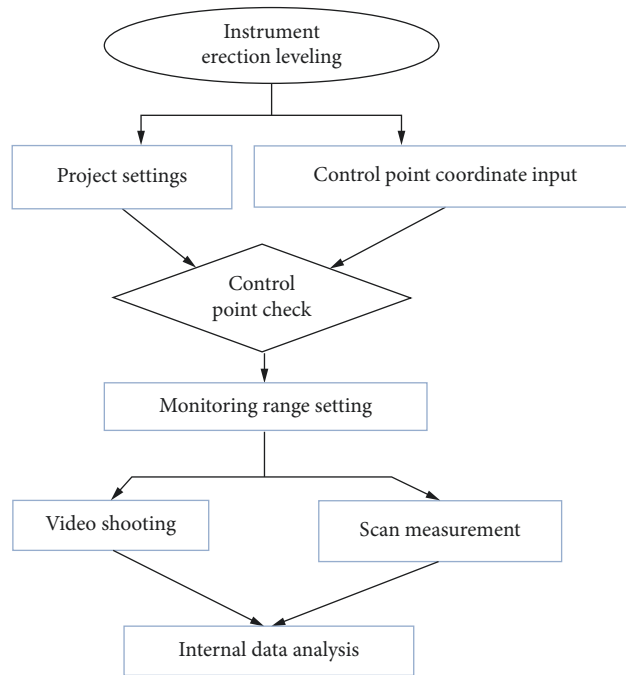
FIGURE 5: Scanning flowchart.

*3.2. 3D Laser Scanning Equipment and Operation Process.* In order to carry out 3D laser scanning of the slope, a Leica MS60 scanner is used, and the angle measurement accuracy can reach  $0.5''$ . This measurement adopts 1000 Hz mode for scanning, its ranging accuracy is 300 m/1.0 mm, and the distance is 50 m. The relevant parameters are shown in Table 3. The main process of scanning is shown in Figure 5.

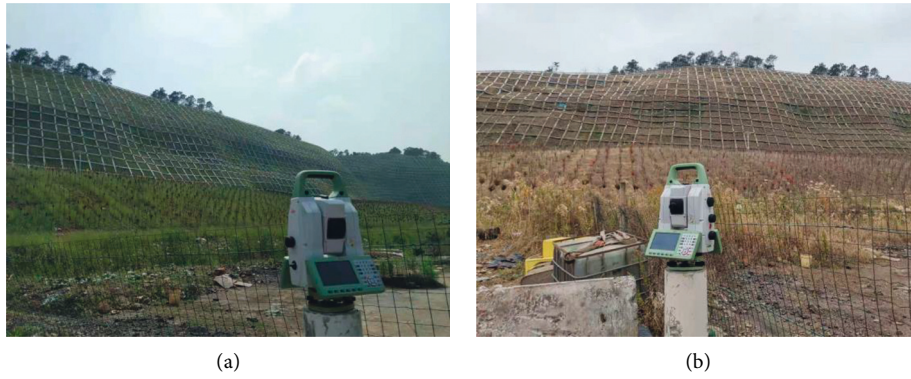
FIGURE 6: Slope data collection site. (a) 2020-5-16. (b) 2020-11-28.

*4.1. On-Site Data Collection.* After the construction of the slope of Shunguo Mountain was completed, two phases of scanning work were completed successively by 3D laser scanning. The status of the slope during the operation period before and after the rainy season was monitored and analyzed, as shown in Figure 6.

The first phase of scanning work was carried out on May 16, 2020. On the afternoon of May 16, the main part of the slope was scanned. The scanning distance was 170 m, and the horizontal and vertical point intervals of the farthest point were 5 mm and 10 mm, respectively. The second scan was carried out on the afternoon of November 28 after the rainy season. The distance, range, and point interval of this scan were basically the same as those on May 16.

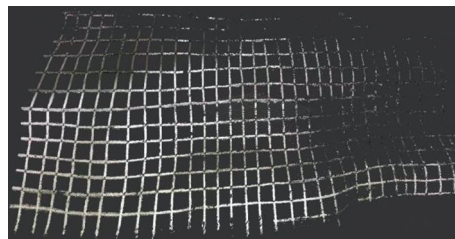
FIGURE 7: The initial modeling of the slope.

**4.2. Initial Modeling of Slope.** The collected original point cloud data of Shunguoshan was filtered and denoised to remove redundant information and noise data. Consequently, the point cloud data was registered, and a solid model was established corresponding to the slope according to the slope shape and point cloud data, namely, the 3D model reconstruction. The detailed process and method are shown in Table 4. The initial modeling of the slope is shown in Figure 7.

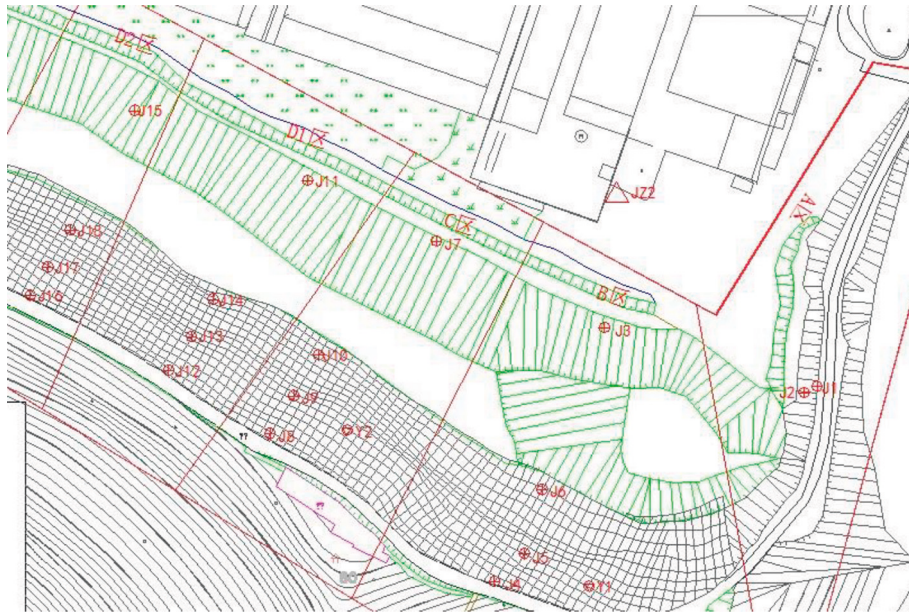
FIGURE 9: Layout of displacement monitoring points.

A total of 37 displacement monitoring points are arranged in the slope deformation monitoring area, and six monitoring points, J8, J9, J10, J12, J13, and J14, are selected

in the scanning area (as shown in Figure 9). The direction and level changes are shown in Figure 10.

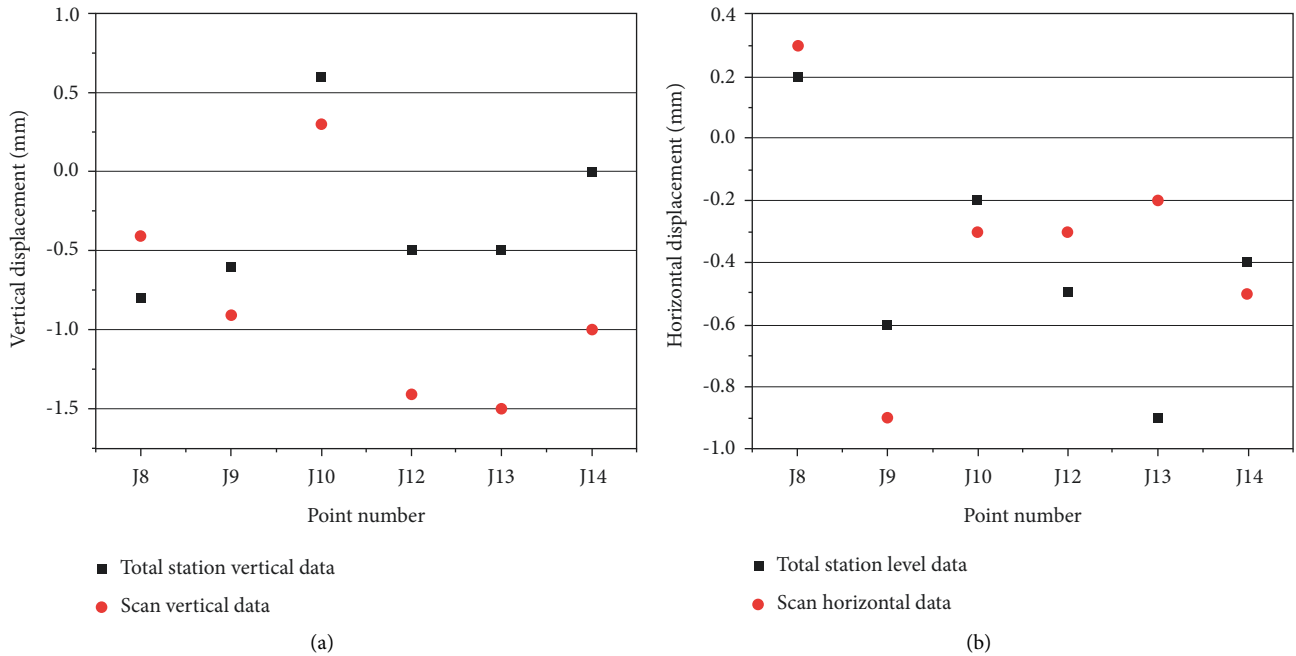
FIGURE 11: Deformation and displacement of the landslide using total station and 3D scanner. (a) Comparisons of vertical displacement. (b) Comparisons of horizontal displacement.

Results showed that the three-dimensional laser scanning monitoring data was similar to the total station monitoring data, and the vertical data at points J12, J13, and J14 had an error of 1 mm, which may be related to the actual weather and operation at that time. Among them, the maximum vertical displacement of the laser is 0.0015 m, the maximum horizontal displacement of the laser is 0.0009 m, and the displacement does not exceed  $\pm 1.5$  mm, indicating that the treated slope is in a stable state. After the rainy season, the slope is still stable, and the slope protection has reached the design target.

We compared the vertical and horizontal monitoring data with the total station as shown in Figure 11.

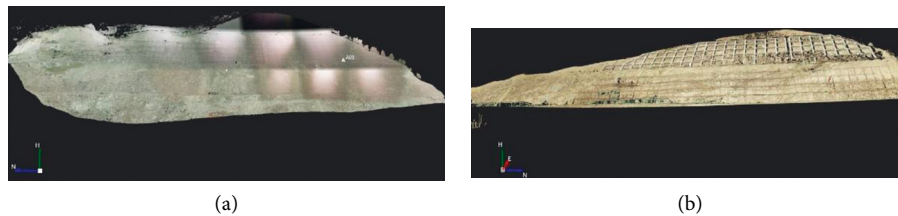
FIGURE 12: Schematic diagram of 3D modeling of slope. (a) Area a. (b) Area b.

**5.1. Raw Point Cloud Data Acquisition and Initial Modeling.** We go to the monitoring site and complete the first on-site application, the collection of raw point cloud data. The collected original point cloud data is filtered and denoised to remove redundant information and noise data. Then the point cloud data is spliced, that is, three-dimensional modeling. The preliminary results are shown in Figure 12.

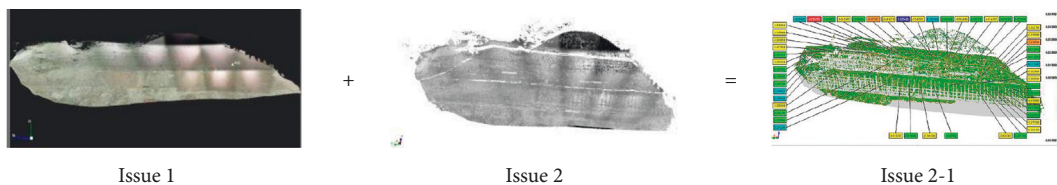
FIGURE 13: Process of phase 2-1 deformation diagram.

**5.2. Analysis of Slope Body Deformation in Area a.** Following the second 3D laser scanning, the point cloud data of the first and second scans are superimposed to obtain the analysis effect diagram of the slope deformation point cloud of the second-1st period. The analysis flow chart of area A is shown in Figure 13.

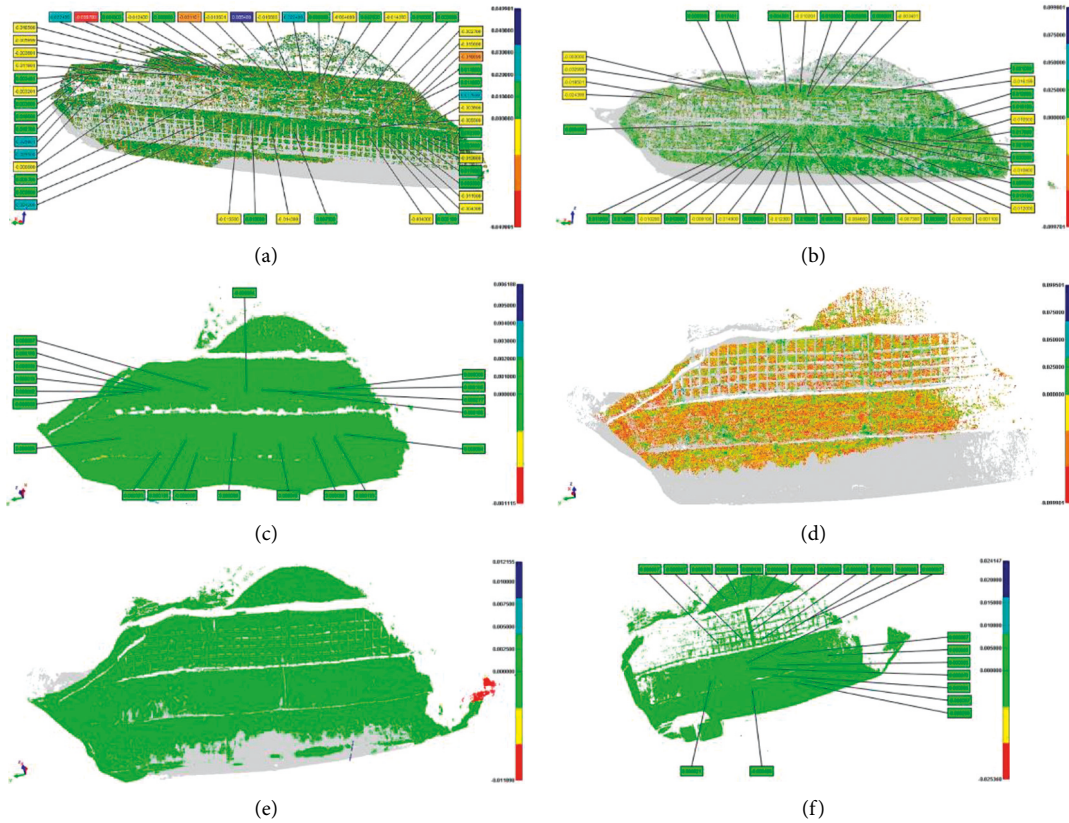
FIGURE 14: Deformation diagram of slope body in area A (point cloud data chromatogram comparison diagram). (a) Issue 2-1. (b) Issue 3-2. (c) Issue 4-3. (d) Issue 5-4. (e) Issue 6-5. (f) Issue 7-6.

Deformation diagram of slope body in area A (point cloud data chromatogram comparison diagram) is shown in Figure 14. According to the point cloud data, from the analysis of phase 2-1 and phase 3-2 deformation maps, the overall displacement of the slope here is relatively stable, and the deformation is less than  $\pm 0.05$  m. Although the local fluctuation is large, there is no obvious change. Preliminary finding is that there is no overall slump risk of the slope here. However, the surface layer of the slope, especially the third-level slope, has the risk of local collapse and the fall of weathered rock and soil. Attention should be paid to the follow-up construction process and strengthen construction protection.

According to the observation of phase 4-3, the displacement of the slope surface is relatively stable as a whole. The deformation amount is less than  $\pm 3$  cm, and there is no obvious local fluctuation and large deformation. Since all the slope excavation has been completed and there is less disturbance, there is no overall risk of collapse of the slope here. However, the subsequent construction process may impact the slope, and it is necessary to pay attention to observation and strengthen protection.

The deformation diagrams of phases 5-4 and 6-5 are analyzed. The displacements of grades 4, 5, and 6 and the slopes of grades 3 and 4 are relatively small, and the overall stability is relatively stable. No obvious construction safety hazards are found. According to different points in the chromatogram, it can be observed that the third-level slope and the first-level slope have an uneven local settlement, and certain support methods should be adopted.

In phase 7-6, the slope displacement is small, the overall is relatively stable, and the difference between the point cloud data and the previous phase is small. There is no obvious construction safety hazard.

To sum up, during the construction process, the maximum deformation of the slope here is not more than  $\pm 0.05$  m, and there is a certain degree of uneven settlement locally, but the whole is in a stable state. With the progress of construction protection, the state of the slope becomes more and more stable.

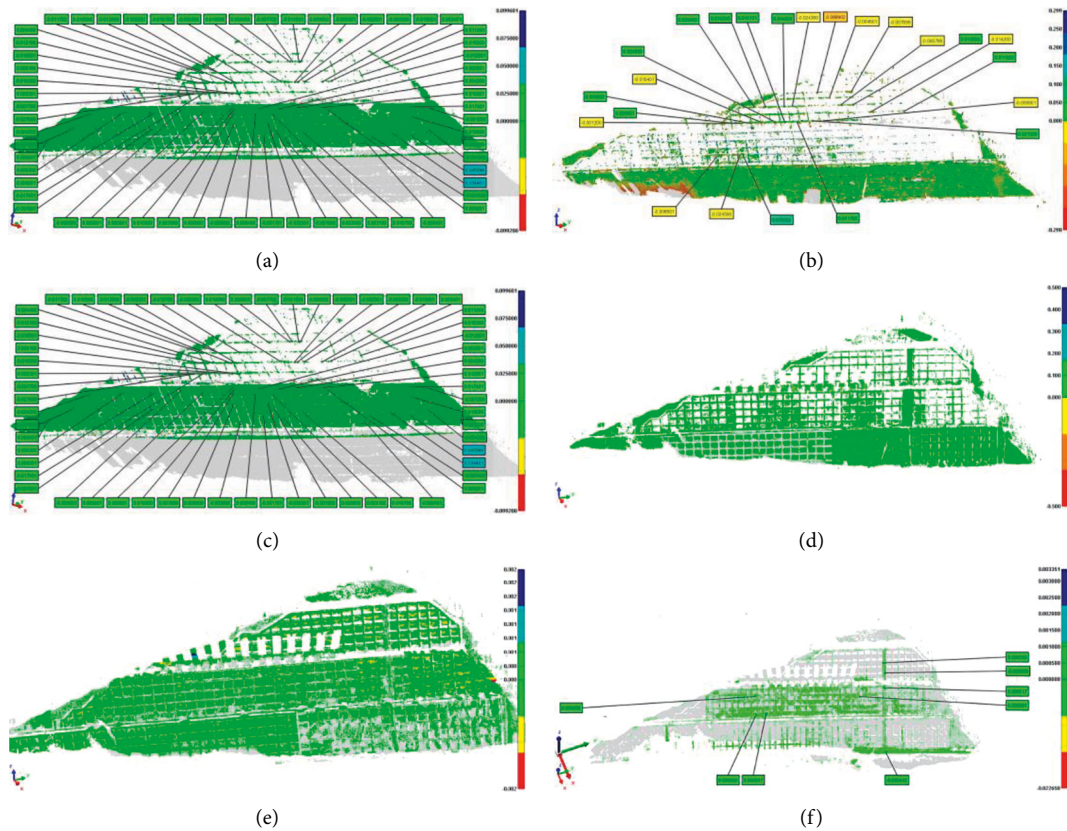
FIGURE 16: Deformation diagram of slope body in area B (point cloud data chromatogram comparison diagram). (a) Issue 2-1. (b) Issue 3-2. (c) Issue 4-3. (d) Issue 5-4. (e) Issue 6-5. (f) Issue 7-6.

Deformation diagram of slope body in area B (point cloud data chromatogram comparison diagram) is shown in Figure 16. According to the point cloud data, the deformation maps of phases 2-1 and 3-2 were observed. The displacement of the slope surface was relatively small, the overall stability was relatively stable, and there were no obvious construction safety hazards. However, some points in the chromatogram were selected in phase 3-2, and it can

be observed that the slope has uneven settlement and uplift of  $\pm 0.1$  m, and attention should be paid to later construction and protection.

According to the analysis of the deformation diagrams of phases 4 and 3, the displacement of the fourth, fifth, and sixth slopes is relatively small, the overall stability is relatively stable, and there is no obvious hidden danger of construction safety. However, by clicking on some different points in the chromatogram, it can be observed that the third-level slope has uneven settlement and uplift of  $\pm 0.04$  m, which is due to the local uneven deformation caused by blasting construction and excavation and unloading of the second-level slope. Certain support methods should be adopted.

In the 5-4th, 6-5th and 7-6th phases, the slope displacement of the slope is relatively stable as a whole, the deformation amount is less than  $\pm 0.015$  m, and there is no obvious local fluctuation large deformation. Since there is no construction excavation shortly and there is a less artificial

disturbance, there is no overall risk of slope collapse here. However, the subsequent construction process may impact the slope, and it is necessary to pay attention to observation and strengthen protection. Phases 7-6 indicate that the excavation below the slope causes less disturbance to the upper part.

In short, during the construction process of this slope, there are local settlements and uplifts with a maximum amount of no more than  $\pm 0.1$  m and the whole is in a stable state. With the progress of construction protection, there are fewer safety hazards on the slope.
