Research Article

Experimental Study on Mechanical Properties of Rebar in Steel Half-Grouted Sleeve Connections with Construction Defects

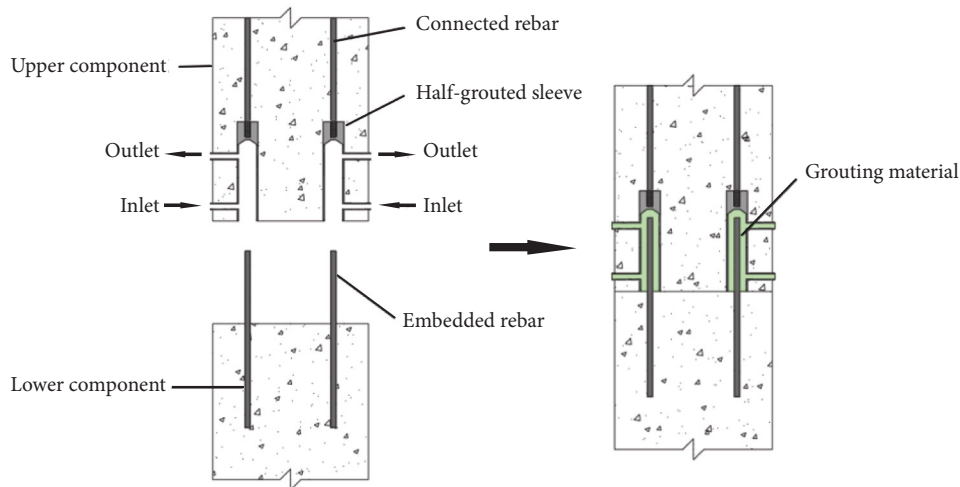
FIGURE 1: Prefabricated concrete component connection using half-grooved sleeves.

grouted sleeve include whole-grouted sleeve and half-grouted sleeve. The half-grouted sleeve is mechanically connected by the connected rebar of the upper component at one end, while the embedded rebar of the lower component at the other end is inserted into the sleeve cavity, which is connected by injecting high-strength and slightly expanding cement-based grout. This setup is illustrated in Figure 1; the technology is convenient and widely adopted [5–7]. The performance of the grouted sleeve is crucial to the viability of the structure. Therefore, many scholars have extensively studied different varieties, inner cavity structure, and new defects of grouted sleeve connections performance.

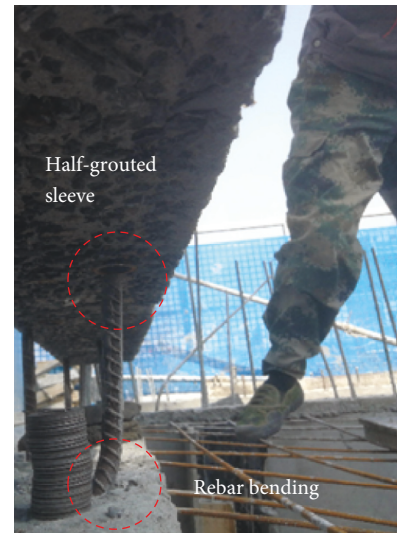
FIGURE 2: Rebar bending.

- (3) Rebar bended specimen: the sleeves of the upper precast components cannot be accurately connected with the embedded rebar extending from the lower components in the process of assembling precast concrete components. Workers often make adjustments by hammering causing

rebar bended joints. Three groups of rebar bended specimens were prepared, and the bent area deviated from the center of the sleeve by 20 mm, 40 mm, and 60 mm.

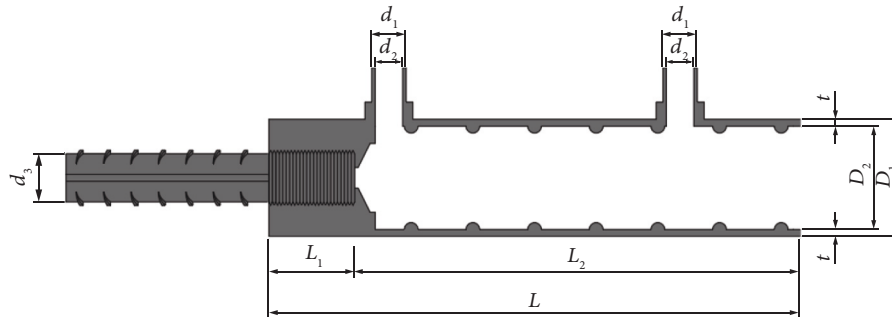
FIGURE 3: Axial profile of half-grooved sleeve.

2.1. Materials. High-quality structural steel half-grouted sleeve was used in this study, as shown in Figure 3. The dimensions are shown in Table 1. The mechanical properties of half-grouted sleeve were measured by practical test. Sleeve tensile strength ≥ 600 MPa, yield strength ≥ 355 MPa, and elongation $\geq 15\%$.

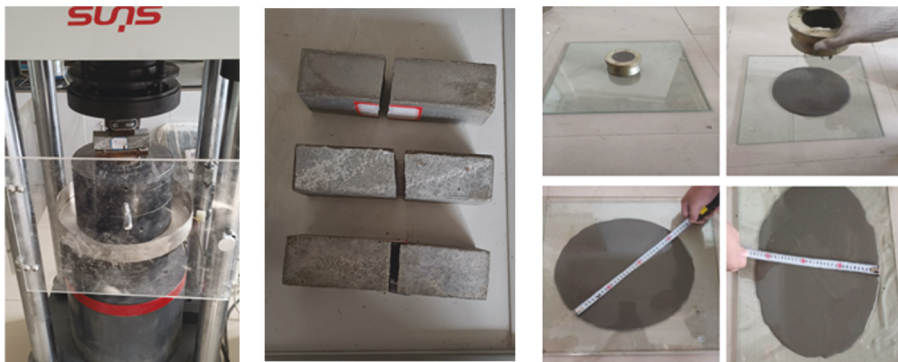
FIGURE 4: Grout properties test.

The binder used in the half-grouted sleeve was made of cement-based materials composed of high-strength cement, high-strength fine aggregate, and various polymer additives. The grouting material had several advantages, such as early strength, high strength, micro expansion, high fluidity, and noncorrosive of rebar. Before formal grouting, test blocks and grout fluid were made under the same conditions to determine whether the grouting material inside the casing reached the expected strength, as shown in Figure 4.

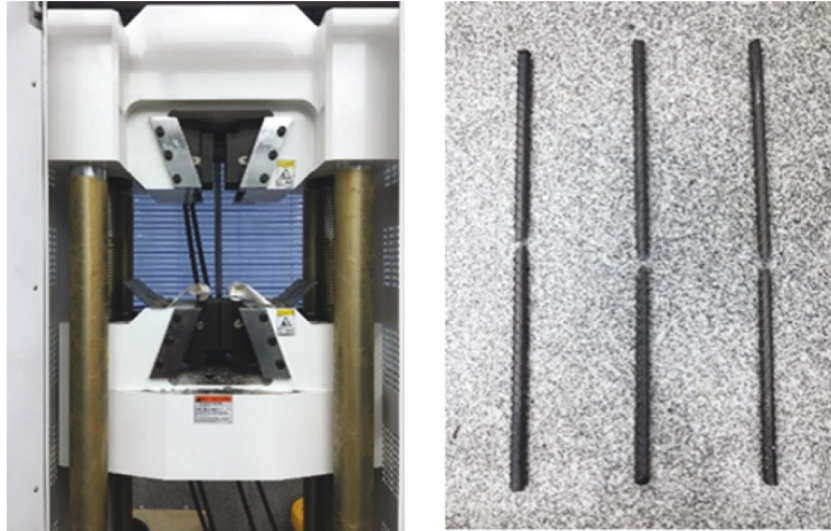
FIGURE 5: Rebar properties test.

The 14 mm diameter HRB400 grade rebar was adopted. The material properties of the connected rebar, including yield strength and ultimate strength, were tested, as seen in Figure 5. The properties of the rebar material are shown in Table 3.

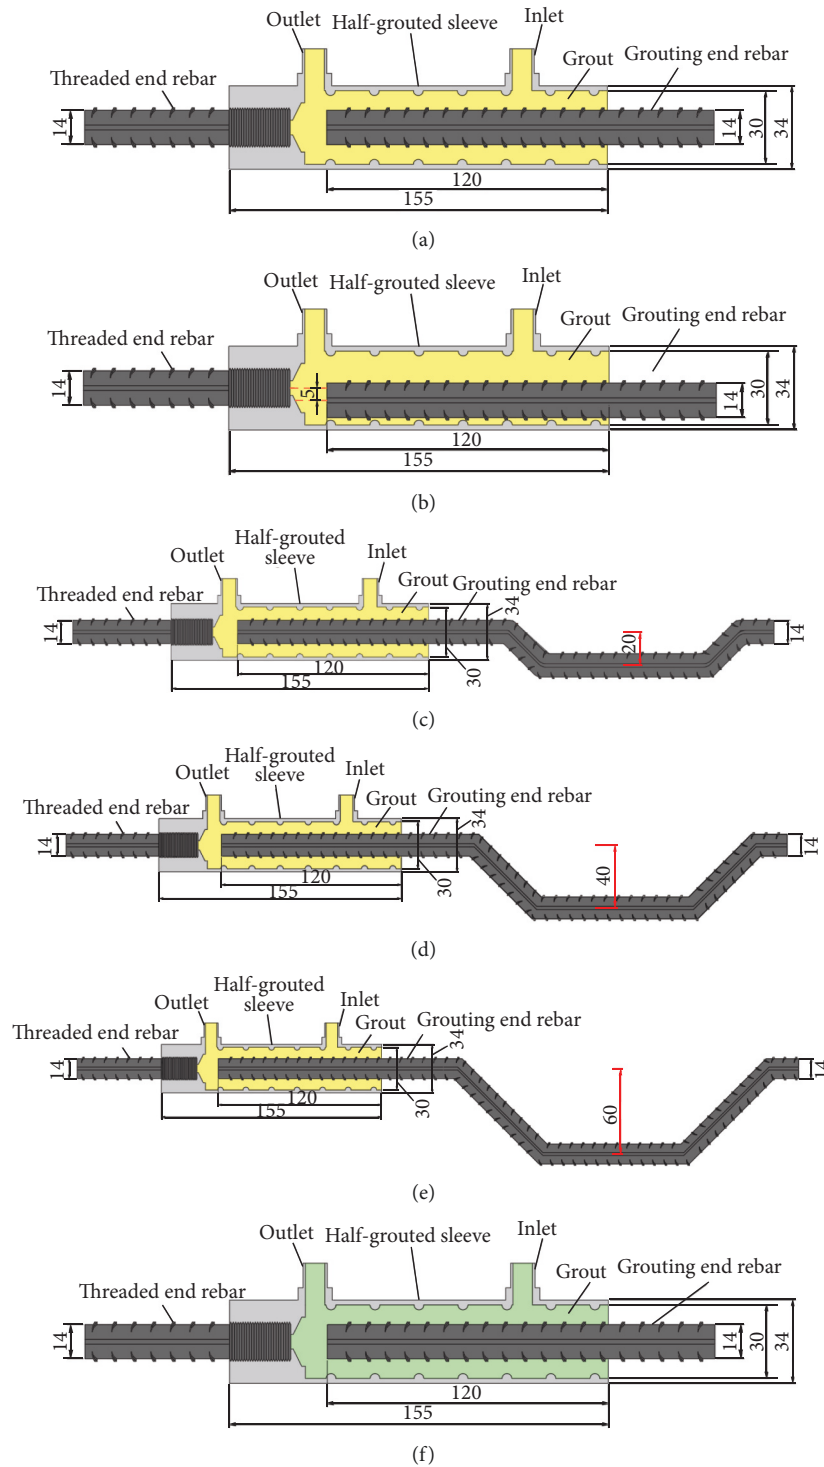
FIGURE 6: Details of the specimens (unit: mm). (a) GT14-BM, (b) GT14-PX-5, (c) GT14-WZ-20, (d) GT14-WZ-40, (e) GT14-WZ-60, and (f) GT14-LD.

Overall, the specimens prepared were of four types: 1 group control, 1 rebar offset group, 3 rebar bended groups, and 3 insufficient fluidity of grout groups (see Figure 6). All the half-grooved sleeves were the same. The grouting material was of the same type and batch, and the rebar was HRB400 with a 14 mm diameter. Details of the specimens are presented in Table 4.

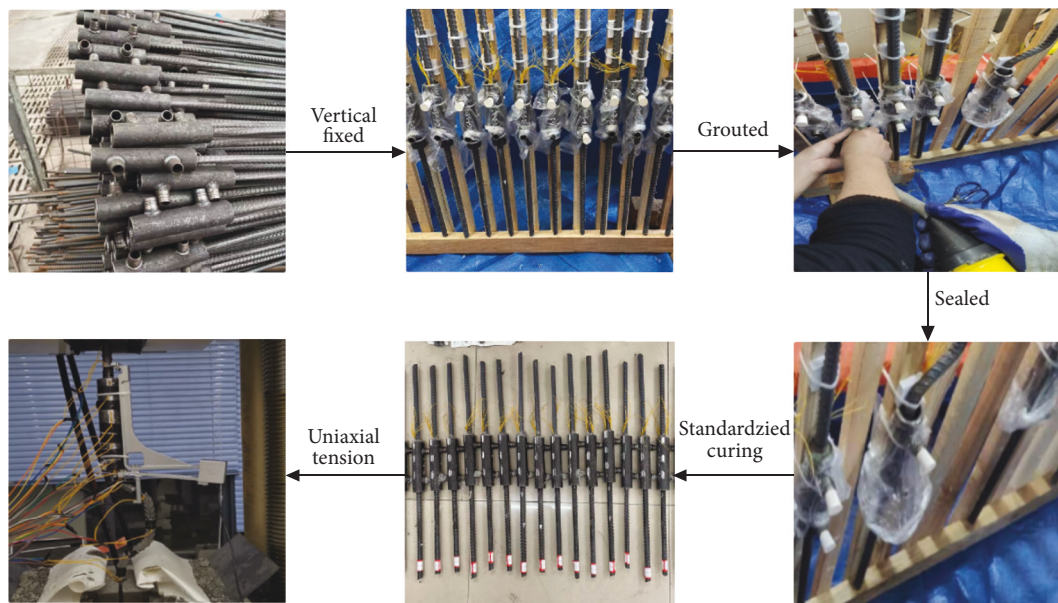
FIGURE 7: Experimental procedure.

performed. All specimens were vertically fixed on the wooden bracket. The independent grouting method was adopted for vertical members, and uniaxial tension experiment was conducted after 28 days of standard maintenance. The procedure is illustrated in Figure 7.

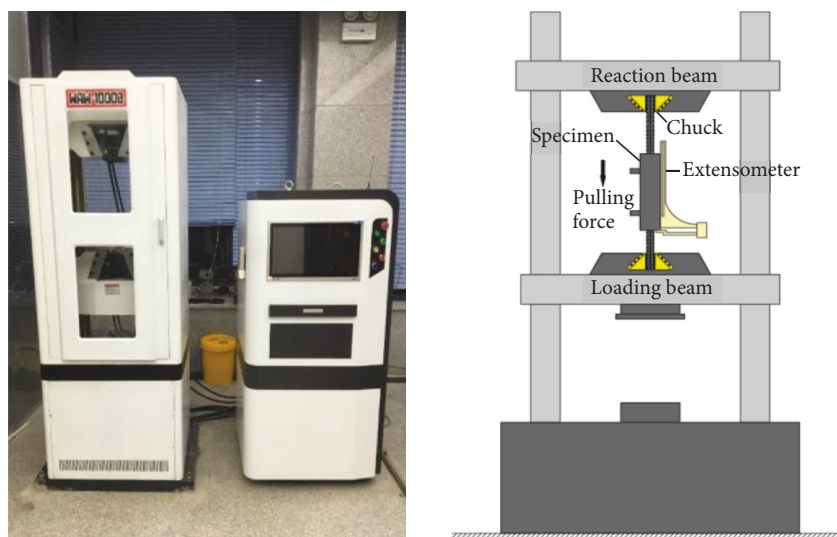
FIGURE 8: Experimental device.

2.3. Experimental Device and Loading Pattern. The WAW-1000B electronic hydraulic universal machine (Figure 8) was used in this experiment. The machine has upper and lower clamps; the specimen was fixed vertically by controlling the lower clamps. To observe the failure of the grouting material, the grouting end was kept downward during loading. The entire test and measurement were conducted under displacement control. The loading rate was 5 mm/min, and the experiment was terminated when the specimens were damaged.

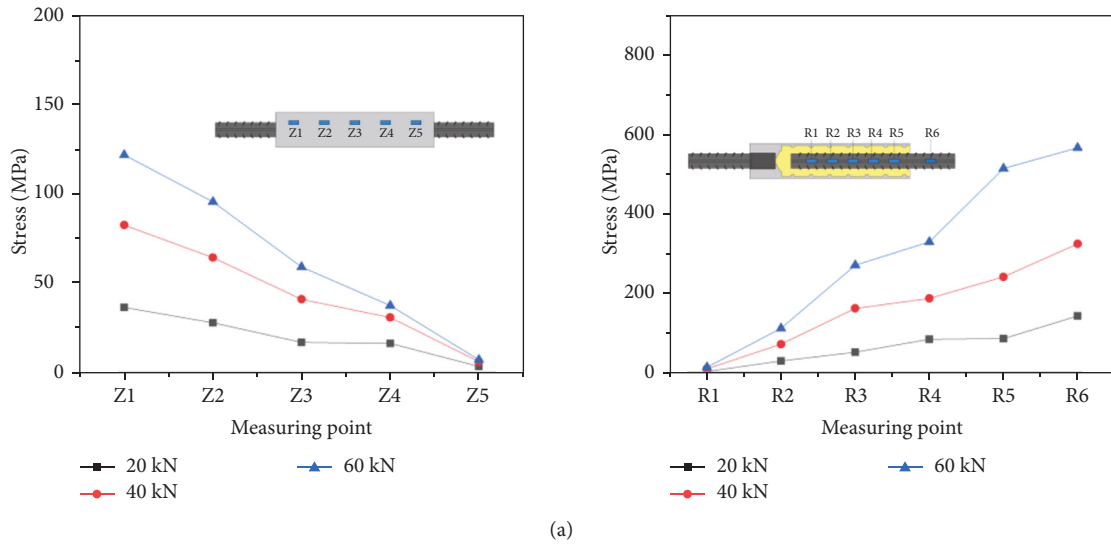
FIGURE 14: Stress distribution curves. (a) GT14-BM-1, (b) GT14-PX-5-3, (c) GT14-WZ-40-3, and (d) GT14-LD-30-1.

3.5. Stress Distribution Curves. Figure 14 presents the stress distribution curves of the sleeve and rebar at different axial positions under the loading of 20 kN, 40 kN, and 60 kN in specimens GT14-BM-1, GT14-PX-5-3, GT14-WZ-40-3, and GT14-LD-30-1 (they are not all listed because of space limitation). The two stress distribution curves are similar to the inclined roof shape; particularly, the GT14-WZ-40-

3 curve fluctuates considerably and has an obvious “inflection point” in the bended area. This observation is mainly because the rigidity and resistance to deformation of rebar reduce after bending. Additionally, it can be observed that the stress of the grouting end rebar in the nonanchorage region was greater than that in the anchorage region, and the stress gradually decreased with an increase in anchorage depth. The maximum sleeve stress was near the threaded end, while the minimum was near the grouting end, which increased with anchorage depth of rebar at the grouting end. It can be concluded that, under the action of high strength load, much of the stress of the half-grouted sleeve connections was borne by the sleeve and grouting material, and the stress of the rebar inside the sleeve was small. Therefore, the connection strength of prefabricated components can be guaranteed in practical engineering.

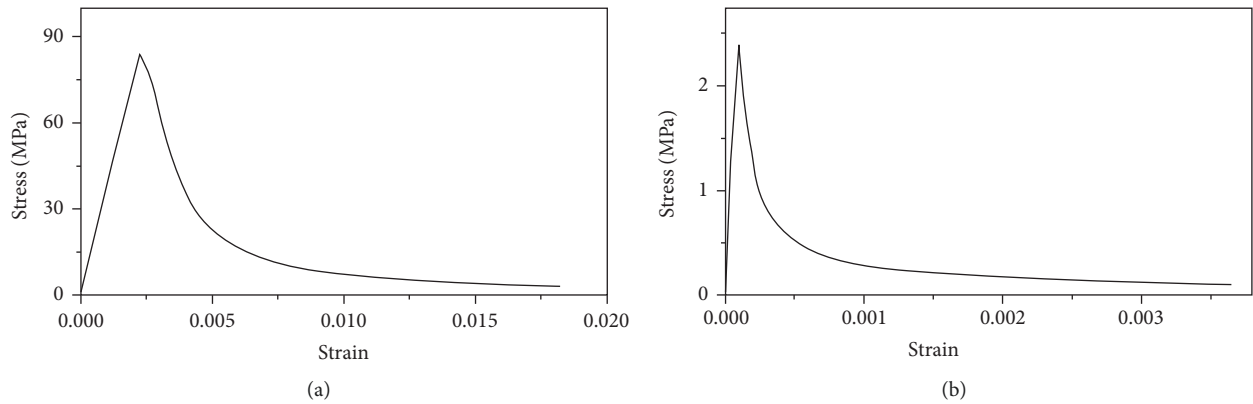
FIGURE 15: Stress-strain curve of grout. (a) Uniaxial compression of concrete. (b) Uniaxial tension of concrete.

material is typically selected according to high-strength concrete [30]. The concrete plastic damage model selected in this simulation is based on the stress-strain curves of concrete under uniaxial tension and uniaxial compression optimized by GB50010-2010 [31]; the constitutive relationships are shown in Figure 15.

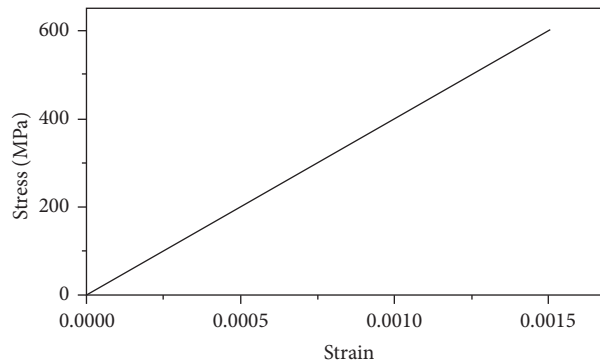
FIGURE 16: Sleeve stress-strain curve.

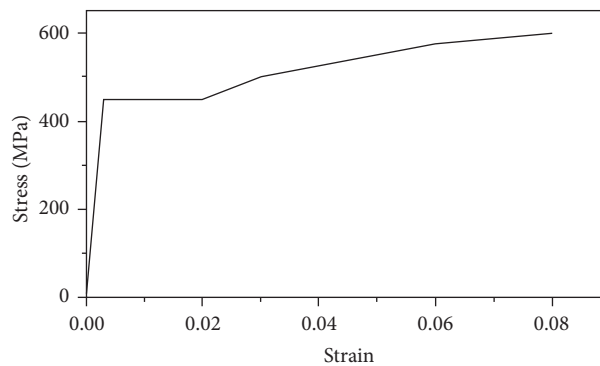
FIGURE 17: Rebar stress-strain curve.

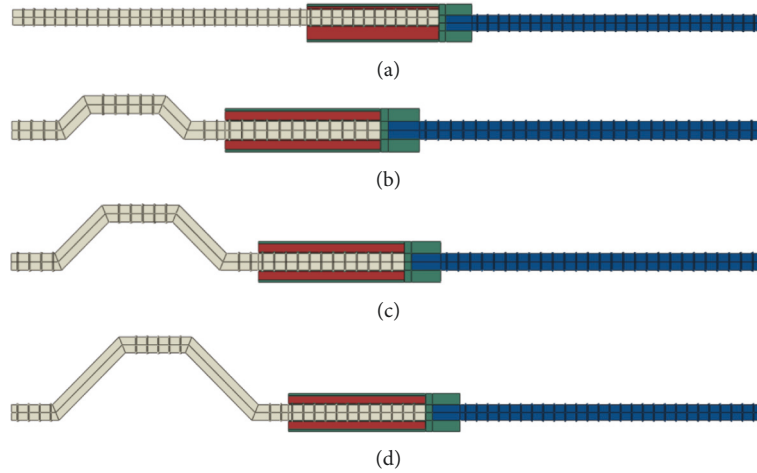
FIGURE 18: The finite element model. (a) GT14-PX-5, (b) GT14-WZ-20, (c) GT14-WZ-40, and (d) GT14-WZ-60.

4.2. Finite Element Model. The grouting material, sleeve, and rebar in the model used C3D8R element, all parts of the model as shown in Figure 18. The grouting material, sleeve, and rebar at the grouting end were set in contact; the friction coefficient was 0.2, and the "tie" constraint was set between the rebar at the threaded end with the sleeve.
