Research Article

Experiment Investigation on Fretting Wear and Wear Debris Performance for the Stem-Cement Interface

Lanfeng Zhang,¹ Shirong Ge,¹ and Hongtao Liu²

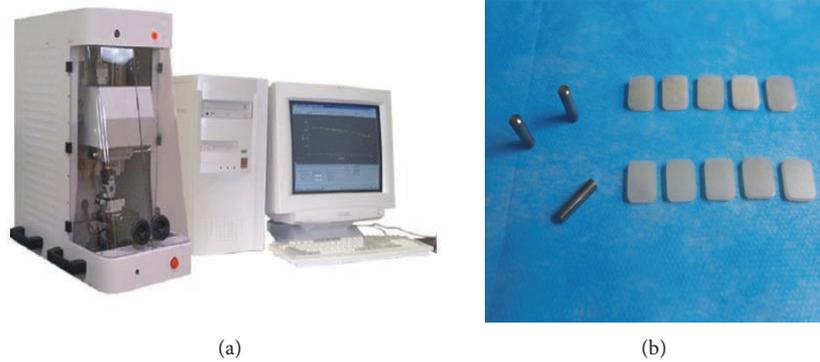
FIGURE 1: Equipment for the tribology experiment between simulated femoral stem and bone cement: (a) UMT-III universal multifunction tester; (b) titanium alloy and bone cement samples for tests.

2.1. Experiment Equipment and Materials. The experiment will be made on UMT-III microfriction and wear tester (as illustrated in Figure 1(a), UMT-III, Centre for Tribology Inc., Campbell, CA, USA) produced by USA Center Company. Medical titanium alloy Ti6Al4V pins are adopted with a diameter of 4 mm and a height of 10 mm, which were manufactured to simulate the femoral stem; the average roughness arranges from 0.03~0.06 μm [17]. Bone cement is made into rectangle blocks of 12 mm long, 8 mm wide, and 4 mm high in model making process (as illustrated in Figure 1(b), Synthetic Material Research Institute, Tianjin, China), and the surface roughness is 0.3 μm . Mechanical property and compositions of the tested materials are as follows in Tables 1, 2, and 3 [29, 30].

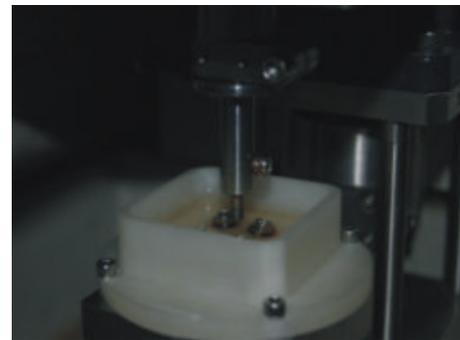
FIGURE 2: Reciprocating fretting friction test.

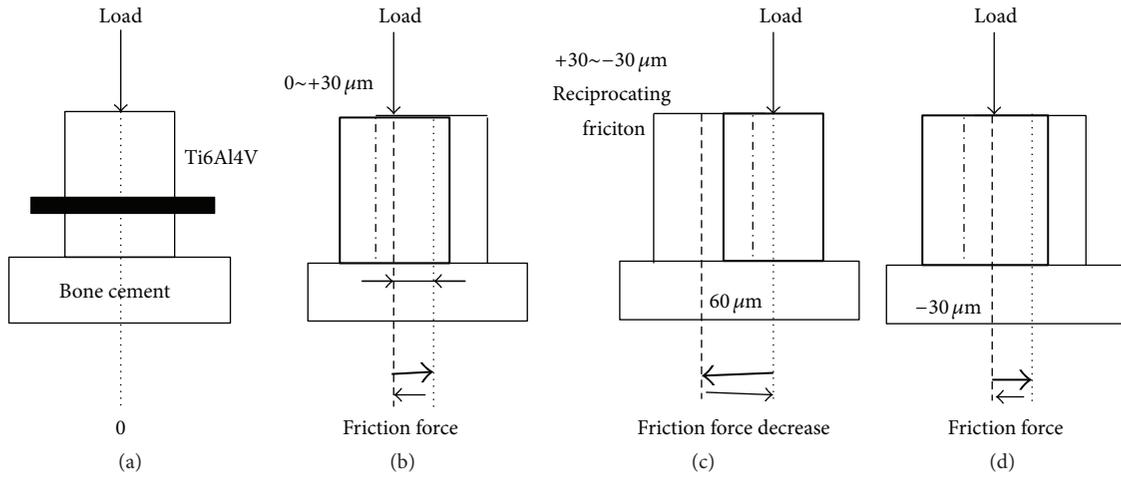
FIGURE 3: Titanium alloy and bone cement interface fretting wear operation illustration: (a) under the load of 20 N, 40 N, 60 N, and 100 N, respectively, Ti6Al4V and bone cement interface contact; (b) fretting starting amplitude; (c) 60 μm move back; (d) to lateral 30 μm, namely, move back to the original location, forming a wear cycle period.

Titanium alloy and bone cement interface fretting is a reciprocating process (Figure 3(a)). Take $30 \mu\text{m}$ starting fretting amplitude for instance, move $30 \mu\text{m}$ aside and the friction force occurs, the rear end of Ti6Al4V metal material wears with bone cement, which makes an edge wear of $30 \mu\text{m}$ approximately and the wear scrap accumulation (Figure 3(b)). Shift back $60 \mu\text{m}$ in unloading; the titanium

alloy has tip shift back and wear at $\pm 30 \mu\text{m}$ place and makes $30 \mu\text{m}$ wear (Figure 3(c)). Shift the detector aside $30 \mu\text{m}$ to its original place, and forms a wear cycle motion (Figure 3(d)).

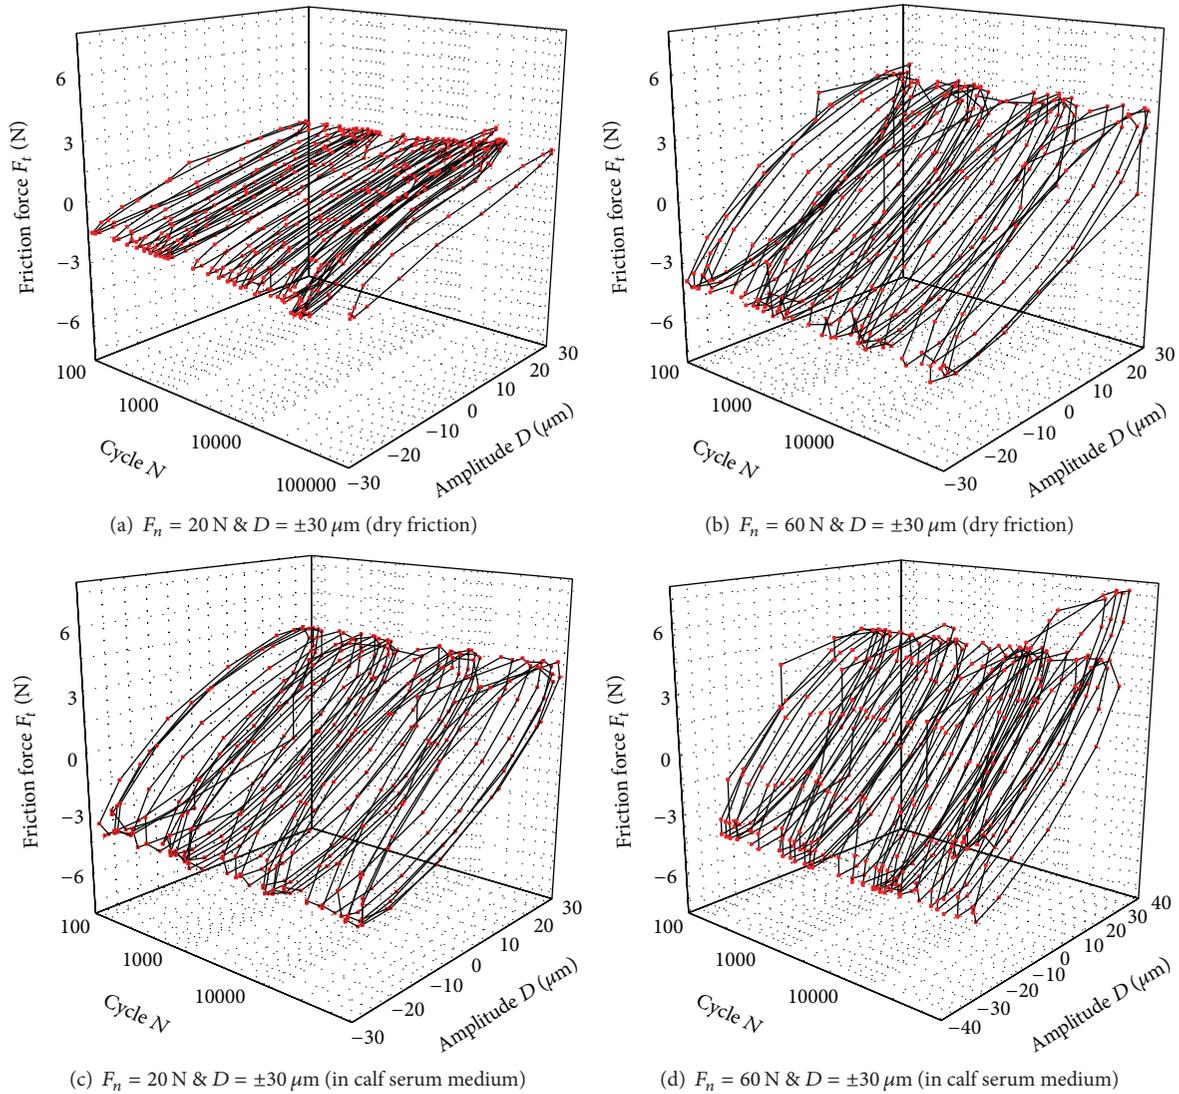
FIGURE 4: F_t - D - N 3D curves of fretting wear of titanium alloy and bone cement in different medium and under different loads.

3.1. Mechanism of Fretting Operation. In purpose of analyzing the process of fretting movement, F_t - D - N curves are being analyzed when $F_n = 20 \text{ N}$ and $D = \pm 30 \mu\text{m}$ and $F_n = 60 \text{ N}$ and $D = \pm 30 \mu\text{m}$, respectively. Figure 4 shows the fretting operation of titanium alloy surface and bone cement matrix under the circumstances of dry friction and calf serum lubricants. In dry friction, when $F_n = 20 \text{ N}$ and $D = \pm 30 \mu\text{m}$, F_t - D curve is in shape of parallelogram at early stage, while with the increase of fretting cycle, when $N \approx 2000$, F_t - D curve transforms into straight line gradually (Figure 4). When $F_n = 60 \text{ N}$ and $D = \pm 30 \mu\text{m}$ (in Figure 4(b)), the distance between loading upper curve and unloading lower curve increases, which illustrates the energy consumption at early stage is slightly higher; meanwhile, when $N \approx 1000$, F_t - D curve transforms into ellipse. When $N = 5000$, the distance between loading upper curve and unloading lower curve decreases, which illustrates the energy consumption drop, whereas in calf serum lubricants, when $F_n = 20 \text{ N}$ and $D = \pm 30 \mu\text{m}$, the F_t - D curve transforms from parallelogram into ellipse ($0 \leq N \leq 1000$), and when $N \approx 5000$, the curve transforms into flat ellipse (Figure 4(d)).

The F_t - D curve transforming into parallelogram at early stage indicates that the contact area is completely in slippage and wear region, and because elasticity and plasticity transformations of different materials occur in contacting and cooperating process, three-matrix abrasion has not formed in friction surface; therefore, the energy consumption of microamplitude is slightly higher. When the load and cycle increase to a certain extent, the F_t - D curve turns into ellipse gradually, which indicates that the tangential fretting operates in mixed region (the medium transition phase between the overall slippage and partial slippage of the interface). With the cycle increase, F_t - D curve will close and transforms into flat ellipse, which indicates that the interface is in balance between elasticity and plasticity transformation and contact stiffness, partial slippage region, and adhesion region come into being on wear interface.

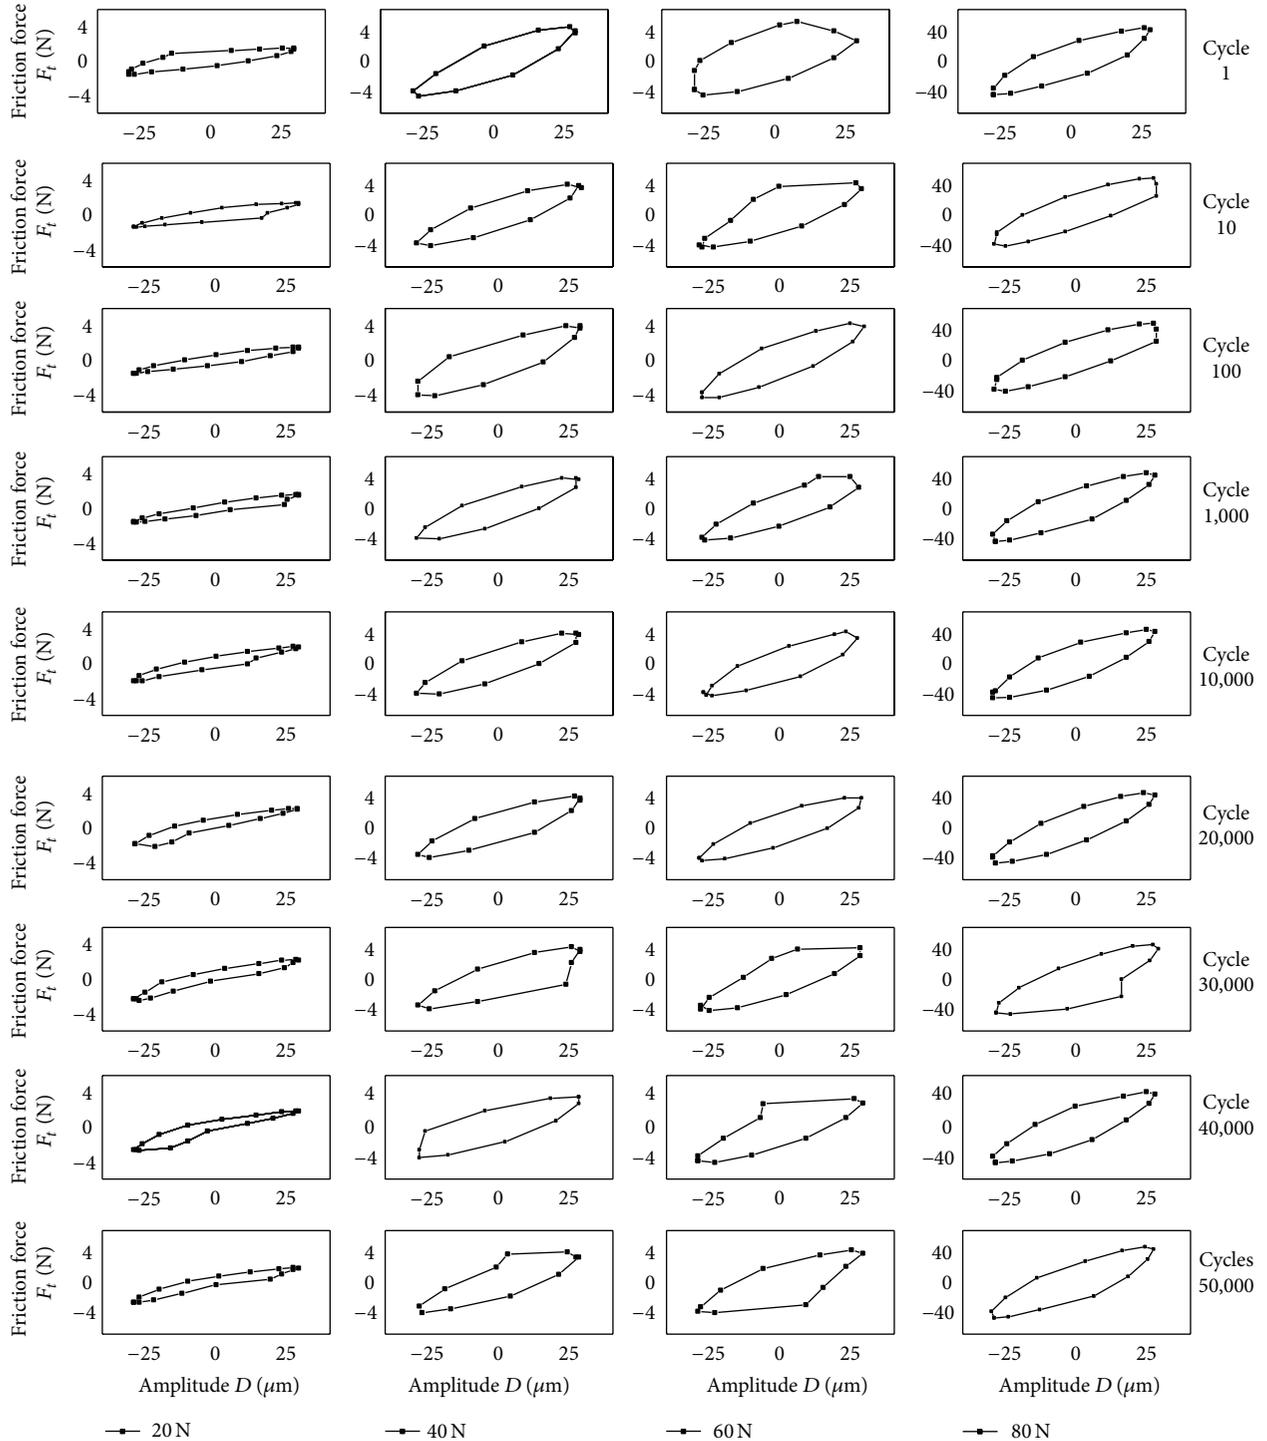
FIGURE 5: F_t - D hysteresis loops ($\pm 30 \mu\text{m}$) of titanium alloy and bone cement under different loads in dry test.

The size of fretting contact area, stress distribution, wear depth, and wear quantity are all determined by loads; F_t - D curve in the same cycle changes with the increase of contact loads. As illustrated in Figure 5, when $N = 1$ (1 cycle), F_t - D curve ($\pm 30 \mu\text{m}$) is basically parallelogram at the early stage, except that under 80 N load is ellipse at the early stage. There is no change when cycle period reaches $N = 10$ (Figure 5) and under 20 N load, which indicates that the surface is still in the elastic area, whereas, when under the loads of 40 N and 60 N , the F_t - D curve transforms from parallelogram into ellipse gradually; for it is just the early stage of wear period, there is no obvious change in fretting diagram. When the load reaches 80 N , obvious elasticity and plasticity transformations occur on the bone cement surface; yet F_t - D curve remains unchanged. When the cycle period reaches $N = 100 \sim 1000$ (Figure 5), F_t - D curves under different loads change gradually. When under 20 N load, the F_t - D curve seems like parallelogram, while under 40 N and 60 N loads, the curves will change alternately between parallelogram and ellipse, which indicates that the wear interface begins to transit from slippage to partial slippage. Analyzing from Figure 4, we can find out from the fretting figure in hysteresis loops of $N = 20,000 \sim 40,000$ and under 20 N load that the original ellipse turns into lines gradually with the influence of cycles, which illustrates that the straight line slopes in the loading and unloading process are the same and the wear quantity remains stable. When under 40 N , 60 N , and 80 N , the F_t - D curve has transformed into stable ellipse. When the cycle period reaches $5,000$ cycles, F_t - D curve remains stable; the fretting diagram under 20 N loads is linear while that under 40 N , 60 N , and 80 N turns into stable ellipse.

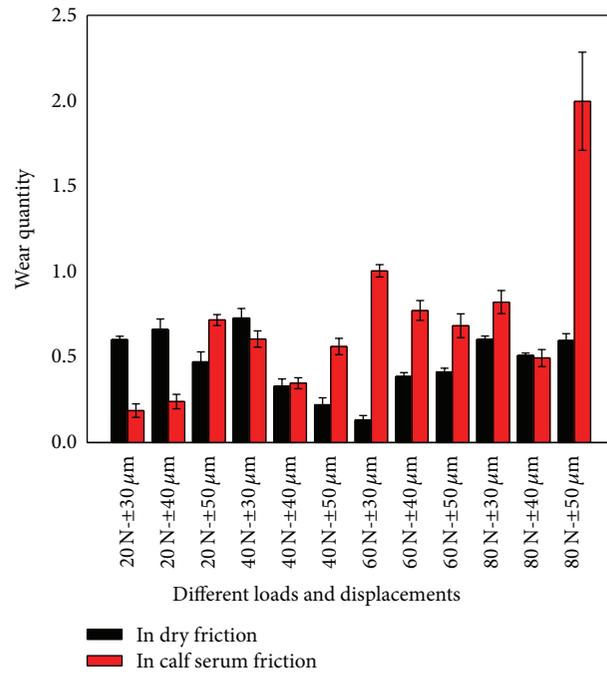
FIGURE 6: Bone cement sample fretting wear quantity.

3.2. Fretting Wear Quantity Analysis of Bone Cement Matrix. As illustrated in Figure 6, the wear quantity of bone cement sample increases with adding contact loads in different wear conditions, amplitudes, and loads. Some researches demonstrated that the proteins in fretting tribological behavior play a passive role in protecting the wear region [20–28]. Under the same contact load, the wear quantity of bone cement in the calf serum is greater than that in the air.

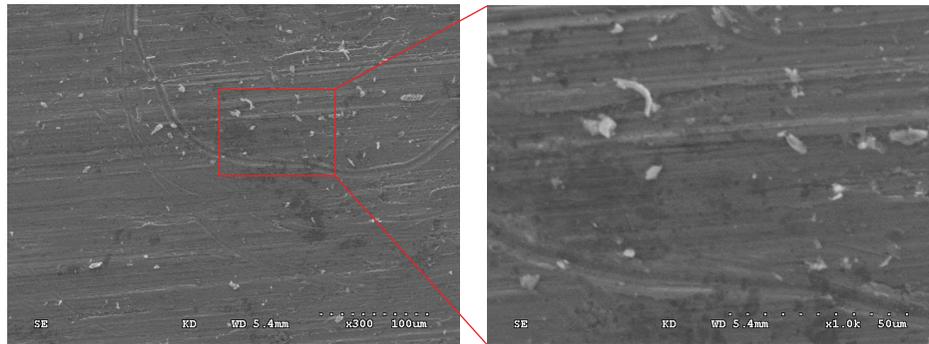
FIGURE 7: SEM graph of bone cement wear debris group.

3.3.1. Morphology Study on Bone Cement Wear Debris. After transplanting the artificial stem into human's body, for the extremely rigid biological friction and wear environment on titanium alloy and bone cement interface, friction interrelated biomechanical changes are unpredictable and the wear period is relatively long; therefore wear types can be found out through the study on the interrelated wear debris appearance produced in friction. As shown in Figure 7, the bone cement wear debris are in various shapes, including the wear debris in strip, block, sheet, and ball shape and the different particle sizes. Some basic rules can be found out that the larger the size of the wear debris is, the more complicated the surface becomes, and the appearance of wear debris with smaller particle size transforms gradually into sphericity or near sphericity. After studying and observing the wear debris for

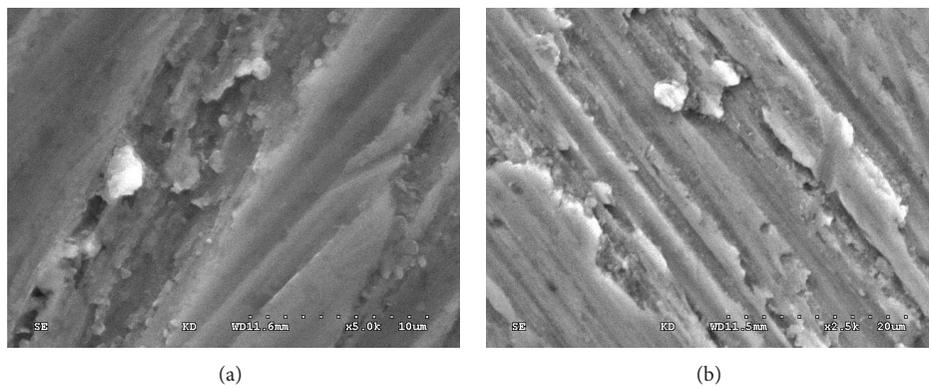
FIGURE 8: Morphology figure of bone cement spherical wear debris.

(I) *Spherical Wear Debris*. The maximum and minimum debris sizes of spherical wear debris are basically $10\ \mu\text{m}$ and $1\ \mu\text{m}$ approximately, which distributes widely and is one kind of wear debris that exist in greatest amount. It can be found in Figure 8 that the surface texture of the spherical wear debris is quite smooth. It is inspected that wear debris with large particle sizes usually exist in shapes of block, sheet, or strip, whereas those with small particle sizes tend to be in spherical or near spherical shapes, which results from the cooperation of repeated rubbing in the reciprocating fretting wear and the debris wear, which is formed in the late period of wear debris abrasion. When the wear debris accumulate to a certain degree, they will be attached to bone bed and induce osteoclast activating factor to make broken bone physiological response under the joint capsule press and they are the main wear debris that induce hip aseptic joint replacement loosening.

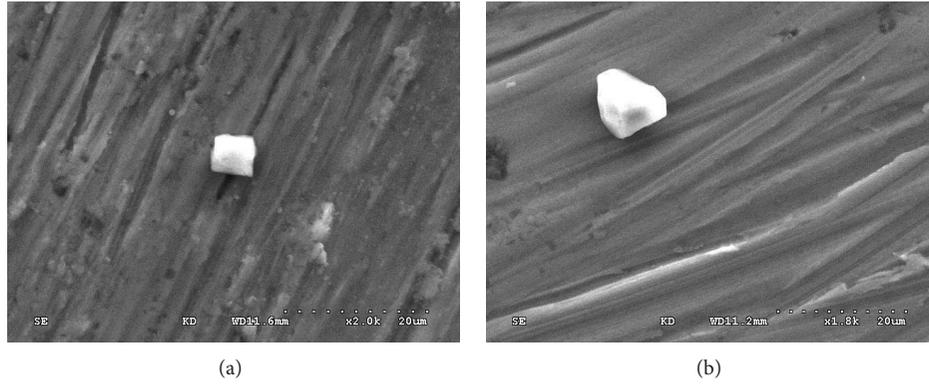
FIGURE 9: Tuberos wear debris of bone cement.

(II) *Tuberous Wear Debris*. The length and width ratio of tuberous wear debris (Figure 9) is nearly $2\ \mu\text{m}$ with the spindle-shaped or flat tuberous appearance, and obvious lines rise and fall on its surface. Water prop shaped wear debris is mainly formed by adhesion wear and is always ripped or torn in the process, and its particle size is about $5\ \mu\text{m}$, while flat wear debris originate from the crack nuclear on friction surface caused by fatigue stress on the friction interrelated surface, which rips off at the weak bonding point of bone cement matrix under the friction interrelated adhesion, and its particle size is about $2\sim 20\ \mu\text{m}$. The debris are formed at the interface debonding period, attached to the titanium alloy surface, and are the early product of fretting wear.

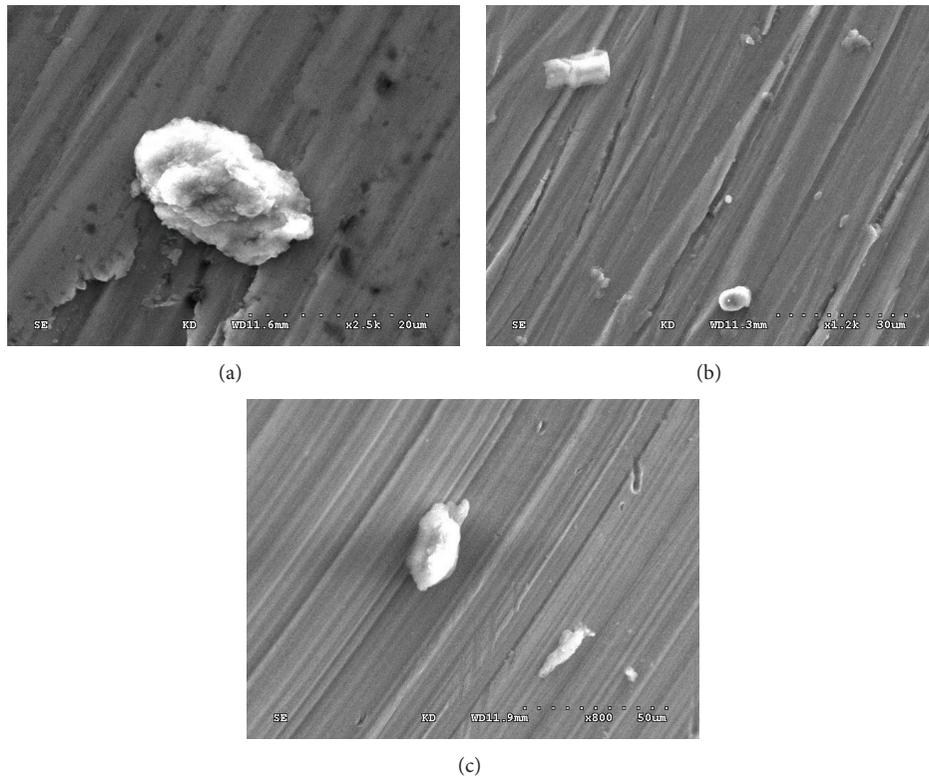
FIGURE 10: Morphology figure of bone cement messy ellipse wear debris.

(III) *Ellipse Wear Debris*. The width and length ratio of ellipse wear debris is from 2 to 5 and the appearance takes the shape of ellipse (Figure 10). Obvious lines rise and fall on wear debris surface, which is mainly produced and developed from bone cement tuberous wear debris. Tuberous debris are polished into ellipsoid gradually under the reciprocating wear model and long term three-matrix abrasion, and the ellipsoid wear debris are the early forms of spherical wear debris with the particle size of 2 to $15\ \mu\text{m}$ approximately. This type of wear debris is formed under the repeated roller compacted damage of large bone cement tuberous wear debris ripped off.

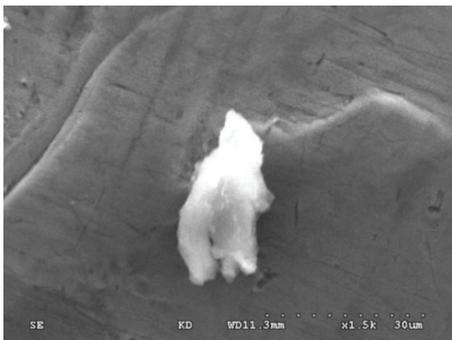
FIGURE 11: Lacerated wear debris of bone cement.

(IV) *Lacerated Wear Debris*. Lacerated wear debris originates from the dropping of asperity slippage wear which makes cracks on matrix surfaces, for wear debris produces in the same direction with that of crack extension, the existing parts peel off from matrix under cutting and furrowing, together with fatigue wear, lacerated wear debris come into being. This type of debris has irregular and coarse edge line and the particle size is $5\sim 35\ \mu\text{m}$ (Figure 11), which is formed at the fatigue wear stage.

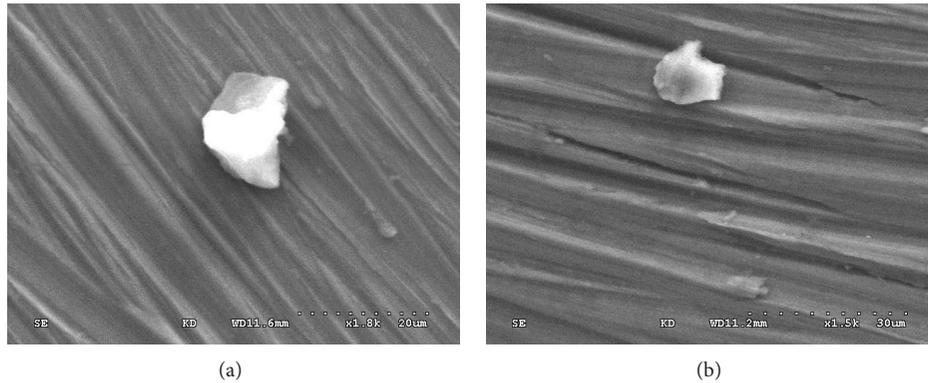
FIGURE 12: Sheet wear debris of bone cement.

(V) *Sheet Wear Debris*. Sheet wear debris has relatively large area and small thickness and takes the shape of irregular polygon (Figure 12). It is mainly because the tiny materials peel off between surface and subsurface under fatigue effect and then, attached to material surface, sheet wear debris is formed after reciprocating press, and its particle size is 20 to $50\ \mu\text{m}$. This kind of wear debris is formed at the fatigue wear stage.

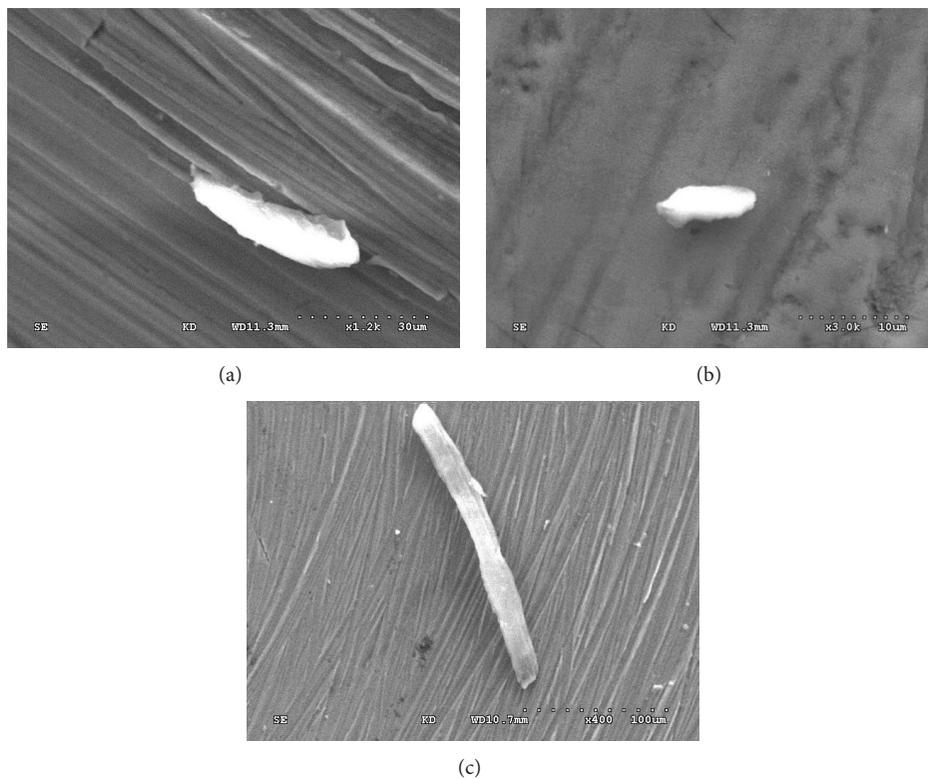
FIGURE 13: Morphology figure of bone cement strip wear debris.

(VI) *Strip Wear Debris*. Pole-shaped wear debris has a diversified structure in appearance. There are mainly three formation reasons for strip wear debris; firstly, the matrix is ripped off the matrix in scraping action; secondly, wear debris are formed in the friction process; thirdly, sheet wear debris are rubbed into rope shaped wear debris in friction interrelated motion, which reflects the motion state of reciprocating fretting wear, and the length of wear debris is 15 to $110\ \mu\text{m}$ (Figure 13). It is the derived product of ellipsoid wear debris and it is formed at the middle and late stages.

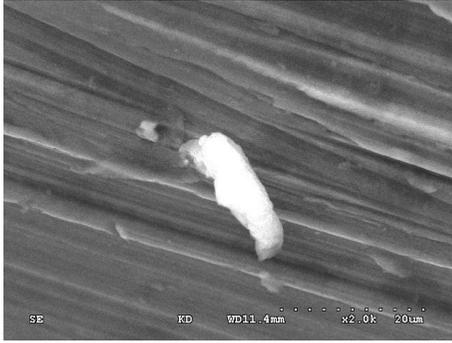
FIGURE 14: Morphology figure of bone cement pole-shaped wear debris.

(VII) *Pole-Shaped Wear Debris*. Pole-shaped wear debris has a diversified structure in appearance, curvy edge line, and stable surface lines, and its size is 5 to $30\ \mu\text{m}$. There are two main reasons for the formation of pole-shaped wear debris; firstly, debris are produced in thermoplastic transformation and microcutting. Pole-shaped wear debris are usually produced in breaking in period with the size of $10\sim 50\ \mu\text{m}$. Secondly, it is formed because of the falling furrow edge drop in surface cutting, and its size is 10 to $80\ \mu\text{m}$ (Figure 14). Pole-shaped wear debris are generated at the same stage with strip wear debris and then suffer from abrasive wear.

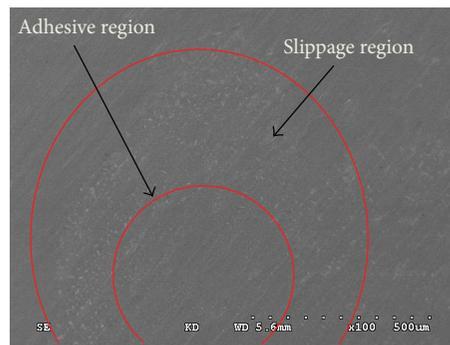
FIGURE 15: SEM Morphology graph of Ti6Al4V alloy wear debris group.

3.3.2. *Morphology Study on Titanium Alloy Wear Debris*. It can be found in Figure 15 that titanium alloy wear debris are small in size and most of which take the irregular

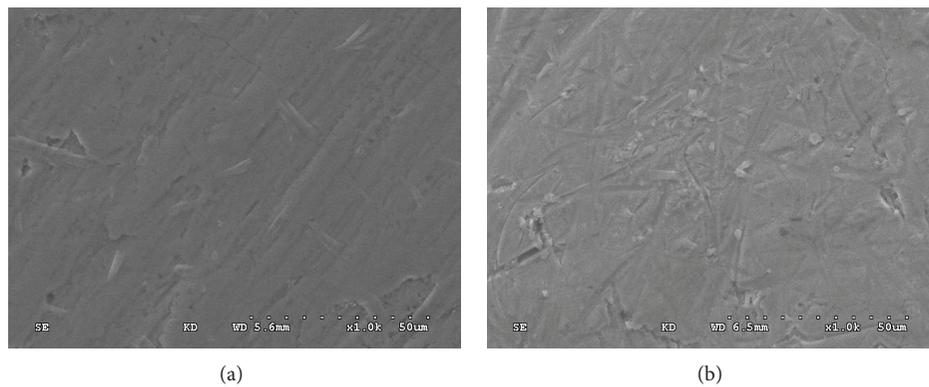
FIGURE 16: Morphology figure of titanium alloy strip wear debris: (a) debris in dry condition; (b) debris calf serum.

(I) Strip Wear Debris. Strip wear debris is commonly seen in titanium alloy wear debris group with the size of 10 to 50 μm . It has rather smooth surfaces and there are various reasons for its formation. First of all, the previously ripped small titanium alloy wear debris transform gradually into abrasive wear form in fatigue wear process. On the other hand, the large sheet wear debris' edges are hardened and become thin and sharp

which scrapes titanium alloy matrix in friction process. Such kind of wear debris has rather sharp wings; the existing wear debris on friction surface generated in fretting wear process come into being (Figure 16) at the late stage.

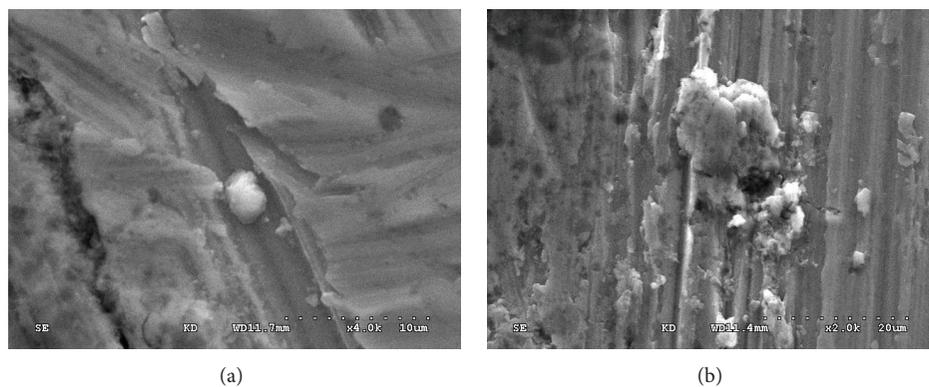
FIGURE 17: Morphology figure of titanium alloy spherical wear debris.

(II) Spherical Wear Debris. Spherical wear debris of titanium alloy in spherical shape are shown in Figure 17(a) which are small in size and whose distribution scopes are usually smaller than 15 μm . There are uneven lines on the surface and many debris gather around. (Figure 17(b)). They are mainly the products of fatigue wear and adhesion wear caused by the broken large wear debris which come into being in titanium alloy fretting wear. In addition, the falling debris cannot escape from wear region easily and finally the spherical wear debris comes into being with the size of 1 to 30 μm approximately. This type of wear debris is formed in the late period of fatigue wear.

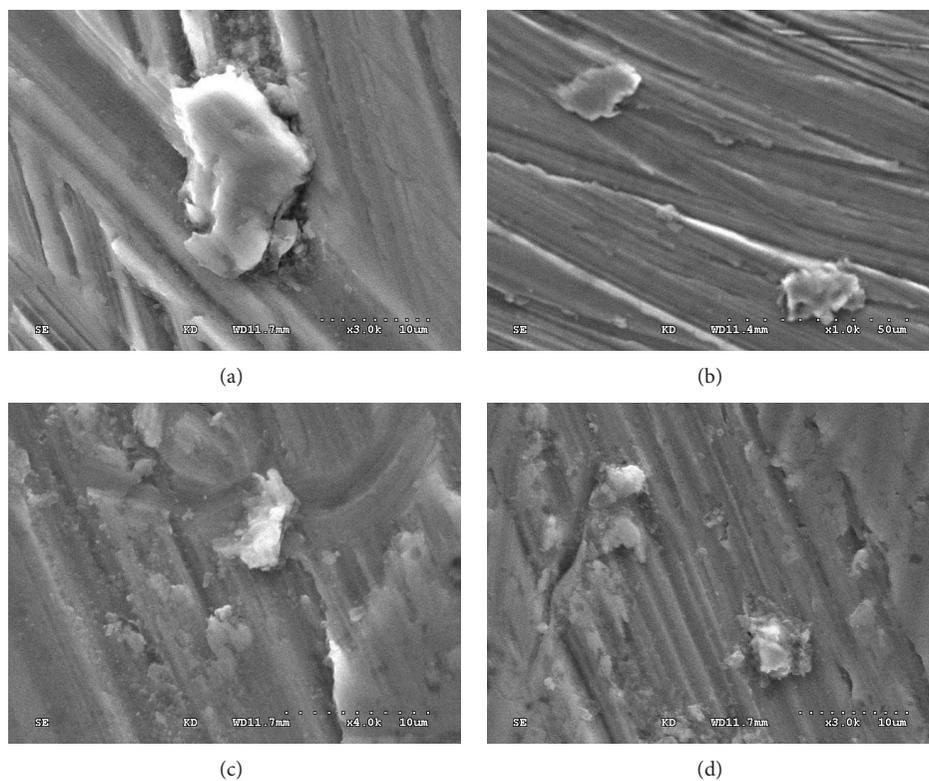
FIGURE 18: Morphology figure of titanium alloy tuberos wear debris.

(III) *Tuberous Wear Debris*. Wear debris of this type are spindle-shaped (Figures 18(a) and 18(b)) or in flat shape (Figures 18(c) and 18(d)) with a small width and length ratio and complicated edge outlines, and there are uneven lines even obvious scars. Spindle-shaped wear debris come mainly from adhesion wear with a size of 5 to 100 μm , while the flat wear debris are formed because the crack nuclei formed on friction surface under the fatigue stress on the friction interrelated surface peel off and tear away from matrix at the weak bonding point of matrix materials under the effect of interface adhesion, and their distribution scopes are 5 to 50 μm . They originate from lacerated wear formation and come into being at the mid-term stage of fatigue wear.

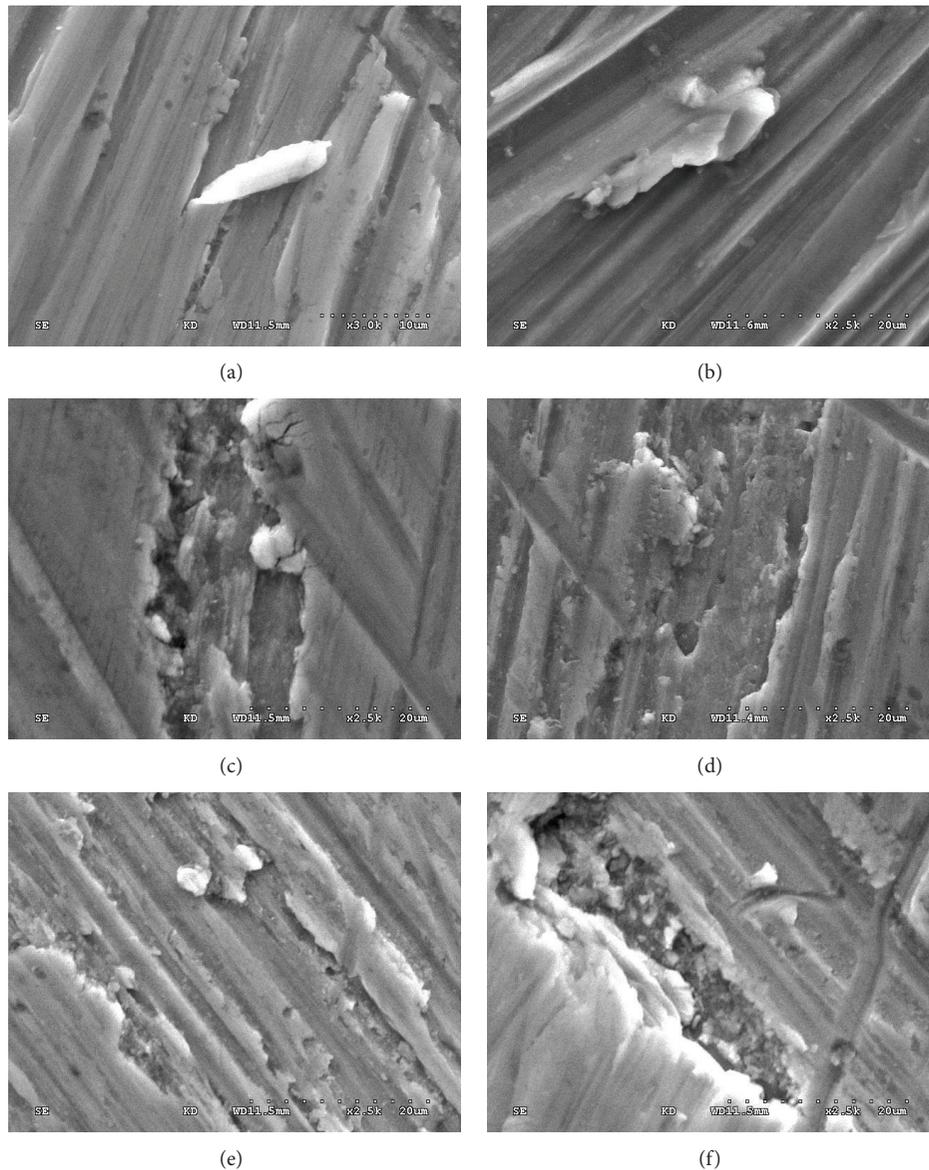
FIGURE 19: Morphology figure of titanium alloy lacerated wear debris.

(IV) *Lacerated Wear Debris*. Lacerated wear debris are the products of friction interrelated reciprocating motion with irregular and coarse surface and uneven lines on the surface which give people the sense of hierarchy and mainly from the falling debris from titanium alloy matrix under the fretting fatigue effect (Figures 19(a) and 19(b)). With the cycle load, cracks on fatigue wear edges extend in vertical direction with wear direction (Figures 19(c) and 19(d)). The successive wear accelerates the ripping of titanium alloy surface and then the wear debris come into being. The common size distribution scope is 5 to 50 μm and titanium alloy extends in different sizes from partial peeling to complete peeling which makes the wide distribution of wear particle size (Figures 19(e) and

19(f)). This kind of wear debris is formed at the early stage of fatigue wear.

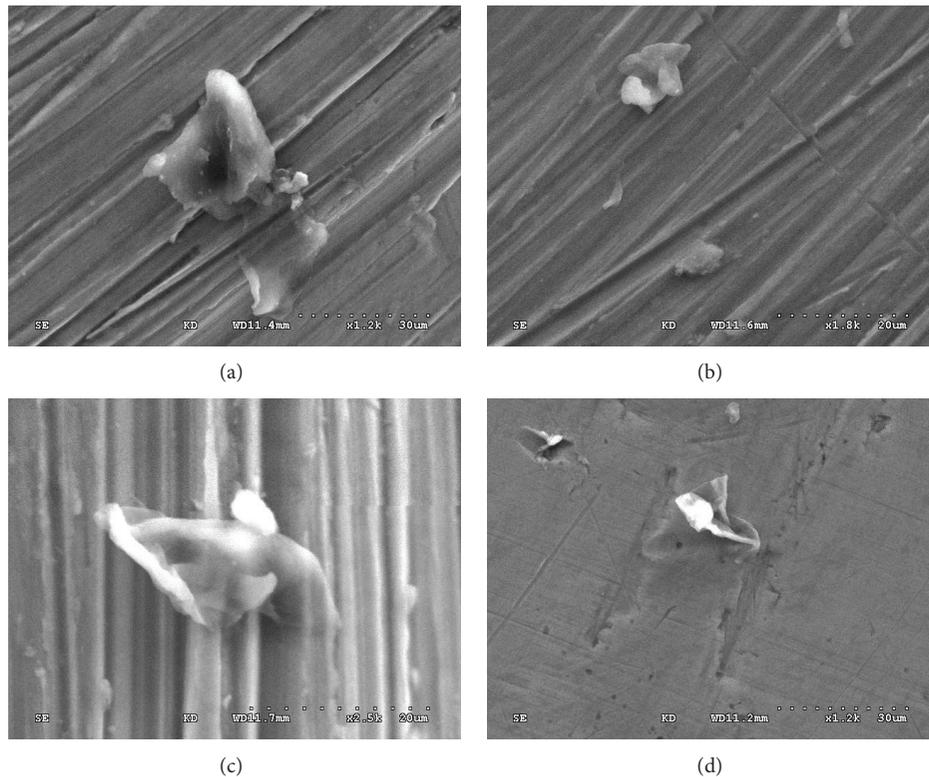
FIGURE 20: Morphology figure of titanium alloy sheet wear debris.

(V) *Sheet Wear Debris*. The titanium alloy sheet wear debris have relatively wide size distribution ranging within the scope between 5 and 60 μm and smooth surface. There are two reasons for the formation. On the one hand, the early stripping tuberous debris of titanium alloy transform and harden in fretting wear process, and for the hardness and tension are higher than those of the matrix, therefore this type of wear debris comes into being. On the other hand, the fatigue peeling occurs on the wear surface of large titanium alloy under the effect of fretting wear which is broken into wear debris in smaller sizes in the reciprocating wear motion (Figure 20). This type of wear debris originates from tuberous wear debris and forms at the late stage of fatigue wear.
