Research Article

A Study on the Slope Failure Monitoring of a Model Slope by the Application of a Displacement Sensor

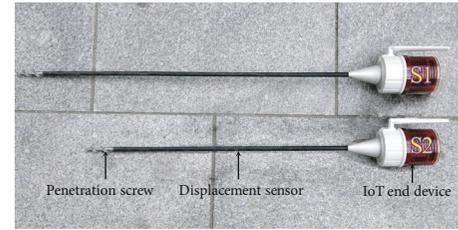
FIGURE 1: Displacement sensors of 800 mm and 1000 mm length.

2.1. Design of a Subsurface Displacement Sensor. The subsurface displacement sensor developed and patented by Tamate [31] has been upgraded in this study. It is composed of a stainless steel pipe with an outer diameter of 10 mm and a thickness of 1 mm. A strain gauge was attached to the central part of the pipe, which was connected via 2-active gauge method to generate a response to the bending deformation. A penetration screw of 80 mm in length was installed on the bottom end of the pipe for easy installation. The outer surface of the displacement sensor was glazed with a final coating agent after attaching the strain gauge, as well as a weather-resistant heat-shrinkable tube, in order to prevent damage to the wire and cable of the strain gauge during its penetration into the model slope. Finally, a waterproof connector that helps to record the response from the strain gauge was connected to the centre of the hexagonal plug. The penetration-type pipe strain gauge patented by Tamate [31] had a sensor and warning system, with an alarm unit, as two separate units were connected by a wire, but the two units, along with the IoT end device, have been assembled into a single, integrated unit in this study, which increases workability in the field. The displacement sensors of different lengths, viz. 800 mm and 1000 mm, were used in this study, which helps in predicting the depth of the slip surface during failure. Figure 1 shows the displacement sensors used in this study.

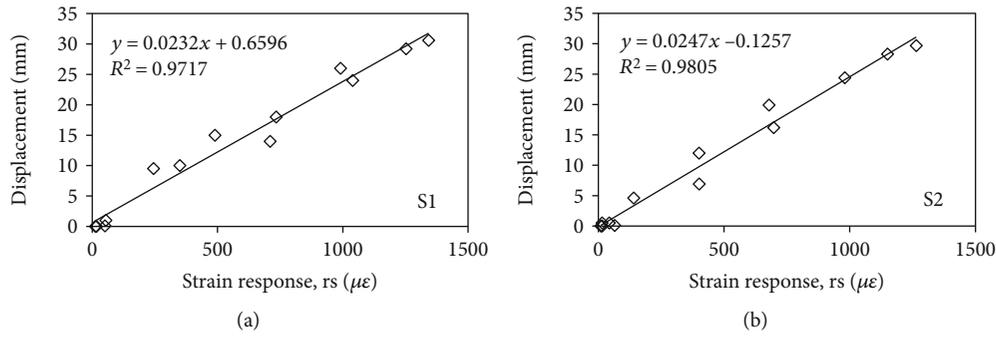
FIGURE 2: Results of displacement sensor tests: (a) 1000 mm and (b) 800 mm.

The trend lines of the test results were found to be approximately linear and expressed as a linear function. In addition, the strain response of the displacement sensor at the free end for various load increments is determined easily, and the result can be applied to the qualitative understanding of the ground displacement behaviour.

In addition, the results of this test confirmed that the strain response due to displacement is somewhat different in either case (refer to Figure 2). This type of phenomenon is considered to be due to the variation of the modulus of deformation for various lengths of the displacement sensor, as well as the heterogeneity of the stainless steel (STS304), which is the main material of the sensor body, and strain gauge joint errors.

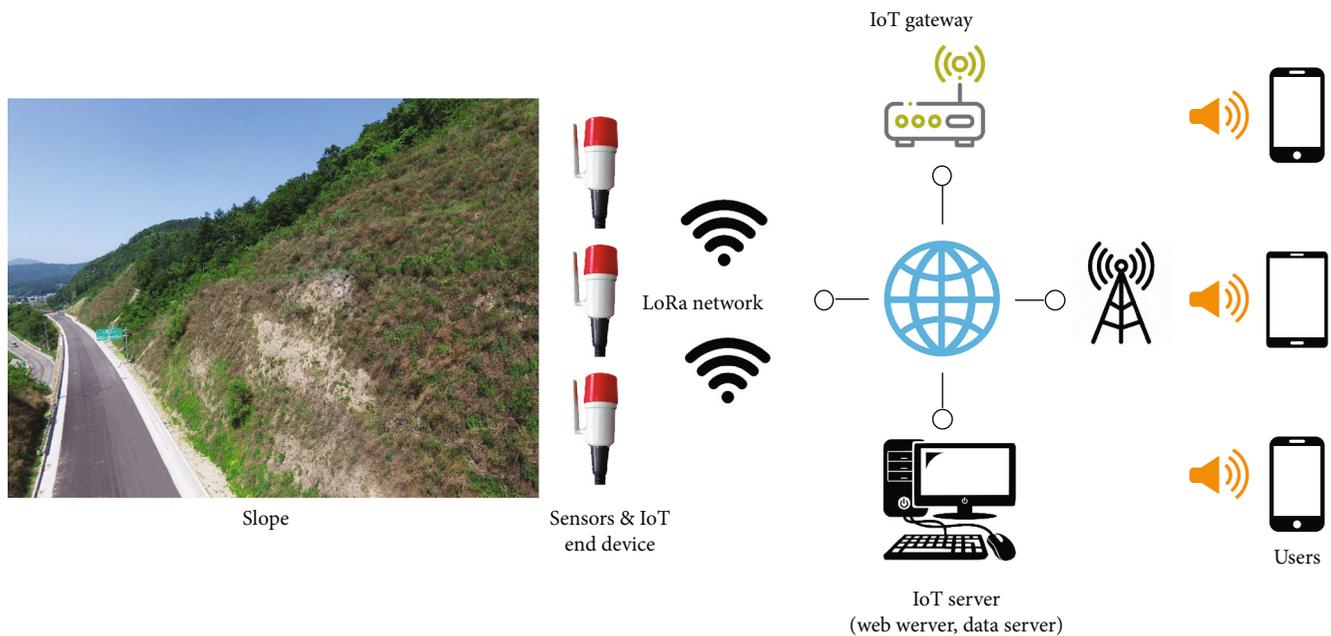
FIGURE 3: Configuration diagram of the monitoring system.

An IoT monitoring system consists of a server, a client, and a gateway (Figure 3), and repeaters can be added

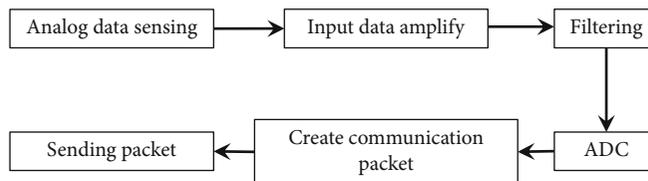
FIGURE 4: Sensing data flow chart in the IoT client.

Optionally, the failure threshold value set by the server can be recognized, and local people can be alerted, by raising the warning signal. Figure 4 shows the data flow of the sensor values in the IoT client.

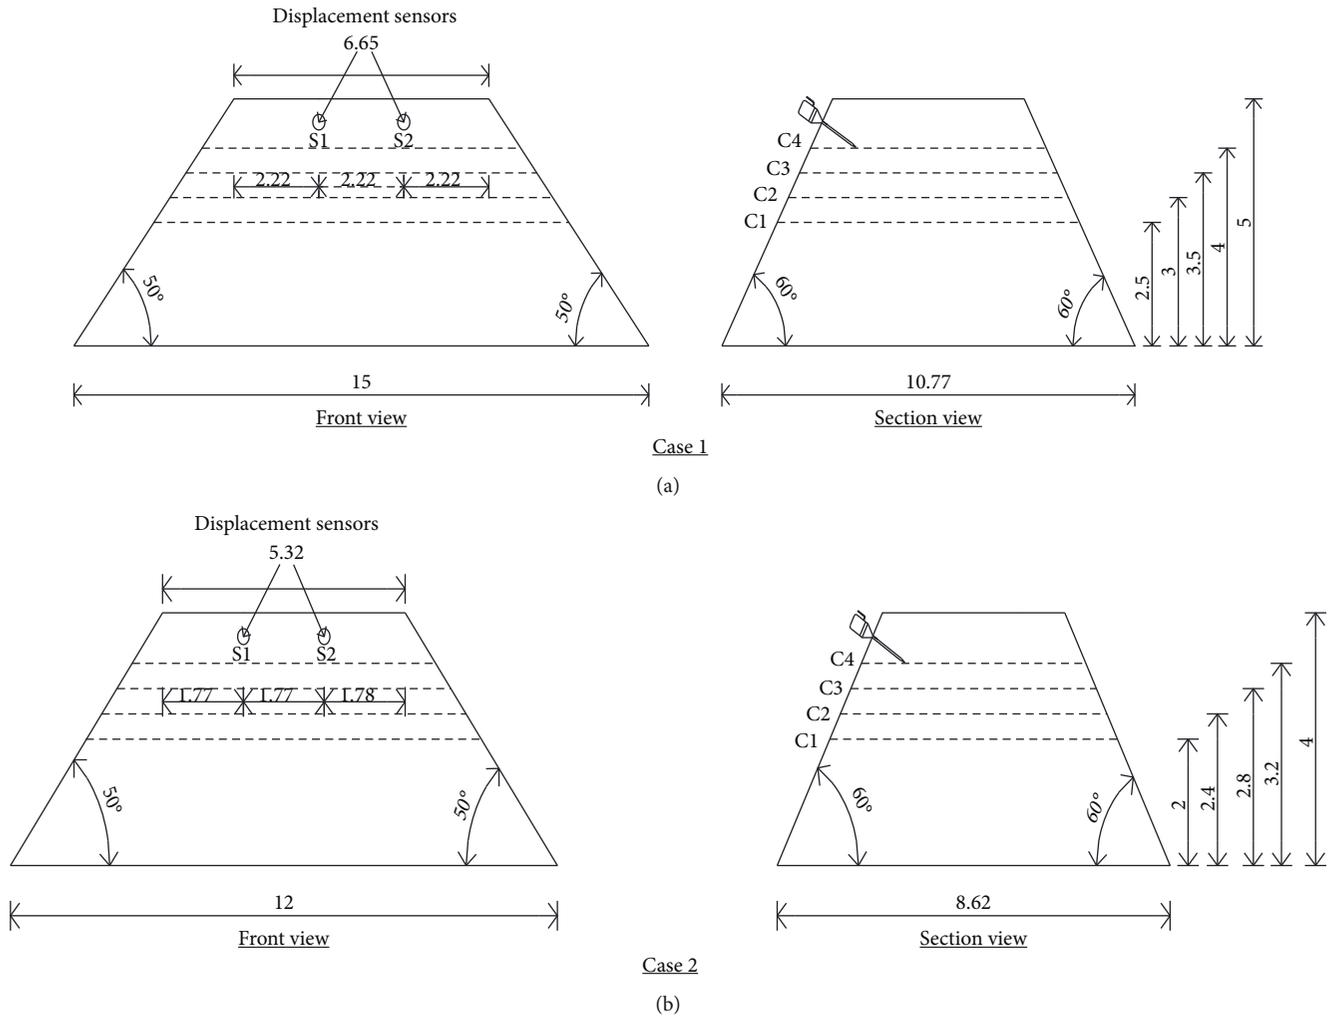
FIGURE 5: A schematic diagram of the model slope: (a) case 1 ($H = 5$ m) and (b) case 2 ($H = 4$ m).

The slope height was 5 m and 4 m, and the crest length was 6.65 m and 5.32 m in case 1 and case 2, respectively. The angle of inclination of the slope was 60° in both cases (Figure 5). To simulate slope failure, the final cut section, C4, was selected (1.0 m and 0.8 m below the crest line of the slope), considering the fact that increasing the slope height increases the slope distance. In all cases, the same test conditions were applied to all the cut sections, and the waiting time was given after each cutting in order to analyse the slope movement behaviour during cutting.

4.2. Installation of the Subsurface Sensor. Figure 6 shows the installation process of the subsurface displacement sensors on the model slope surface. The designed displacement sensors were installed perpendicular to the slope surface using the penetration screws attached to the lower portion of the sensor, and the sensors were installed at a horizontal spacing of 1.77 m and 2.22 m in case 1 and case 2, respectively (Figure 5).

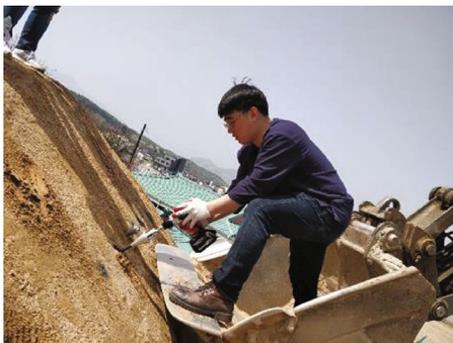
FIGURE 6: Drilling subsurface deformation sensors.

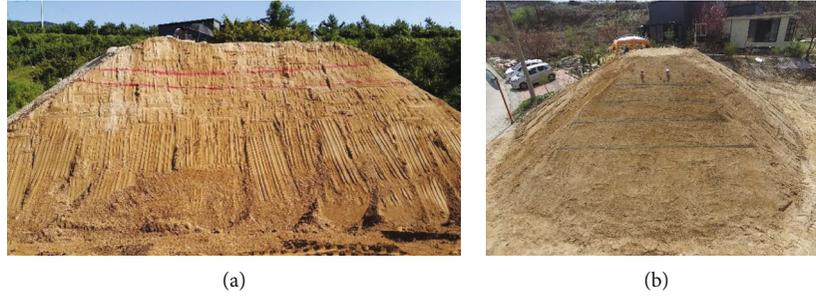
FIGURE 7: Model slope: (a) case 1 and (b) case 2.

operation was carried out in four steps, from C1 to C4, such that the cut surface was vertical. The time required for each cut, including the waiting time after the cutting process, was 9 minutes for case 1 and 6 minutes for case 2, and continuous measurements were performed to include changes between two consecutive cuts. The displacement data were recorded at an interval of one second, whereas the shear strain data were collected at an interval of 10 seconds in the previous study [27]. The model slope for both the cases is shown in Figure 7, and the slope failure is shown in Figure 8.

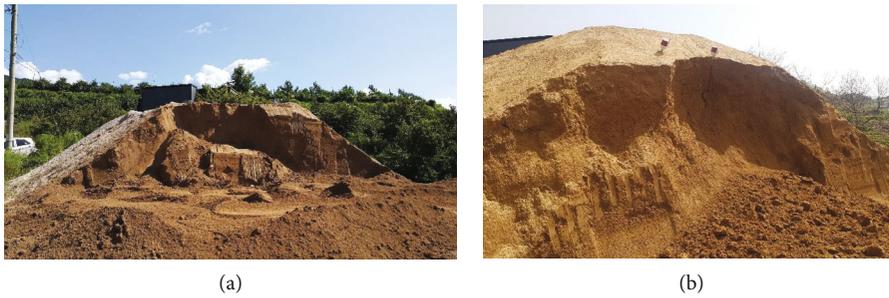
FIGURE 8: Slope failure: (a) case 1 and (b) case 2.

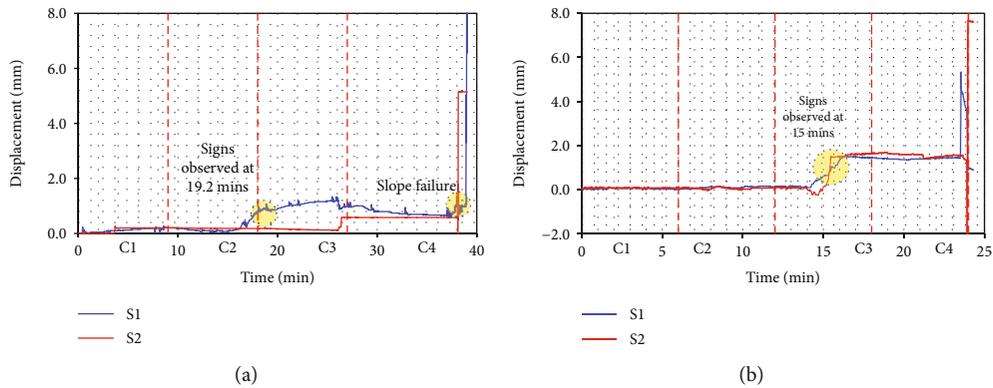
FIGURE 9: Displacement-time graph: (a) case 1 and (b) case 2.

5.1. Slope Movement over Time. Figure 9 shows the time-dependent displacement distribution of slope failure during slope cutting of 5 m (case 1) and 4 m (case 2) slope heights, respectively. The horizontal axis shows the elapsed time in minutes, and the vertical axis shows the ground displacement in millimeters.

In case 1 (Figure 9(a)), the S1 sensor (1000 mm length) showed infinitesimal displacement during C1 cut section and showed some precursors during waiting time of C2

cut section. This slope behaviour can be considered to be identical to the plastic deformation prior to slope failure observed by Tamate and Hiro [27]. Tamate and Hiro [27] referred it as the first failure, whereas it is considered signs or precursors before the final slope failure. Since the slope maintained its stability until this point, it was vague to consider this point as a slope failure. Then the displacement was almost constant till C4 cut section. Similar reactions were observed by the experiments performed by Tamate and Hiro [27] after the signs were observed. Finally, the displacement value surged instantaneously, and finally, the slope failure occurred at 33.9 minutes. However, the S2 sensor (800 mm length) did not show noticeable displacement until the C3 cutting and showed some displacement during waiting portion of the C3 cutting. The displacement

value remained constant after then, and slope failure occurred suddenly at 33.9 minutes.

In case 2 (Figure 9(b)), both the sensors, S1 and S2, showed almost similar behaviour. The precursors of slope failure were observed at about 15-16 minutes, and then almost constant displacement values were observed. Finally, the slope failure occurred abruptly at about 23-24 minutes.

In both cases, the slope failure phenomenon could not be clearly measured by the S2 sensor (800 mm length) since there was no proper ground movement before the slope failure. So the suitable length of the displacement sensor for the prediction of slope failure, in this study, can be considered to be about 1000 mm. Hence, the length of the displacement sensor should be designed by considering the anticipated depth of the slip surface during slope failure.

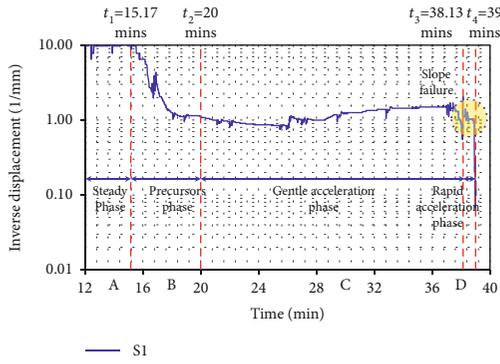
FIGURE 10: Inverse displacement-time graph for case 1.

Figure 10 shows the displacement value measured by the S1 sensor converted in terms of the inverse displacement. The horizontal axis shows the time elapsed from 12 minutes, at which the slope movement was observed, to 40 minutes, at which the experiment was ended, and the vertical axis shows the inverse displacement.

It is observed that there is no change in slope movement until 15.17 minutes, and some infinitesimal displacement values recorded until this time point are not considered in the analysis because they are regarded as the noise of the electrical signal generated during transmission of the displacement data and the vibrations caused by the excavation equipment (i.e., the backhoe).

In section B (t_1 - t_2) of Figure 10, a sudden inverse displacement was observed during waiting section of C2 cutting stage and the beginning of the C3 cutting stage. Since the slope at this time was calculated as 1.59/mm/min, it was considered the onset of slope instability. The slope of the C section (t_2 to t_3) significantly decreased to 0.03/mm/min compared to section B. This suggests that the reaction of the slope instability that occurred in section B is continuously maintained. At the D section (t_3 - t_4), which is the waiting section after the completion of C4 cutting, the slope failure

occurred by a geometric increase of the slope with a value of 2.25/mm/min just before the slope failure.

In this study, a change in inverse displacement was observed in the precursor phase. We proposed a slope instrumentation standard for an early warning system that warns when slope failure conditions are progressing (Table 2). Figure 10 shows the concept of inverse displacement for the prediction of slope failure.
