Research Article

Multidisciplinary Approach Applied to the Diagnosis of the Facade of the Arciprestal Church of Santa María de Morella (Castellón, Spain)

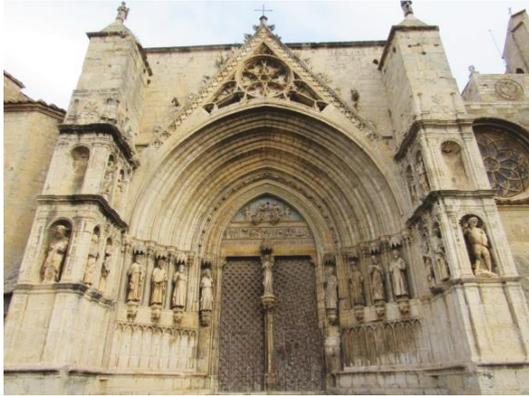
FIGURE 1: Door of the Apostles, Archpriest Church of Santa Maria of Morella.

The Door of the Apostles (dels Apòstols) is the cover object of the interdisciplinary study (Figure 1). The portal is named by the apostolate that is housed in the bottom of the blind arches and jambs. The eardrum has a frieze run where scenes from the life of Mary and childhood of Jesus are represented. We also found a Madonna and Child under a Gothic canopy in the mullion of the door. In the tympanum, there is a representation of the Coronation of the Virgin. Besides this door, it has a Gothic window and a rose window that illuminates the interior of the Church [8].

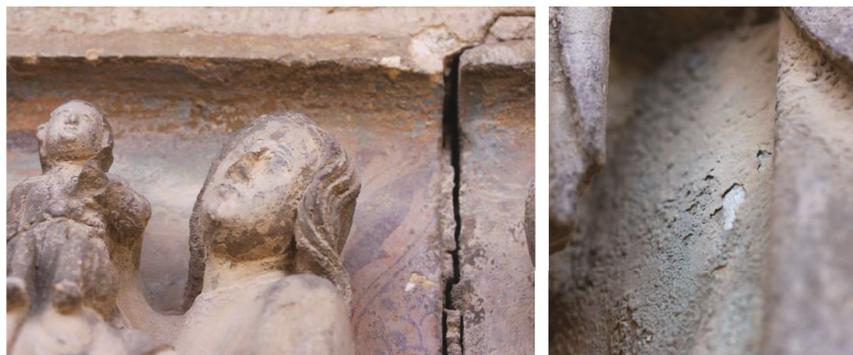
With regard to the conservation status of the door, it was observed during the diagnosis that the pathological processes, more or less important depending on the area studied, are related to the degradation of stone material and polychromies. The images in Figure 2 are details of the frieze on the door, where you can see the important alteration of the stone and the polychromies, with disintegration mechanisms, surveys, losses, and superficial deposits.

FIGURE 2: Door of the Apostles, Archpriest Church of Santa Maria of Morella. Details of the state of conservation of the polychromy on stone.

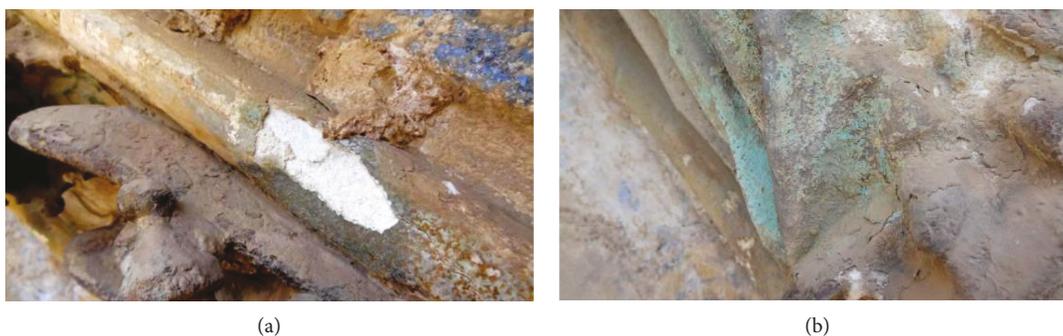
The alterations that the door presents are varied and have introduced changes in the stone at a superficial level and in the polychromies. In the latter case, the color layers have obviously suffered mechanisms of alteration due to dustiness due to loss of binder, desquamation, formation of surface crusts, manifesting in differential chromatic tones, changes

in surface texture, and variation in chemical composition and physical properties (Figures 3(a) and 3(b), details of the sculptural elements on the door). The chromatic alterations are easily observable and are mainly due to deposits of dirt and possible chromatic alterations of the pigments.

FIGURE 3: Details of the Door of the Apostles, Archpriest Church of Santa Maria of Morella. (a) Deposits of dirt, formation of crusts, and decohesion stone support. (b) Details of dirt, crusts, and areas with lifts and loss of cohesion of layers.

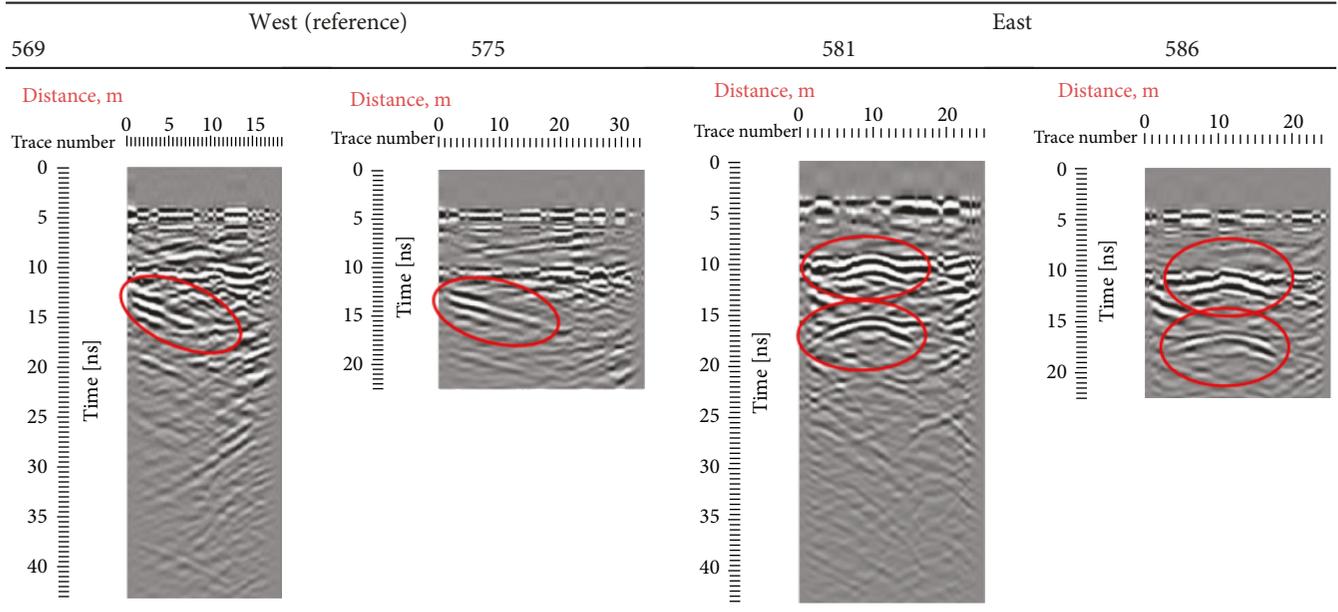
from 0 to 5 ns, we have a homogeneous response which represents the air that is why in all the radargrams, the first reflection was obtained at approximately 5 ns, which represents the surface of the stone. Other reflections that can also be seen in all the radargrams are the one at a 45° that are present both in the left and in the right sides of the records which were produced due to the sculpture presence on the edges of the investigated area; this reflection is highlighted with red at different travel times (Table 1).

In the radargrams, the horizontal axis represents the length of the record, and the vertical axis represents the travel time of the electromagnetic wave through the propagation medium (in our case stone), measured in ns. Both in the 20 ns and in the 10 ns radargrams conducted on the East side of the portal (581, 586), hyperbolic reflections can be observed which represent the crack; due to the strong reflection, it can be estimated that the crack goes in depth. In the rest of the radargrams acquired on the East part of the portal, the same results could be observed in the crack areas. On the stone block surface or in depth, any other cracks cannot be observed; then, the three ones were visible on the surface, representing the main structural problem on the stone facade.

TABLE 1: Radargrams of the façade. Measurements labelled as 569 and 575 at West zone and Measurements labelled as 581 and 586 at East Zone. Sculpture presence is highlighted with red at different travel times.

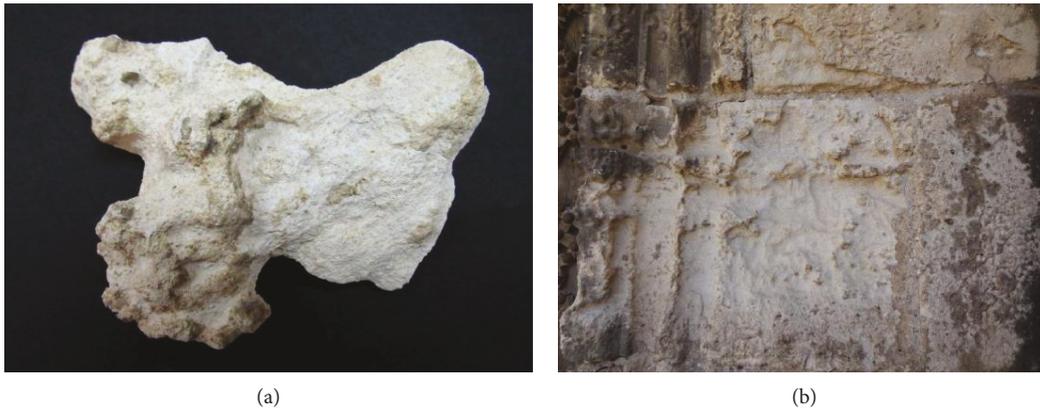
FIGURE 4: Detail of an ashlar stone of the Door of the Apostles, Archpriest Church of Santa Maria of Morella. (a) Conservation status of the stone support and (b) extracted fragment for a laboratory study with SEM-EDX.

4.2.1. Stone Support: SEM-EDX Study. Different fragments of stone support were extracted from the door, in areas significantly affected by alteration mechanisms with disintegration and pulverization phenomena (see Figures 4(a) and 4(b)). The main instrumental technique used to assess the state of conservation of the stone has been the SEM-EDX [1, 10]. Through this technique, it has been possible to observe and analyze different surface areas of the stone, without previous preparation and in cross section.

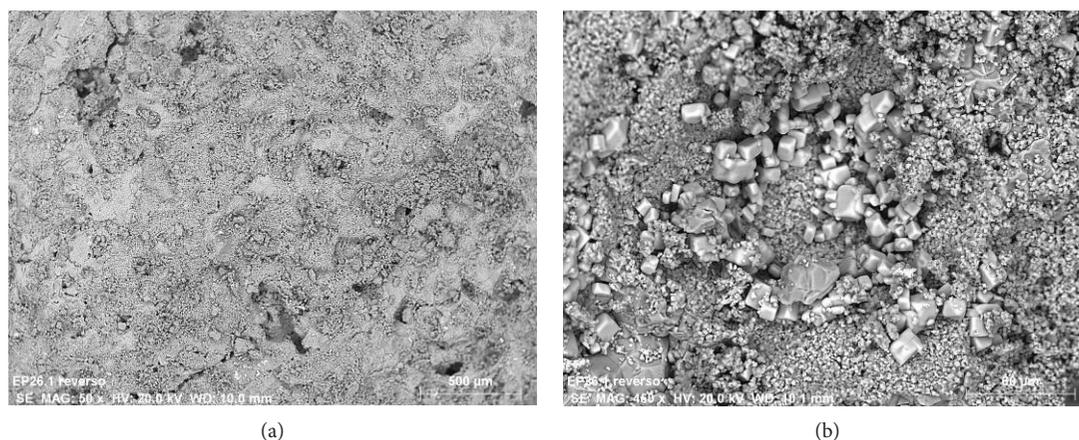
The observations to the stone surface by SEM show a rather eroded structure, with a generalized presence of disintegration, fracturing, increased porosity, and crystallizations of products of different nature (see the SEM micrograph of Figure 5(a)). The microanalyses detect high concentrations of the chemical elements of calcium, with lower proportions of silicon and aluminum. The chemical elements can be associated with the calcium carbonate CaCO_3 , the main constituent of the stone support and mineralogical compounds based on aluminosilicates. Generally, on the surface of the stone, sulphur related to calcium sulphate CaSO_4 is detected as a product of chemical alteration of calcium carbonate or as crystallizations due to the presence of saline aqueous solutions (see spectrum of the EDX microanalysis of Figure 6). As shown in Figure 5(b), the surface presents characteristic crystallizations of cubic morphology, which based on the EDX microanalysis are constituted by chlorine and sodium, indicating the presence of salts based on sodium chloride

FIGURE 5: SEM micrographs in backscattered electron mode. (a) General morphological characteristics of the surface of the stone and (b) crystallizations of salts.

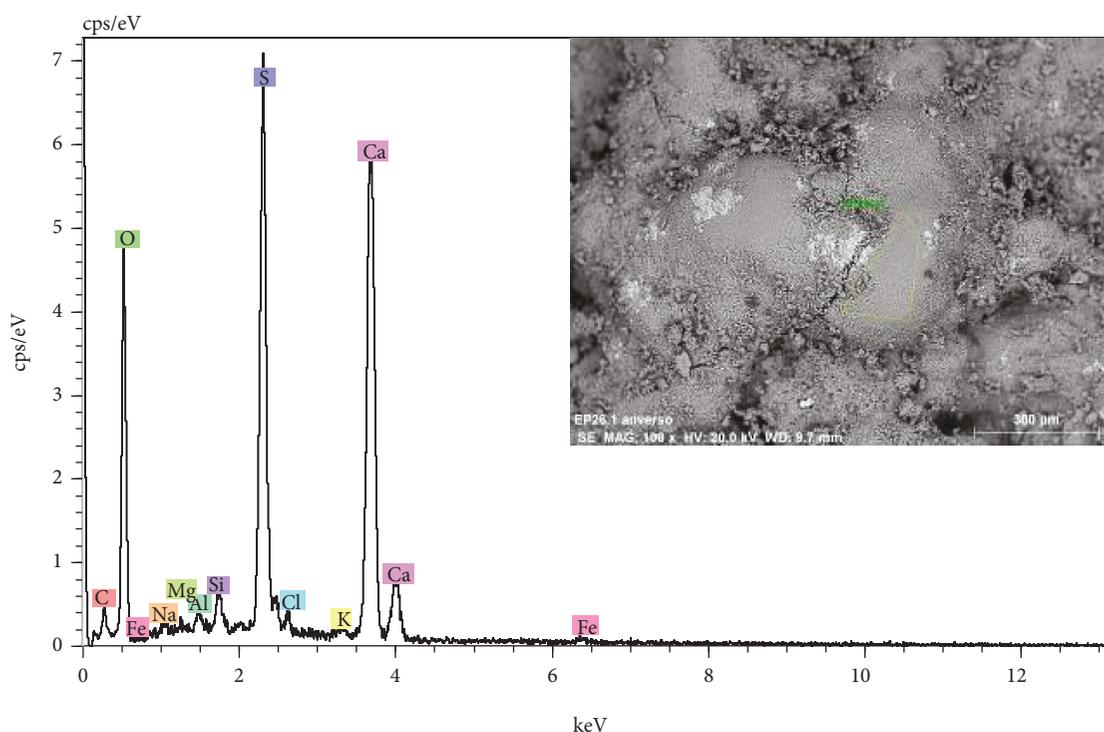
FIGURE 6: EDX microanalysis and SEM image (inset) of an area of the surface of the stone. The elements of calcium and sulphur corresponding to the presence of calcium sulphate.

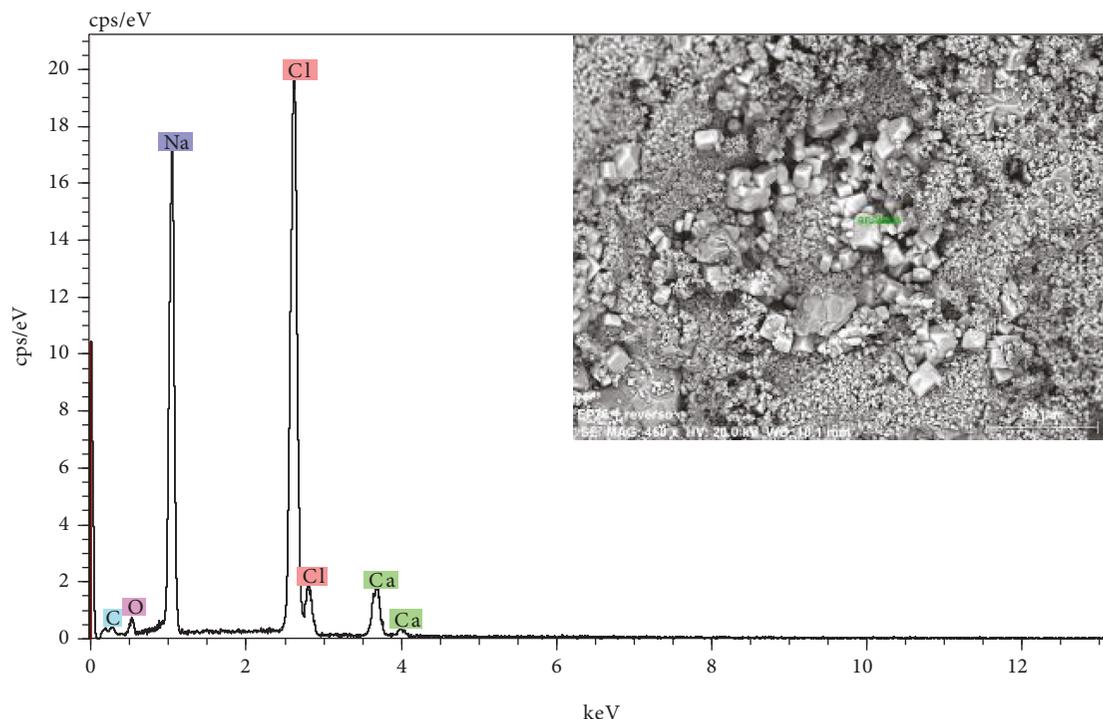
(see Figure 7). The crystallizations of the different salts, in the interior and in the surface of the stony substrate, would cause part of the mechanisms of disintegration and pulverization of the microcrystalline structure of the rock [11].

FIGURE 7: EDX microanalysis and SEM image (inset) of salt crystallizations. The elements of chlorine and sodium corresponding to sodium chloride.

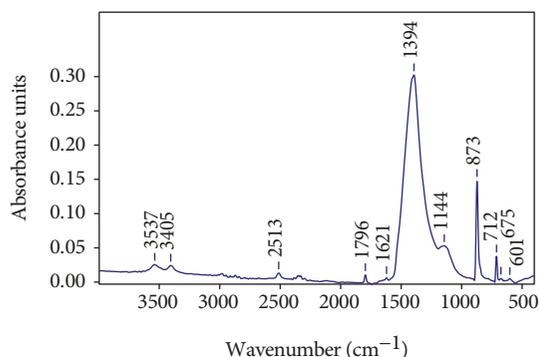
The identification of the mineralogical components has been carried out using FTIR. The analyses have confirmed the presence of calcium sulphate in its dehydrated phase $\text{CaSO}_4 \cdot 2\text{H}_2\text{O}$ (gypsum) and calcium carbonate (CaCO_3 , calcite) as a constituent of the stone. In the spectrum of Figure 8, the characteristic absorption bands of calcium carbonate at 1420 cm^{-1} , 875 cm^{-1} , and 712 cm^{-1} and calcium sulphate dihydrate at 1144 cm^{-1} , 675 cm^{-1} , and 601 cm^{-1} are

observed. The displacement of the sulphate SO_4^{2-} band at 1394 cm^{-1} is possibly due to sodium chloride.

FIGURE 8: FTIR spectrum of the sample surface of the stone support.

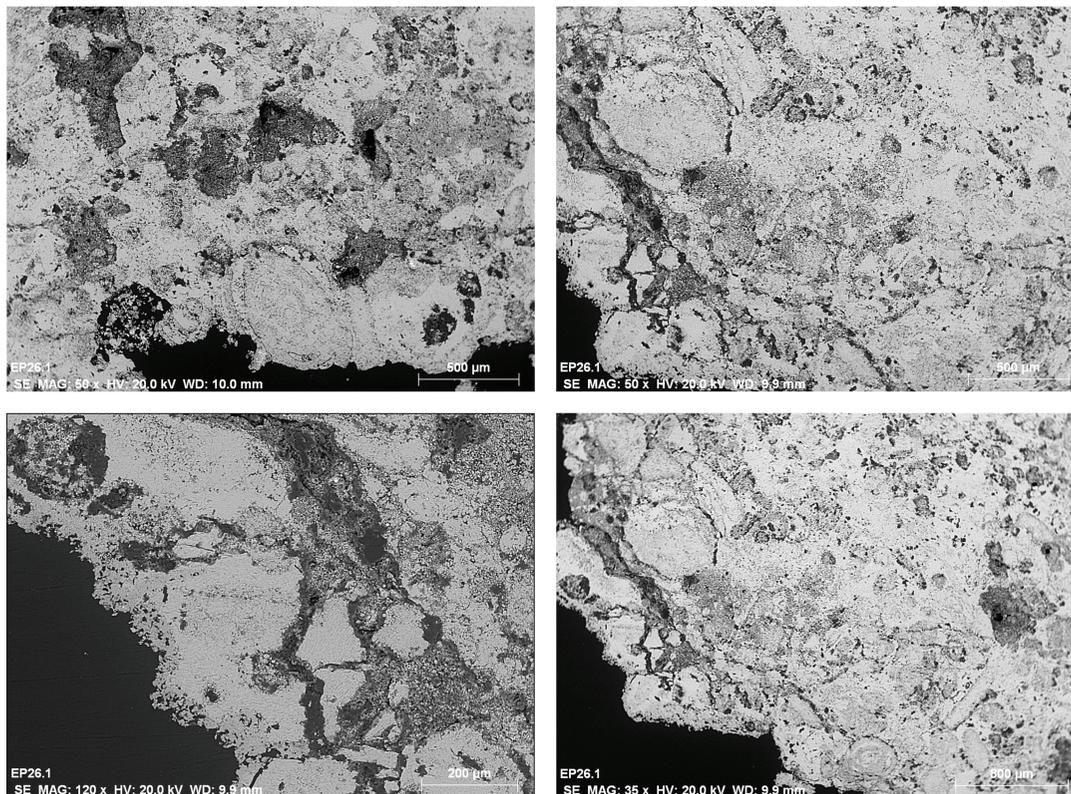
The stone support has been successively observed and analyzed in cross section [12]. The stone is characterized by high porosity and microfractures due mainly to the internal and superficial crystallization of salts as can be seen in the backscattered electron mode of SEM micrographs (Figure 9). In the X-ray map of Figure 10, the chemical elements of chlorine, sodium, and sulphur, related to the presence of sodium chloride and calcium sulphate in the structure of the stone, are identified and located. Calcium is related to both calcium sulphate and calcium carbonate, constituents of the stone

FIGURE 9: SEM micrographs in the backscattered electron mode of different areas of the cross section of the stone support.

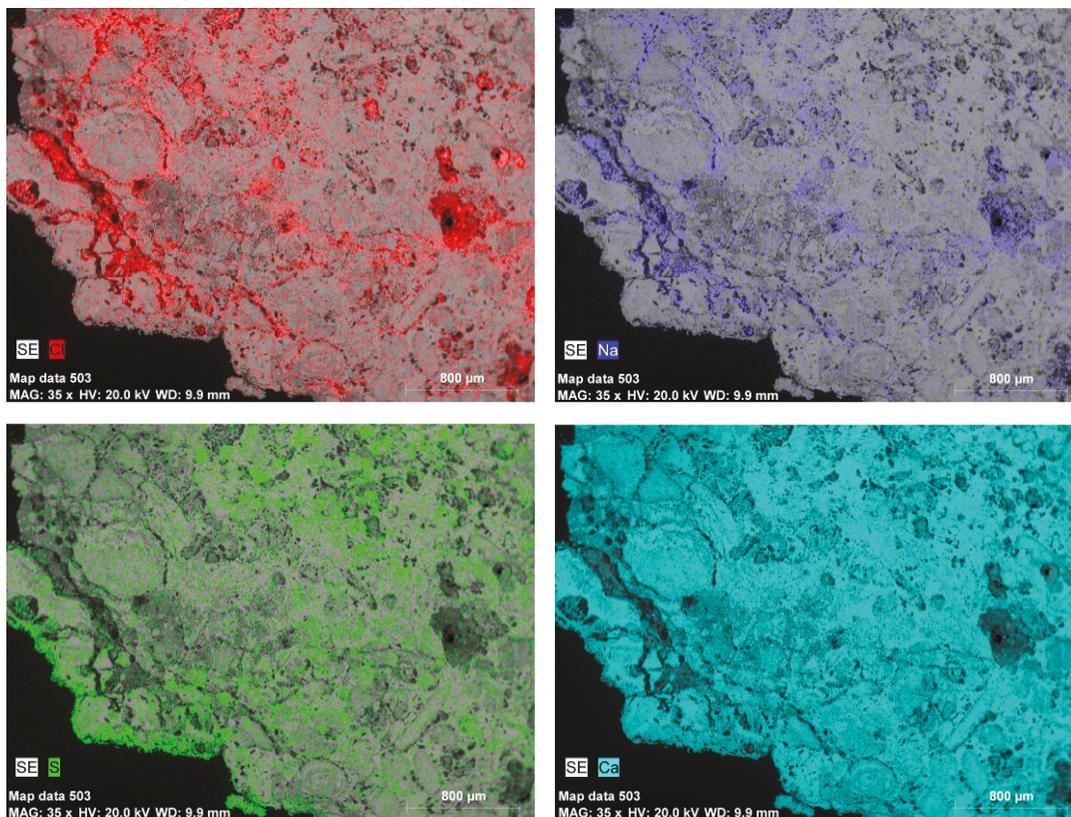
support. The maps evidence that halite and gypsum are weathering forms and halite occupied mainly the pores and factures under the surface while gypsum is located on surface and inner pores. The distribution of both alteration products occupied different positions on the structure of the stone, and their combined action is the cause of the weathering forms observed due to the formation of surface crusts and desquamation.

Generally, high concentrations of sodium chloride are detected in the lower areas of the cover, possibly due to the treatment of the soil with salt in the presence of snow. Differently, the presence of calcium sulphate is quite generalized; this last compound can be related both to the mechanisms of chemical alteration of the stone support and to superficial deposits.

FIGURE 10: Distribution map of the elements of chlorine, sodium, sulfur, and calcium in the cross section of the stone support.

The results provided by the SEM-EDX, through observations and microanalysis of stone samples, will allow establishing the most appropriate intervention methodologies for the work, such as the elimination of soluble salts or consolidation treatment support in the areas of greatest disaggregation.

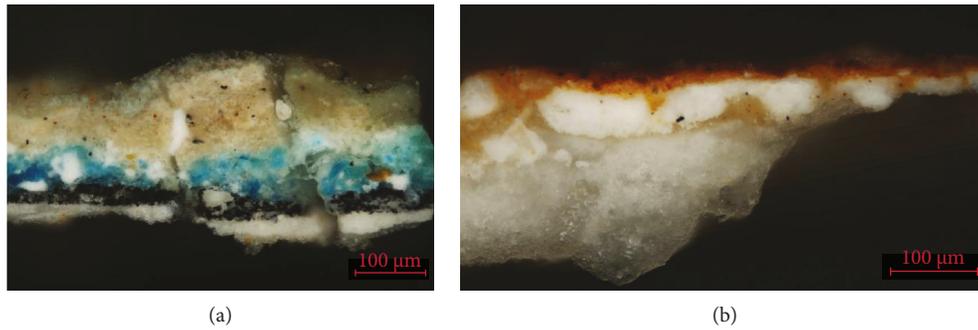
4.2.2. Polychromy Study. The polychromatic samples have been prepared in a stratigraphic section for their study with OM with visible and ultraviolet light and SEM-EDX [13, 14]. The techniques have identified in the primitive intervention of the fourteenth century, where there is existence of a white preparation stratum that sits directly on the stone support, followed by the different layers of color. In general, a polychromy is observed with a careful and rigorous traditional technique where there is no complex superposition of layers, in which the general thickness of the color layer ranges between 15 and 30 μm [15]. In the hair, garments, or decorative elements of the different sculptural elements, the gold leaf has been found on a reddish preparation based on earth, demonstrating the existence of a wide decoration of the cover with gold elements. The images in Figure 11 are examples of the stratigraphic study with optical microscopy of samples corresponding to the oldest polychrome intervention on the door.

FIGURE 11: Optical microscopy images. (a) Stratigraphic section of a blue polychrome sample. (b) Stratigraphic section of a sample of ochre polychrome.

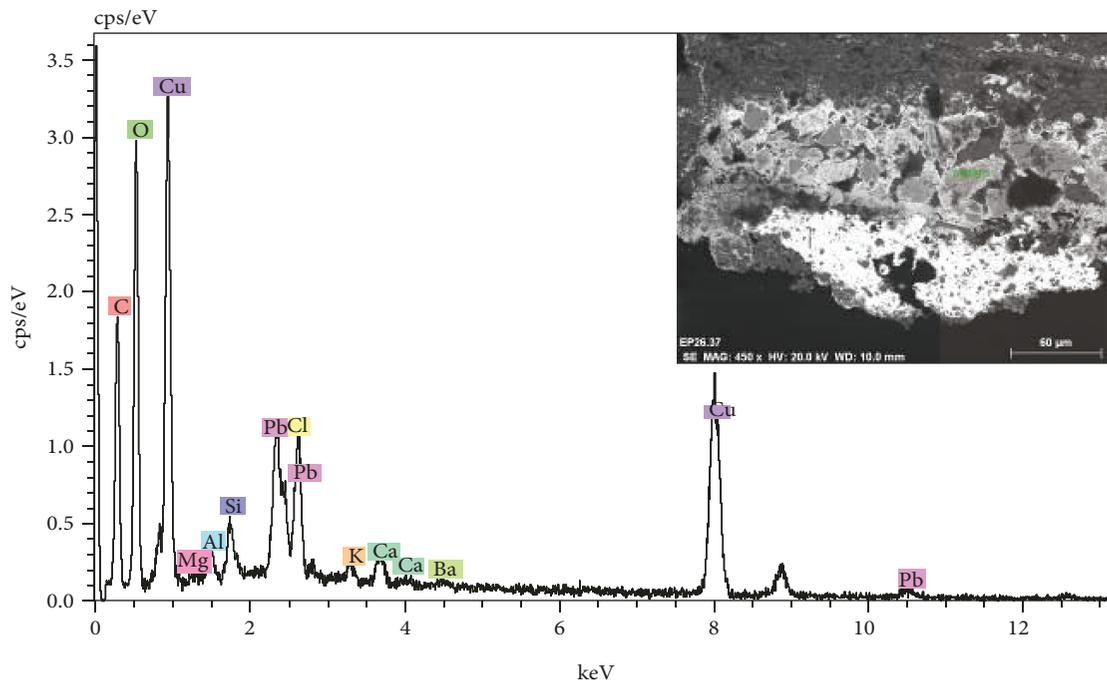
The pigments have been characterized with SEM-EDX by identifying the characteristic chemical elements. These have been related to the pictorial materials used, which turn out to be typical of the period such as lead white, yellow ocher, red ocher, earth, azurite, copper green, and carbon black. Figure 12 shows the microanalysis performed on a blue particle present in the polychrome layer, in which copper is

FIGURE 12: EDX microanalysis and SEM image (inset) of the blue pigment present in the stratigraphic section. The copper characteristic of azurite is detected.

detected, a chemical element that is related to the azurite pigment ($\text{Cu}_3(\text{CO}_3)_2(\text{OH})_2$). In the same microanalysis, the high chlorine content can be seen that corresponds to the presence of salts or a possible chemical alteration of the pigment. In general, the pigments are finely ground, with the exception of the azurite pigment, which is observed with a coarser granulometry, since it is a less opaque pigment. In the latter case, the blue layer of azurite sits on a layer of carbon black preparation (see Figure 11(a)). These results confirm that in the old polychrome of the door of *Los Apóstoles*, the use of a technique and pictorial materials that are common in the XIV-XVI centuries is reflected [16].

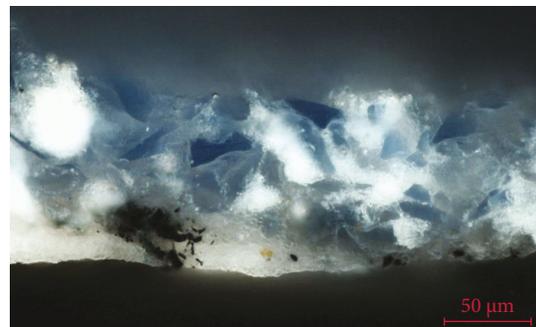
The study has also made it possible to identify the subsequent polychromatic interventions carried out on the cover. In this case, specific interventions have been observed in the sculptural elements, where the most characteristic is the use of the blue enamel pigment (cobalt silicate), according to XRF data. A pigment of artificial origin is known since

FIGURE 13: Optical microscopy image of the stratigraphic section of a blue polychrome sample corresponding to an intervention.

the middle ages in the processing of glass. In painting, it was used during the XVI and XVII centuries [17] (see Figure 13 and the microanalysis spectrum of Figure 14).

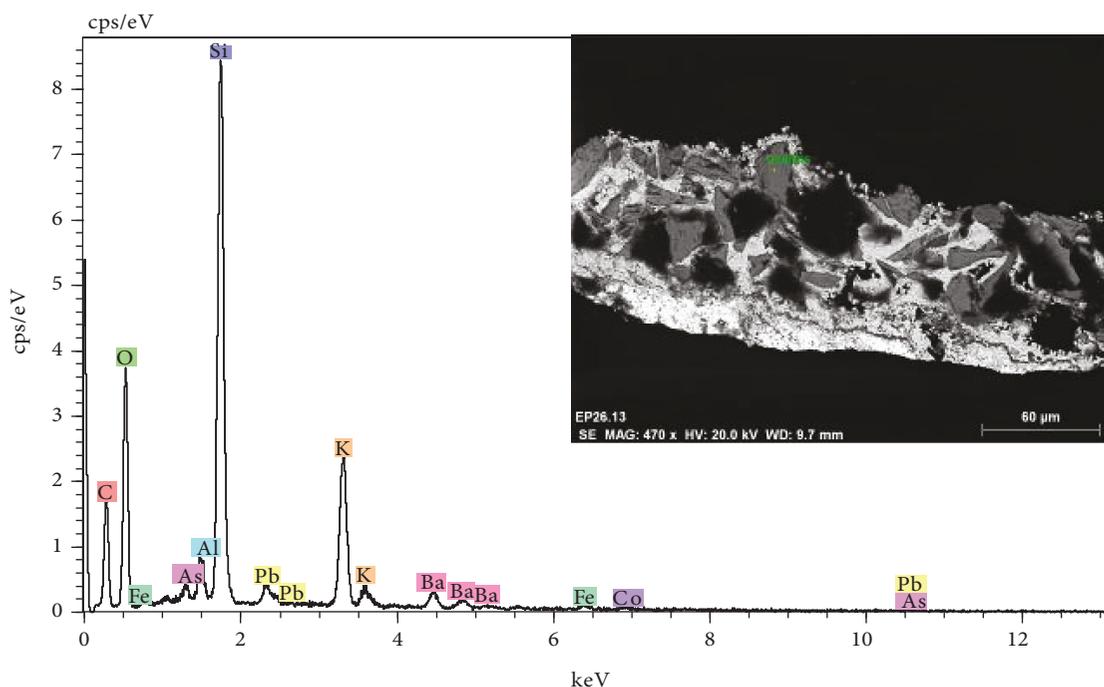
FIGURE 14: EDX microanalysis and SEM image (inset) of the blue pigment present in the stratigraphic section. The elements of silicon and cobalt characteristic of blue enamel are detected.

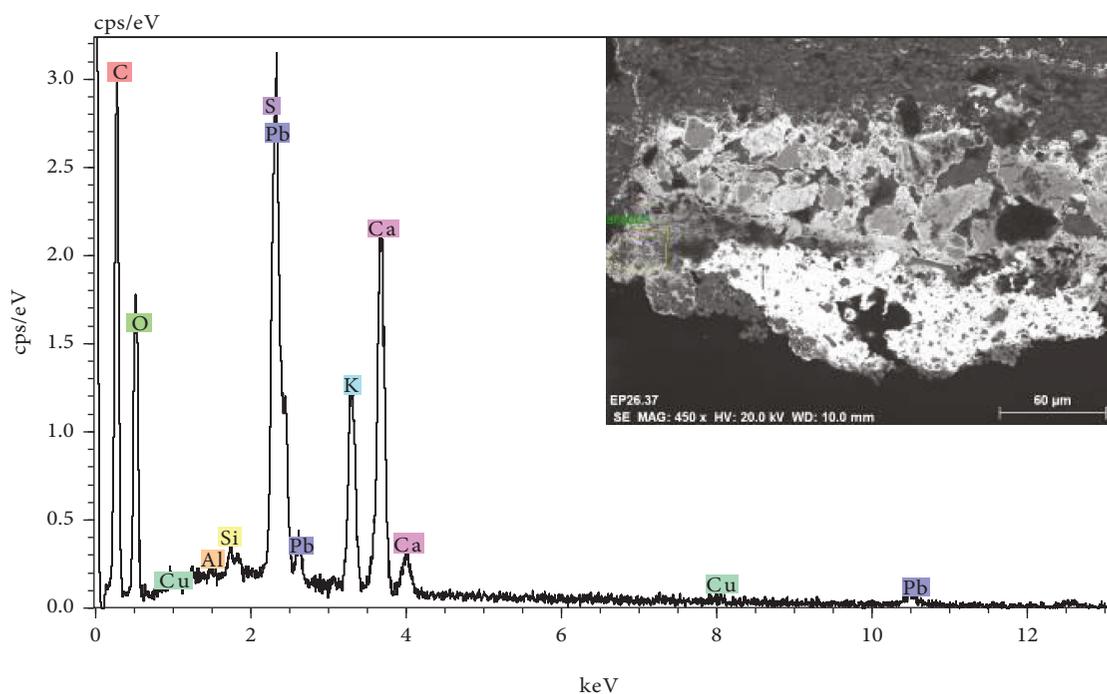
FIGURE 15: EDX microanalysis and SEM image (inset) of an area corresponding to the alteration of the white lead pigment. A high concentration of potassium is detected.

The stratigraphic study with SEM-EDX has been decisive in evaluating the conservation status of the color layers and their constituents. As shown in the EDX microanalysis of Figure 15, lead white is usually found associated with high

concentrations of potassium and sulfur. This result is possibly due to the chemical alteration of the pigment where among the possible causes, an intervention of cleaning the surface with potassium carbonate can be considered. The

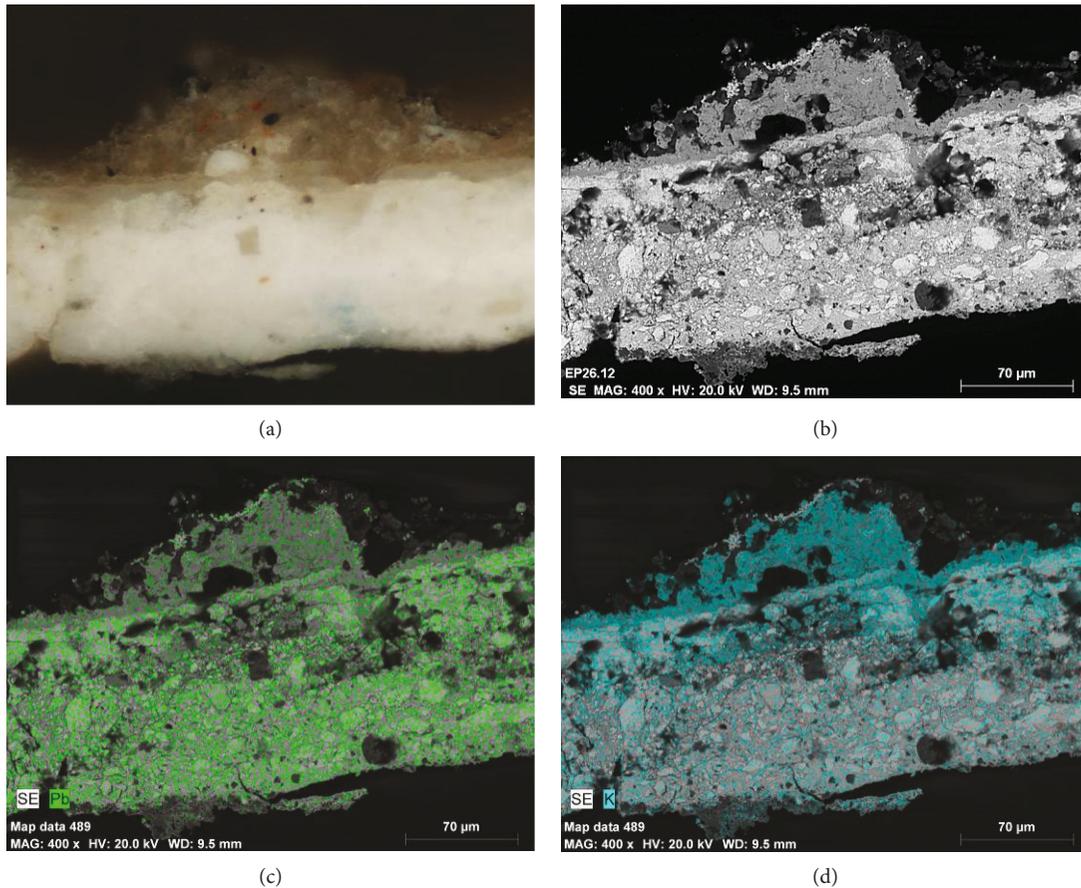
FIGURE 16: (a) Stratigraphic section of the polychrome sample observed with optical microscopy and (b) respective SEM image in the backscattered electron mode. (c, d) Distribution map of the elements of lead and potassium.

treatises of the 20th century advised this basic substance in solution with water to clean the dust deposits of the polychrome surfaces [18]. It is observed that, generally in an extensive way, this chemical alteration of the pigment is based on lead, with its possible solubilization, diffusion, and precipitation both in internal and superficial areas. The alteration of the lead white by the presence of potassium is evidenced in the optical microscopy image and distribution map of elements of Figure 16. Figure 16(a) is relative to the

stratigraphic section of a white polychrome sample observed with optical microscopy. A first stratum based on lead white is observed, on which a layer of ochre shade is spread, which based on the EDX microanalysis is made up of elements of dirt and alteration products enriched in potassium.

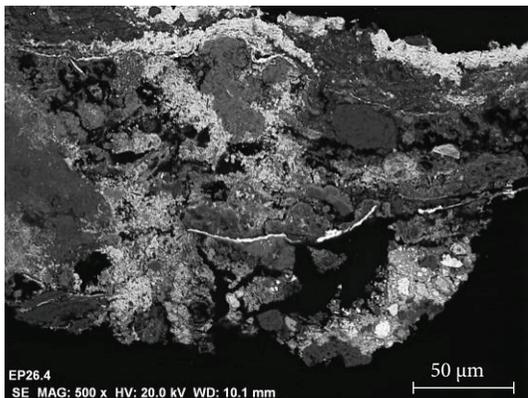
FIGURE 17: Stratigraphic section of a polychromatic sample observed at the SEM in the backscattered electron mode.

The majority of the samples present a polychrome with a disintegrated and pulverulent appearance. This alteration is due to the partial loss of the binder, as well as the crystallizations of sodium chloride and calcium sulphate that produce a series of longitudinal and/or transversal ruptures that cause both a lack of adhesion and cohesion of the strata, resulting in detached layers (see the SEM micrograph of Figure 17).

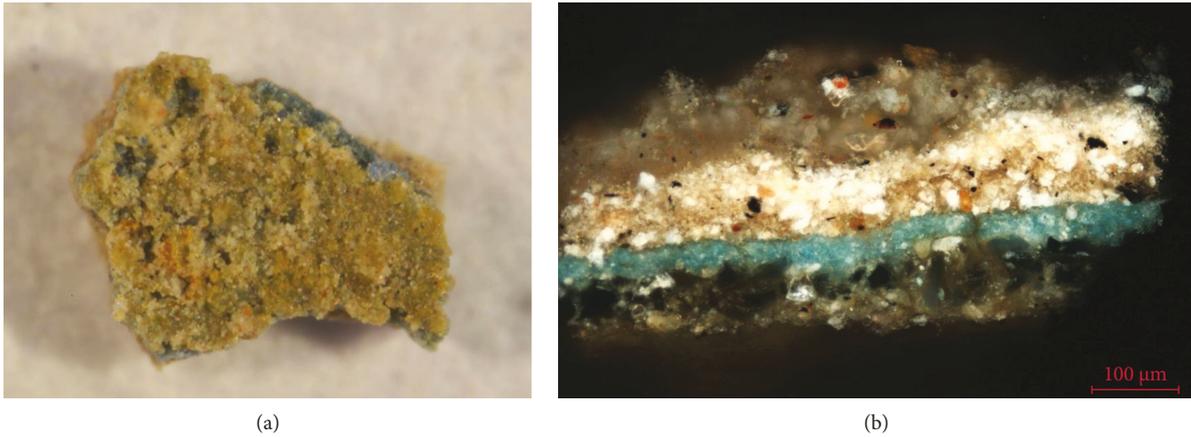
Another significant aspect is the presence of a crust of ochre huge on the surface of the polychrome. In the stereoscopic microscopy image of Figure 18(a), relating to a sample of polychrome extracted from the door, the presence of a

FIGURE 18: (a) Blue polychrome sample with an ochre-colored superficial crust. (b) Stratigraphic section of the polychrome sample observed with optical microscopy.

surface layer of ochre tonality that extends over the blue polychrome is observed. As shown in the images of the stratigraphic section observed with optical microscopy (Figure 18(b)) and electron microscopy (Figure 19 inset), this stratum has a considerable thickness and is basically composed of calcium and sulphur, with varying concentrations of silicon and aluminum, as reflected in the micro-analysis spectrum of Figure 19. The characterization of the mineralogical constituents carried out with FTIR has identified the presence of calcium sulfate, calcium carbonate, silicates, and calcium oxalate monohydrate (Whewellite).

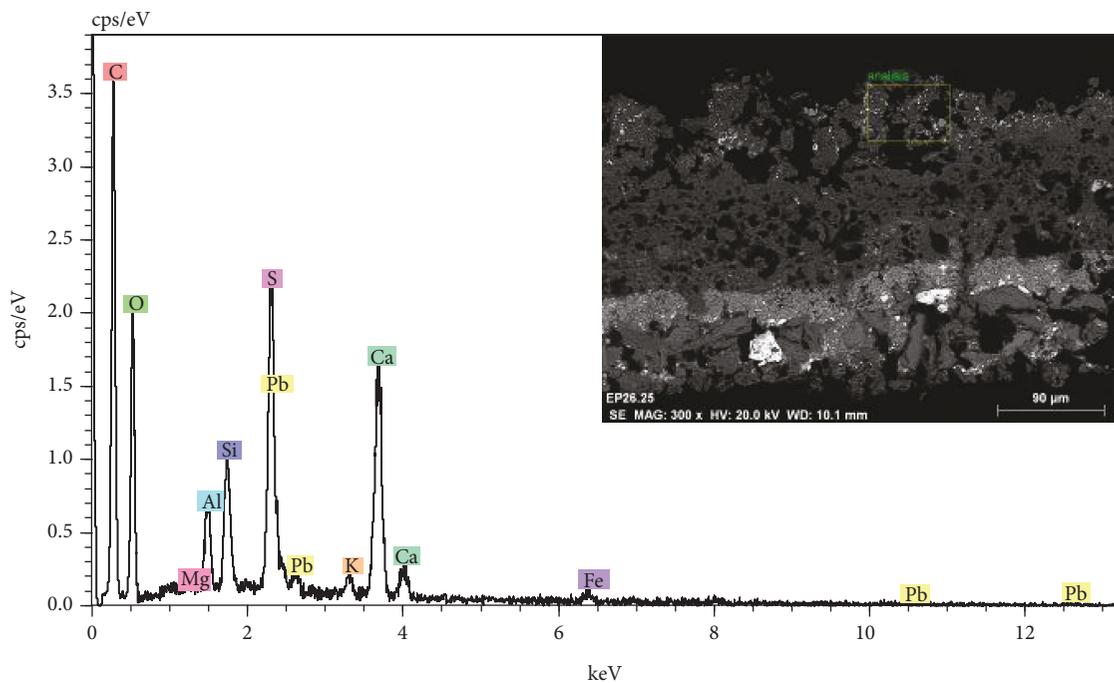
FIGURE 19: EDX microanalysis and SEM image (inset) of the stratigraphic section of a sample with a surface crust. The calcium, sulfur, silicon, and aluminum elements that are associated with the presence of calcium carbonate, calcium sulfate, and aluminosilicates are detected.

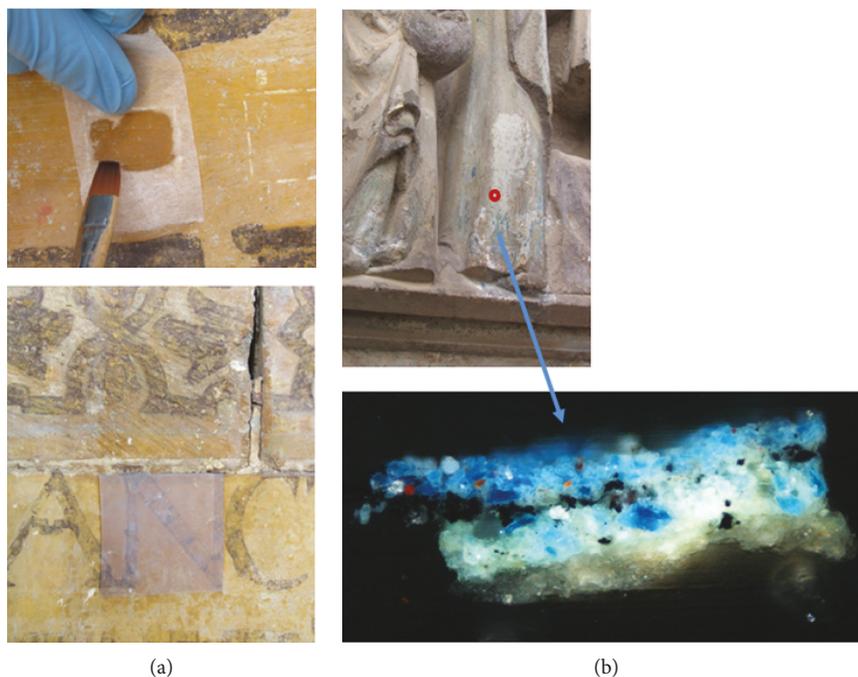
FIGURE 20: (a) Application of consolidants and agar agar gels for cleaning surface dirt. (b) Application of the laser as a cleaning and evaluation system using optical microscopy and SEM-EDX.

the monitoring of the various cleaning systems tested (agar agar gels, packaging, mechanical cleaning, or laser) stands out (Figure 20). Regarding the latter, the possible risks could be determined in terms of physical-chemical modification of the materials constituting the cover.

In this case, the evaluation of the treatments was carried out by means of sample extraction and its study with optical microscopy and SEM-EDX. Figure 20(a) shows the stratigraphic section with optical microscopy of a blue polychrome sample after the laser cleaning treatment. The treatment allows the removal of surface dirt without affecting the integrity of the azurite polychromy.
