Research Article

Fracture Analysis and Fatigue Strength Calculation of Anchor Bolt Used in Circulating Water Pump in Nuclear Power Plant

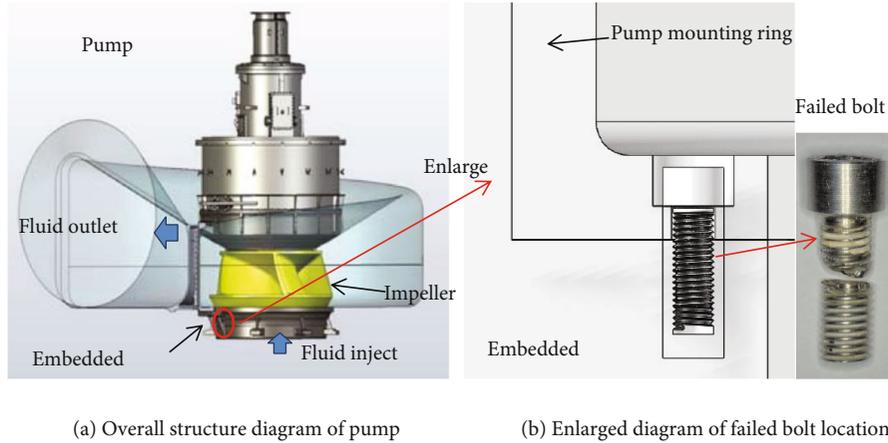
FIGURE 1: Structure of embedded parts under circulating water pump.

A cooling water pump is a very important equipment in nuclear power plants. During overhaul, it was found that the fixing bolts of the embedded parts of four CR1QS1 pumps were broken. The pump is a single-stage, vertical, bottom-suction concrete volute centrifugal pump. The pumps were fixed on the concrete embedded parts with 8 M12 × 1.75 hexagon socket bolts through the mouth ring, as shown in Figure 1. The purpose of the protective cap is to protect the bolt from erosion. The working medium of the pump is sea water.

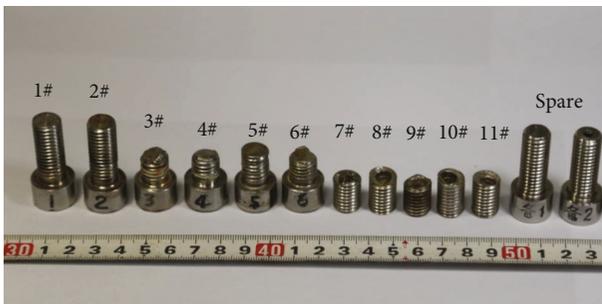
FIGURE 2: Bolts in service and spare parts.

2.1. Fracture Analysis. The bolts in service are shown in Figure 2, in which Nos. 1 and 2 were the unbroken bolts, Nos. 3-6 were the head of the broken bolts, and Nos. 7-11 were the rest of the broken parts of the broken bolts. Compared with the spares, their surfaces were the same as the serviced bolts, indicating that there was no corrosion.

2.3. *Energy Disperse Spectroscopy Analysis.* Table 4 shows the composition of the fracture surface after cleaning by Energy Disperse Spectroscopy (EDS). The result is the same as the previous conclusion in Section 2.1, that is, as can be seen in Figure 2, the broken bolts were as glossy as the spare parts, and there was obviously no corrosion.

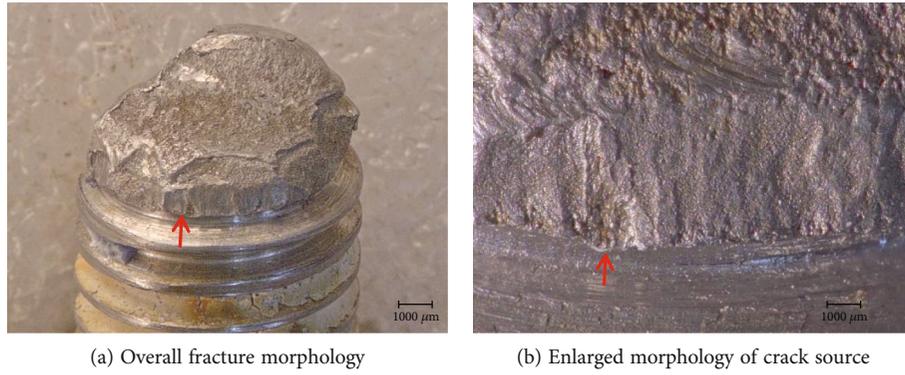
The fracture of No. 3 bolt in Figure 2 is representative. Take it as an example to illustrate the fracture form of bolts. Figures 3(a) and 3(b) are the overall morphology and local morphology of the No. 3 bolt, respectively. There are obvi-

ous radial lines on the edge of the thread teeth, which is the fracture source as the point indicated by the arrow. The fracture source extends to the core, and then the bolt breaks when the crackle reaches the middle. This is the instantaneous fracture zone region, where the section is rough and uneven. The instantaneous breaking zone occupies a relatively large area, indicating that there is a large residual pretightening force when the bolt is broken.

FIGURE 3: Fracture of No. 3 bolt in Figure 2.

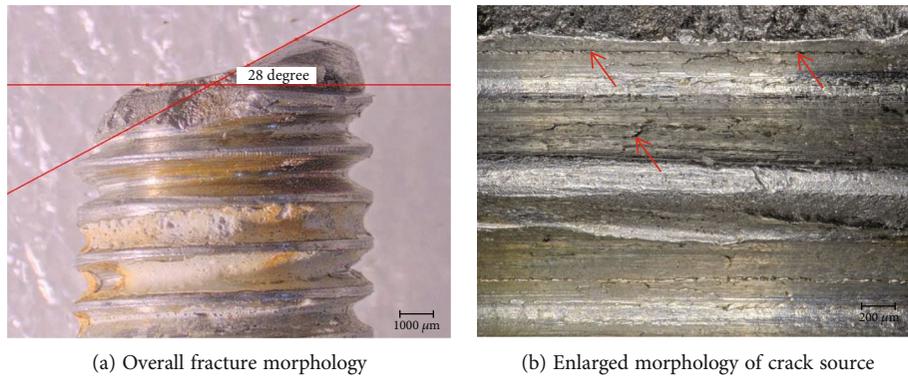
The macromorphology of No. 3 bolt fracture was observed by stereoscope, as shown in Figure 4(a). The fracture was uneven, with the thread teeth about 28° , which was about the direction of principal stress. Further zooming in and observing what is shown by the arrows in Figure 4(b), the source of the cracks is located at the machining tool mark at the root of thread, and there are a lot of microcracks around.

FIGURE 4: Macroscopic observation of thread profile of No. 3 bolt.

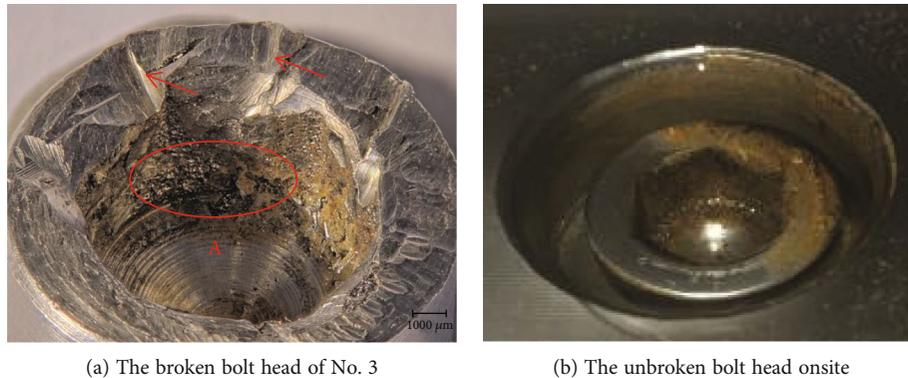
Figure 5(a) is the morphology of the inner hexagon of the head of No. 3 broken bolt. The top of the bolt head is damaged when the sample was taken on site, as shown by the arrow. But the inner hexagon area is damaged during tightening, as shown in the region. Figure 5(b) shows the morphology of the unbroken bolt head, with the inner hexagon of the screw head intact. The comparison shows that the broken bolts have overtightening behavior when they were installed.

FIGURE 5: Comparative morphology of hexagon socket head.

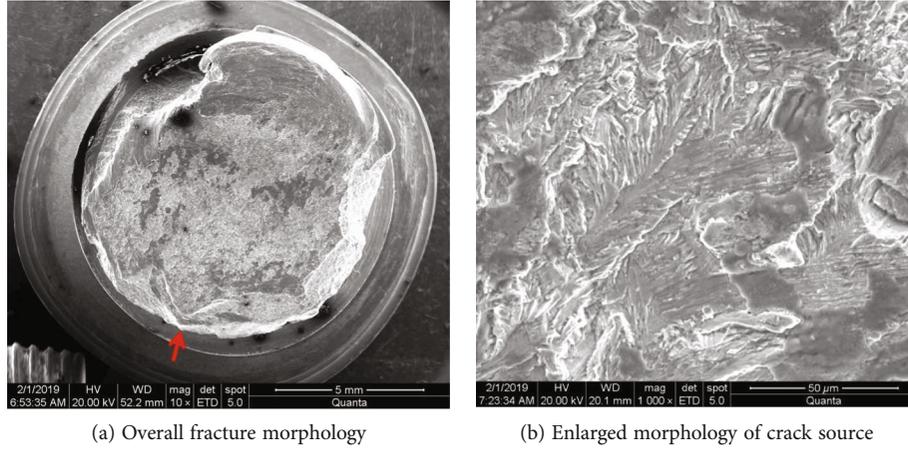
Figure 6(a) is the overall graph taken with a Scanning Electron Microscope (SEM), which shows the fracture source by arrow. Figure 6(b) is a micrograph of the expansion zone, which shows typical fatigue fracture characteristics. This shows that the process of fracture propagation also has the effect of alternating stress.

FIGURE 6: SEM photos of No. 3 bolt.

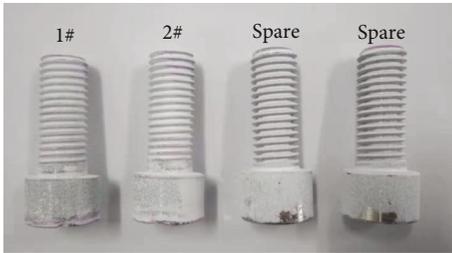
Figure 7 shows the macroimages of four unbroken screws through dye penetrant inspection, and no cracks are found on the surface. The metallographic structures of the unbroken and broken bolts are, respectively, shown in Figures 8(a) and 8(b), which show an austenite + ferrite structure. This conforms to the characteristics of dual phase steel, without obvious abnormality.

FIGURE 7: Macroimage of dye penetrant inspection for screws.

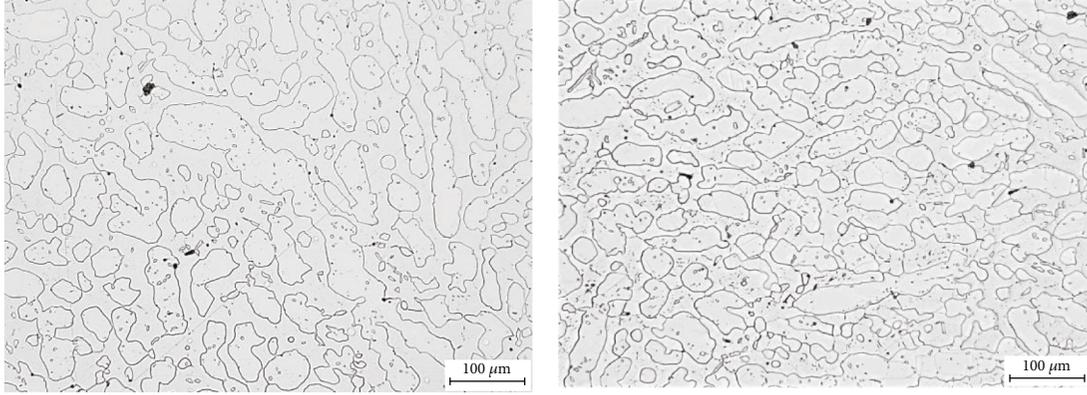
(a) Transverse metallographic structure of No. 2 screw

(b) Transverse metallographic structure of No. 11 screw

FIGURE 8: Microstructure of the sample bolts.

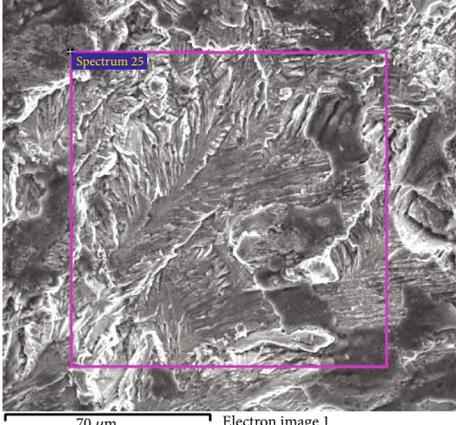
TABLE 4: Composition of washed fracture surface.

Element	Weight (%)	Atomic (%)	Test position
C K	6.20	20.20

O K	7.39	18.09	
Al K	0.36	0.52	
Si K	0.85	1.18	
Cr K	22.41	16.88	
Mn K	1.18	0.84	
Fe K	54.28	38.06	
Ni K	4.80	3.20	
Mo L	2.53	1.03	
Totals	100.00	100.00

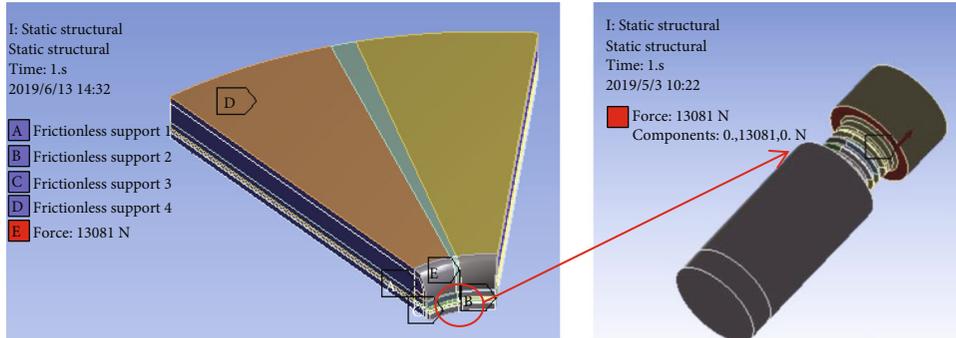
The pump and the foundation ring are connected by 8 bolts. The finite element model takes 1 bolt and one eighth of the foundation including the ring and concrete, as shown in Figure 9. According to the equipment maintenance man-

FIGURE 9: Finite element model.

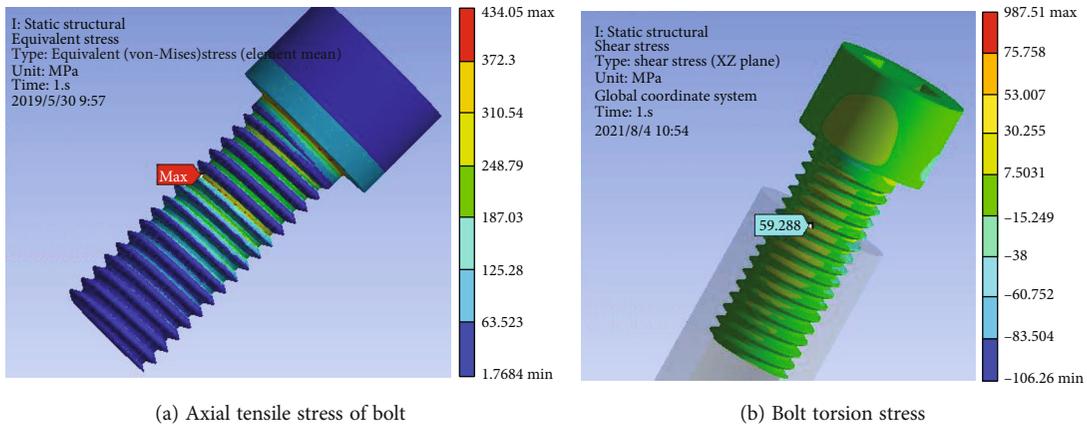
The axial tensile stress and torsional stress of the bolt are shown in Figures 10 and 11, respectively. The axial tensile stress σ_m is 434.05 MPa, and the torsional stress τ_m is 59.29 MPa at design torque. If the overtightening torque reaches 1.2 times the design value, the axial tensile stress σ_m is 520.86 MPa, and the torsional stress τ_m is 71.41 MPa. The inner hexagon of the broken bolt head has been seriously damaged, and the actual torque is far greater than 1.2 times the design value.

FIGURE 10: Stress value at design torque.

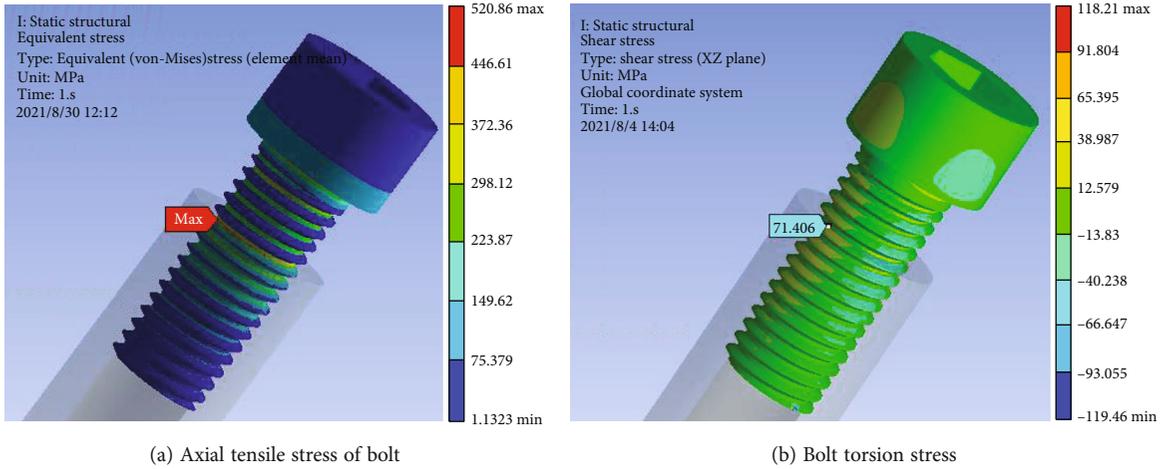
FIGURE 11: Stress value at 1.2 times design torque.

ure. However, the stress of 520.86 MPa caused by the preload is relatively large. Therefore, the measure to improve the safety factor is to control the bolt preload or increase the bolt diameter.

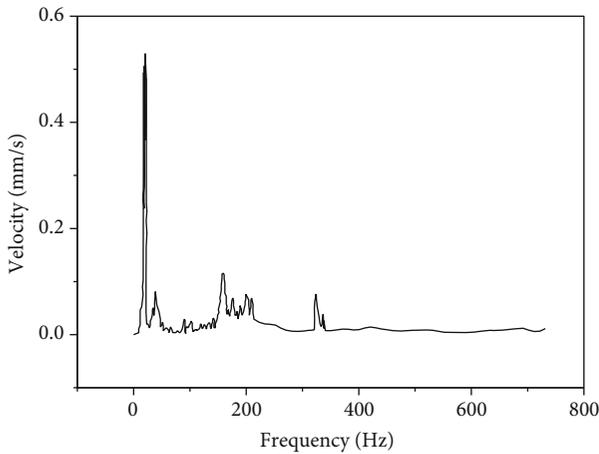
3.1.2. *Calculation of Bolt Working Stress.* When the pump runs, the impeller will have a working load, acting on the bolt axis direction. The stress is a symmetrical cyclic strain produced by the axial vibration when the pump is running. The axial load was obtained by actual measurement. A speed sensor was installed at the bearing, and the excitation spectrum load was the relationship between the speed and the frequency spectrum, as shown in Figure 12.

FIGURE 12: Vibration excitation load spectrum.

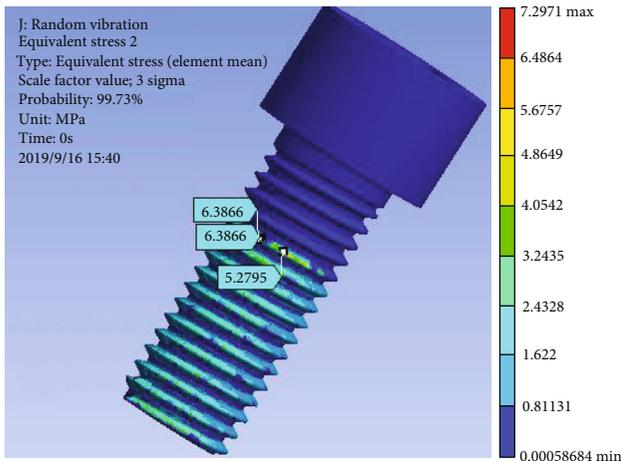
The workbench random vibration analysis module was used to calculate the stress response of vibration fatigue. The excitation was loaded on the concrete foundation. The finite element equivalent stress diagram is shown in Figure 13, in which the maximum equivalent stress σ_a is 7.3 MPa.

FIGURE 13: Equivalent stress of bolt.
