Advances in Civil Engineering

Advances in Non-Destructive Technology for Buildings and Energy Assessment

**Advances in Non-Destructive
Technology for Buildings and Energy
Assessment**

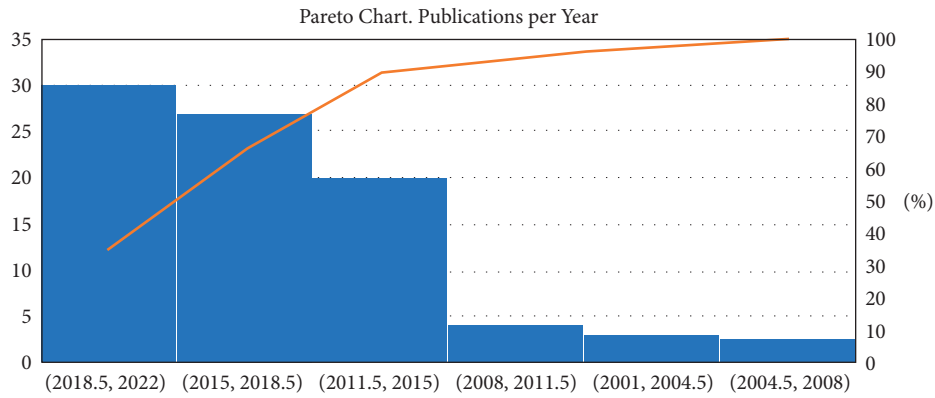
FIGURE 1: Number of related publications reviewed in this work (99 selections) per year since 2000.

Studies combining IRT and GPR for building assessment have shown an exponential increase in interest since 2000. Figure 1 shows the number of publications relevant to this review topic per year since 2000. Most were published since 2015, with a substantial jump from previous years, with 7–8 publications per year since 2018. Most of the publications reviewed were articles, with 87 publications (87.9%), followed by conference papers and book chapters with 10 (9.9%) and 2 (2.2%) publications, respectively, as shown in Figure 2. Regarding the number of publications per objective, an equal distribution has been found over the years, with 32% in

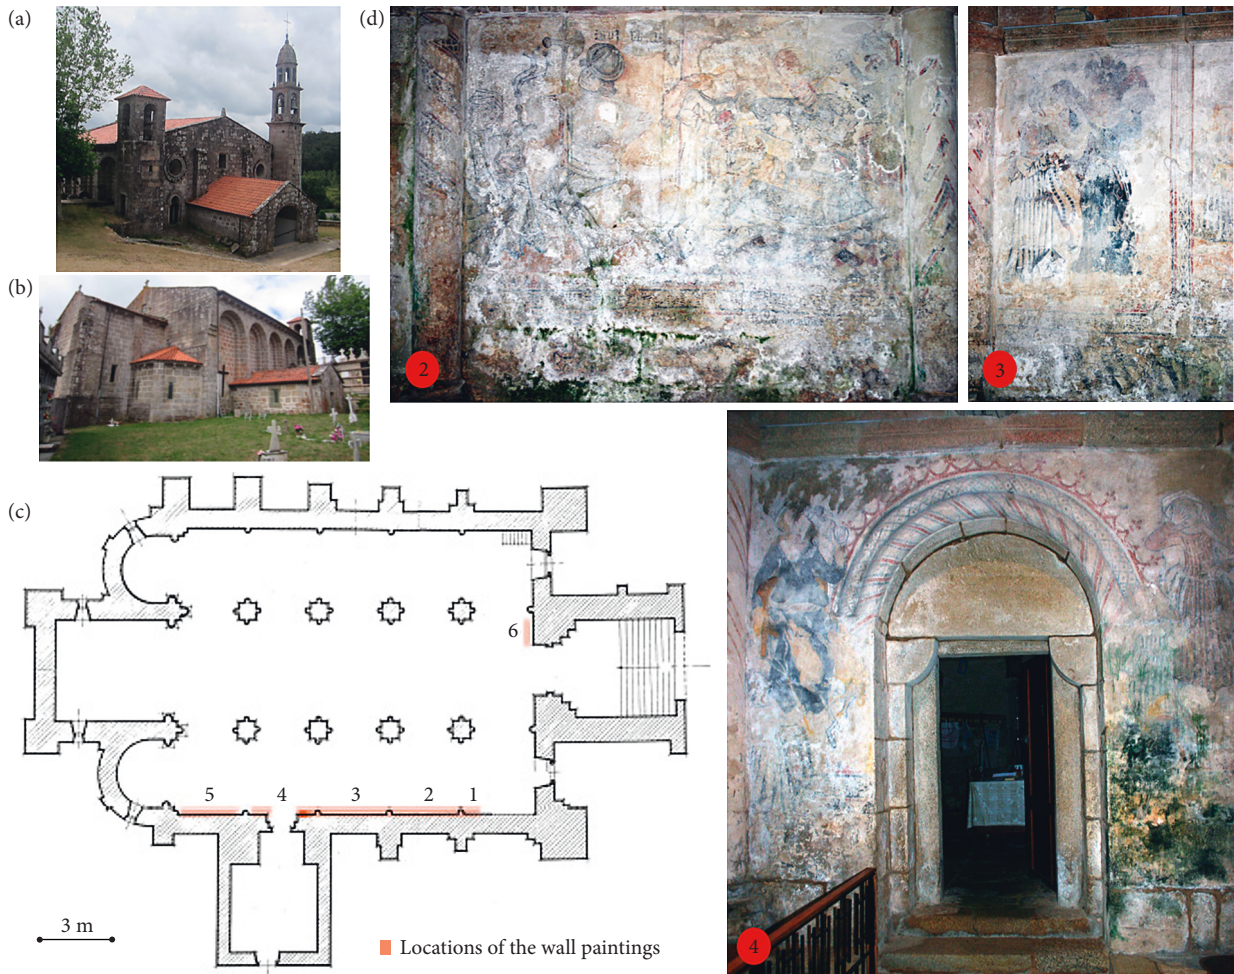
FIGURE 9: General view of the San Julián de Moraime Church (a), northern wall (b), plant view of the interior and locations of the wall paintings (c), and some of the paintings showing deterioration (d).

5.3. Heritage Preservation: Moisture Detection in San Julián de Moraima Church (Muxía, NW Spain). This Church, which was declared an Asset of Cultural Interest in 1972, has more than 46 m² of medieval wall paintings. As shown in Figure 9, these paintings are located in five sections through the northern wall, and represent the seven capital sins: section 1—sacred form, section 2—the pride and the greed, section 3—the anger and the lust, section 4—the gluttony and the envy, section 5—the sloth and the death. There are visible signs of deterioration such as moisture, presence of fungi and algae, saline efflorescence (chlorides, sulfates, nitrates, and nitrites), calcareous formations by carbonation, and dissolution of pigments. The main factors contributing to this deterioration are: (i) moisture, which multiple origins (moisture by capillarity and infiltration, residual moisture, and moisture caused by condensation); (ii) climatic conditions (the site of Moraima has a wet and warm weather during all the year with a maximum temperature of 11° and 20°C in winter and summer, respectively); (iii) presence of marine aerosols given its proximity to the coast; (iv) the interior of the Church is below the ground level; and (v) the northern wall is the least sunny and ventilated, coinciding with the drainage ditches of the rainwater. This situation mainly affects the first three sections. Section 4 gives to the Sacristy, which provides isolation from the outside, however, the contact with the corresponding buttresses implies entry of moisture. In the last section, the outer wall coincides with a flat ground and, therefore, where rainwater accumulates. It has no drain.

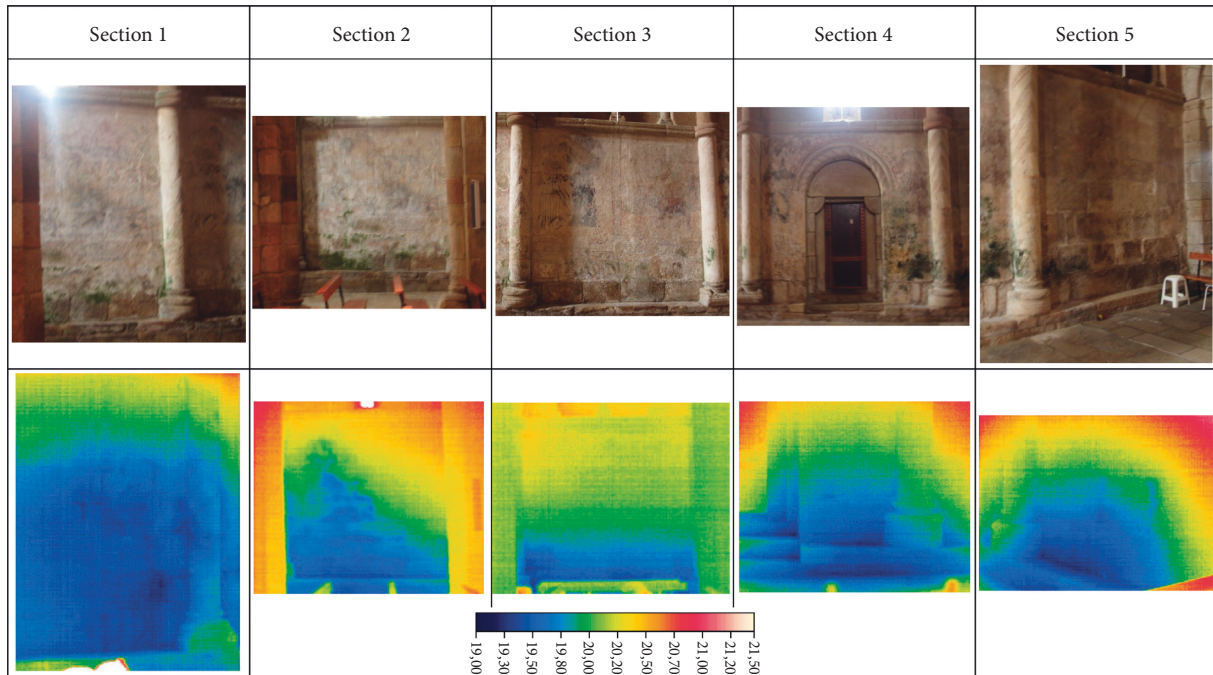
FIGURE 11: Thermographic inspection of the Moraine church. The color palette applied is the same for all images, showing temperatures between 21.5°C and 18.0°C.

The thermographic inspection corroborates the detection of moisture as the main pathology in the Church: it appears as a lower temperature area in the images, due to the higher thermal inertia of water (Figure 11). The images of all sections show the presence of moisture in the lower part of the walls, as a sign of water capillary action. This pathology is coherent with the presence of water on the ground detected by the GPR inspection. In Sections 2 and 4, where efflorescence and mold were visible to the eye, the higher effect of the presence of water hid the thermal signs of these pathologies on the thermal images.
