Retrieval Research in Hip and Knee Arthroplasty

Guest Editors: Thomas M. Grupp, Sandra Utzschneider, and Steven M. Kurtz

Backside Wear Analysis of Retrieved Acetabular Liners with a Press-Fit Locking Mechanism in Comparison to Wear Simulation In Vitro

Failure of Polyethylene Inlays in Cementless Total Hip Arthroplasty: A Retrieval Analysis

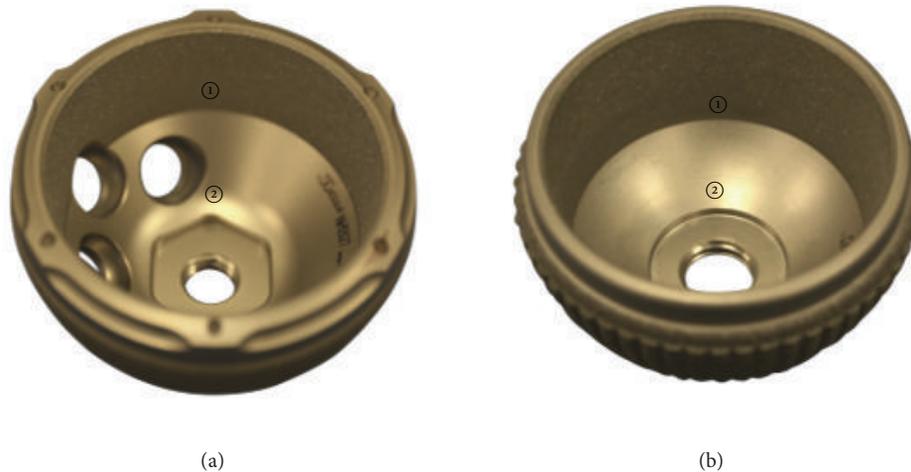
FIGURE 1: (a) P-Cup and (b) P-Fit metallic shell with grit blasted rough titanium conical inner surface at the rim ① and milled-drilled smooth surface on the concave area ②.

liner and the shell, which is based on a press-fit cone with a large surface area and through a contact with the base of the shell, which will be achieved after the load in service. A grit blasted rough titanium inner surface ($R_z = 20\text{--}32\ \mu\text{m}$) along the rim of the shell intends to stabilize the liner to it. Furthermore, the conical fixation surface of the liners intends to form a seal against the migration of wear particles from the articulation joint. The screw drill holes of the Plasmacup (further referred to as P-Cup) are located in the cranial region of the shell. The Plasmafit liners (further referred to as P-Fit) analyzed did not have screw drill holes. The polyethylene liners of the two different cup systems can have either a symmetrical (Sym) or a posterior wall (PW) design. In the symmetrical design, the liners fit symmetrically in the shells, whereas the posterior wall liners contain a polyethylene hood that extends outside the shell in the luxation direction in order to increase luxation stability.

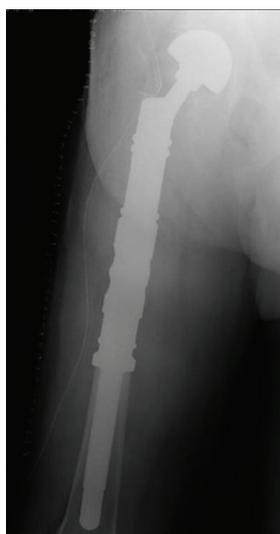
FIGURE 2: Postoperative X-ray after proximal femur resection and reconstruction with silver-coated modular prosthesis (MUTARS Implantcast Ltd., Buxtehude, Germany).

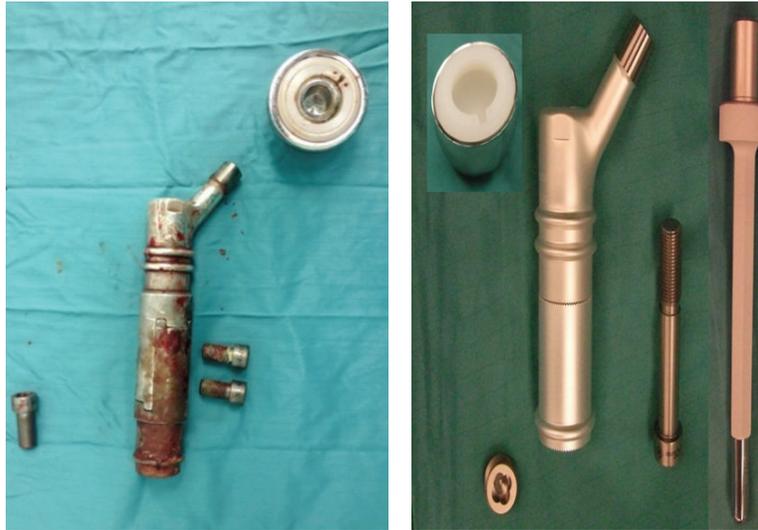
FIGURE 3: Silver-coated proximal femur prosthesis explanted 27 months after surgery compared with a new silver-coated prosthesis.

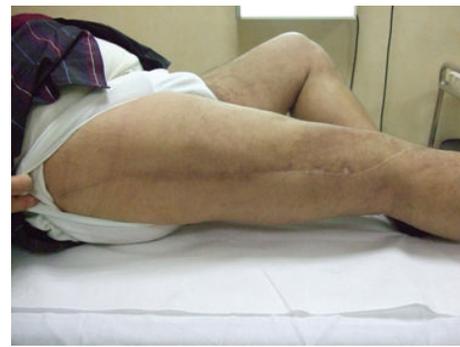
FIGURE 6: Long term clinical follow-up did not show general or local sign of silver toxicity, even in wider resection and at each time considered.

No difference between silver-coated prosthesis and uncoated tumor prosthesis group was recorded for functional scores considered. No patient ever showed local or general sign of toxicity secondary to silver exposition at each time considered, even in wider resection (Figure 6).

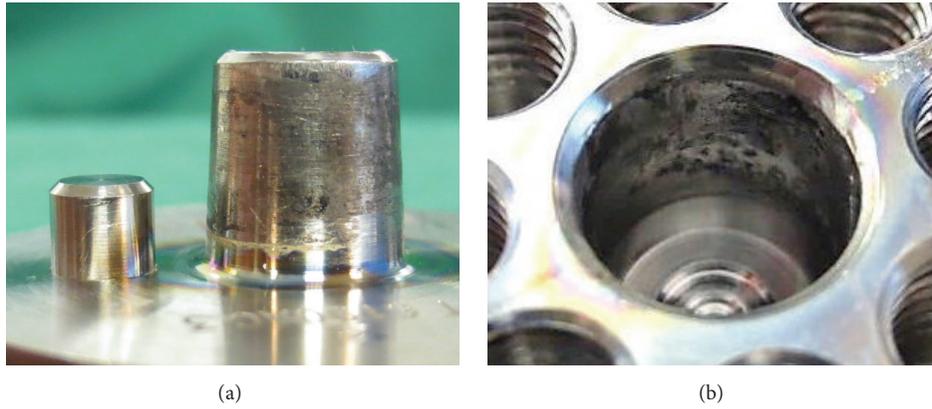
FIGURE 3: Severe tribocorrosion on male (a) and female (b) taper of a retrieved prosthesis. The time to revision was 9.2 years.
