The Effect of Coastal Environment on the Degradation of Reinforced Concrete Structures

Advances in Civil Engineering

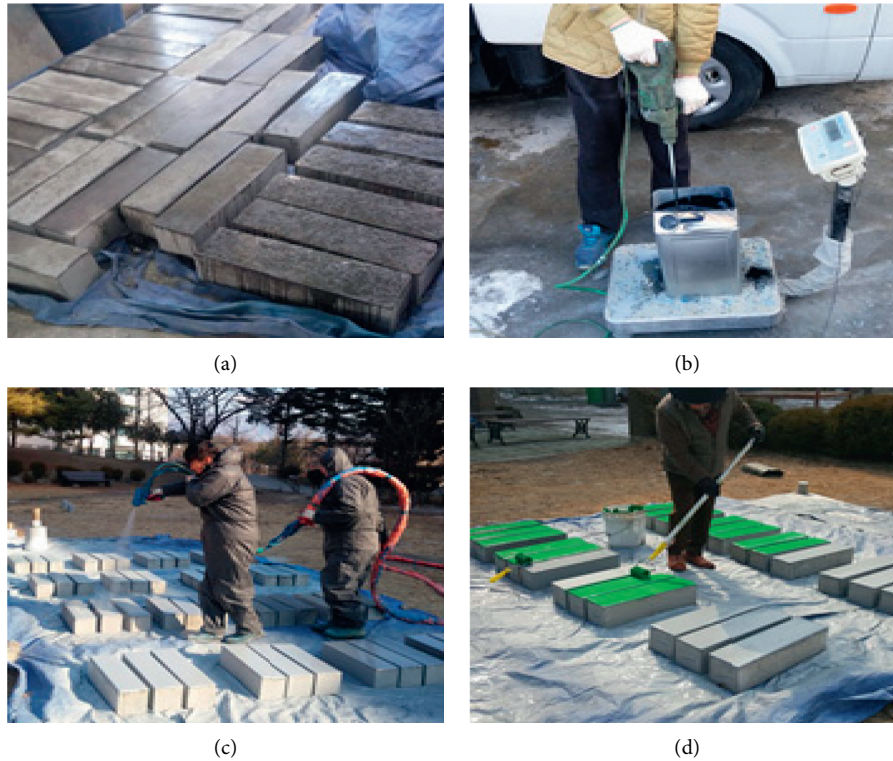
FIGURE 1: FRPU spraying operation: (a) primer painting; (b) mixing of prepolymer and fibers; (c) FRPU spraying; (d) primer painting.

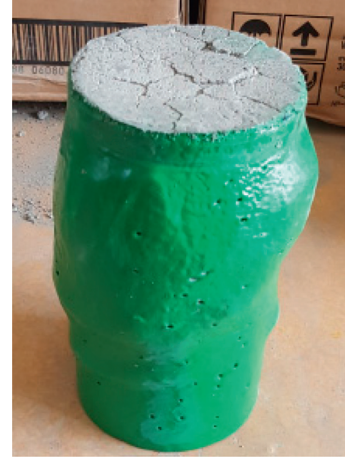
FIGURE 3: Failure mode of polyurea-reinforced concrete cylinder.

reinforced concrete cylinder may be subjected to an eccentric load, and its accurate compressive strength can rarely be measured because the polyurea cannot be sprayed with a constant thickness along the circumferential surface. Figure 3 shows the failure mode of a polyurea-reinforced concrete cylinder through eccentric loading with an irregular expansion of the concrete cylinder. In addition, it is shown that the polyurea constrains the inner core concrete and fails by a loosening of the polyurea used to enclose the concrete pieces. This indicates that polyurea is effective in enhancing the ductility without a debonding.

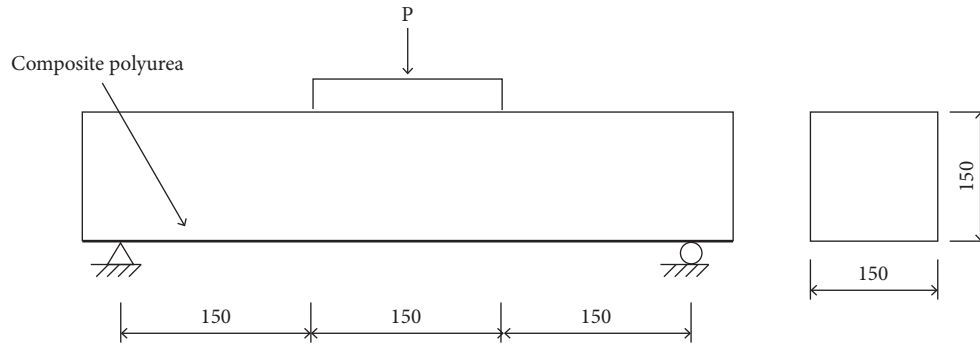
FIGURE 4: Loading system of concrete beam (unit: mm).

Concrete beams of size 150 mm × 150 mm × 150 mm for testing the flexural strength are manufactured without reinforcing bars, and the load is applied at two points on the beam, as shown in Figure 4. The experiment results indicate the flexural performance including the load-carrying capacity and flexural ductility. The initial crack begins at the bottom face of the midspan section. The unreinforced concrete beam simultaneously fails with the advent of the initial cracking because of the low tensile strength of the concrete. The polyurea- and FRPU-reinforced concrete beams exhibit an abrupt reduction in the flexural strength the moment the initial cracking occurs. However, the load after the initial cracking gradually increases and is carried by the polyurea or FRPU on the tension side. The specimens reach the second peak load. The additional cracks are gradually propagated and widen around the midspan with an increase in the load. The polyurea or FRPU controls the development of cracks without peeling from the concrete surface.

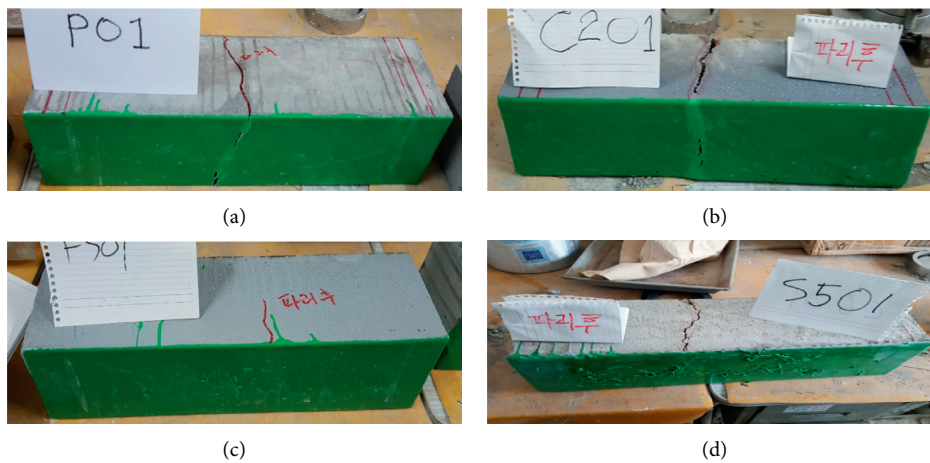
FIGURE 5: Failure mode of specimens: (a) PO1; (b) C21; (c) F51; (d) S51.

Figure 5 shows the failure modes of the specimens. Upon initial loading, the flexure-resisting capacity is retained by the concrete, as well as the polyurea or FRPU. Upon the occurrence of the concrete cracks, the load abruptly deteriorates. Without a polyurea or FRPU reinforcement, the concrete beams abruptly fail under a load. The flexural capacity after the concrete cracks occurs is retained to a certain degree or even increased owing to the tensile strength of the polyurea or FRPU. The polyurea- or FRPU-reinforced concrete beams display a gradual increase in flexural ductility and deflection prior to ultimate failure. It was shown that the strengthened concrete beams ultimately fail through a fracture of the polyurea or FRPU.

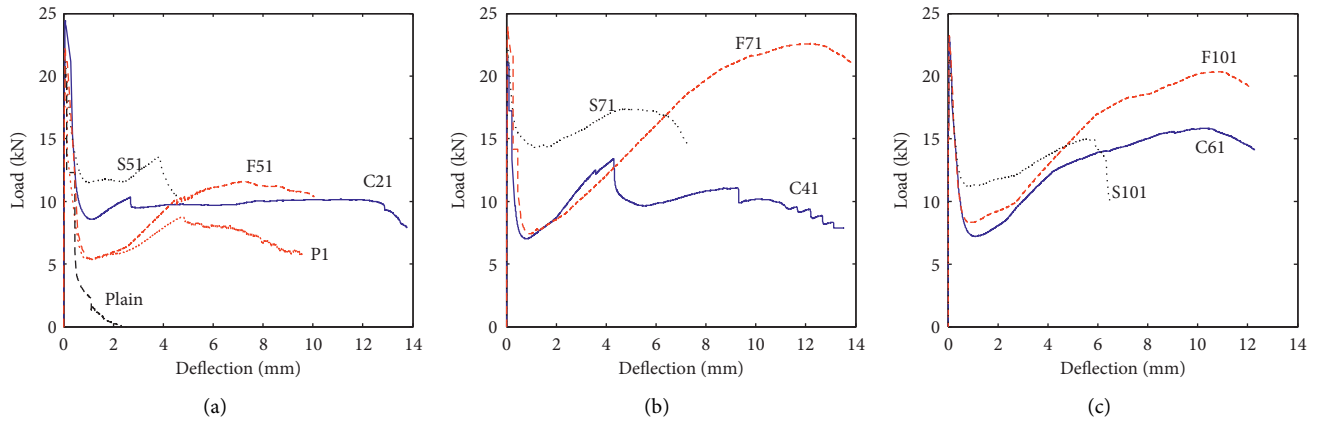
FIGURE 6: Load-deflection curves (spraying thickness of 3 mm): (a) group one; (b) group two; (c) group three.

Figure 6 shows the load-deflection curves of the specimens depending on the fiber types for a spray thickness of 3 mm. The plots are divided into three groups: (a) group 1 is CNTs strengthened by 2%, or milled glass or steel fibers strengthened by 5%, (b) group 2 is CNTs strengthened by 4%, or milled glass or steel fibers strengthened by 7%, and (c) group 3 is CNTs strengthened by 6%, or milled glass or

was found that the polyurea- or FRPU-reinforced specimens retain sufficient flexural ductility owing to their expansibility. The specimens of group 1 in Figure 6(a) exhibit a

similar load-deflection relationship prior to a concrete crack. Specimen C21 reinforced by CNTs also exhibits sufficient ductility. The specimens P1, F51, and S51 resist a load with a constant magnitude after a crack occurrence. The steel fibers of 5 mm in length are manually scattered on the beam surface prior to the polyurea spraying, and their even distribution cannot be expected. Thus, specimen S51 abruptly fails and exhibits little ductile behavior. It was found that the specimens reinforced by milled glass fibers or CNTs retain more load-carrying capacity and flexural ductility than those using polyurea only. The specimens of group 2 in Figure 6(b), which contain more fibers than those in group 1 in Figure 6(a), show a higher second peak load and more flexural ductility. Specimen C41 exhibits an abrupt load deterioration after the second peak load although the ductility is retained to a certain degree. The load deterioration in specimen C41 is caused by the uneven thickness of the FRPU and the uneven distribution of the CNT. It is difficult to obtain a precise and constant thickness because the spraying operation is manually conducted by experts. In addition, it is not easy to evenly disperse the fibers on the concrete surface. It has been shown that specimen F71 retains a high strength after concrete cracks occur, and thus the second peak load nearly reaches the peak load with an increase in the deflection. In group 3 in Figure 6(c), the specimen reinforced by steel fibers abruptly fails at a lower load than that in group 2. It has been estimated that an abrupt failure and low ductility are due to more irregular scattering with an increase in the weight-to-content ratio. It has been observed that the reinforcement by steel fibers has a limitation in the spraying operation regardless of the weight-to-content ratio. The specimen reinforced by CNTs in group 3, shown in Figure 6(c), exhibits a higher load-carrying capacity and more ductility after the cracking than that in group 2. The CNTs have a higher cost than the other fibers. In addition, the F101 specimen strengthened by milled glass fibers retains more load-carrying capacity and flexural ductility with an increase in the weight-to-content ratio.

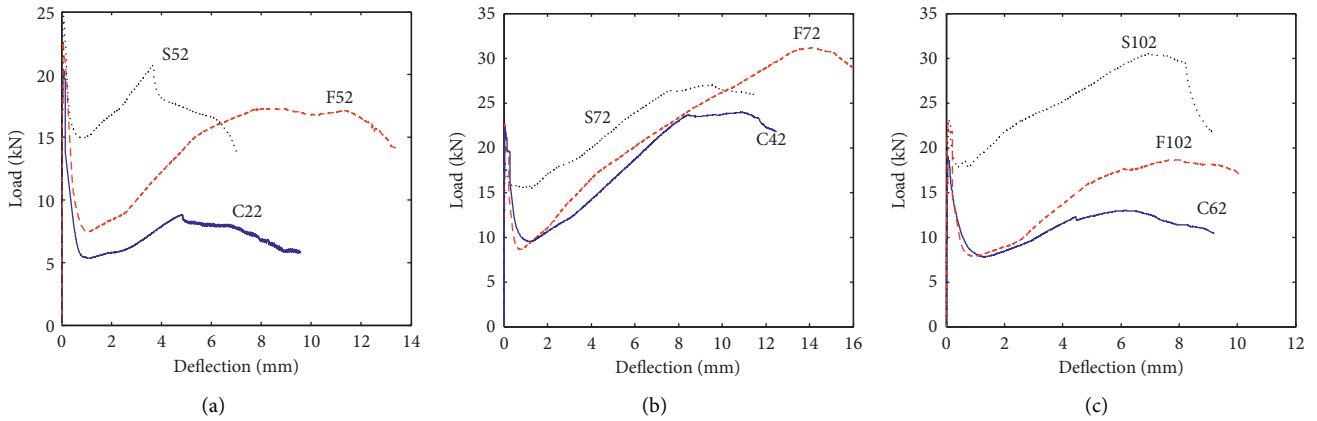
FIGURE 7: Load-deflection curves (spraying thickness of 5 mm): (a) group one; (b) group two; (c) group three.

concrete cracking. After this stage, the load is resisted by the FRPU at the flexural tension face and gradually increases with the deflection. Compared with specimens of 3 mm in thickness, the increase in spraying thickness leads to an enhancement in the load-carrying capacity as well as the flexural ductility. This is due to the increase in the tension-resisting area and the corresponding force. The plots also indicate that the toughness and dissipated energy increase with an increase in the weight-to-content ratio. The specimens reinforced by steel fibers exhibit an enhanced peak load-carrying capacity with an increase in the weight-to-content ratio and the highest flexural ductility at the weight-to-content ratio of 7%. However, it is difficult to state that the most effective ratio is 7% because of the uneven coating thickness of the FRPU and the nonuniform distribution of the steel fibers. The concrete beams reinforced by 2% or 6% CNTs rarely display more load-carrying capacity and flexural ductility than at a weight-to-content ratio of 4%. Based on the synthetic prediction shown in Figure 7, we can predict that the optimum weight-to-content ratio is approximately 4%. The specimens containing milled glass fibers depending on the weight-to-content ratio exhibit an extremely similar tendency as those using CNTs. The optimum weight-to-content ratio of glass fibers should be approximately 7% in terms of economy and strength.

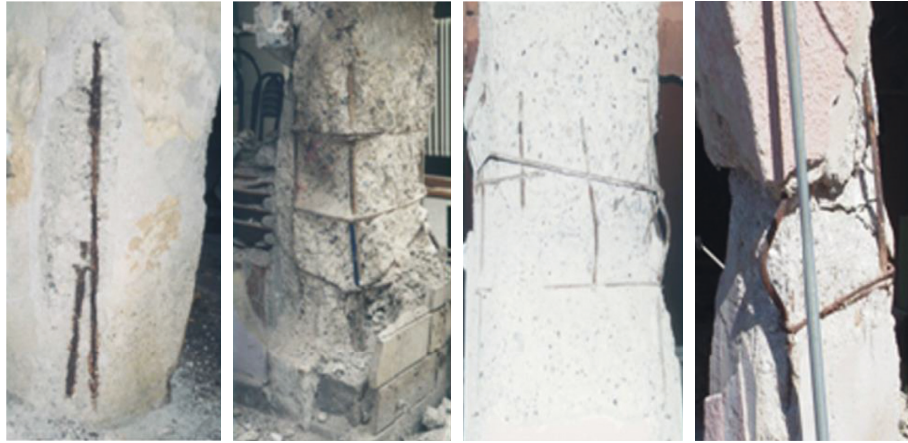
FIGURE 2: Corrosion of RC members damaged during the 1999 Izmit Earthquake in Turkey [7].

There have also been frequent earthquakes all over the world in recent years. If RC structures in earthquake-prone areas are seriously corroded, this will inevitably affect their seismic performance and safety. As shown in Figure 2, reinforcement corrosion of RC members has a significant impact on the structural performance deterioration (i.e., seismic performance degradation) caused by earthquakes [7], as seen following recent strong earthquakes including the 1995 Kobe Earthquake in Japan ($M=7.3$), the 1999 Jiji Earthquake in Taiwan ($M=7.3$), the 1999 Izmit Earthquake in Turkey ($M=7.4$), the 2008 Sichuan Earthquake in China ($M=8.0$), the 2010 Chile Earthquake ($M=8.8$), the 2012 Great East Japan Earthquake ($M=9.0$), the 2013 Lushan Earthquake in China ($M=7.0$), and the 2016 Kumamoto Earthquake in Japan ($M=7.0$).

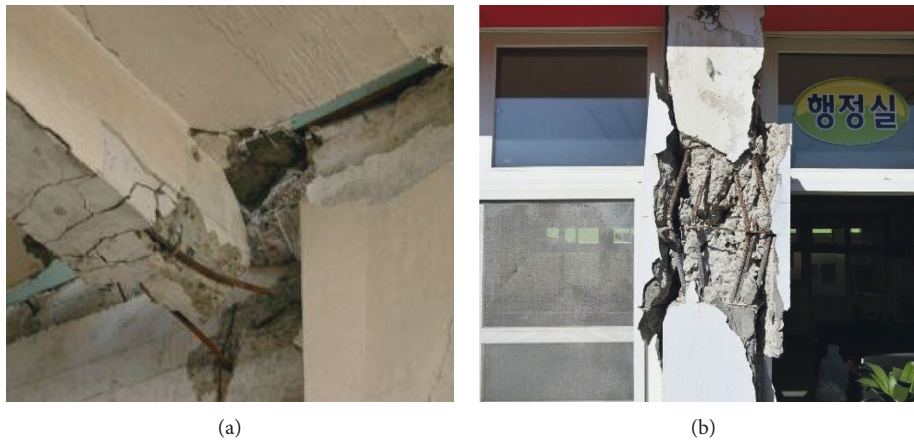
FIGURE 3: Corrosion of RC beams and columns damaged during earthquakes. (a) The 2004 Niigata-ken Chuetsu Earthquake in Japan (b) The 2017 Pohang Earthquake in Korea.

Even though the intensity of the earthquakes was relatively low, we can see from observations of buildings damaged during the 2004 Niigata-ken Chuetsu Earthquake in Japan ($M=6.8$), as well as the 2017 Pohang Earthquake in Korea ($M=5.4$), that corrosion of RC members, including beams and columns, affected failure, as shown in Figure 3. The corrosion of steel leads to a loss of adherence between the reinforcement and concrete over time, in addition to significant losses in cross sections of reinforcement bars. As a result of these losses, reinforcement bars and concrete no

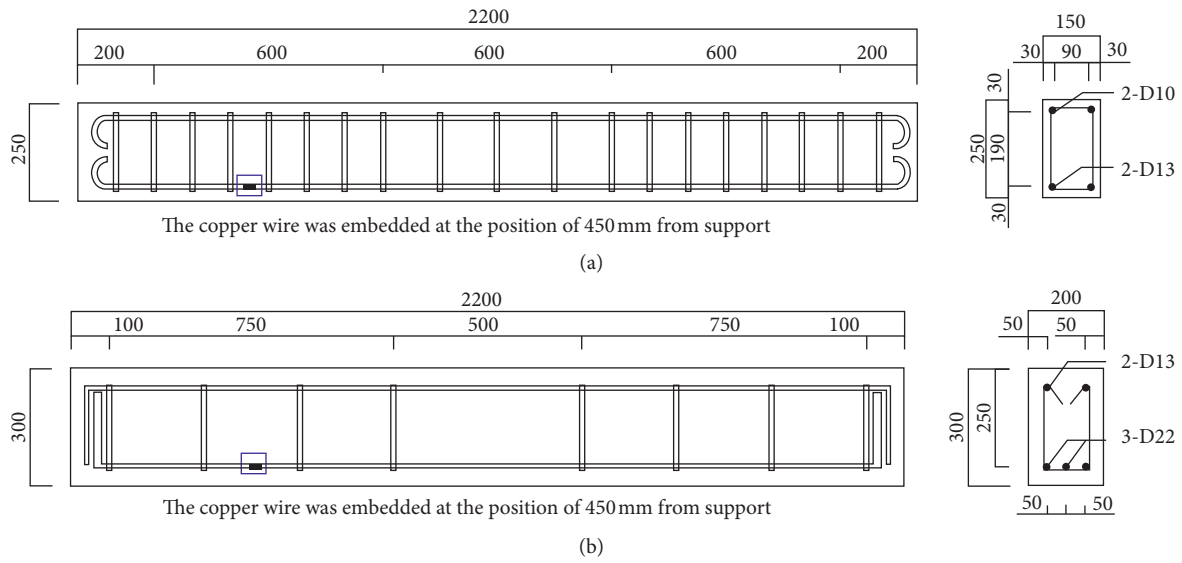
FIGURE 4: Reinforcement details of beams: (a) flexural failure type beam and (b) shear failure type beam.

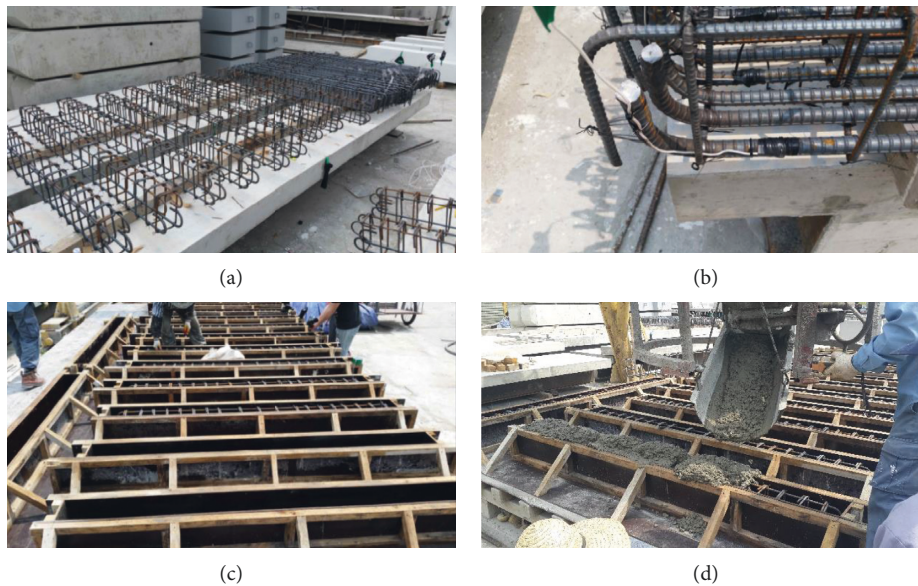
FIGURE 5: Beam manufacturing process: (a) assembly of reinforcing bar cage, (b) wire for corrosion of reinforcing bar, (c) installation of reinforcing bar cage, and (d) placement of concrete.

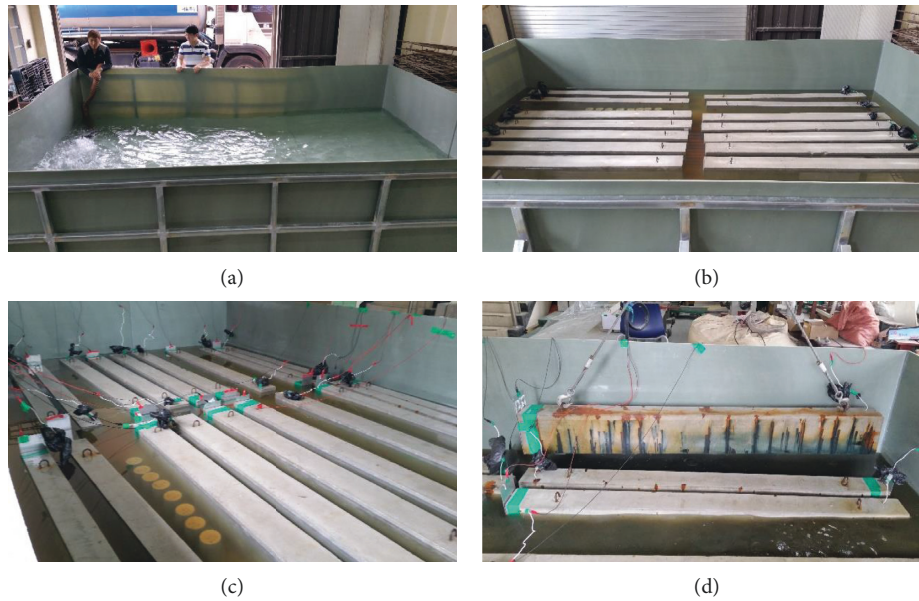
FIGURE 6: Accelerated corrosion setup: (a) tank with 5% NaCl solution, (b) immersion of beam, (c) accelerated corrosion, and (d) corroded beam.

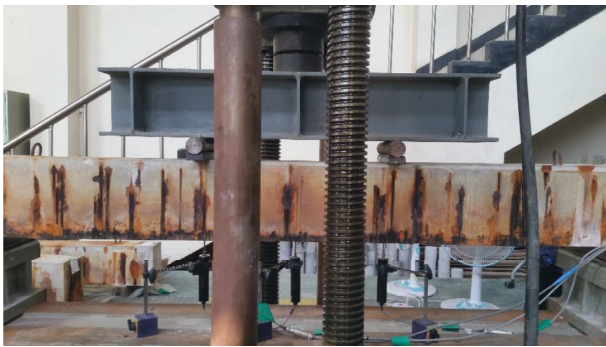
FIGURE 7: Test setup.

2.4. Test Program. All beams were subjected to a four-point bending test under conditions of limited support, as shown in Figure 7. The pure bending span between the two loading points was 600 mm for the flexural failure type beam and 500 mm for the shear failure type beam. The bending test was performed using a universal testing machine. A monotonic transverse load was applied under load control (loading

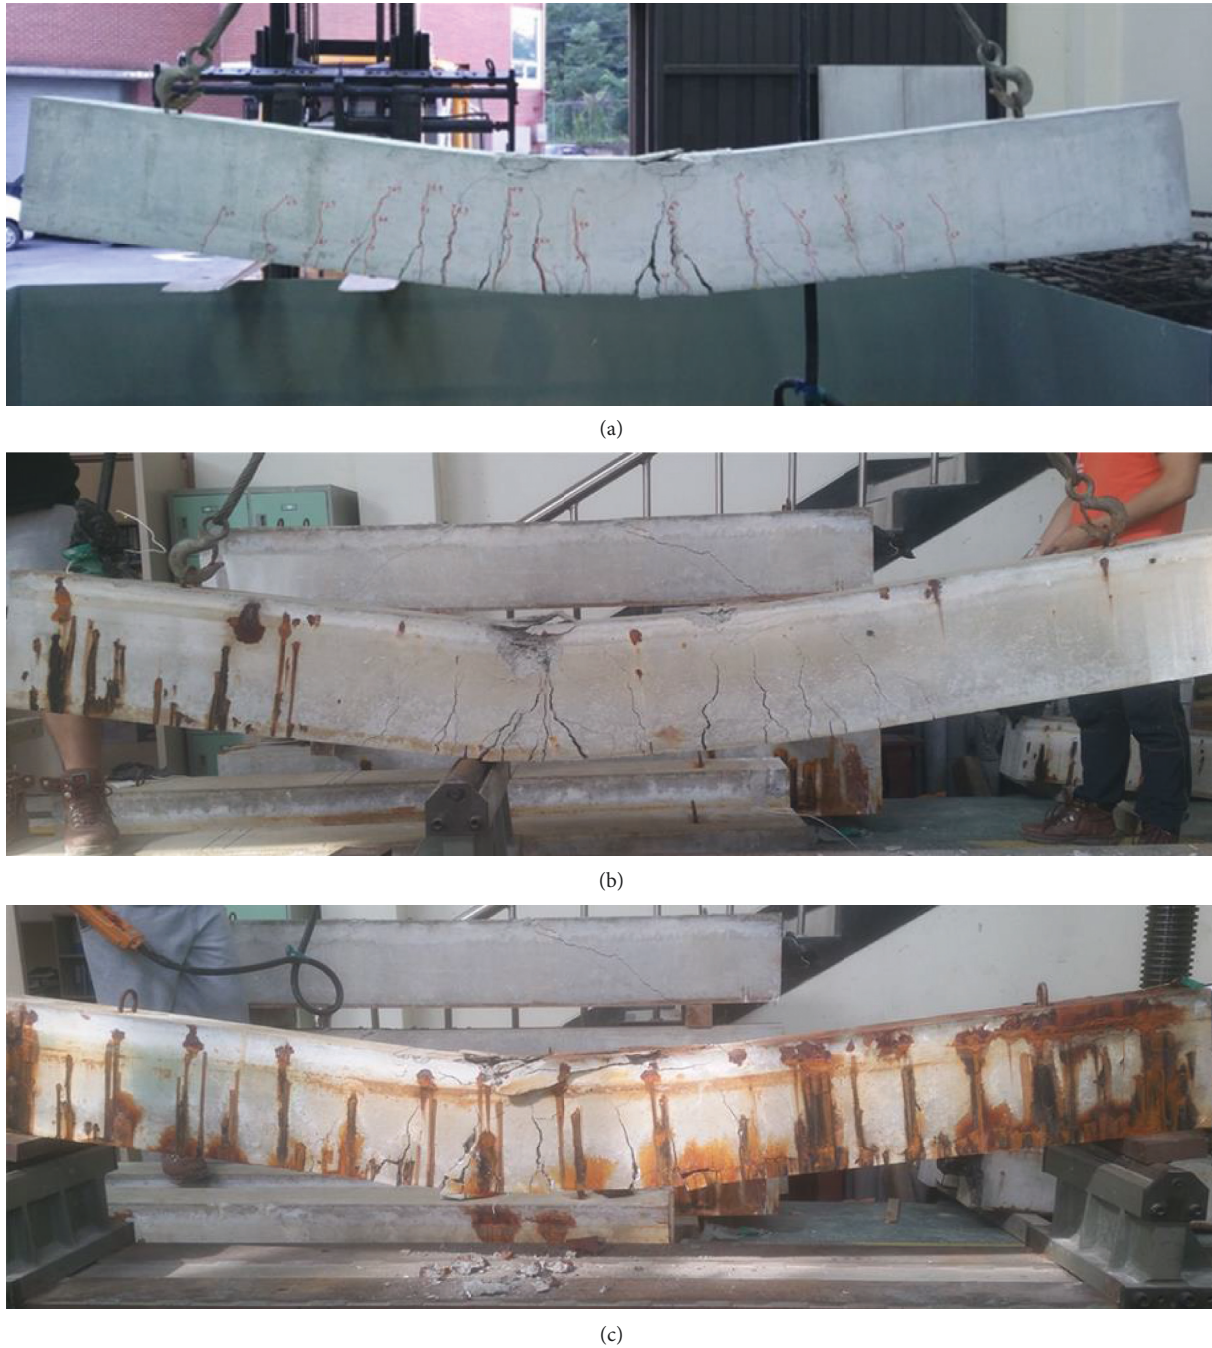
FIGURE 10: Cracking and failure patterns of flexural failure type beams: (a) FB-C0 beam, (b) FB-C4 beam, and (c) FB-C7 beam.

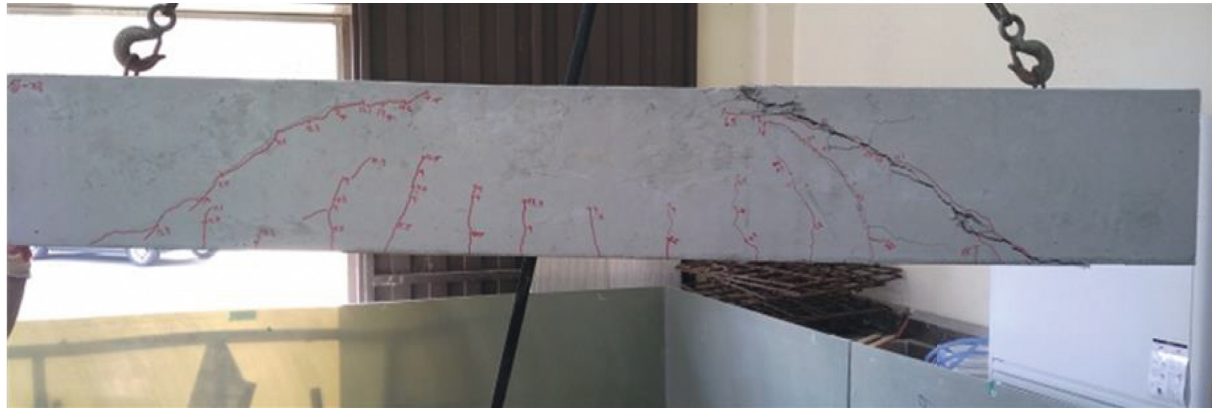
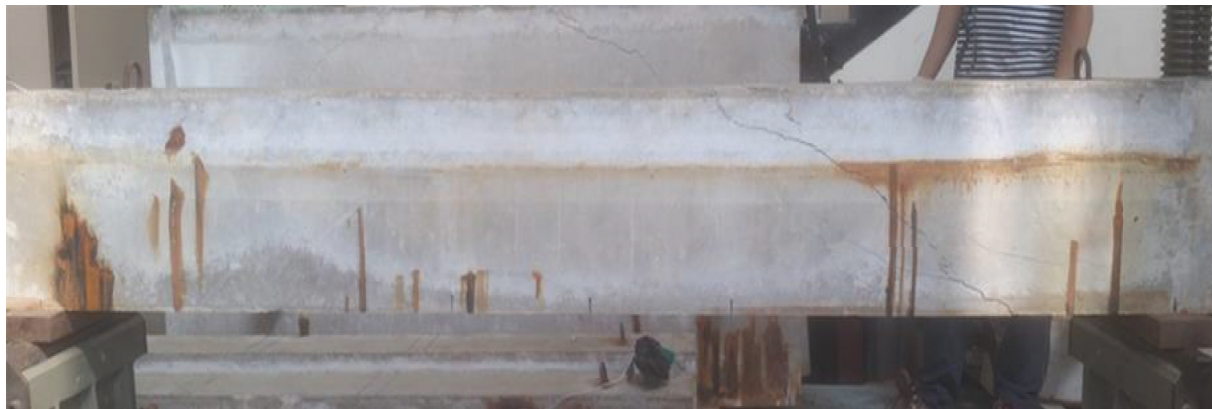
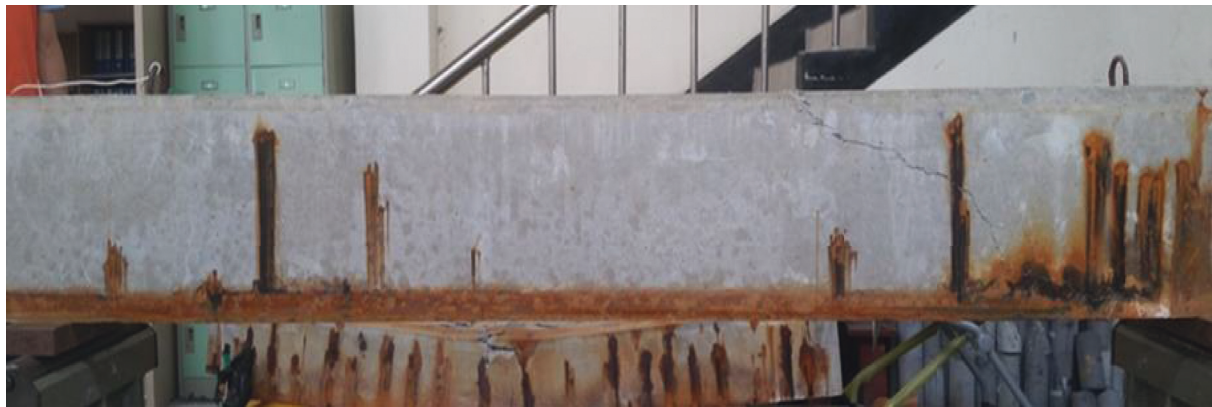
FIGURE 11: Cracking and failure patterns of shear failure type beams: (a) SB-C0 beam, (b) SB-C4 beam, and (c) SB-C7 beam.

Figure 11 shows the cracking patterns at midspan for the shear failure type beams. In the case of the SB-C0 beam, the crack started near the midspan of the beam at a load of 22.0 kN, and the corresponding deflection of the beam at the midspan was 0.52 mm. A diagonal crack was observed in the right part of the beam at a load of 90.2 kN (deflection:

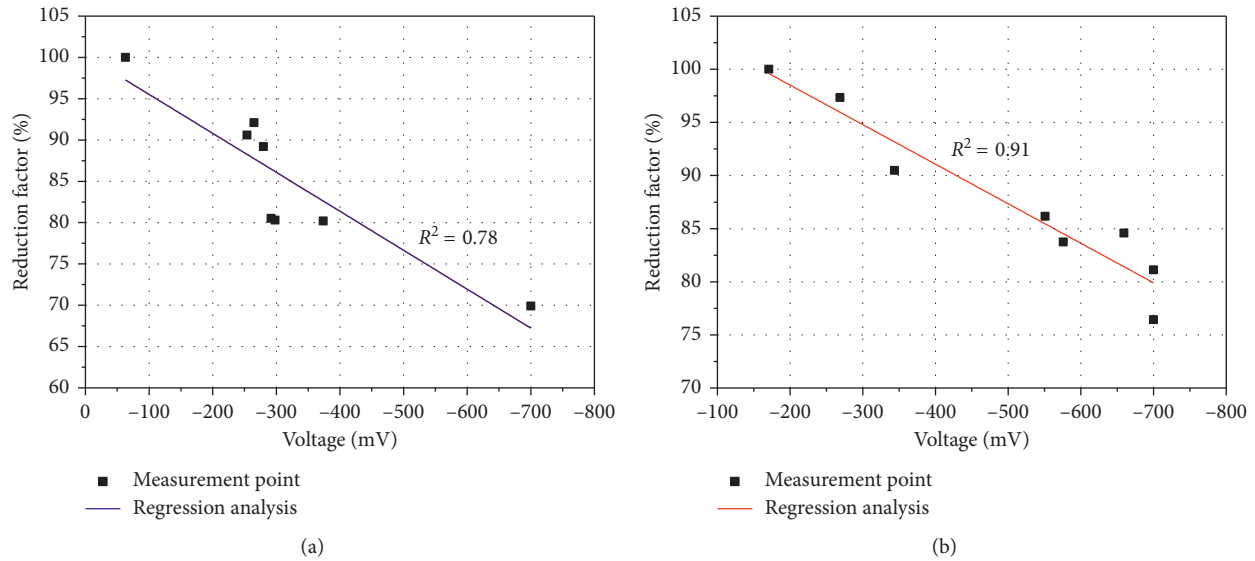
FIGURE 13: Relationship between the performance degradation factor and average potential difference in terms of voltage: (a) flexural failure type beams and (b) shear failure type beam.

Figure 13 shows the relationship between the performance degradation factor and average potential difference. We applied empirical regression models to derive the

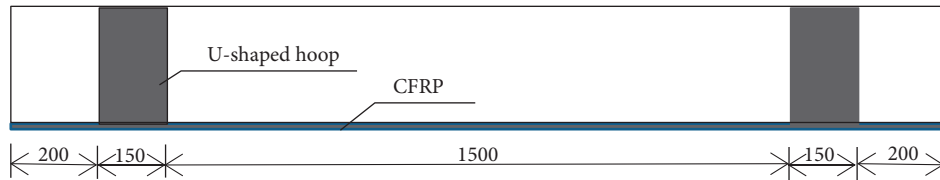
FIGURE 3: Reinforcing scheme of CFRP (unit: mm).

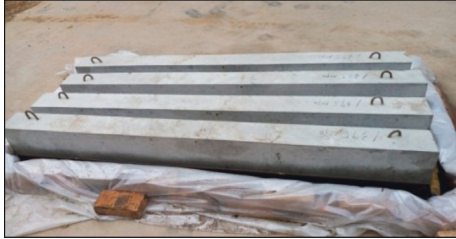
FIGURE 4: Deicing salt corrosion.

After preloading and CFRP reinforcement, the beams were immersed in a deicing salt solution for 120 days. The components of the solution are CaCl_2 and MgCl_2 , and the concentration is 5%. It can be seen in Figure 4.

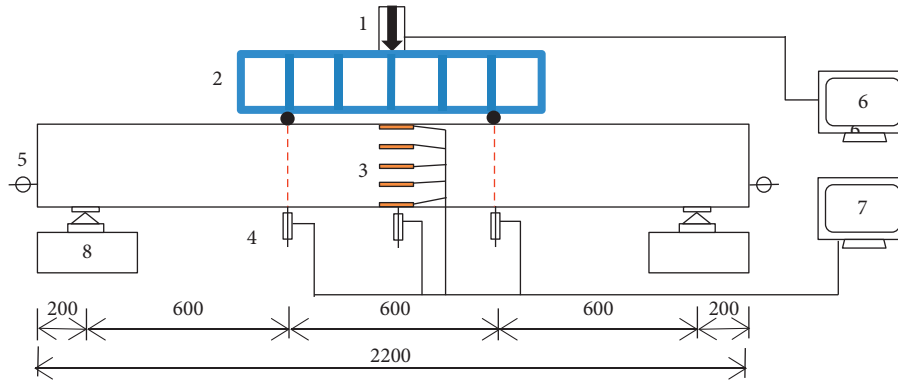
FIGURE 5: Loading test setup (unit: mm). Note: 1, load cell; 2, steel spreader beam; 3, strain gauge; 4, displacement sensor; 5, dial indicator; 6, computer; 7, data acquisition system.

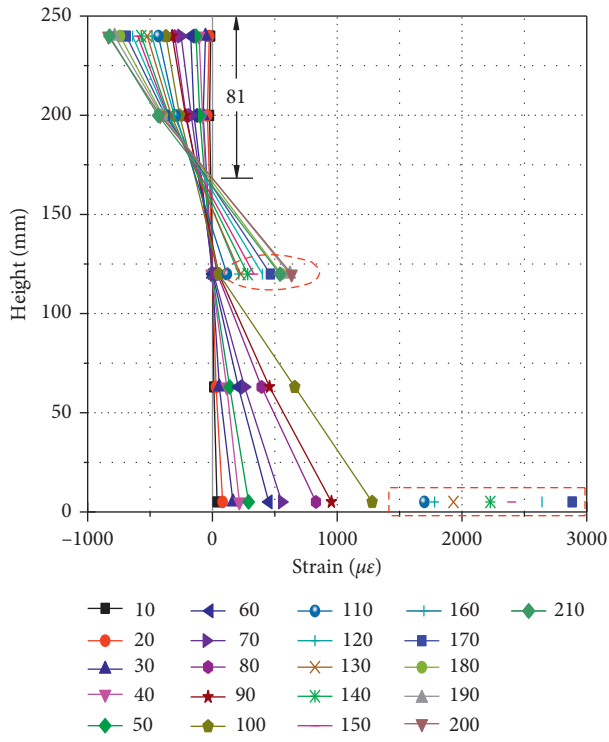
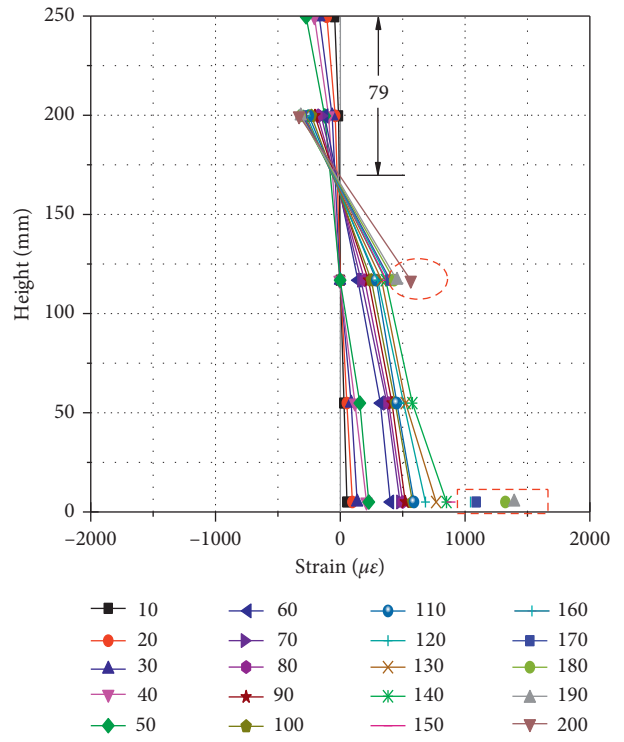
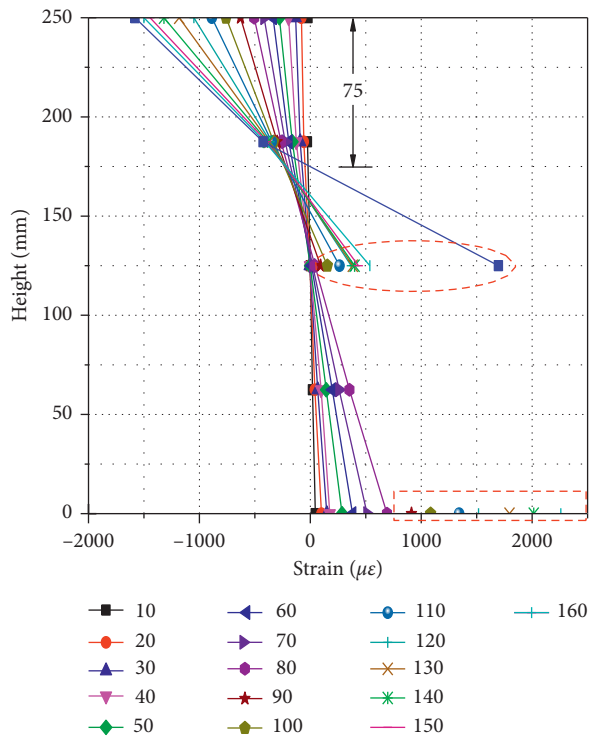
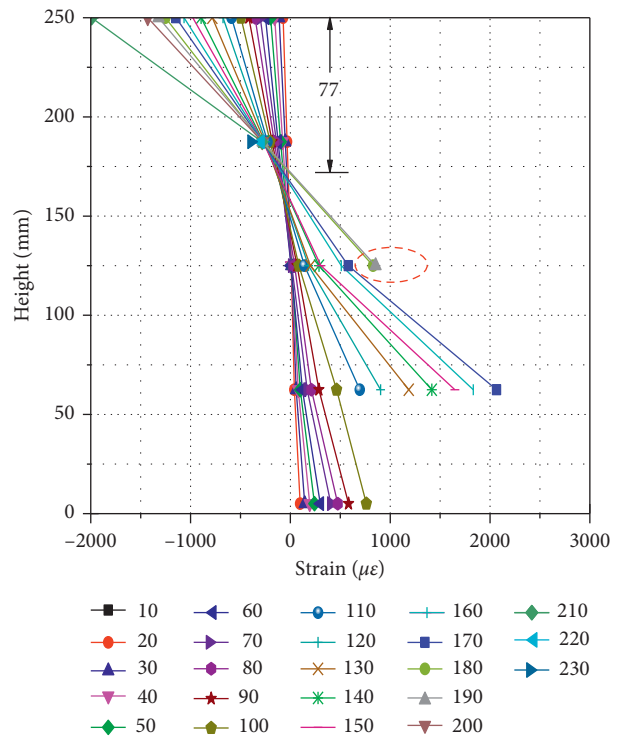
FIGURE 6: Distribution of strain at the midspan. (a) Beam A1, (b) beam C0-1, (c) beam C40-1, (d) beam C60-1, (e) beam C0-3, (f) beam C40-3, (g) beam C60-3, (h) beam B2, (i) beam C40-2, and (j) beam C60-2.

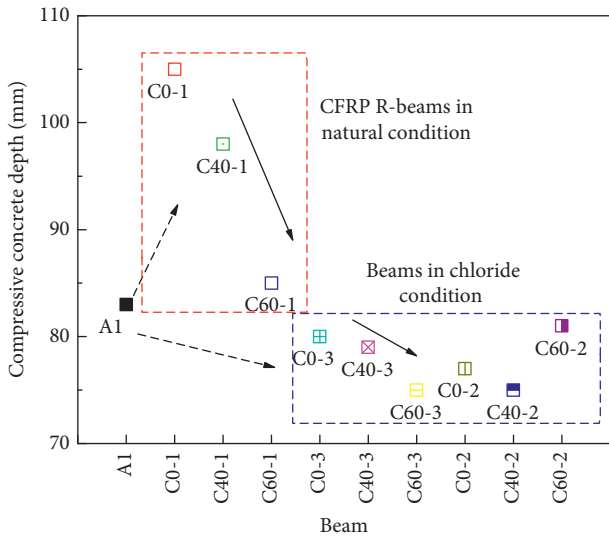
FIGURE 7: Compressive concrete depths at midspan.

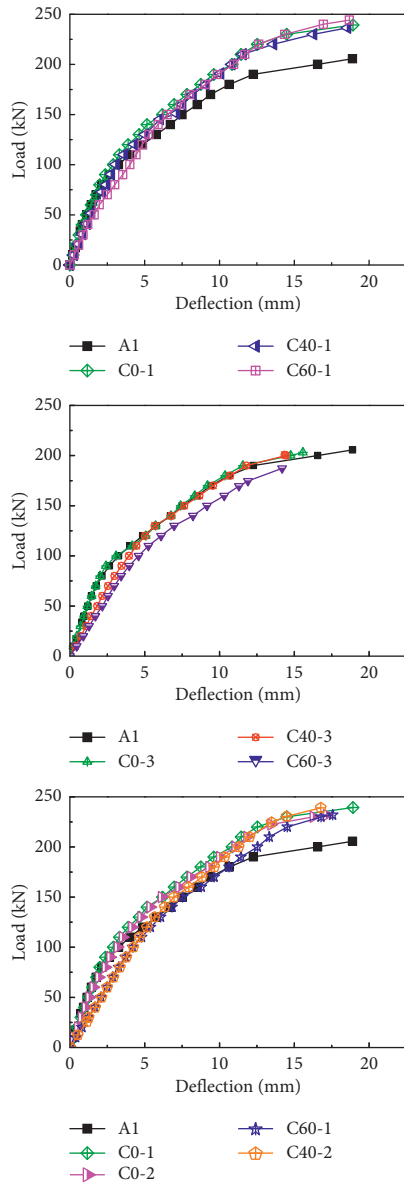
FIGURE 8: Load-deflection curves.

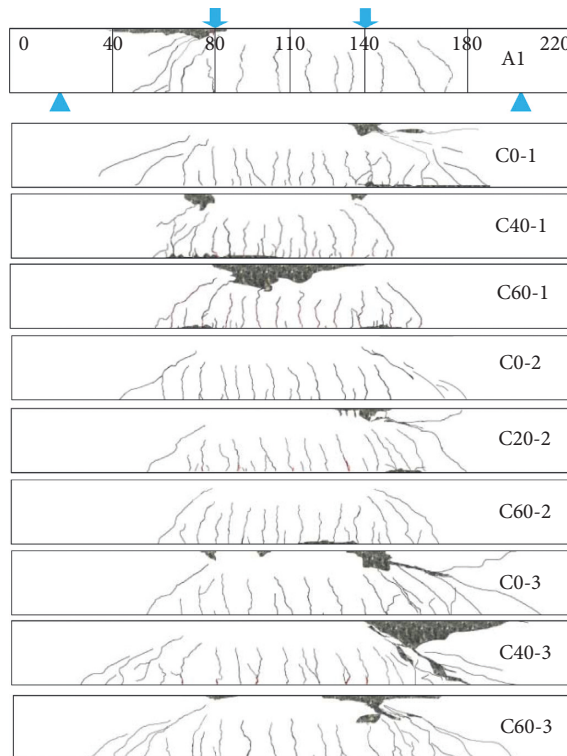
FIGURE 10: Distribution maps of cracks.

3.3.1. Crack Patterns. During the loading process, new cracks appeared firstly in the middle span and below the loading points of the test beams. The cracks in the pure bending span developed vertically upward with the increase of load steps. When the neutral axis reached to the maximum height, the cracks are no longer continued. Then the oblique cracks in the shear spans extended rapidly. The

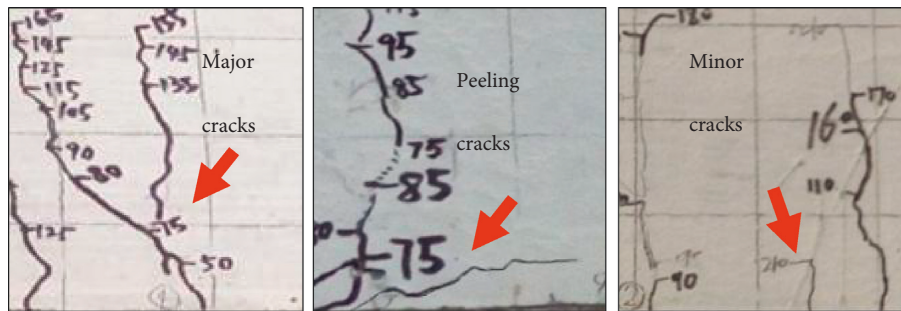
FIGURE 11: Classification of cracks.

Note. MAC, major crack; MIC, minor crack; PEC, CFRP peeling crack; CCF, concrete crush failure; CSF, concrete shear failure; CRF, CFRP rupture failure.

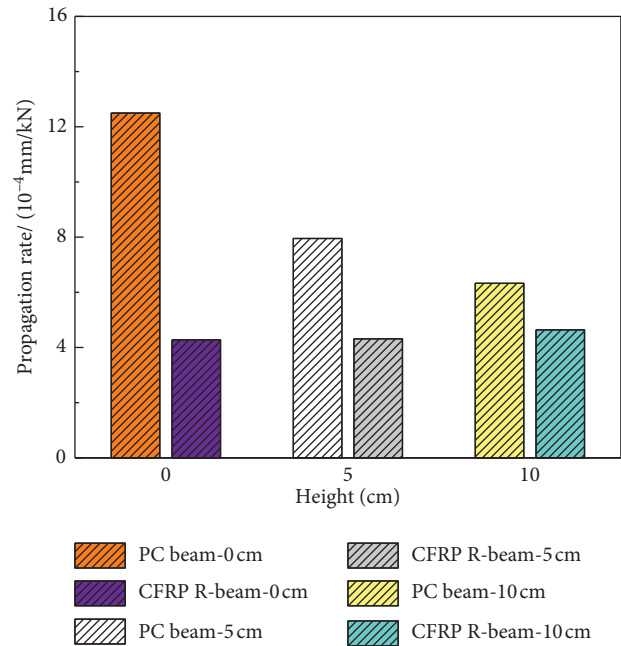
FIGURE 14: Cracking rates.

In conclusion, the average crack widths and cracking rates of the CFRP reinforced beams at the same heights are always smaller than those of the unreinforced beams, and the gaps between them increase with the load steps and decrease with the increase of crack heights. Initial damage and short-term

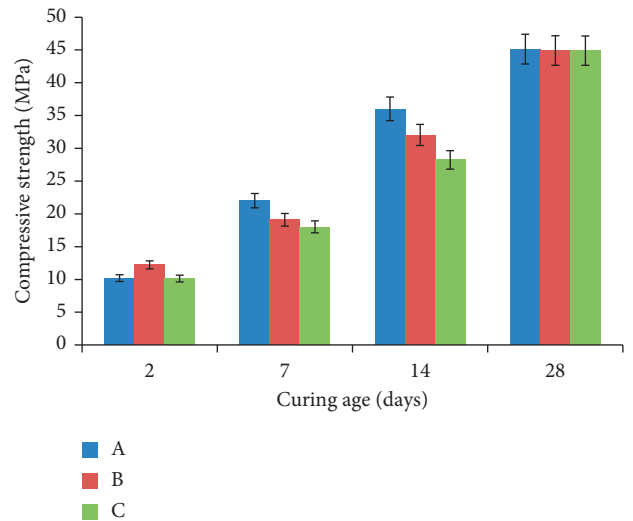
FIGURE 1: Compressive strength at 2, 7, 14, and 28 days for all brands of OPC at w/c 0.5.

From Figures 1–4, it was observed that the compressive strengths increased with curing period at all w/c ratios and for all the test cements. The increase in the compressive strength with curing days was significant. The increase in the compressive strength was significant for all w/c ratios. Hydration

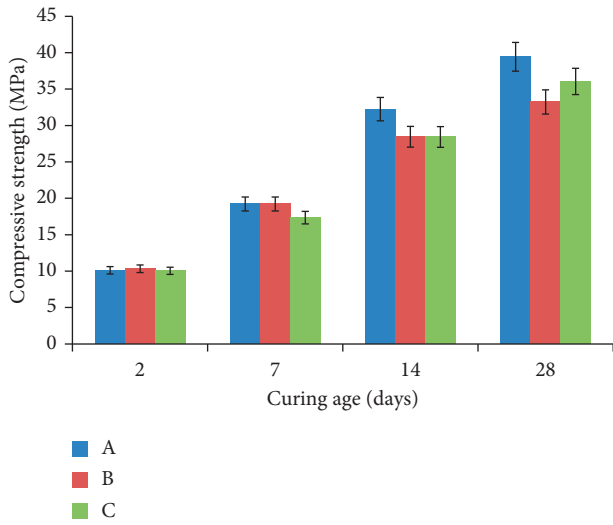
FIGURE 2: Compressive strength at 2, 7, 14, and 28 days for all brands of OPC at w/c 0.6.

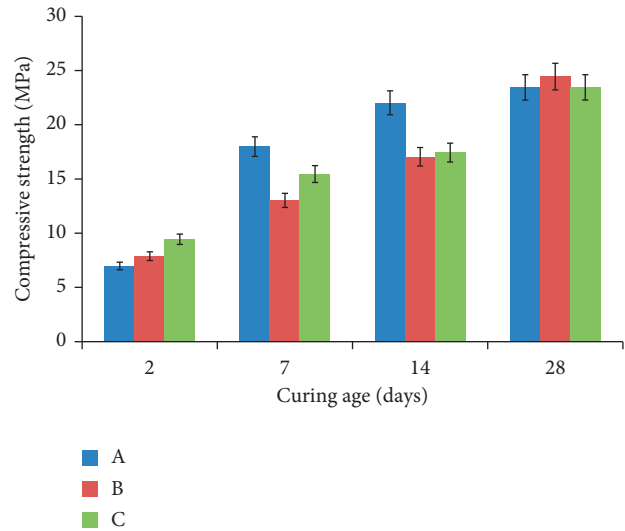
FIGURE 4: Compressive strength of all brands of OPC at w/c 0.7.

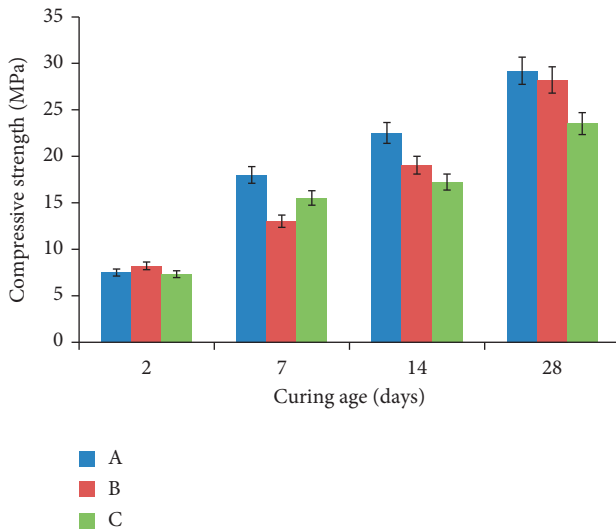
FIGURE 3: Compressive strength at 2, 7, 14, and 28 days for all brands of OPC at w/c 0.65.

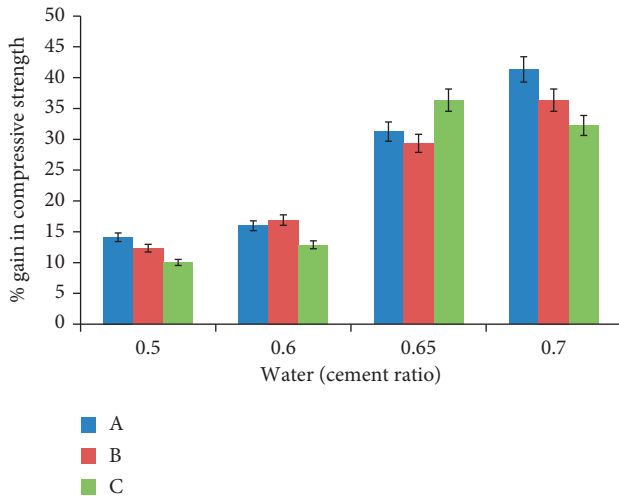
FIGURE 5: Percent gain in compressive strength after exposure to SW.

There was an observed increase in the strength for all the test cements immersed in SW for all w/c ratios. It was also observed that the strength increased with w/c ratio. Chlorides are known to be accelerators of compressive strength in

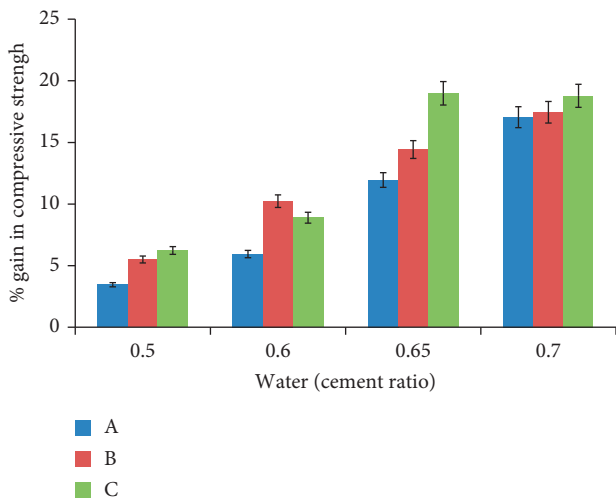
FIGURE 6: Percent loss in compressive strength after exposure of mortars to WLI.

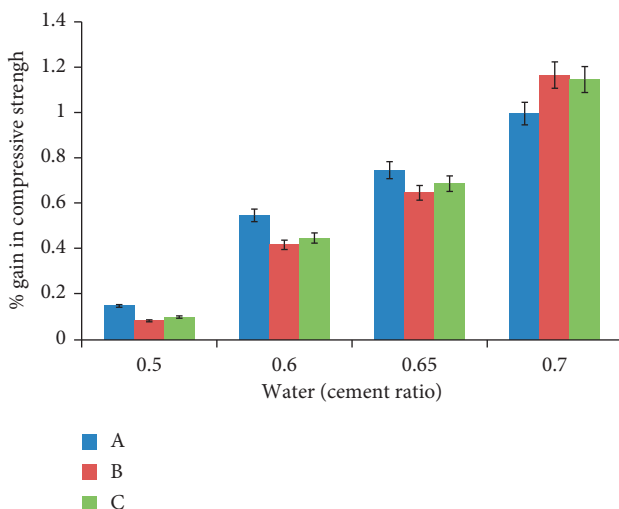
FIGURE 7: Percent gain in compressive strength after exposure of mortars to TW.

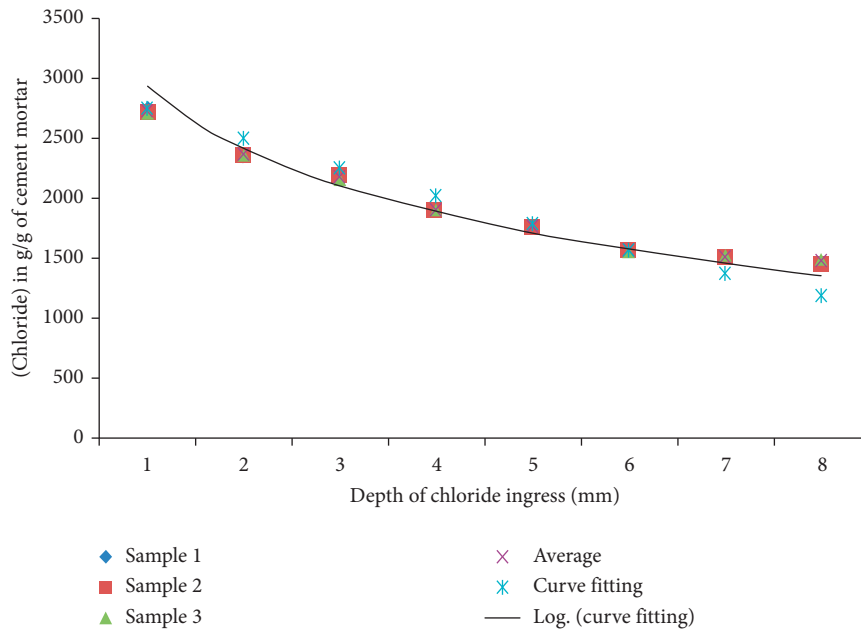
FIGURE 24: Error function fitting for (A) SW (w/c 0.7, Cl⁻), $D_{app} = 3.788 \times 10^{-10} \text{ m}^2/\text{s}$, and $R^2 = 0.9992$.
