The Role and Impact of Geofluids in Geohazards 2020

Lead Guest Editor: Ching Hung

Guest Editors: Xueyu Pang, Guan-Wei Lin, Kuo-Hsin Yang, and Ryosuke Uzuoka

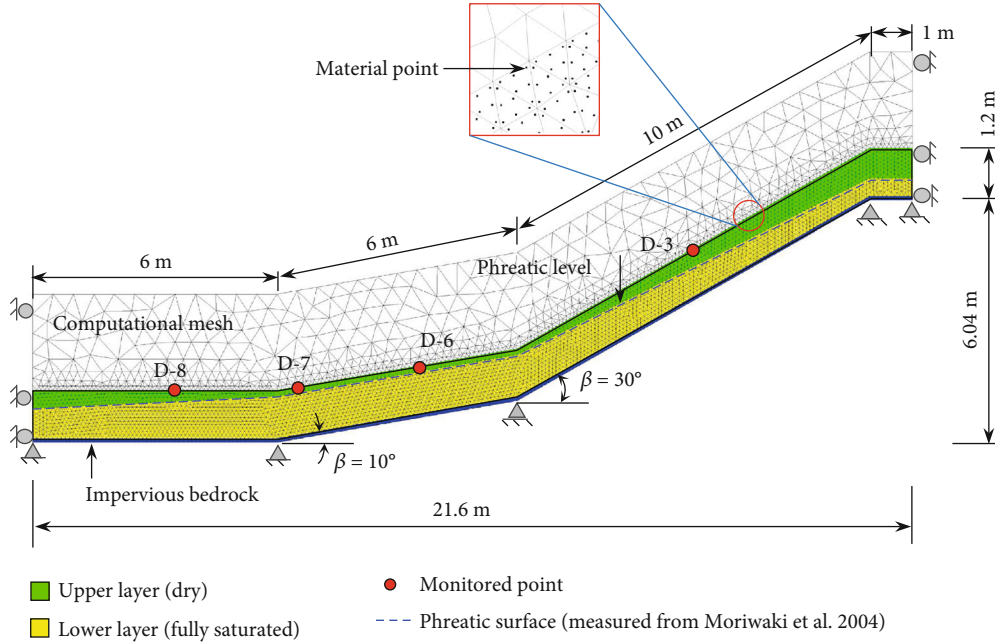
FIGURE 2: Initial geometry of the numerical model for the model validation.

2.2. Model Validation. To validate the proposed numerical model, the MPM result was compared against the results of a full-scale landslide flume test (Figure 2) conducted by Moriwaki et al. [33]. The real landslide case typically involves certain uncertainties associated with in situ conditions such as slope profile, hydrology, and subsurface ground conditions. Compared to real landslide cases, the reasons for selecting

Moriwaki et al. [33] observed the critical water table immediately before slope failure, and its modeling is presented in Figure 2. Therefore, in the initial geometry in the MPM, the slope configuration comprised two layers under the assumptions that, first, the dry material (one phase, single point) is part of the upper layer above the observed phreatic

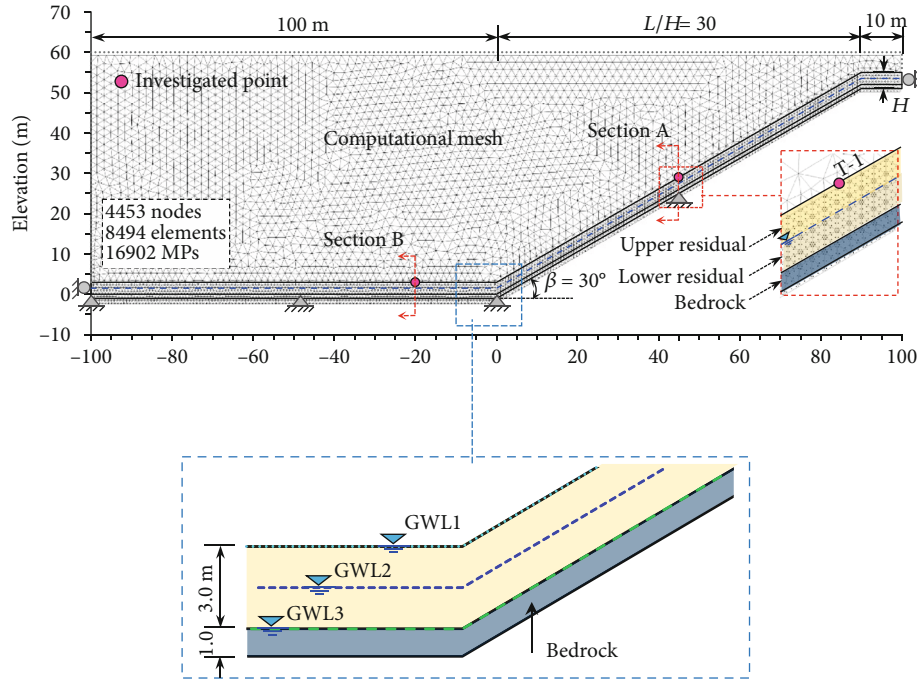
FIGURE 6: Initial geometry of the numerical model for the baseline case and parametric study (enlarged part shows three groundwater level using in the parametric study).

To highlight the kinematics of the failure, Figure 8 displays a comparison of the displacement and velocity evolutions over time at material points T-1 and T-2 on the slope surface (Sections A and B in Figure 6(a)). In the numerical simulation, the soil mass on the 30° slope moved rapidly downward at a calculated maximum velocity of 10.2 m/s. Subsequently, (1) the kinetic energy of the slope decreased over time because shearing occurred between the flowing and deposited material at the horizontal section, and (2) the slope stabilized after $t = 10$ s (i.e., when slope failure was complete). The maximum thickness of the deposited material was 6.5 m in the final deposition profile (Figure 7(h)). Notably, the movement speed of material points on the 30° slope

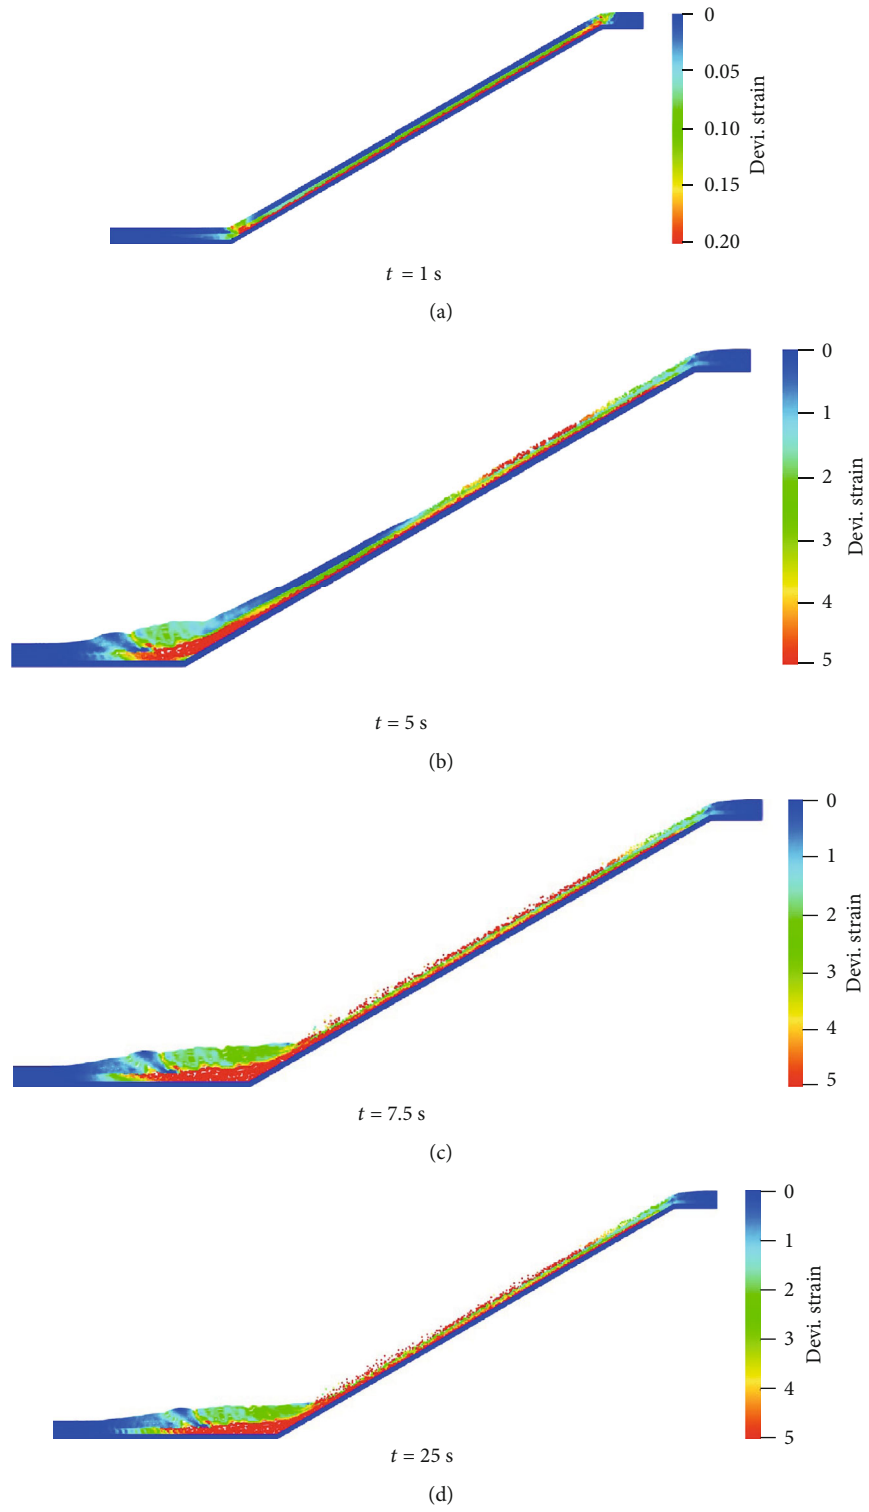
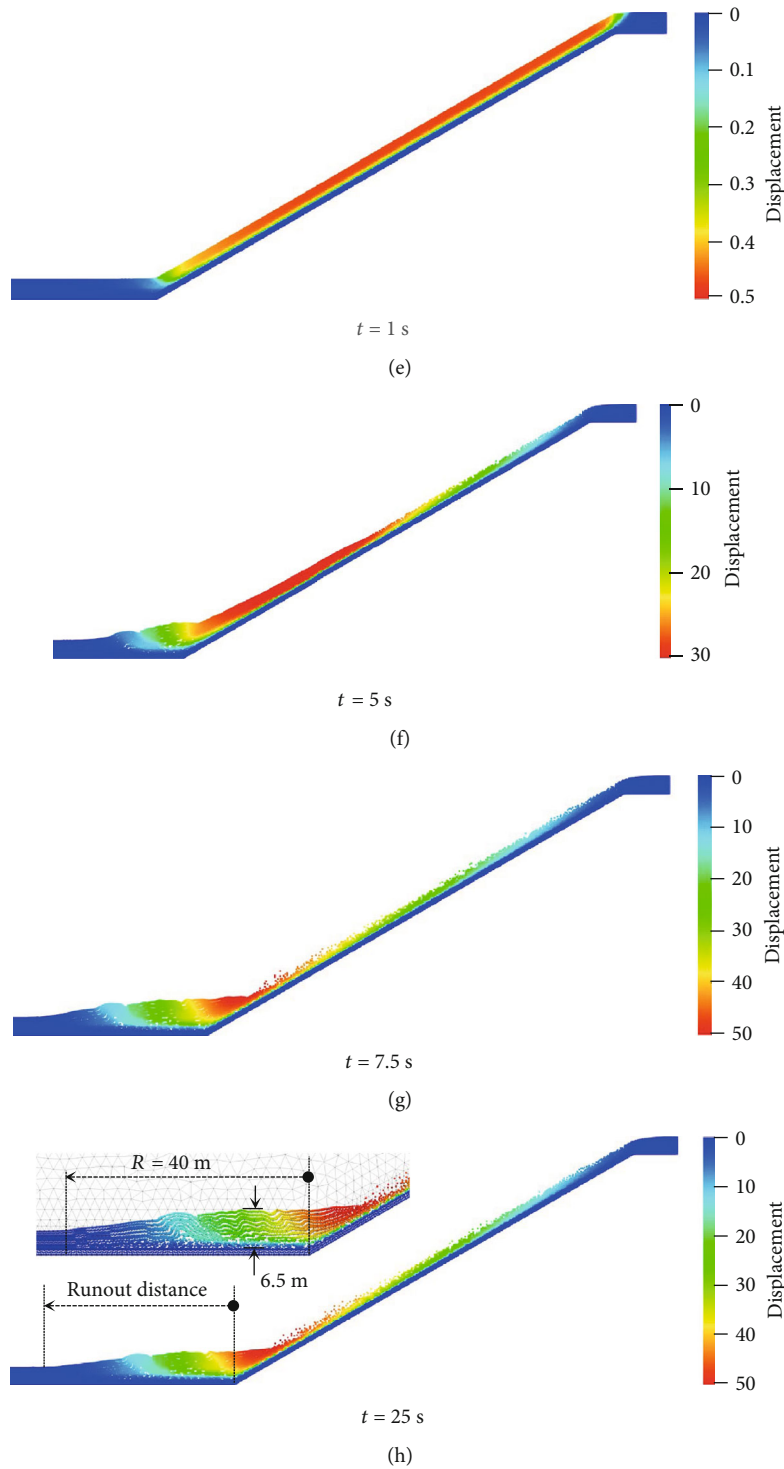
FIGURE 7: Progress of the landslide for baseline case in terms of: (a–d) deviatoric strain and (e–h) displacement contours at different times.

3.2. Baseline Case. Figure 7 presents the evolution of slope failure in the baseline case at $t = 1, 5, 7.5, 10,$ and 25 s in terms

of the deviatoric strain and displacement contours. At the start of the failure stage (Figure 7(a)), the shear strain developed evenly along the soil–bedrock interface on the slope section, and the sliding failure surface extended from the crest to the toe of the slope. The failure mode was categorized as a translational sliding failure. Over time, the landslide mass moved rapidly down the slope along the inclined surface to the toe and extended to the horizontal part of the

slope as a complex failure surface. Displacement within a new sliding failure increased in each successive stage (Figure 7(e)–7(h)). Figure 7(d) presents the slope situation at $t = 25 \text{ s}$, when the sliding failure on the slope was complete. Similar to the results observed in the model validation presented in Section 2.2, the distribution of shear strain in the horizontal part of the slope was affected by combined soil compression and shearing with the formation of multiple

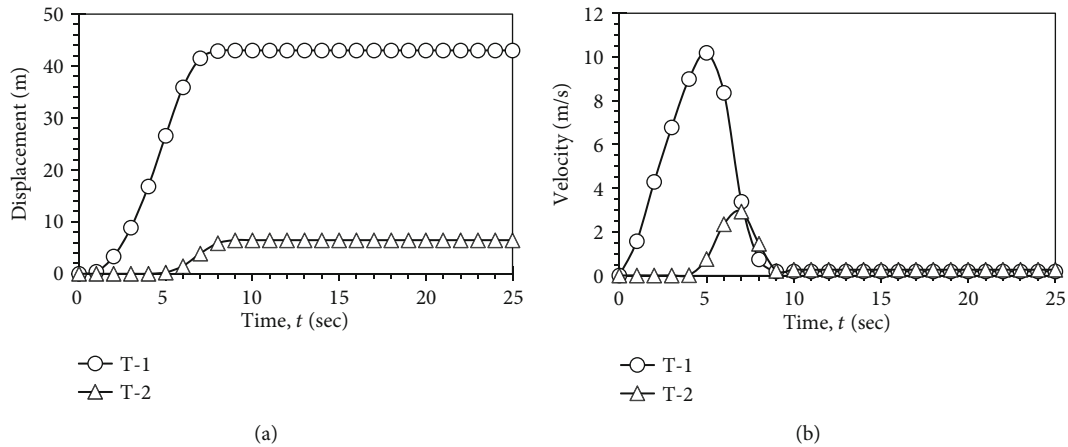
FIGURE 8: Variation of slope displacement and velocity with time: (a) displacement and (b) velocity.

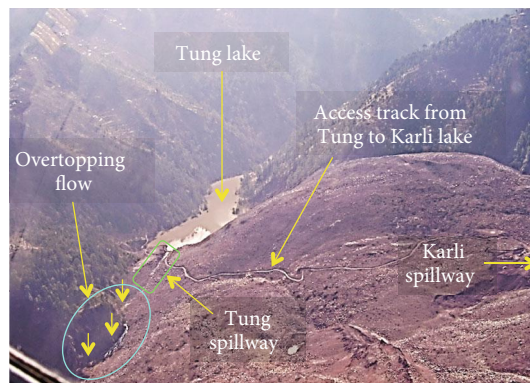
FIGURE 7: (a) Cross-section of the deepest spillway cut along the landslide dam portion blocking Tung lake; (b) photograph of Tung lake overflowing newly excavated spillway (February 12, 2006).

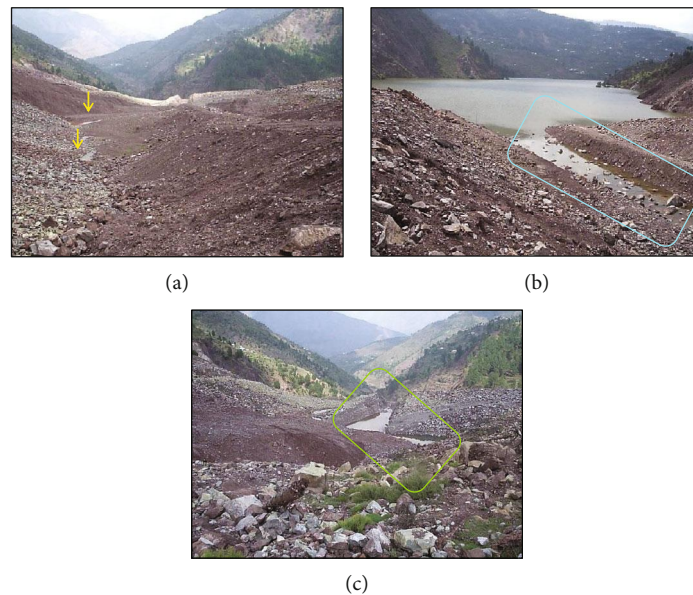
FIGURE 9: Photographs showing (a) locations of seepage points along the downstream slope of the dam (February 2007); (b) Karli lake filled to its capacity overtopping through segment 1 of Karli spillway (April 2007); (c) overtopping water from Karli lake flowing through segment 3 of Karli spillway (April 2007).

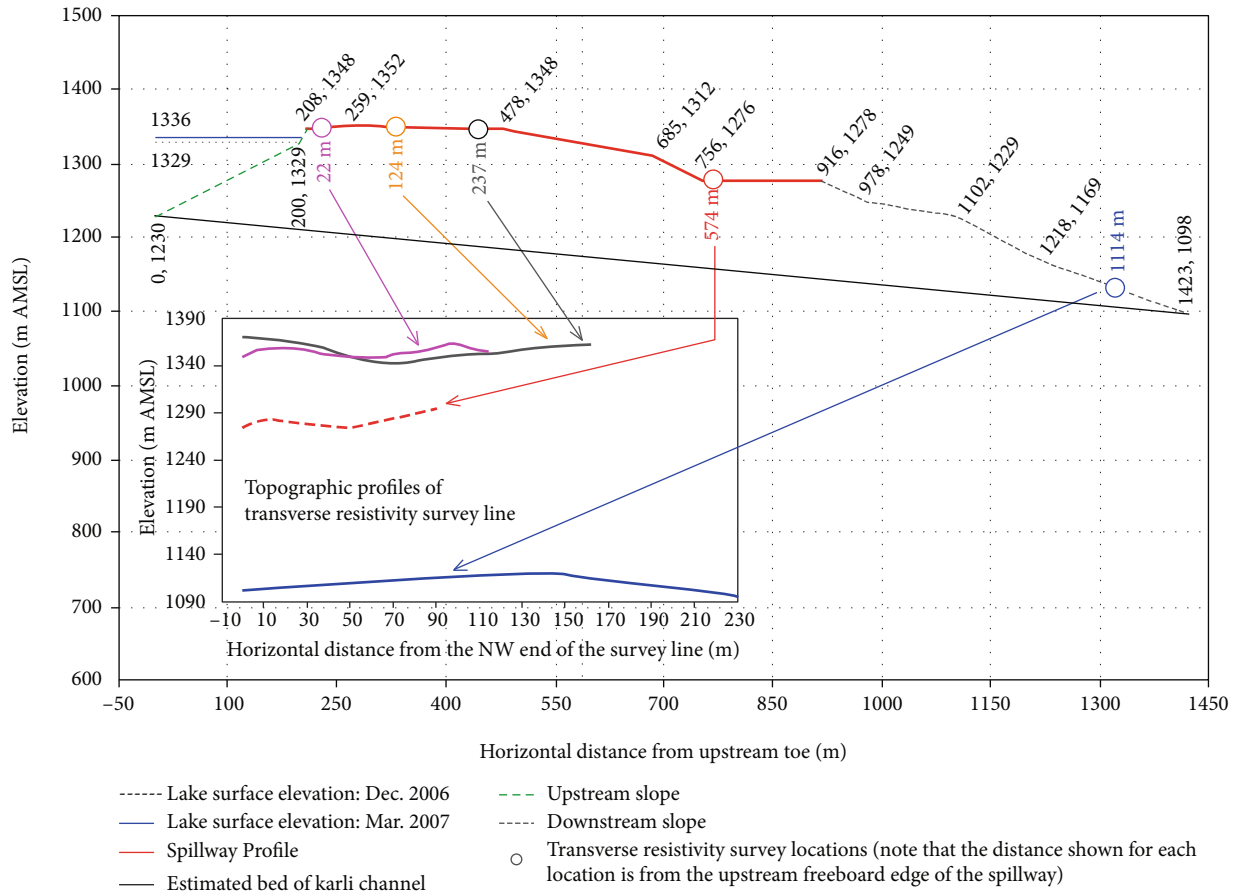
FIGURE 12: Surface topographic profiles of the lines for electrical resistivity surveys; the longitudinal survey line along the Karli spillway and the transverse resistivity locations are shown in the main graph, while the transverse survey lines at 22 m, 124 m, 237 m, 574 m, and 1114 m from the start point of the spillway are shown in the inserted graph.

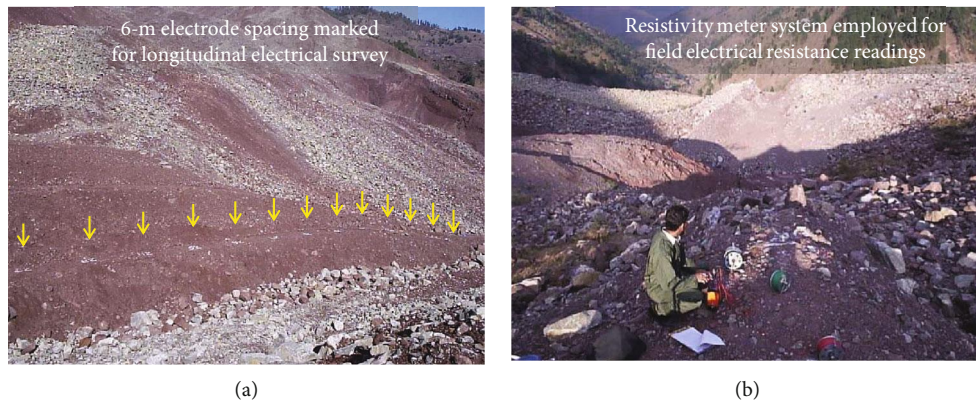
FIGURE 13: Field electrical resistivity survey in progress along the longitudinal survey line of the Karli spillway. The pictures illustrate (a) the marking of the electrode locations and (b) the resistivity system.

The surveys were performed by employing the procedure outlined in [19] and by using the Wenner (alpha) electrode array. A 4-electrode resistivity meter system was used. The test parameters are shown in Table 1. Figure 13 shows the electrode locations marked before the field survey and the electrical resistance readings being recorded at the site.

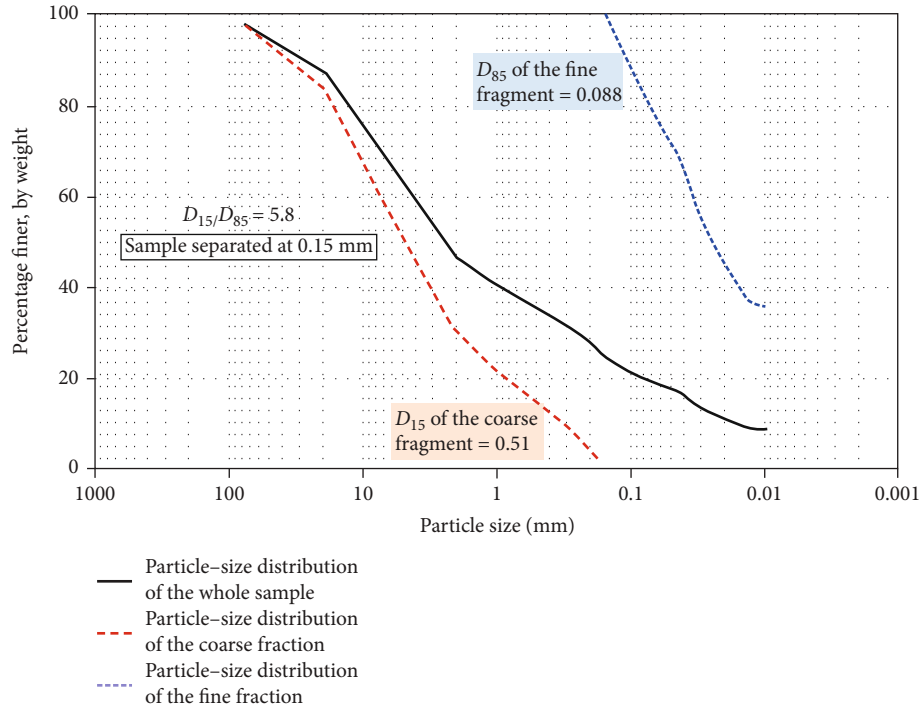
FIGURE 15: Illustration that shows the determination of D_{15}/D_{85} of matrix sample material from the Hattian Bala landslide dam from its grain size distribution separated at 0.15 mm particle size.

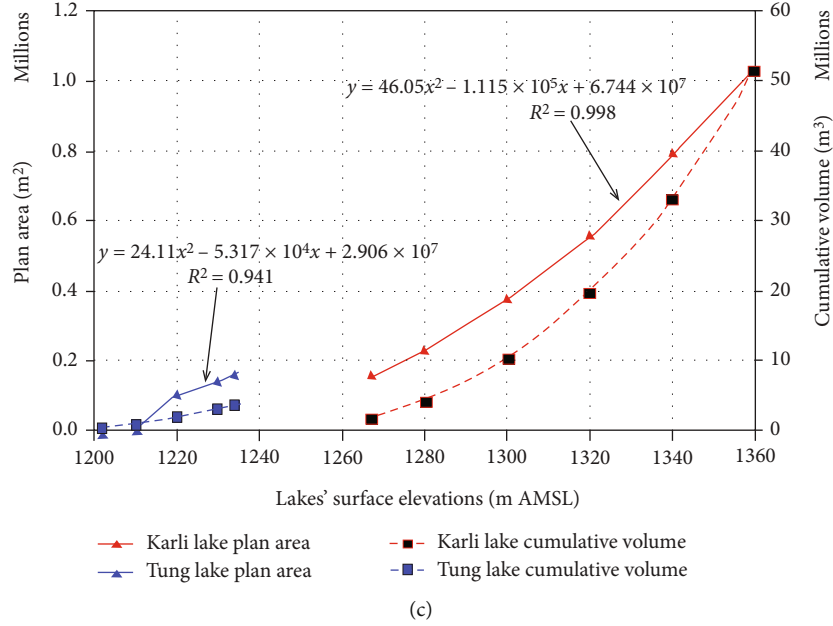
FIGURE 16: (a) Filling curves and lake periodic surface elevations for Karli and Tung lakes (significant events related to Karli lake are also shown): October 08, 2005, to March 31, 2007; (b) hydrological data including inflows of the two lakes and the downstream discharge from Hattian Bala landslide dam, daily precipitation in Hattian Bala area, and the average historical precipitation from NOAA [31]: December 26, 2005, to December 31, 2006; (c) plan area and corresponding cumulative volume vs. lake surface elevation for Karli and Tung lakes calculated from the contour maps.

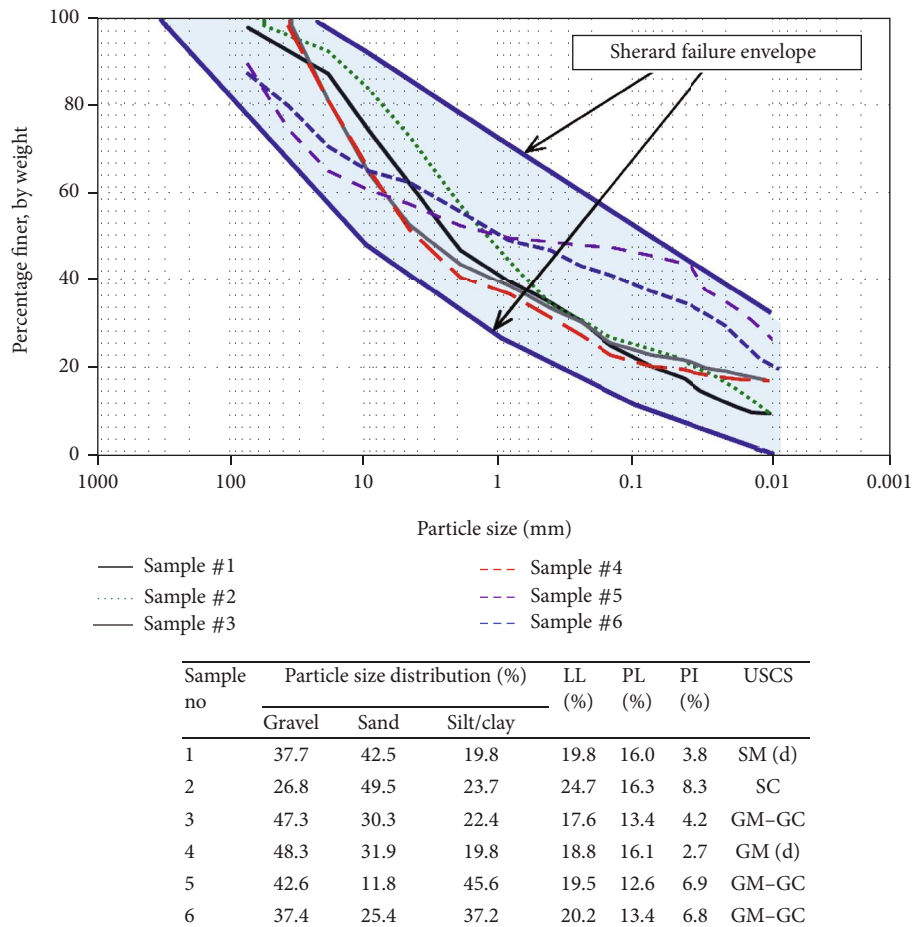
FIGURE 18: Grain size distribution curves, Atterberg limits, and the USCS classification of matrix samples from Karli spillway.

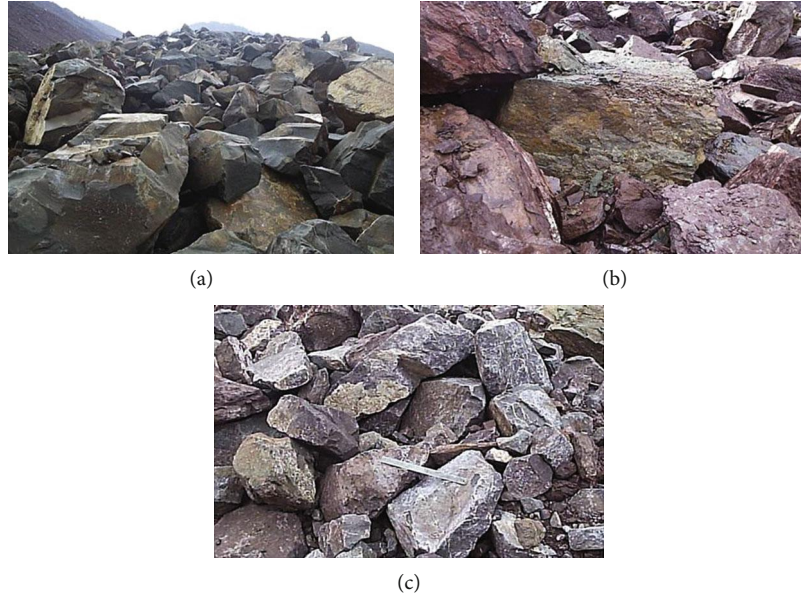
FIGURE 19: Examples of coarse materials from Hattian Bala landslide dam: (a) grey sandstone; (b) purple to reddish-brown mudstone (shale); (c) sandstone (used as a scale is a 12" stainless steel ruler).

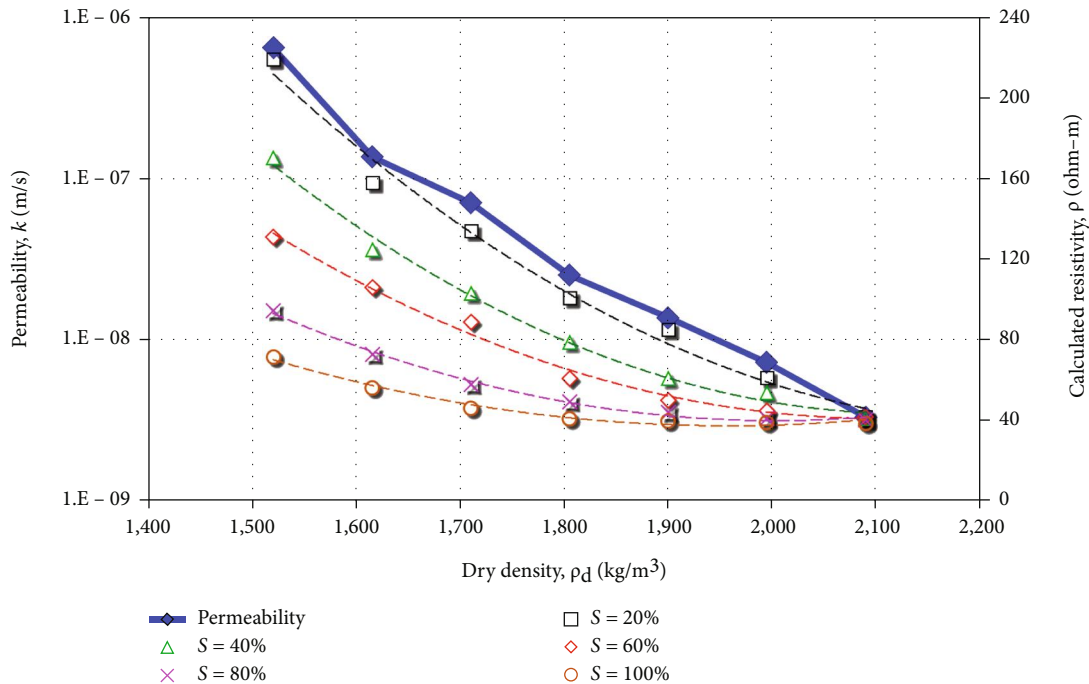
FIGURE 20: Results of laboratory tests on samples of matrix material from the Hattian Bala landslide dam, including permeability tests at different densities (plotted on a semilogarithmic scale on the primary vertical axis), and resistivity at different densities and degrees of saturation (on the arithmetic scale on the secondary vertical axes).

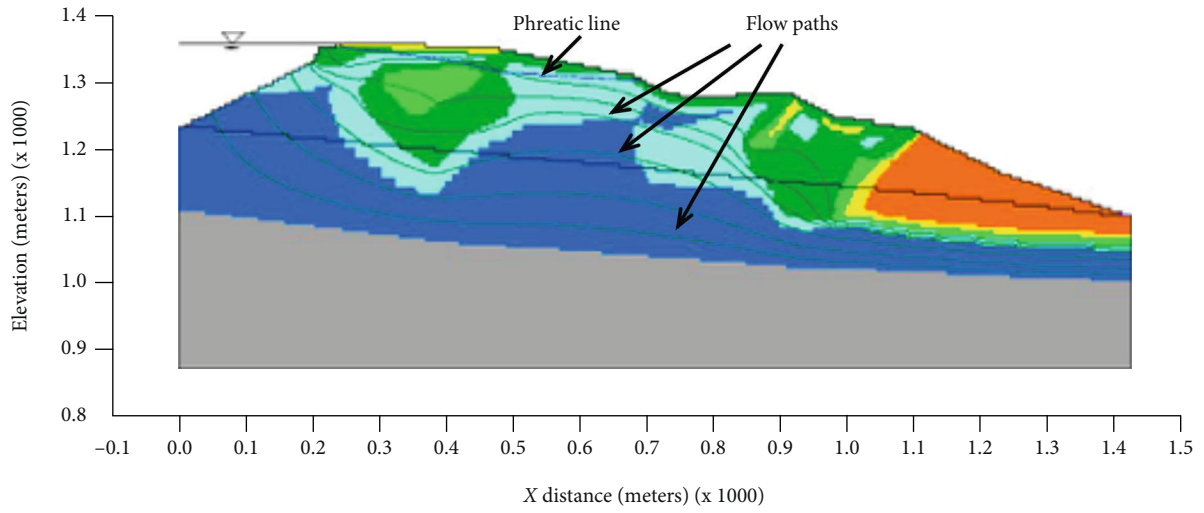
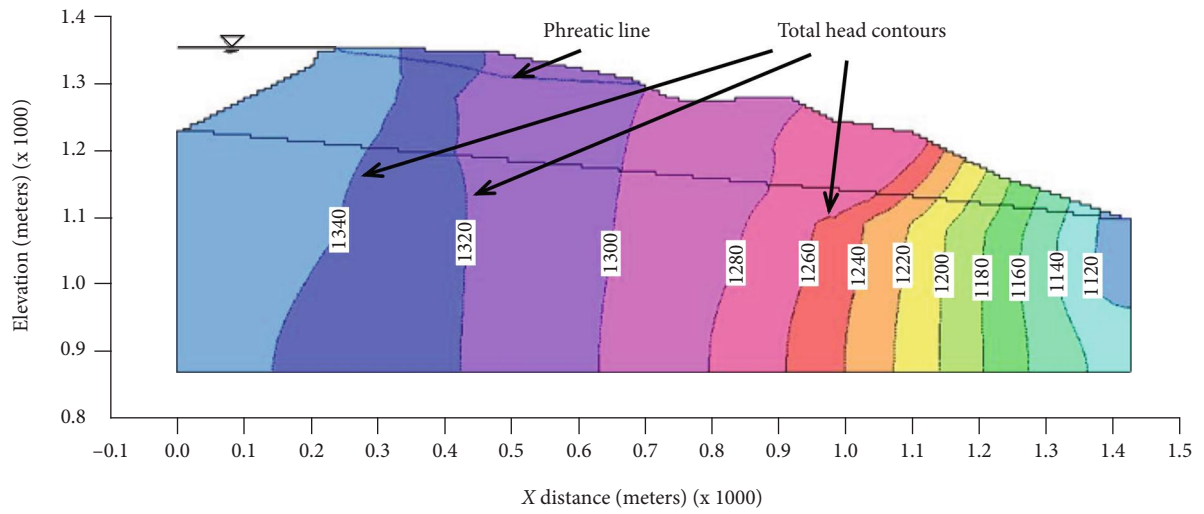
FIGURE 22: SEEP/W simulation results for Karli spillway (lake level at 1352 m AMSL): (a–c) flow paths, total head contours, and velocity vectors, respectively, for the head at the downstream toe end equal to the original channel bed, and (d) velocity vectors for zero flux at the downstream toe end.

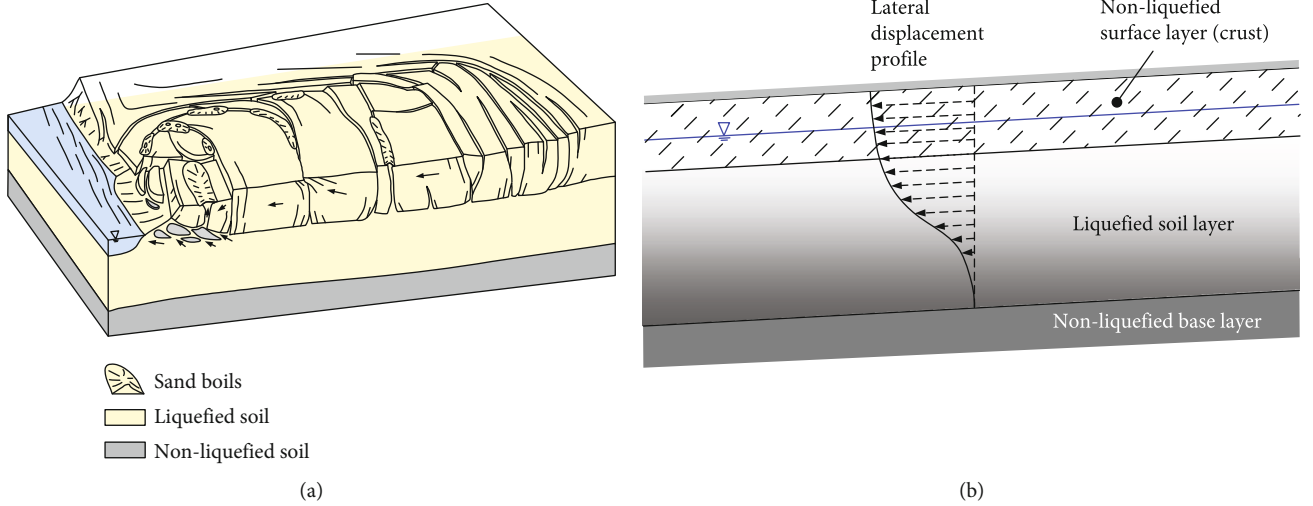
FIGURE 1: Liquefaction-induced lateral spreading. (a) Schematic depiction. (b) Lateral displacement profile. (After [5]).

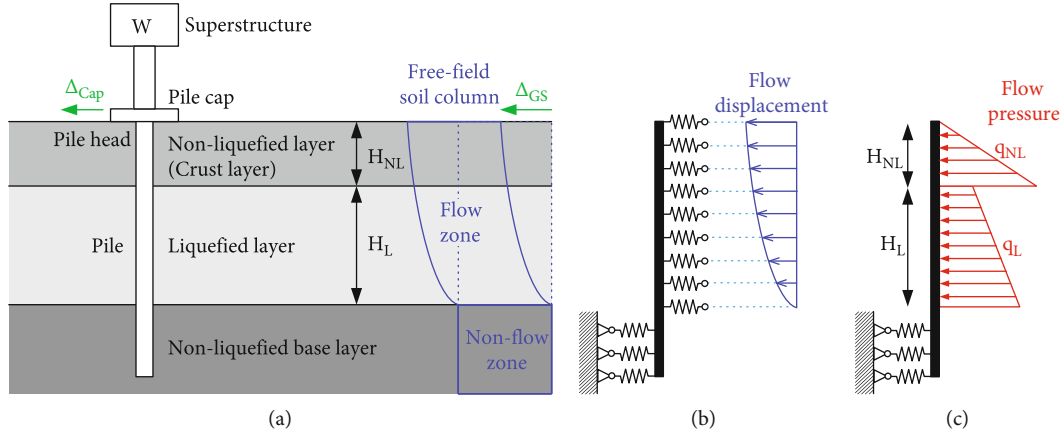
FIGURE 2: Actions of lateral spreading on pile. (a) Typical condition. (b) Modelled as flow displacement. (c) Modelled as flow pressure.

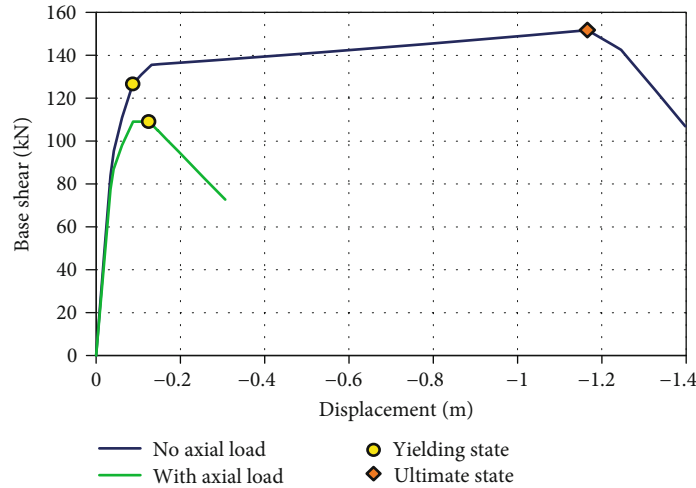
FIGURE 10: Base shear versus pile cap displacement (lateral spreading as flow pressure).

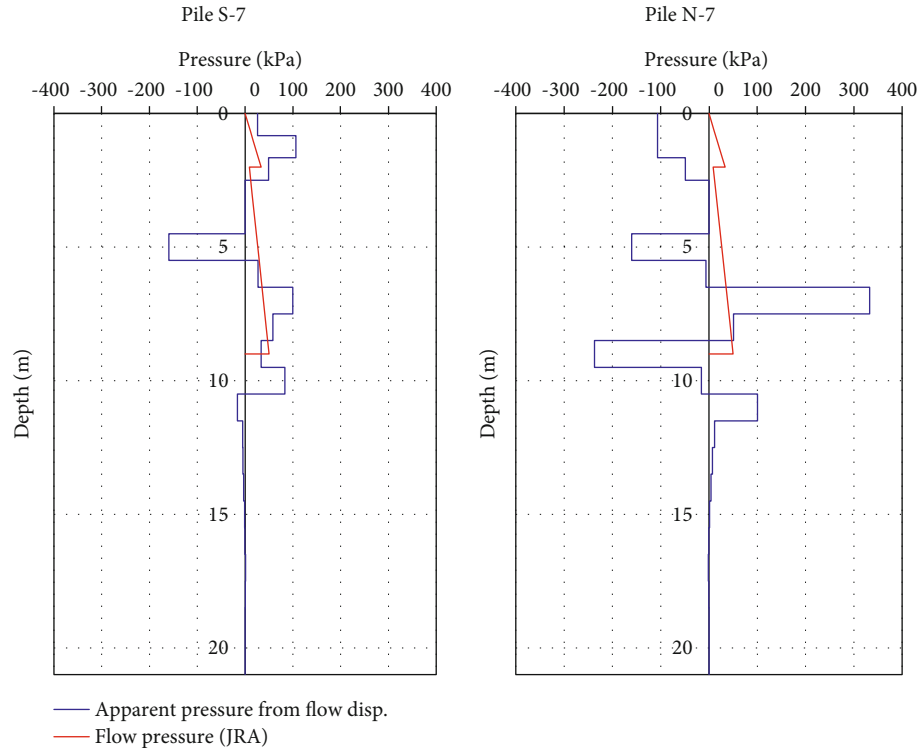
FIGURE 12: Comparison of apparent-pressure diagram from the displacement-based approach and the flow pressure used in the force-based approach.

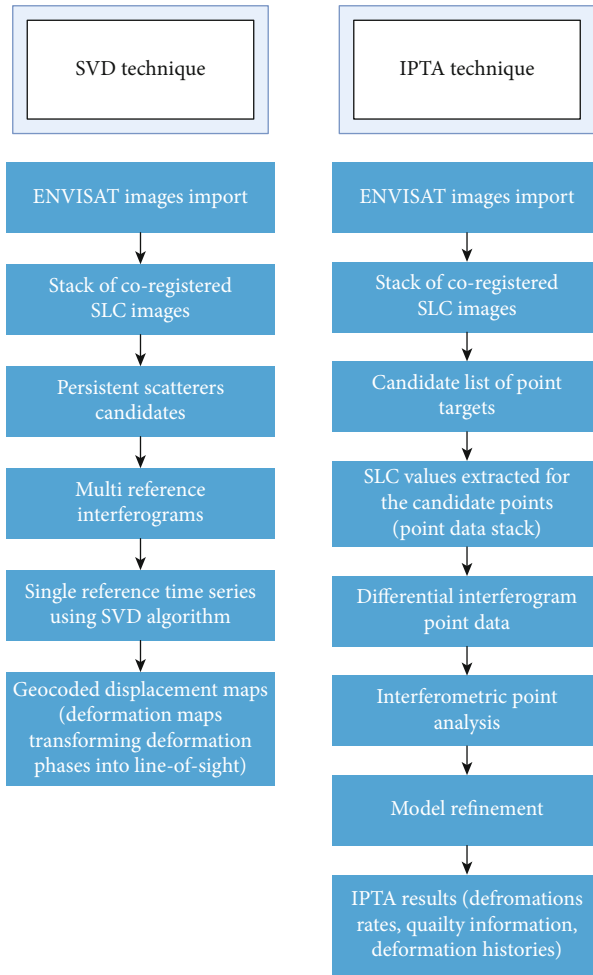
FIGURE 7: Flowcharts of the SVD and IPTA techniques.
