International Journal of Corrosion

Corrosion of Materials after Advanced Surface Processing, Joining, and Welding

Lead Guest Editor: Xizhang Chen

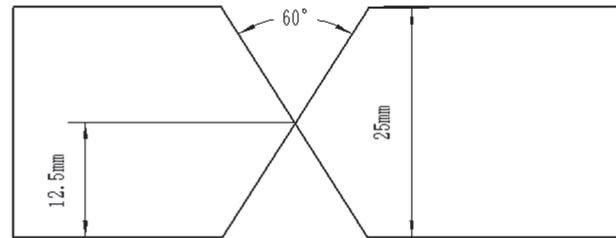
FIGURE 1: Schematic illustration of welded groove.

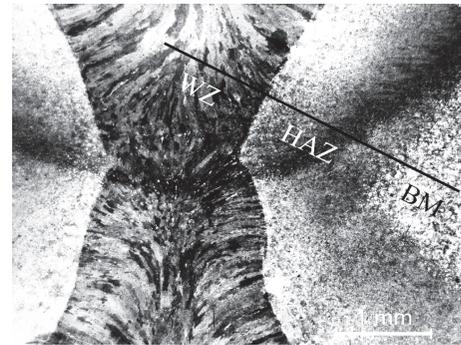
FIGURE 2: Cross section macro-images of the weld joint.

2.2.2. Microstructure Analysis. The micro-images of cross section were shown in Figure 2, which exhibited that joint had good welding quality. Microstructure samples were machined with 10 mm×10 mm×5 mm, which ensured that the specimen contained base metal (BM), heat affected zone (HAZ), and weld zone (WZ). Prior to microstructure testing, the sample was polished sequentially with the number of 120, 240, 400, 600, 800, and 1000 emery papers and then polished to the mirror with 1.5 mm diamond paste. After drying, the specimen was etched by a mixture of 4% nitric acid and ethanol (weight fraction). The sample was dried with air compressor; microstructure of the sample was observed with metalloscope.

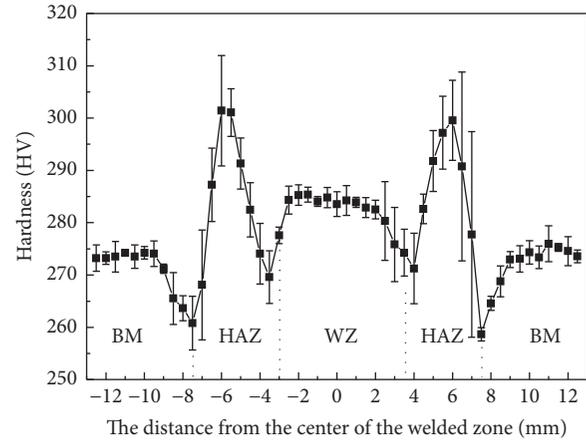
FIGURE 3: The distribution of the hardness in the welded joint.

The hardness of the HAZ in Figure 3 rises relatively fast, where the troostite has a high hardness (about 310 ~ 332 HV). Simultaneously, the decrease of troostite near the WZ leads to

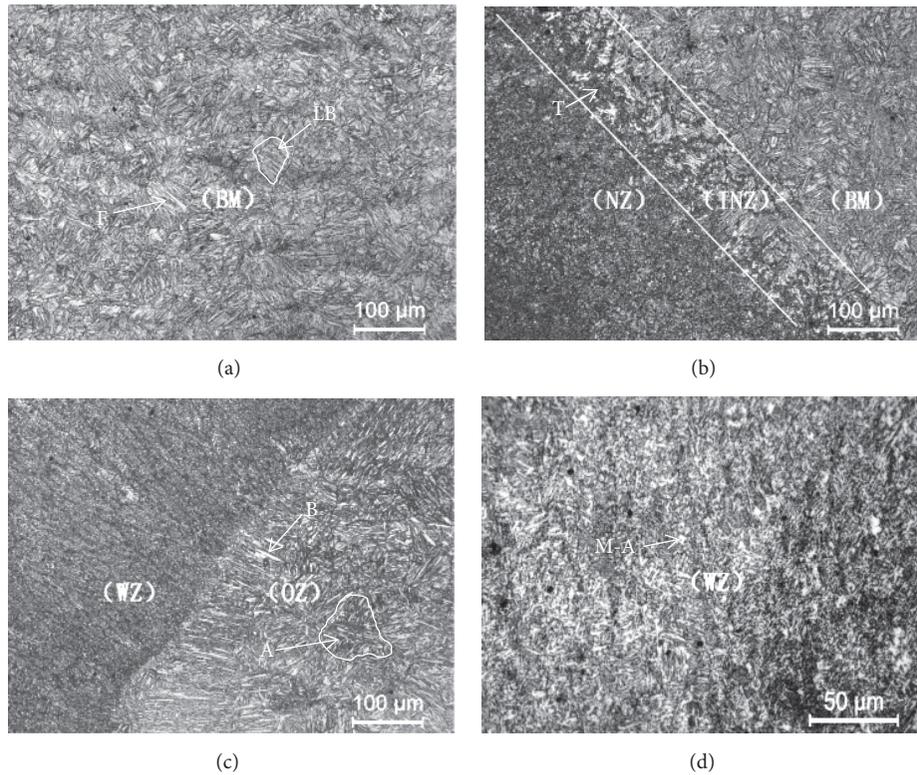
FIGURE 4: The microstructure of BM, INZ, NZ, OZ, and WZ.

Figure 4(b) shows optical micrographs of the cross section of the different welding regions (incomplete normalized zone (INZ) and NZ) of the welded joint. It can be shown that the troostite (black substance) is precipitated out of the coarse bainite in HAZ, and it gradually diffuses into the BM. It obviously detects the diffusion process of the troostite in

INZ, while NZ is completely covered by the troostite (T). This means that this zone has high mechanical properties (hardness and strength).

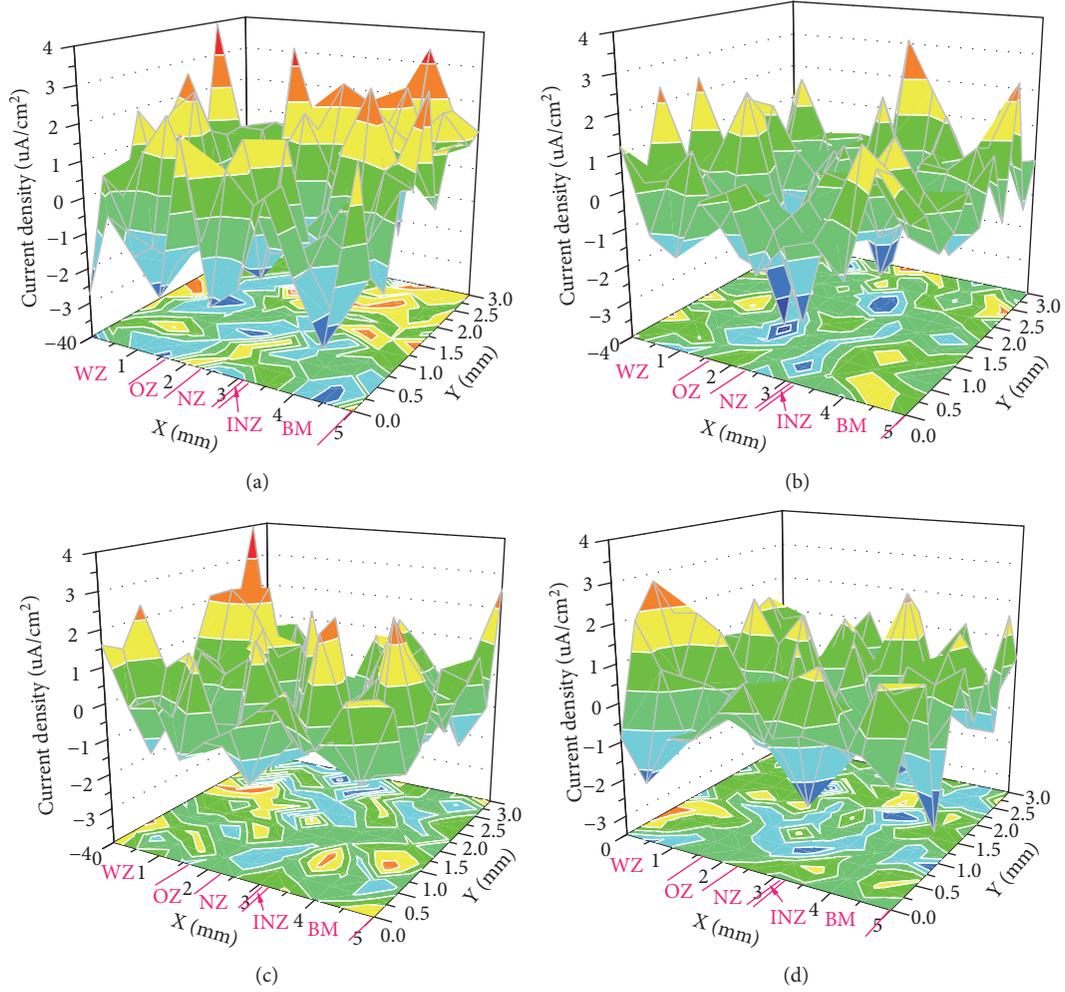
FIGURE 5: SVET current density maps of (a) 0 h, (b) 2 h, (c) 4 h, and (d) 6 h.

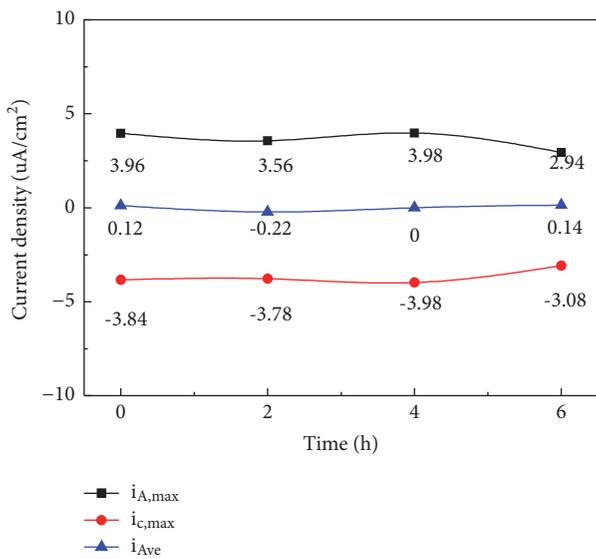
FIGURE 6: The current peak of anodic ($i_{A,max}$), cathodic ($i_{C,max}$), and the average current density (i_{Ave}) in SVET maps.

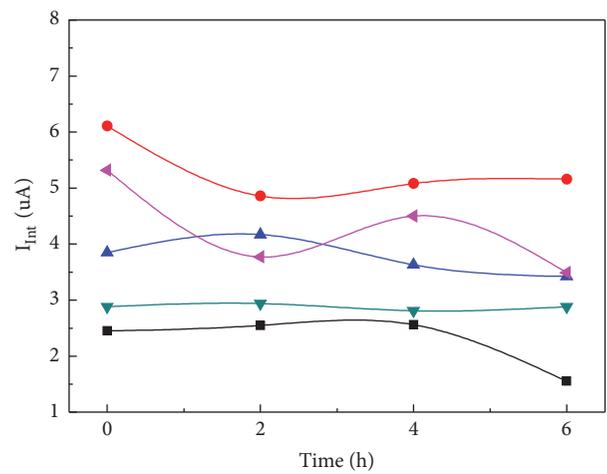
FIGURE 7: Integrated cathodic current (I_{Int}) of different microstructure.

3.6. Corrosion Behavior of Different Zone. Integrated anodic current of different microstructure is as shown in Figure 7. It shows that the integrated anodic current (I_{Int}) of OZ and BM is larger than that of WZ in the whole corrosion process. Combined with SVET maps, the corrosion tendency of microstructure in WZ is relatively high and the corrosion rate is low. At the same time, the degree of corrosion in WZ is lower than that of BM. As the iron dissolves, the integrated anodic current in BM and OZ decreases gradually. Moreover, the corrosion products decrease the corrosion rate of WZ and BM. Due to the coarse microstructure in HAZ, the integrated anodic current increases (0–2 h). With the oxidation of $\text{Fe}(\text{OH})_2$, the integrated anodic current of BM and OZ increases slightly (2–4 h). As the size of microstructure varies, I_{Int} in the BM decreases, while I_{Int} in OZ is relatively stable (4–6 h). Generally, the size of the integrated anodic current reflects the corrosion rate of different regions. With the formation of corrosion products, the corrosion rate of NZ gradually decreases (2–6 h). The weld zone is protected by the cathode and the degree of corrosion is little. Compared with the NZ, the corrosion resistance of the INZ is enhanced, which is due to the decrease of the amount of the troostite.

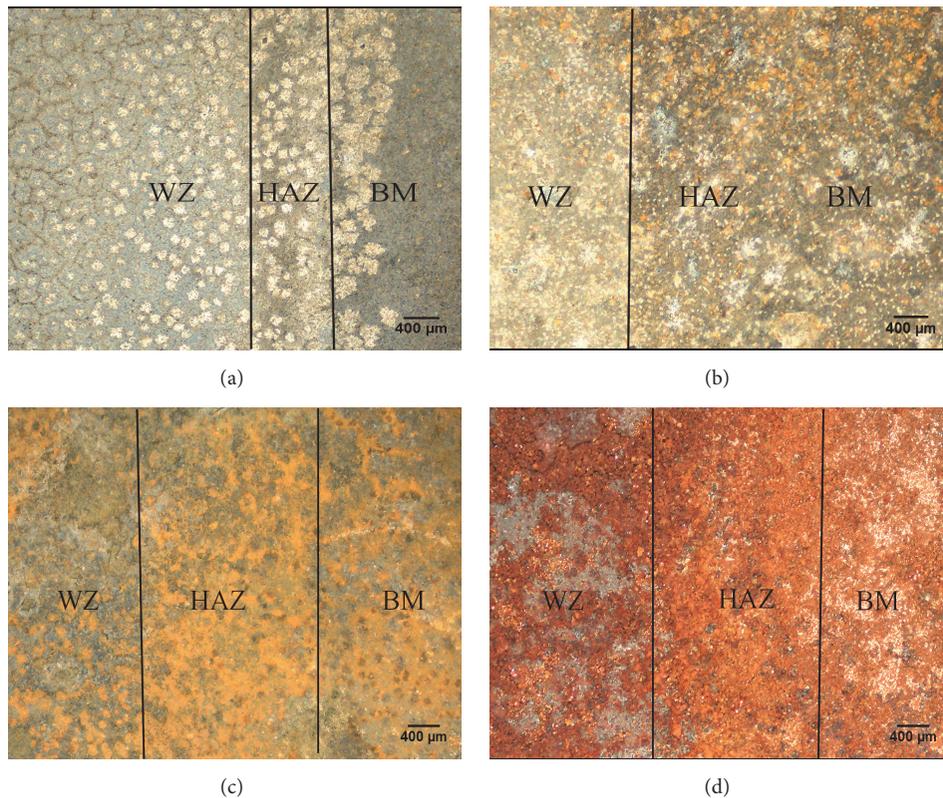
FIGURE 8: The macroscopic appearance of different corrosion time.

As Figure 8 shows, the corrosion degree of each region is not uniform at any time. The grains of granular bainite in

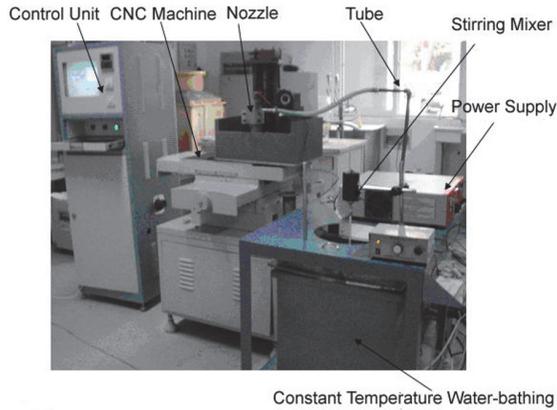
FIGURE 1: Experimental setup for nickel jet electrodeposition.

A self-developed jet electrodeposition setup (see Figure 1) was used to prepare the coating material. The setup is mainly composed of the computer control system, framework,

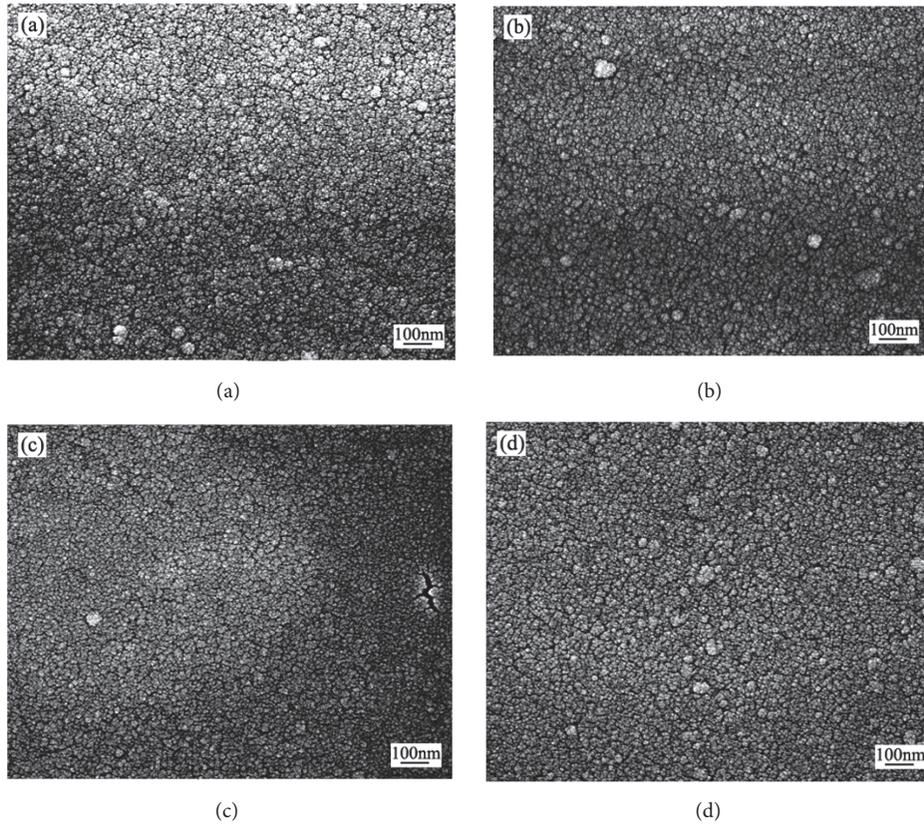
FIGURE 2: SEM micrograph under different current densities: (a) 20 A/dm²; (b)30 A/dm²; (c) 40 A/dm²; (d) 50A/dm².

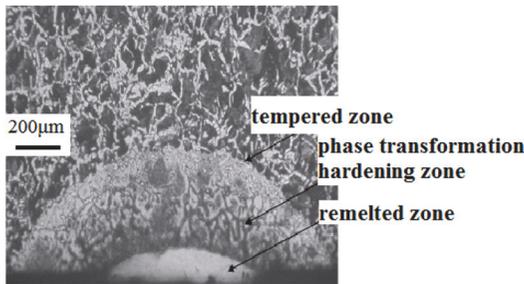
FIGURE 3: Laser melting area micrograph at view of 400 x metallographic microscope 200µm.

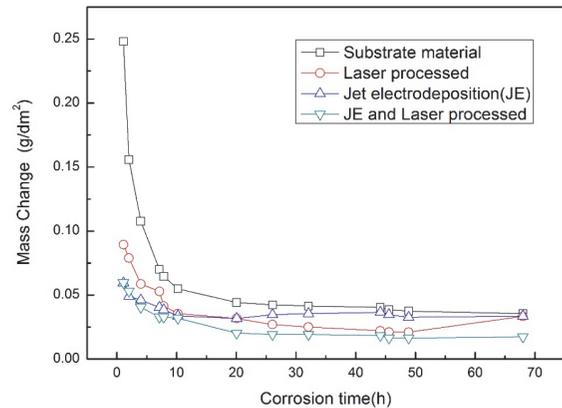
FIGURE 4: Corrosion rate versus time curve.

Figure 4 illustrates the corrosion kinetics of samples including substrate material-1Cr18Ni9, laser-processed specimens, jet electrodeposited specimens, and the specimens with jet electrodeposition and laser scanning process. As seen in the corrosion rate curve, during the first 8 h of exposure, the substrate material was in a very quick corrosion and then the corrosion rate became slow. In the first 20 h, substrate material appeared to deteriorate rapidly while the nanocomposite-coated ones seem to keep a gradually declining trend. Based on such results, it may be assumed that the nanocomposite exhibits an initial and transient corrosion stage that is different from the corrosion of 1Cr18Ni9 counterpart. At the onset of corrosion, the alloy may form a NiO scale containing many defects, such as pores and microcracks. In this case, the corrosive liquid penetrates

while those specimens only receiving the treatment of jet electrodeposition show higher corrosion rate than the ones merely processed by laser. The specimens only treated by jet electrodeposition have much higher corrosion rate after 26h, which is better only than the substrate material, unprocessed 304 stainless steel. This phenomenon might be related to the infiltration of the corrosive medium. On one hand, the laser enhancement refines the grains of electrodeposited coating. On the other hand, the corrosive medium from infiltrating is hardly to travel to the substrate material through the interface

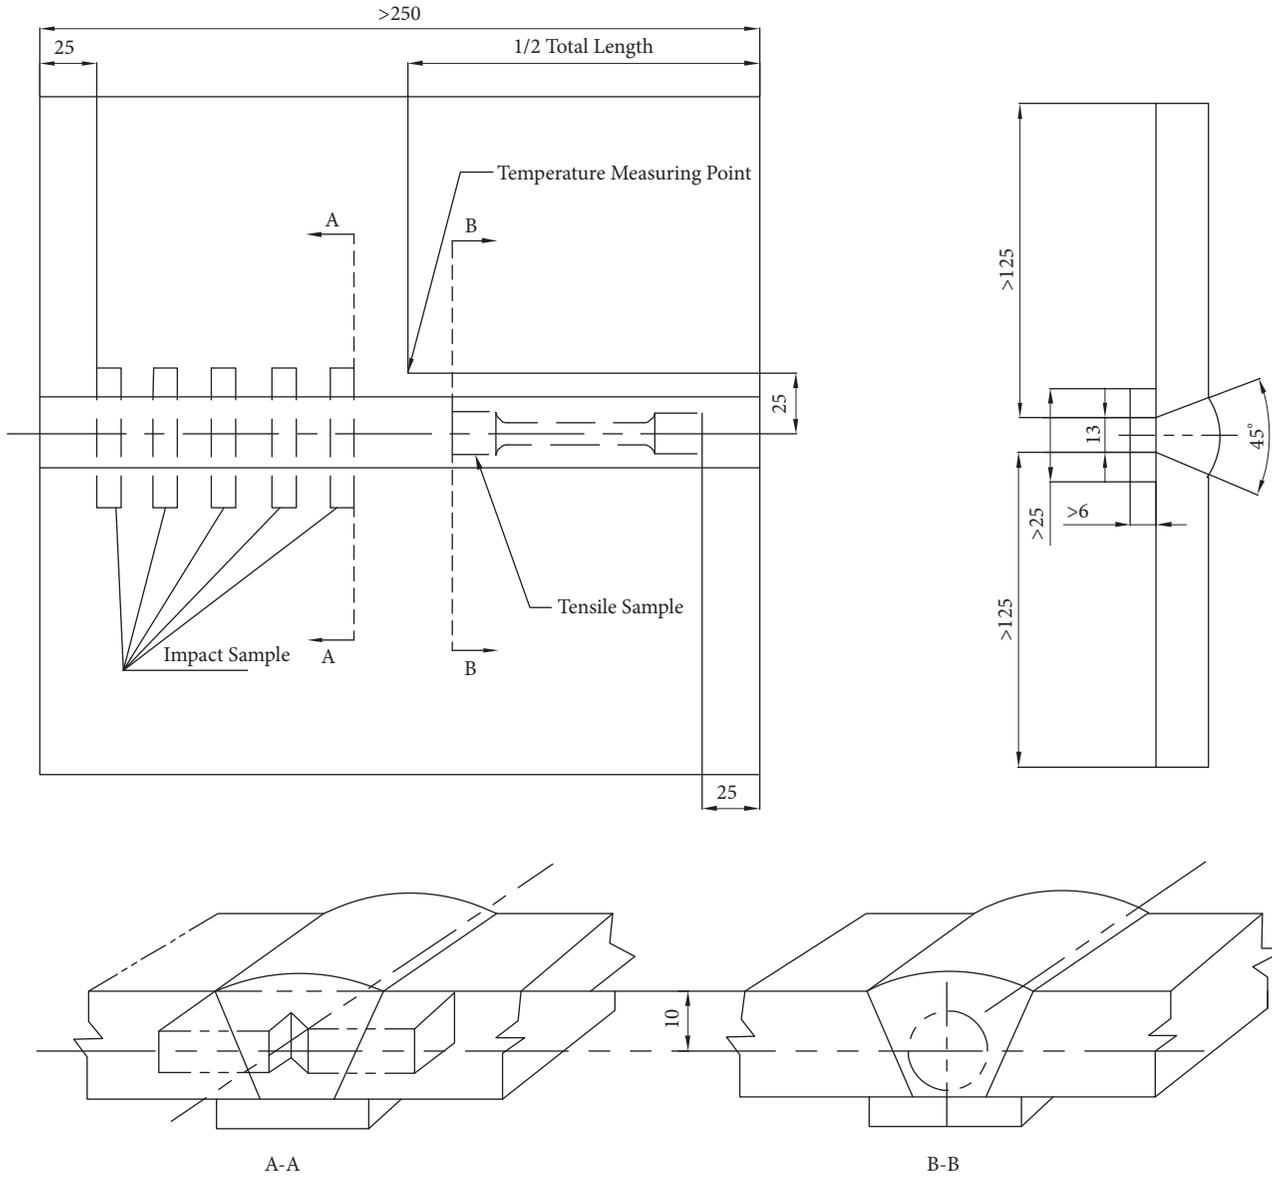
FIGURE 2: Schematic illustrating the grooves in the samples (mm).

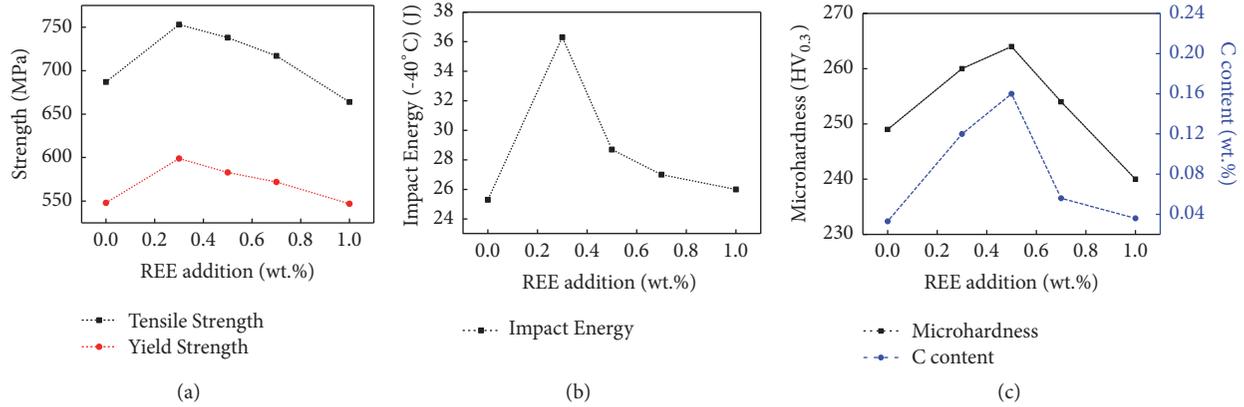
FIGURE 3: Mechanical properties of FCAW-welded metals for different REE contents: (a) tensile properties; (b) low-temperature impact toughness; and (c) microhardness.

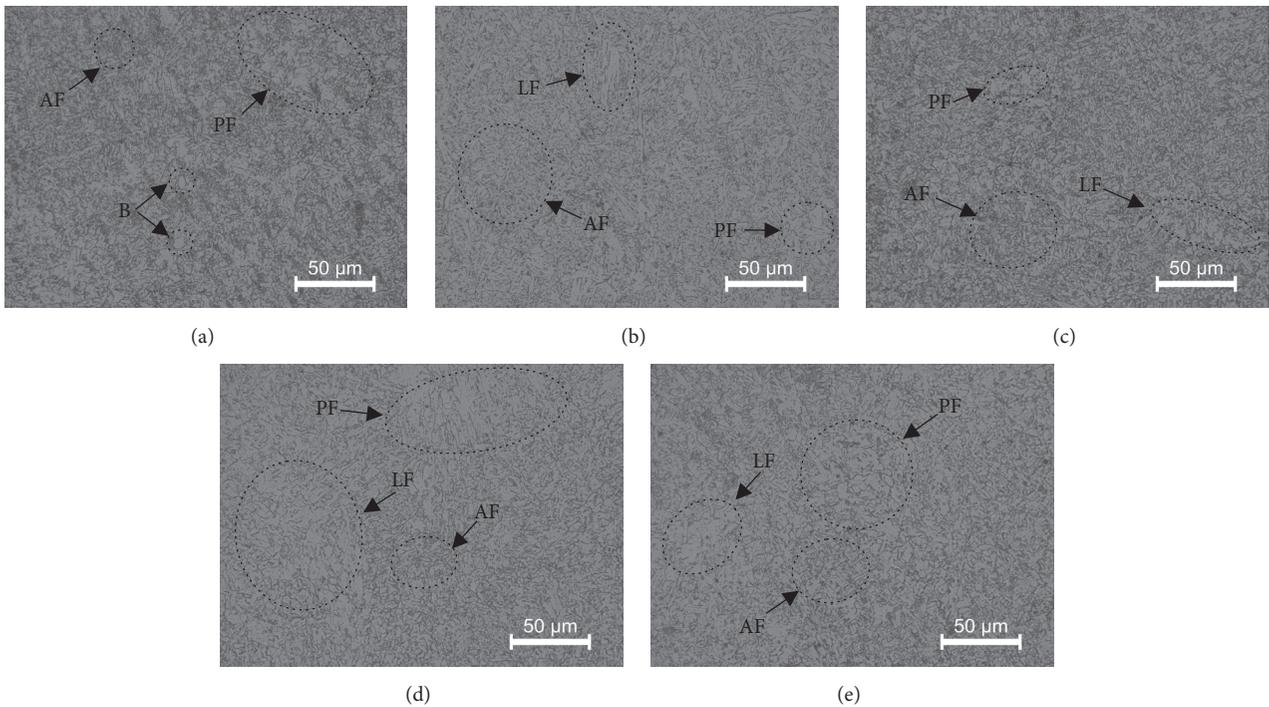
FIGURE 4: OM images of FCAW-welded metals for different REE contents:(a) REE-free, (b) 0.3 wt.%, (c) 0.5 wt.%, (d) 0.7 wt.%, and (e) 1.0 wt.%.

3.3. *Microstructural Analysis.* Figure 4 shows the optical morphologies of the FCAW-welded metals with different REE additions. It is hard to identify any prior austenite

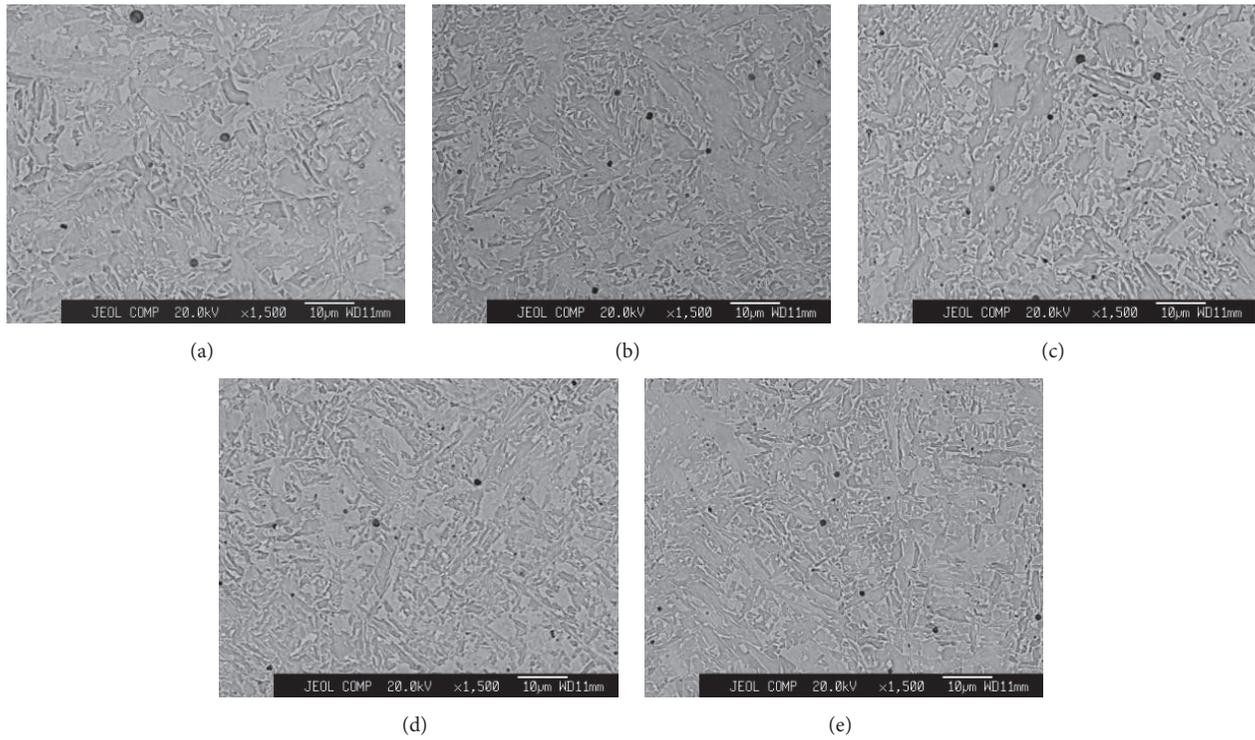
FIGURE 5: Typical SEM images of welded metals with different REE contents: (a) REE-free, (b) 0.3 wt.%, (c) 0.5 wt.%, (d) 0.7 wt.%, and (e) 1.0 wt.%.

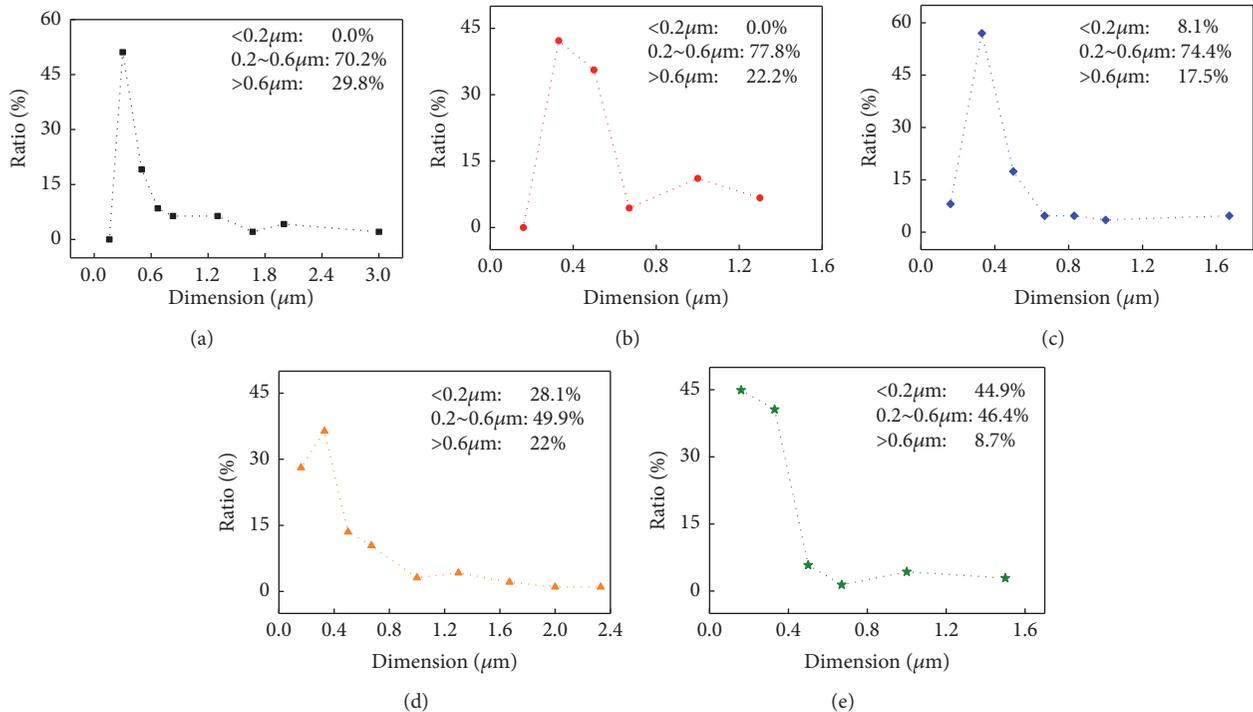
FIGURE 6: Dimension (size) and ratio of the second-phase particles in welded metals with different REE contents: (a) REE-free, (b) 0.3 wt.%, (c) 0.5 wt.%, (d) 0.7 wt.%, and (e) 1.0 wt.%.

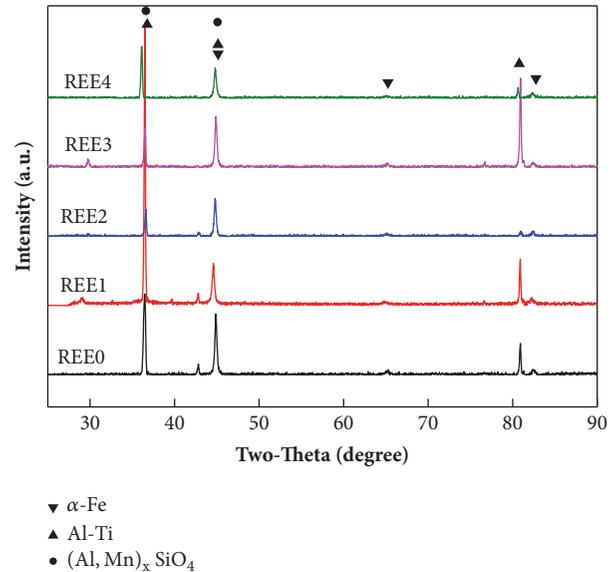
FIGURE 7: XRD analysis results of different FCAW-welded metals.

Phase compositions for each sample were determined using XRD, and the results are shown in Figure 7. The matrix consists of α -Fe (AF), and the second phase consists mainly of an Al-Ti phase and $(Al, Mn)_x SiO_4$ (Al-Mn silicate) phase. Furthermore, $(Al, Mn)_x SiO_4$ is composed of a variety of metallic or nonmetallic oxides including Al_2O_3 , MnO, and SiO_2 , which play a strong role in deoxygenation and greatly reduce oxygen in the welded metals. During the solidification process of the weld pool, the second-phase particles, which consist of Al_2O_3 , MnO, and SiO_2 , formed preferably with high surface-energy [25], where the crystal nuclei for ferrite form. In this way it can substantially reduce the potential barrier for nucleation during the phase transformation from γ to α phase. The second-phase particles in the weld metal are mostly a complex mixture of different phases. Therefore, each phase can be regarded as a high-energy region and form a nucleus for acicular ferrite. Multidimensional nucleation occurs at the end and causes acicular ferrite to overlap, which results in refined grains.

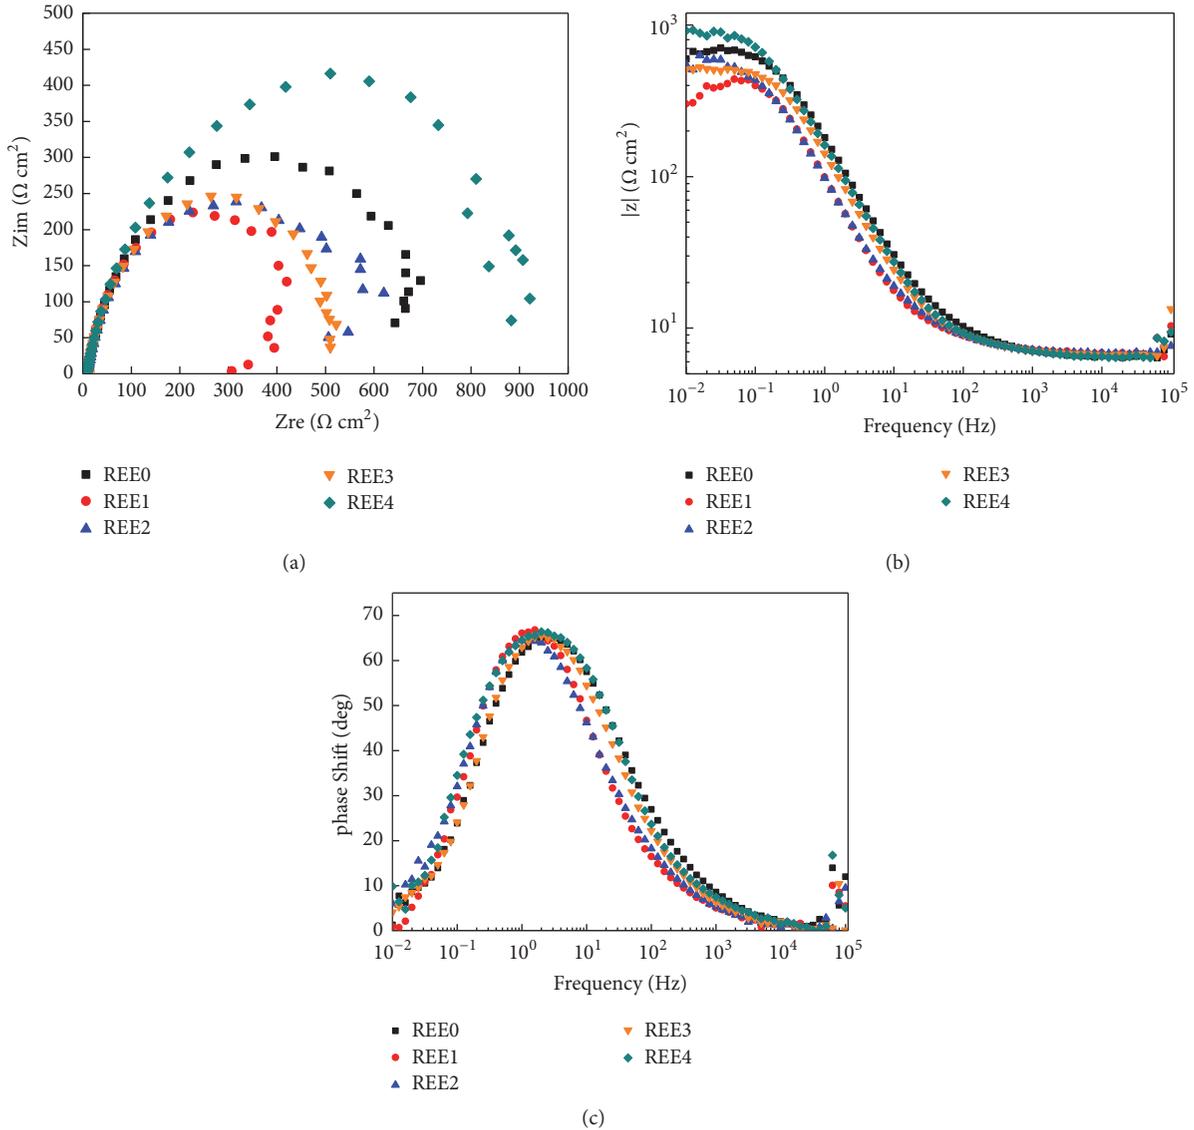
FIGURE 8: (a) Nyquist, (b) Bode, and (c) Bode-phase plots for the FCAW-welded metals with different REE contents versus OCP in a 3.5wt% NaCl solution.

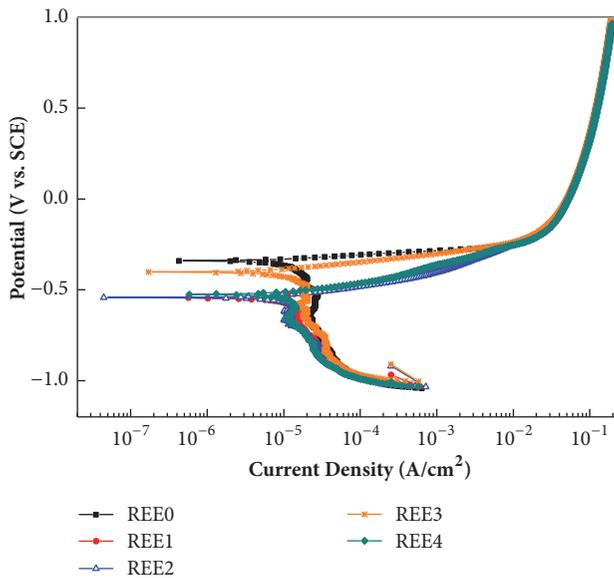
FIGURE 10: Potentiodynamic polarization curves for the welded metals with different REE contents.

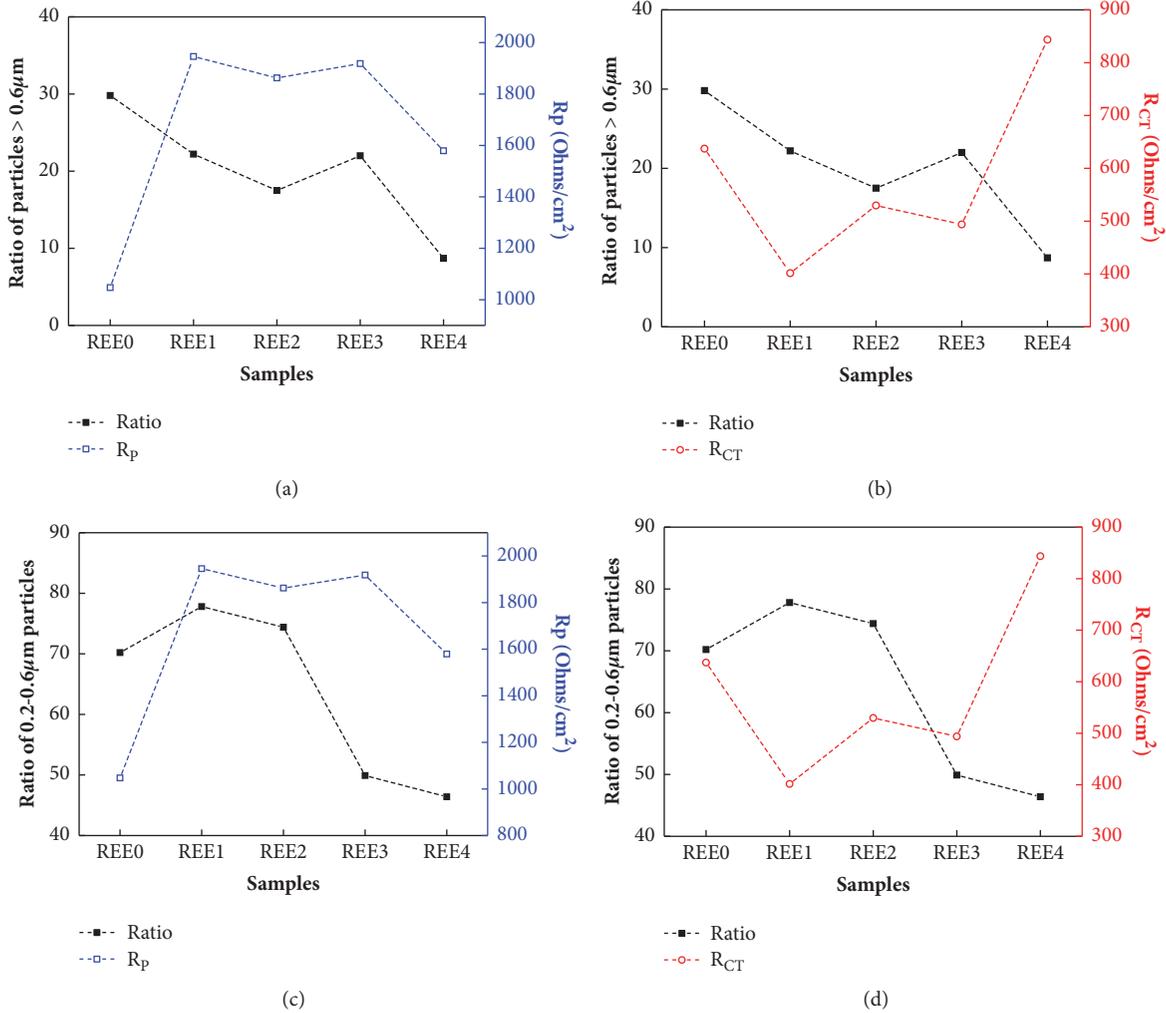
FIGURE 11: Correlation between second-phase particle sizes and the resistance in different welded metals.

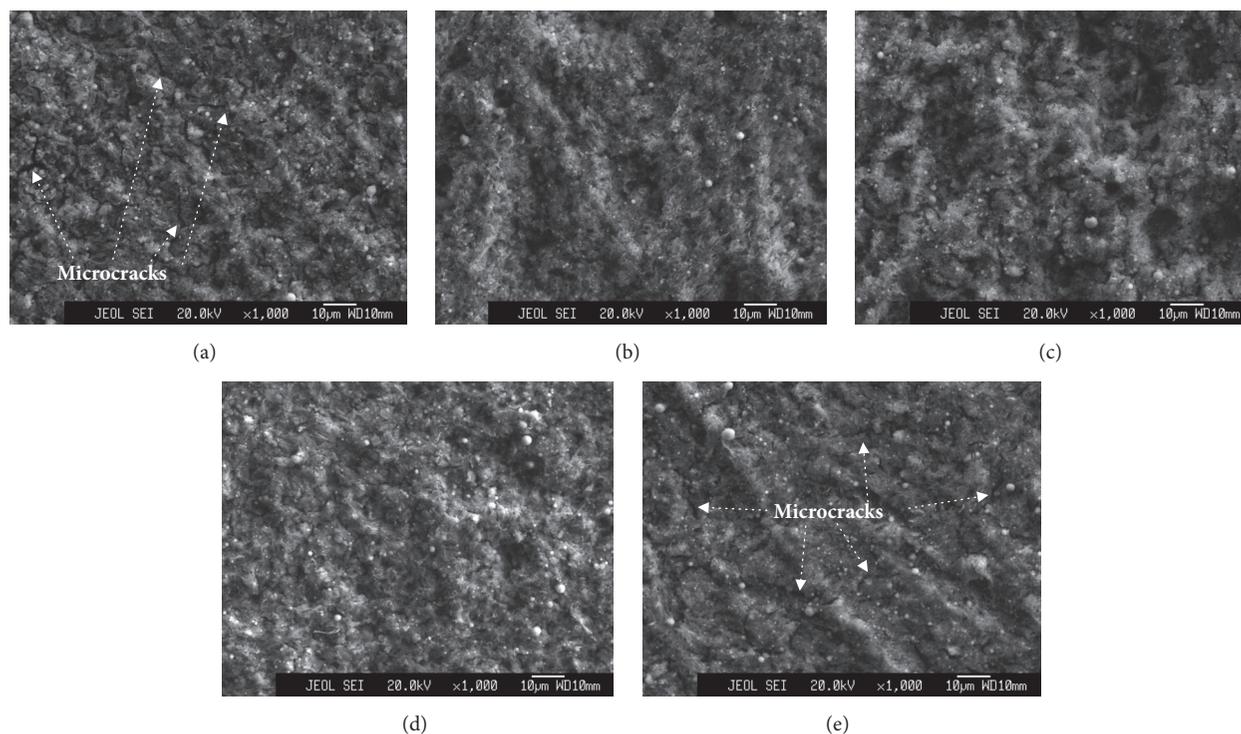
FIGURE 12: Morphology of the welded metals with different REE contents: (a) REE-free, (b) 0.3 wt.%, (c) 0.5 wt.%, (d) 0.7 wt.%, and (e) 1.0 wt.%, after electrochemical testing.

The morphology of the welded metals after electrochemical testing is shown in Figure 12. Significant microcracks can be observed on the corrosive surface of the REE-free welded metal shown in Figure 12(a). The number of microcracks varies with the R_p values of the different REE-containing welded metals. No obvious microcracks were found on the corrosive surface of the REE1 sample; see Figure 12(b).

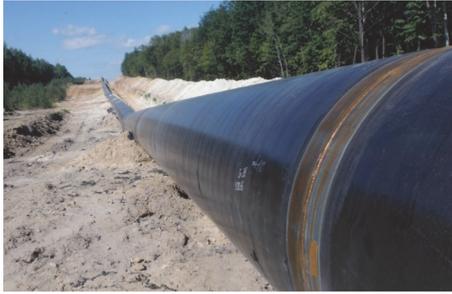
FIGURE 1: Investigated pipeline section.

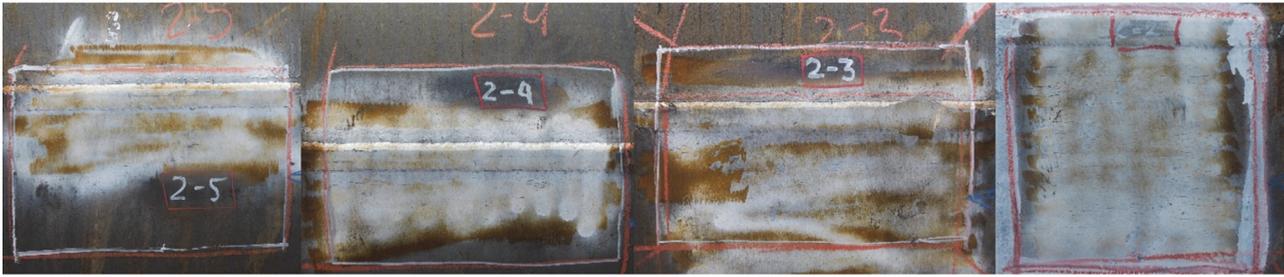
FIGURE 2: Samples with SCC cracks.

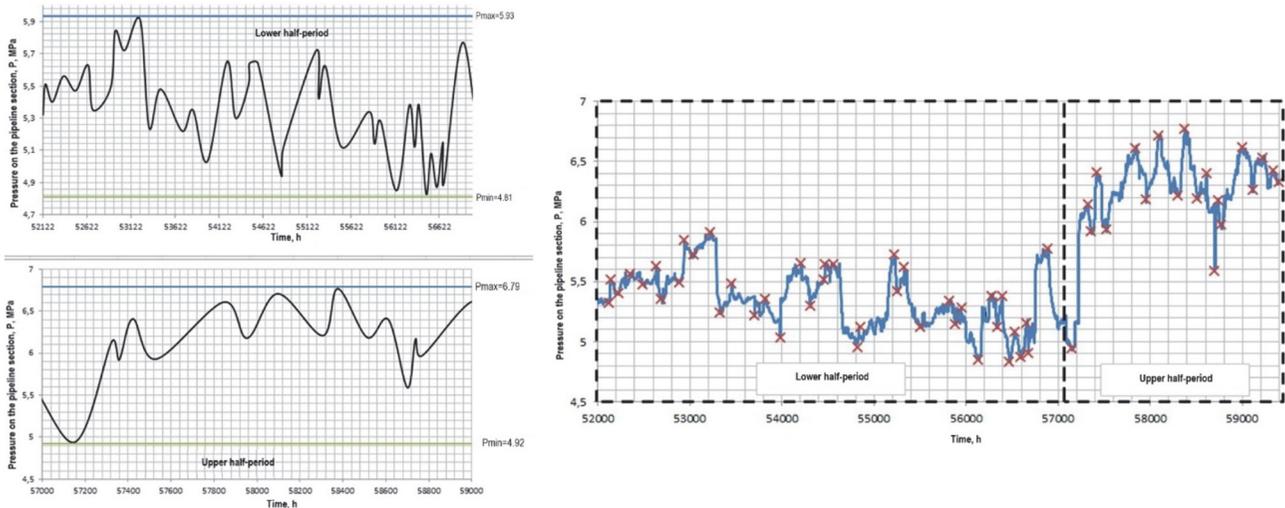
FIGURE 3: The upper and lower half-cycles of the oscillations in the chosen time interval (T).

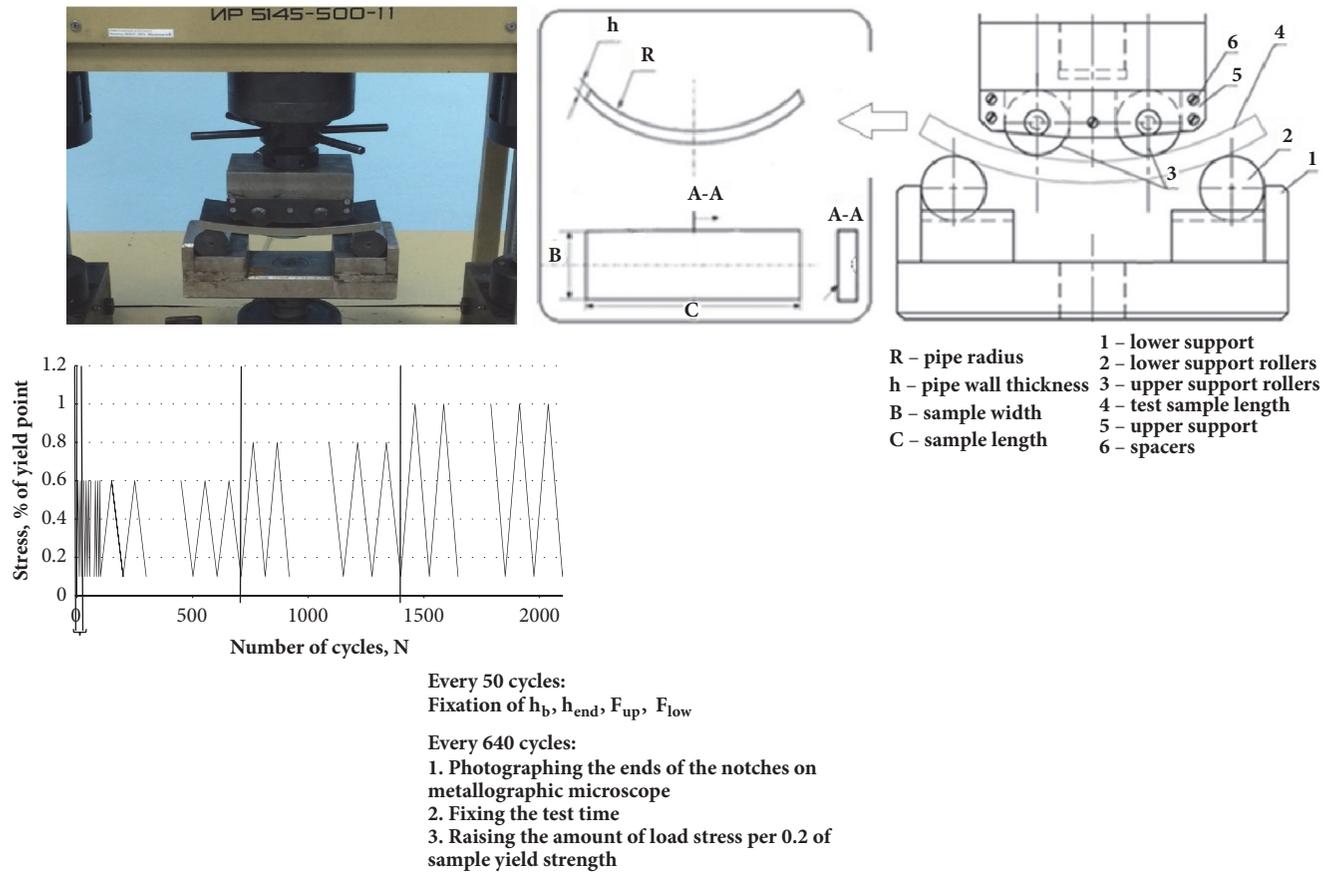
FIGURE 4: Cyclic testing of samples according to the four-point loading scheme.

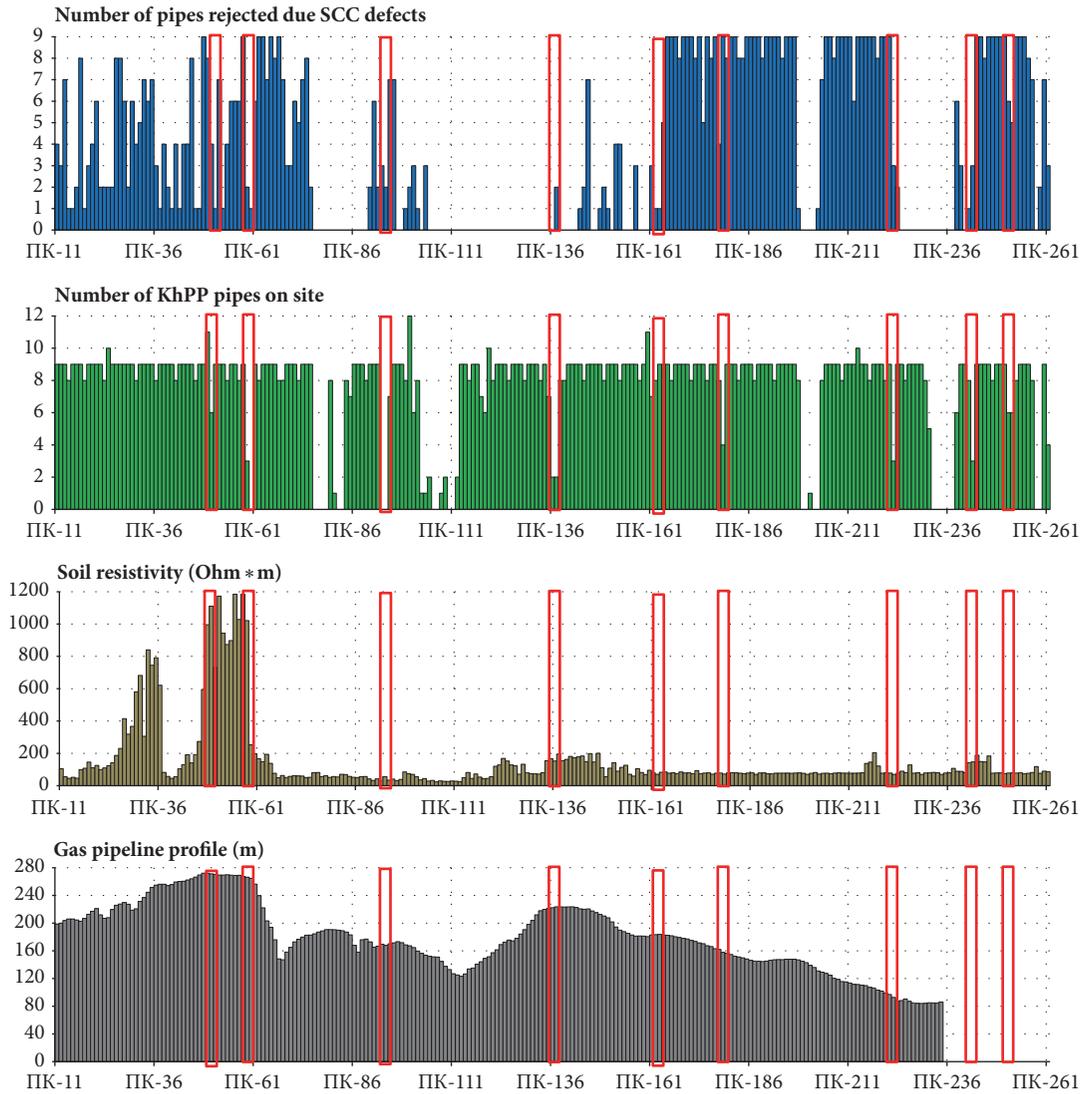
FIGURE 6: Number of pipes with SCC defects, number of KhPP pipes, soil characteristics, and section profile. The X-axis indicates the distance along the pipeline route. Pipeline sections with a small number of pipes produced by KhPP are marked in red.

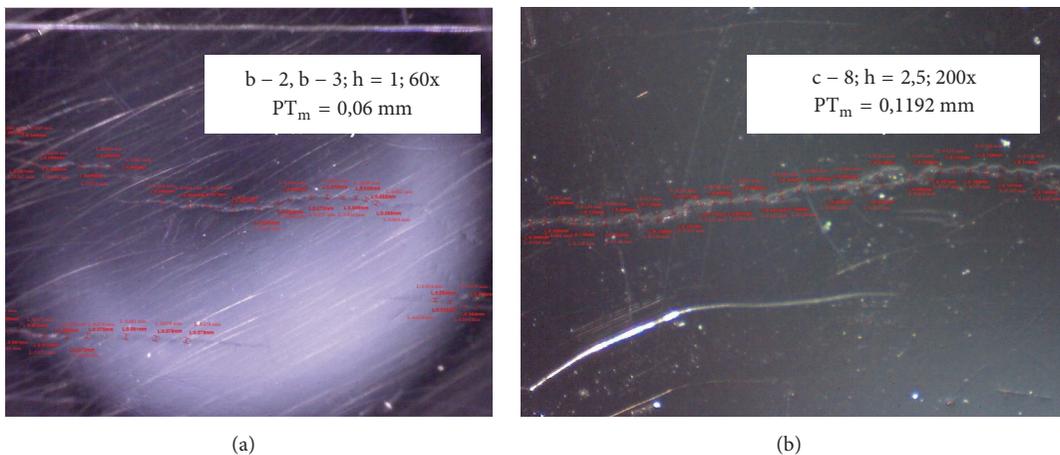
FIGURE 7: Microscopic examination of cracked sections.

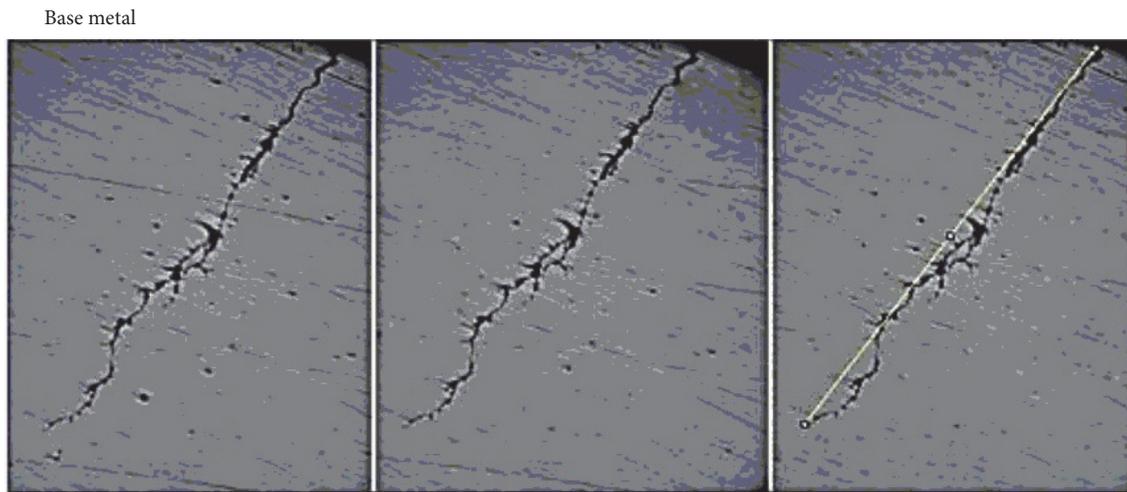
FIGURE 8: Results of crack depth stepwise measurement in the base metal of model sample.

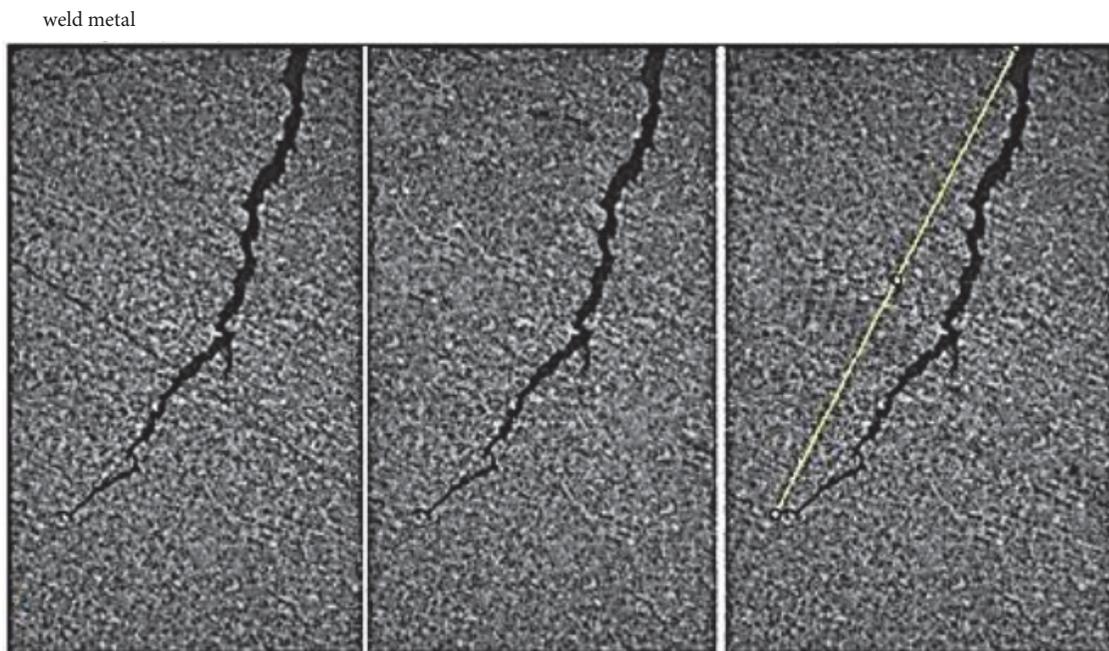
FIGURE 9: Results of crack depth stepwise measurement in the model sample with longitudinal weld section.

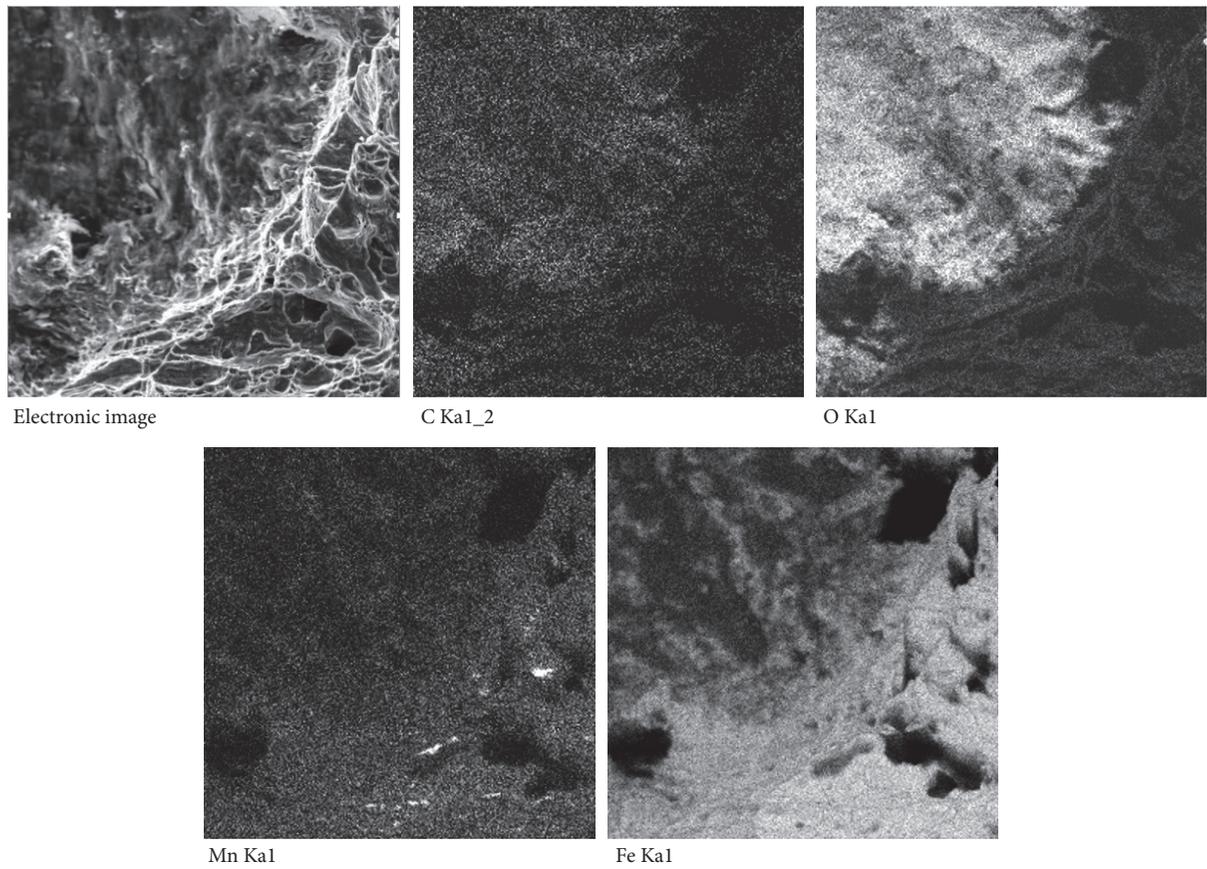
FIGURE 10: Elements distribution maps.
