International Journal of Corrosion

Corrosion of Materials after Advanced Surface Processing, Joining, and Welding

Lead Guest Editor: Xizhang Chen

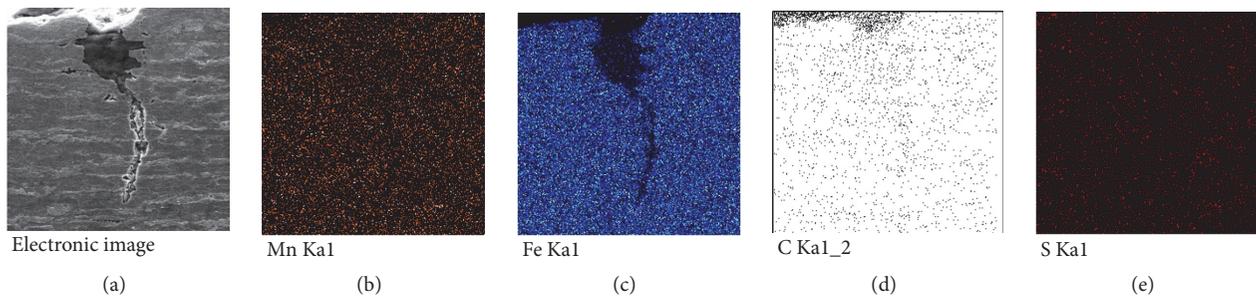
FIGURE 11: Maps of elements distribution in a stress corrosion crack: (a) electronic image of the crack; (b) distribution of manganese; (c) distribution of iron; (d) distribution of carbon; (e) distribution of sulfur.

The maps show an image of cracks in the samples in the spectra of iron, oxygen, carbon, sulfur, and manganese (Figure 11). An increased sulfur content in corrosion products was not observed, as evidenced by the different brightness of the elements spectrum image in the transition from the base

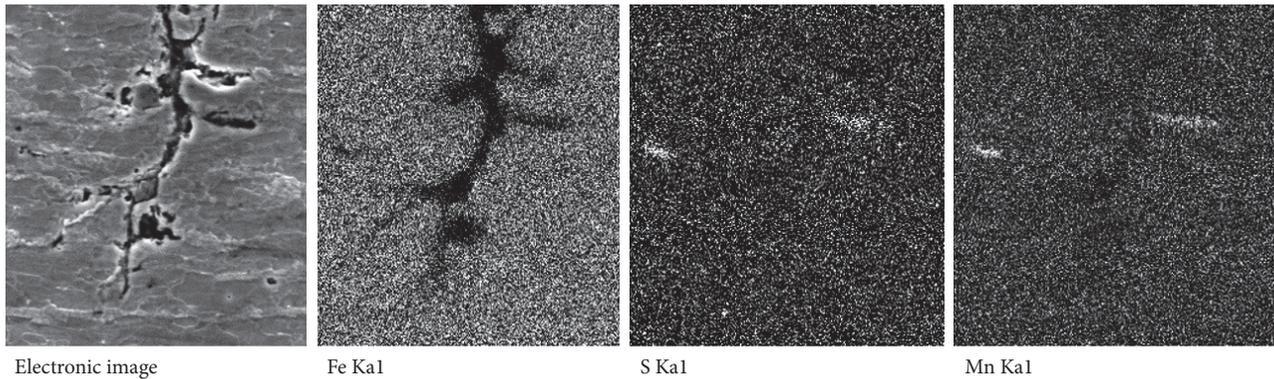
FIGURE 12: Maps of elements distribution in a stress corrosion crack. Increased local sulfur content (manganese sulphide).

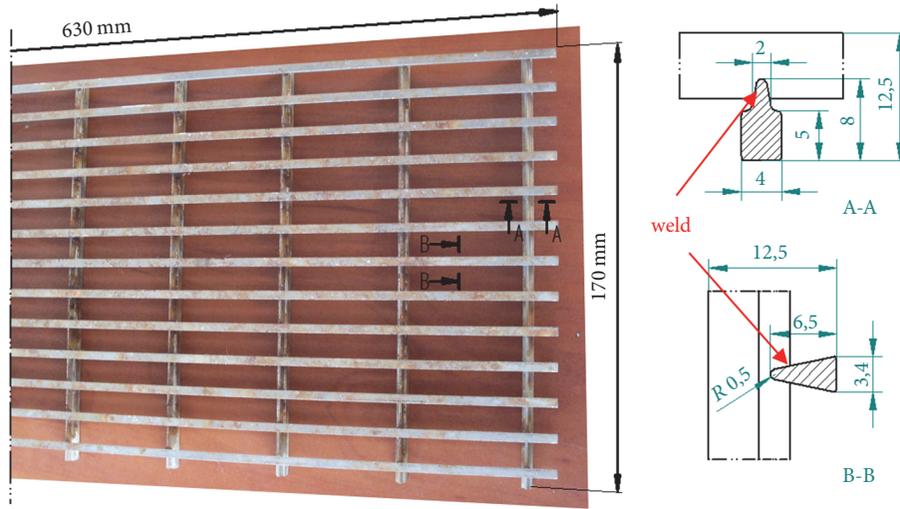
FIGURE 1: Ventilation grille made by resistance welding of stainless steel rods, dimensions in mm.

The object of our investigation was the ventilation grille presented in Figure 1. The weldment areas were mostly severely affected by corrosion, which is visible in optical photographs given in Figure 2 as well as in metallographic weldment cross section in Figure 3. Additionally, in photographs acquired

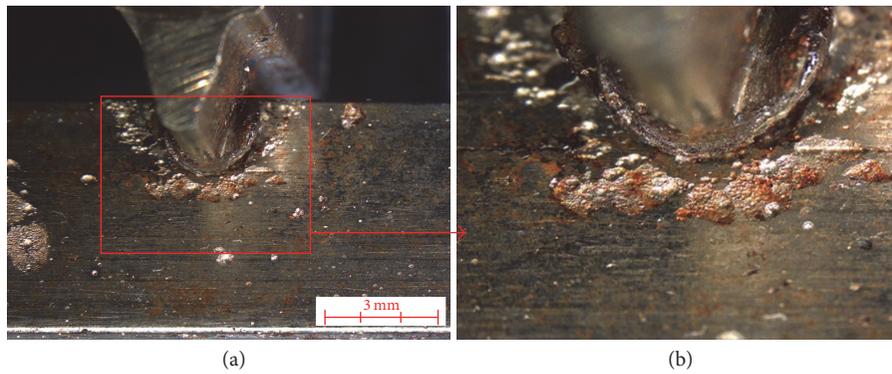
FIGURE 2: Resistance welding weldment corrosion (a) and magnified HAZ (b), stereoscopic microscope.

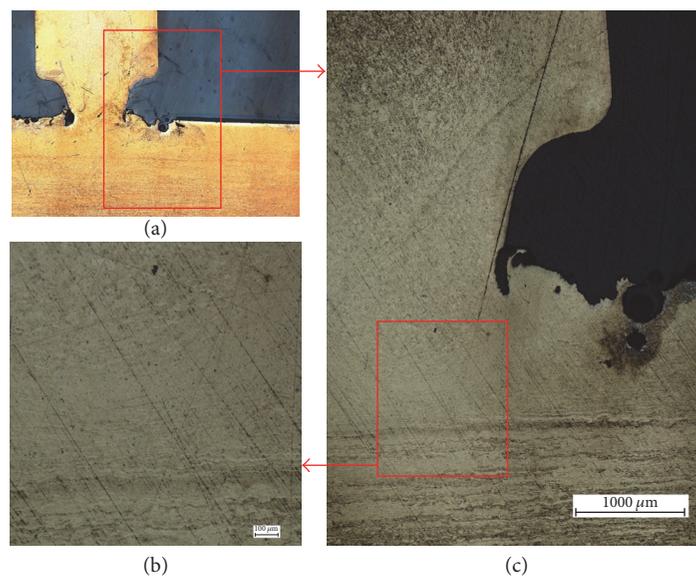
FIGURE 3: Corrosion pits observed in the cross section of joint (a) in the HAZ; (b, c) magnified selected area of microstructure of base metals and heat affected zone presented, metallographic microscope.

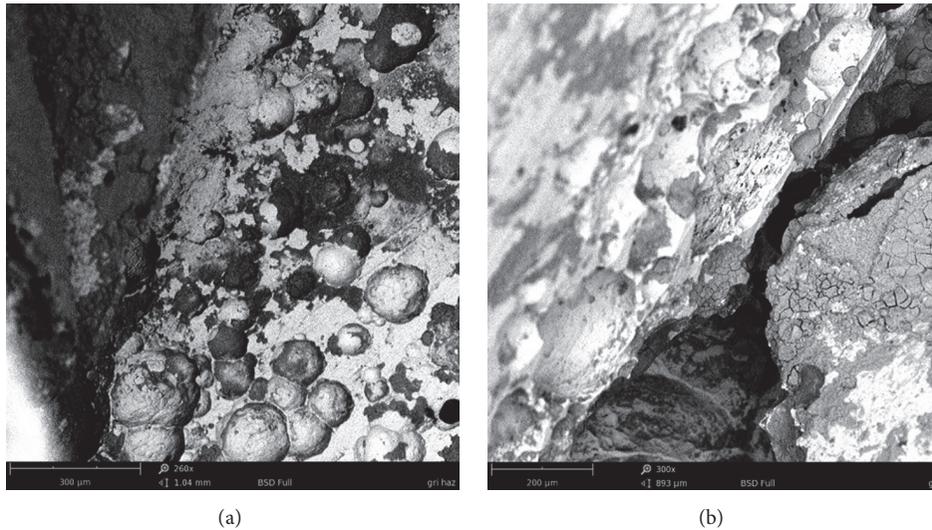
FIGURE 4: The effect of pitting observed in the HAZ (a) and crack between grille rods (b), SEM-BSD.

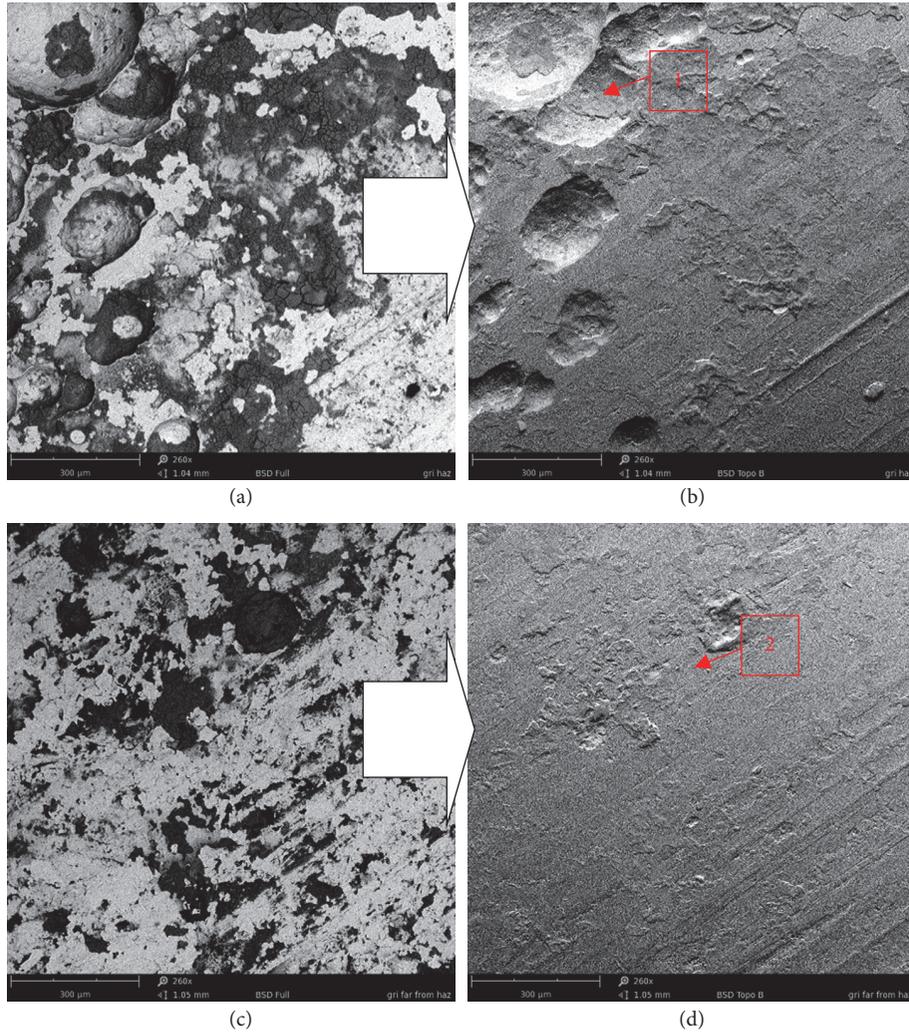
FIGURE 5: Comparison of grille surfaces observed in the heat affected zone HAZ (a, b) and in distance of HAZ (c, d). SEM-BSD and SEM-BSD-topo modes. Points 1 and 2 are locations of chemical analysis; results presented in Figure 6 and Table 2.

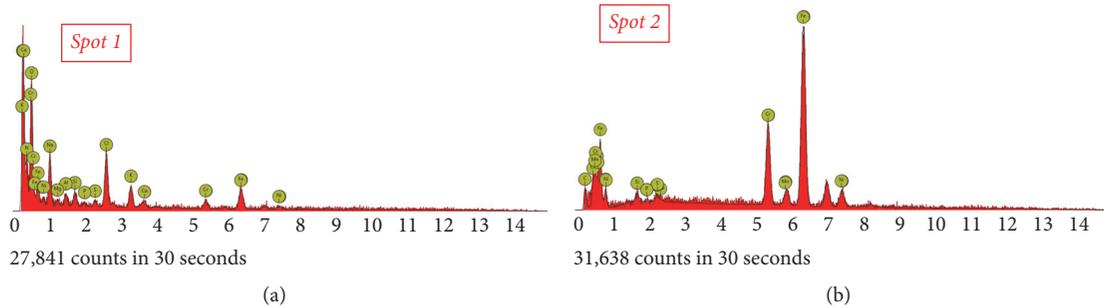
FIGURE 6: Spectrogram (SEM-EDS) obtained due to chemical analysis conducted in spots marked in Figure 5: (a) a corrosive sediment and (b) surface of base metal.

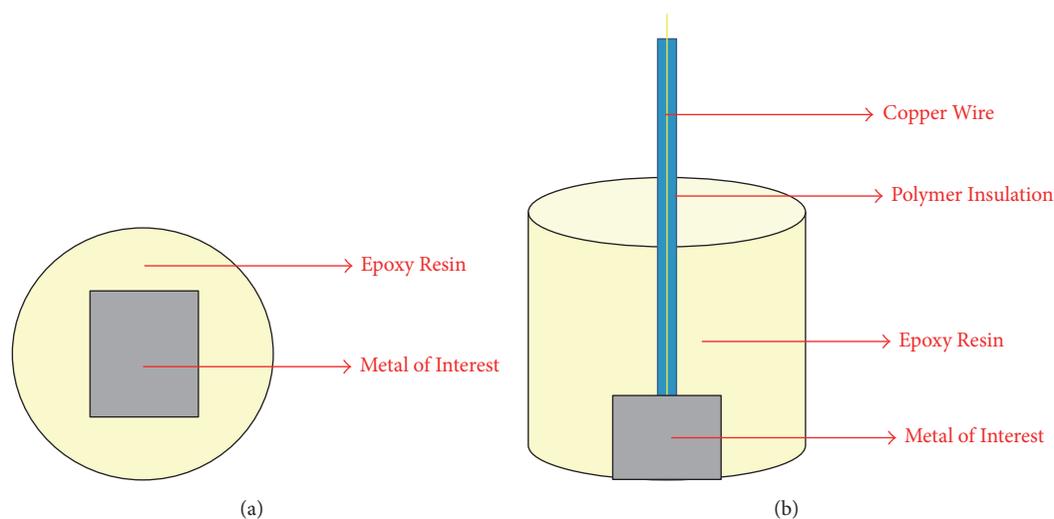
FIGURE 1: Schematic diagram of the working electrode. (a) Bottom view; (b) side view.

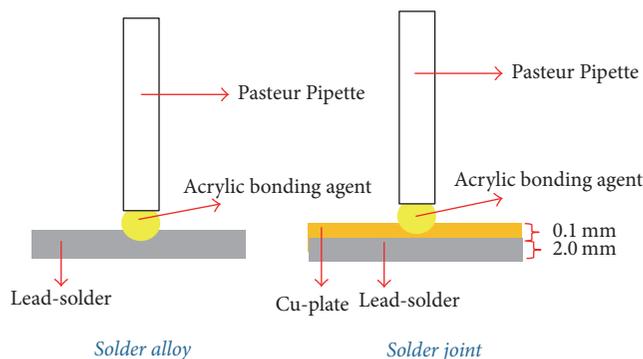
FIGURE 2: Preparation of samples for leaching measurements.

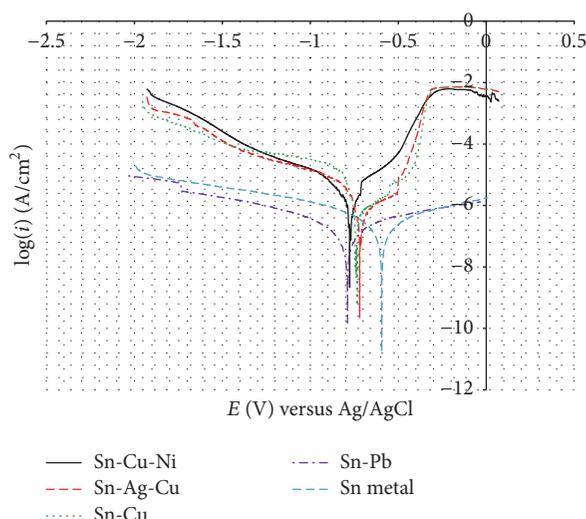
FIGURE 3: Potentiodynamic polarization curves of Sn and solder alloys in 3.5 wt.% NaCl solution under N_2 atmosphere. Scan range: from -1500 to 500 mV ; scan rate: 1.00 mV/s ; step potential: 0.45 mV .

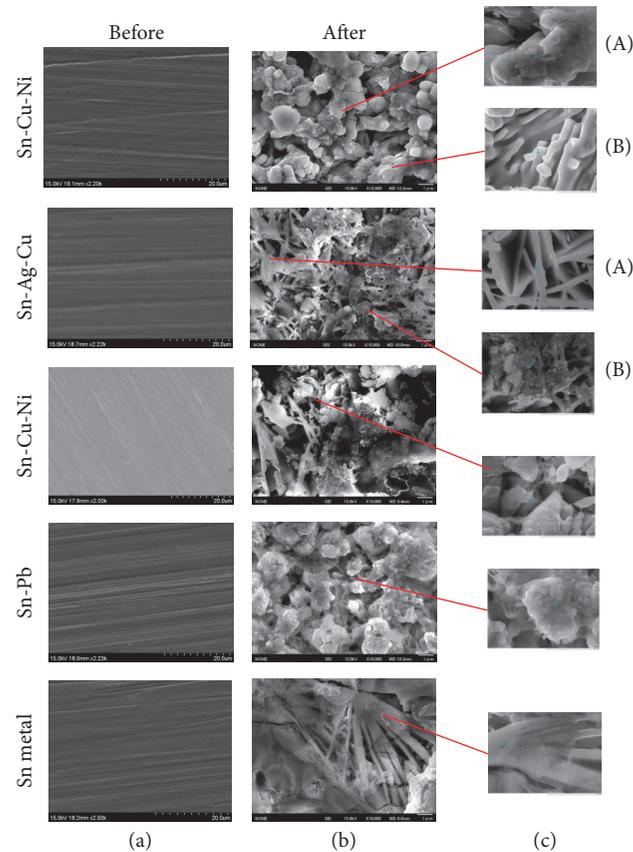
FIGURE 4: The microstructure of the metal surfaces on different solders before (a), after (b), and distinct morphologies on specified points (c) after potentiodynamic polarization tests in 3.5 wt.% NaCl solution.

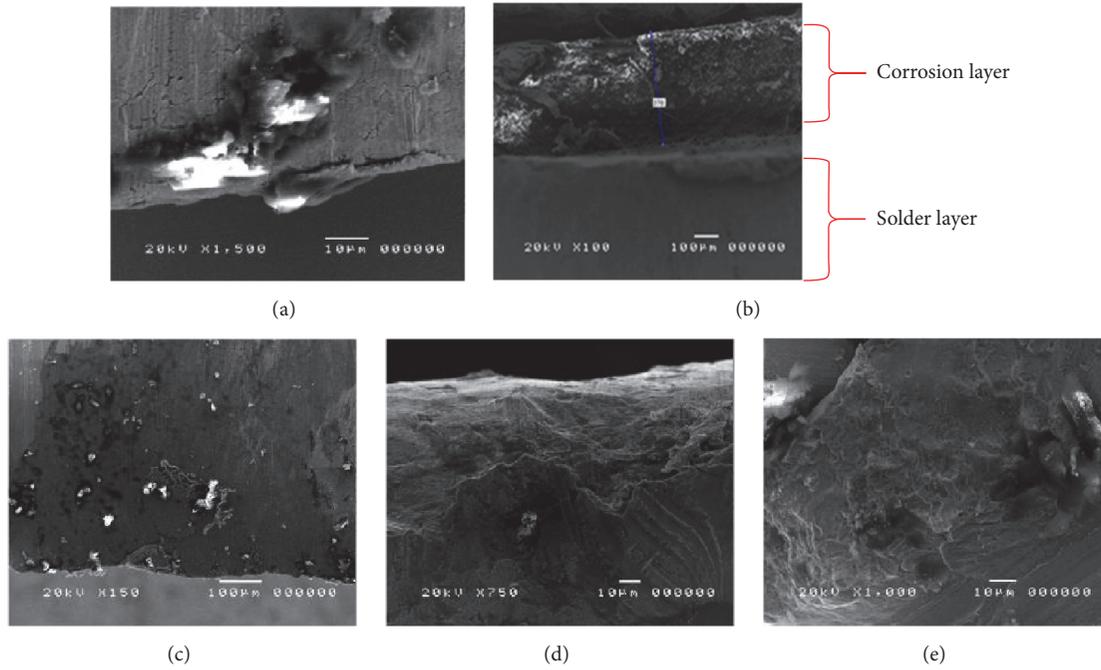
FIGURE 5: Cross-section image of the solders after potentiodynamic polarization test in 3.5 wt.% NaCl solution. (a) Sn; (b) Sn-Pb; (c) Sn-Ag-Cu; (d) Sn-Cu-Ni; (e) Sn-Cu.

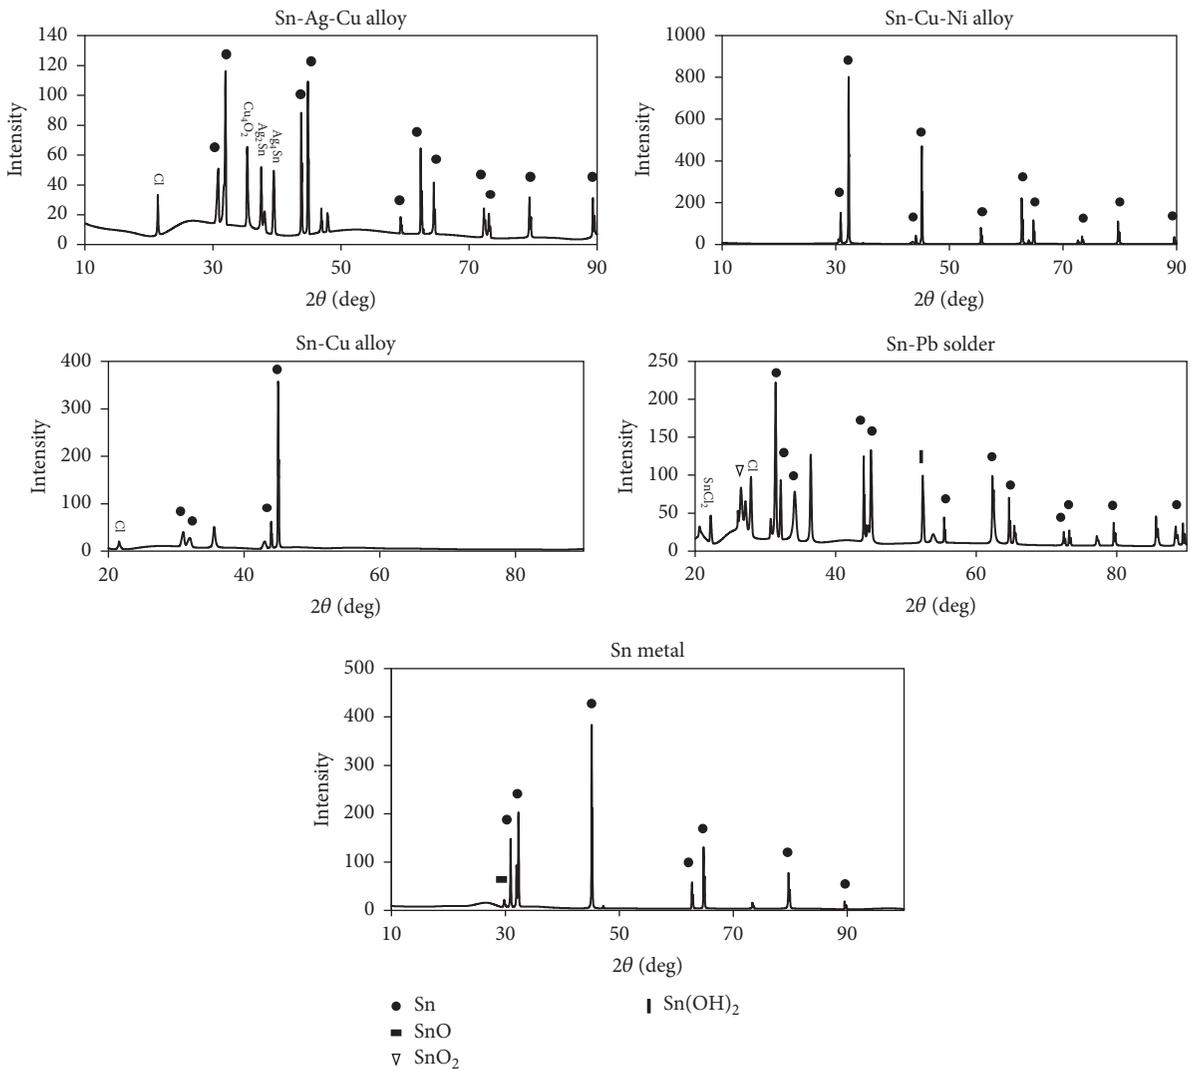
FIGURE 6: XRD patterns of surface product on different solder material after potentiodynamic polarization test.

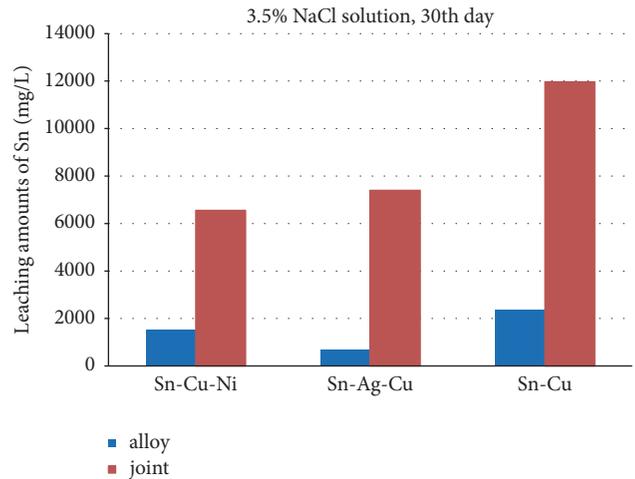
FIGURE 7: Atomic Absorption Spectroscopy (AAS) results on Tin (Sn) leaching from lead-free solder alloy and joint after 30 days.

The solder joints and the raw Pb-free solder alloys were subjected to corrosive media immersion to determine the leaching behaviour (Figure 7). The amount of Sn leached correlates with the corrosion rate of the alloys [25, 29, 34]. Since the results of potentiodynamic polarization test showed that all of the three Pb-free solders had higher corrosion rate than the Sn-Pb solder and Sn metal, leaching amounts of Sn were done only for the Pb-free solders. The leaching amounts of Sn after immersion in 3.5 wt.% NaCl solution after 30 days are observed to be greater for solder joints compared to its corresponding alloy. Sn-Ag-Cu alloy had the highest leaching

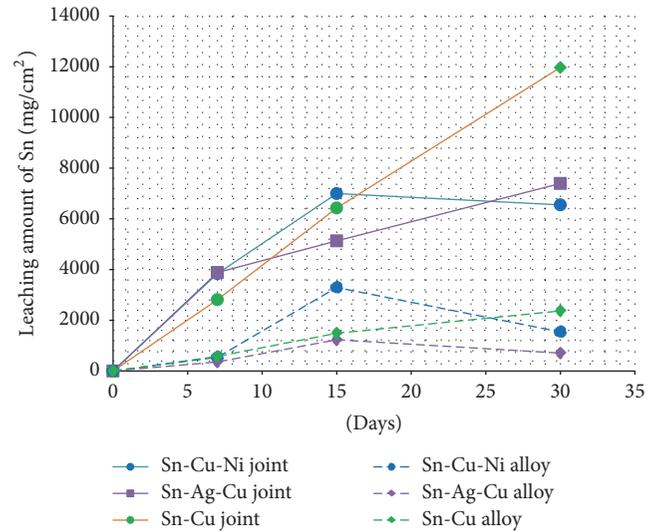
FIGURE 8: Leaching kinetics of Sn from Sn-Ag-Cu, Sn-Cu-Ni, and Sn-Cu alloy and their joints in 3.5 wt.% NaCl solution.

Leaching kinetics of Sn from the metals (Figure 8) show that solder joints gave a higher amount of leached Sn compared to their alloy counterparts. The use of Cu-substrate in the solder joint setup affects the leaching behaviour of Sn. This is because dissimilar metals having different oxidation potentials in contact with each other experience galvanic corrosion [25, 29], which does not occur in solder alloys alone. According to Lao et al., [29] the current density of the solder joint is almost twofold higher than its corresponding solder alloy. Thus, the galvanic cell (anode = Sn; cathode = Cu) accelerates the leaching amount of Sn from the joint.

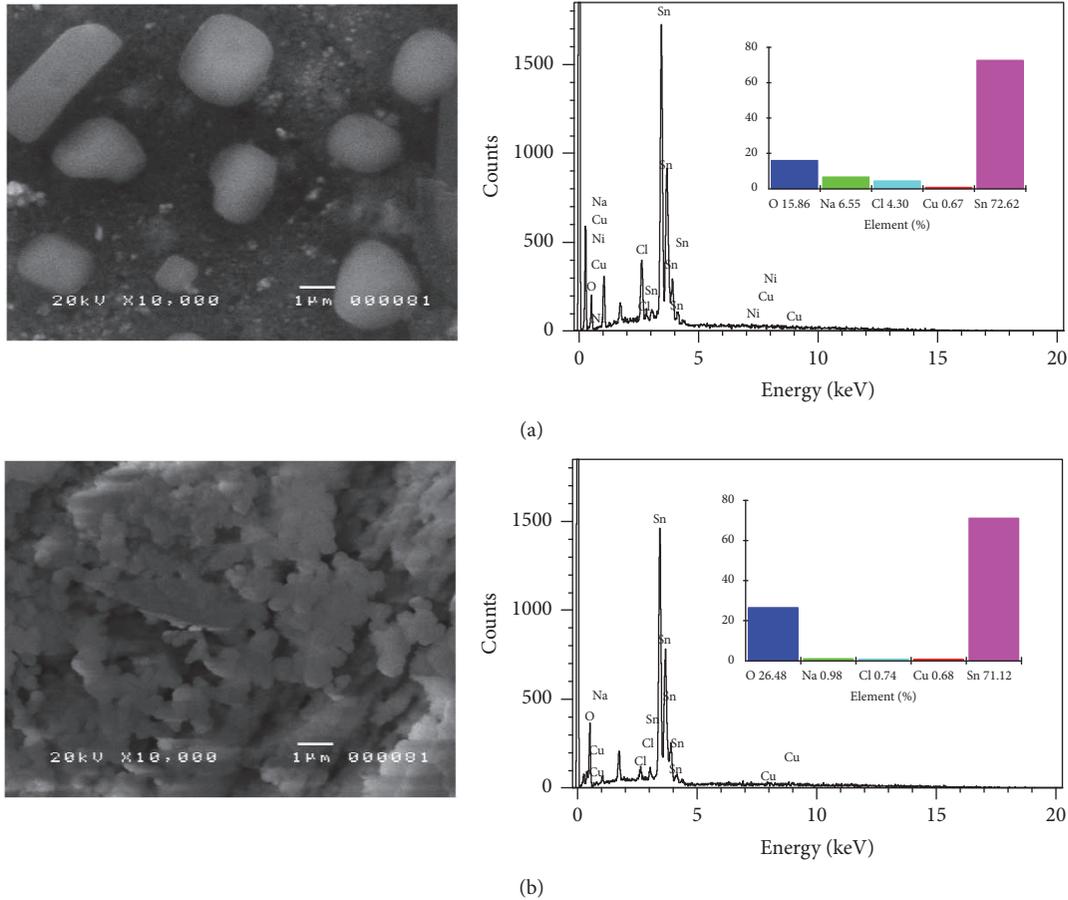
FIGURE 9: Surface morphology analysis of Sn-Cu-Ni (a) solder alloy and (b) solder joint and their corresponding EDS spectra after 30-day leaching measurements in 3.5 wt.% NaCl solution.

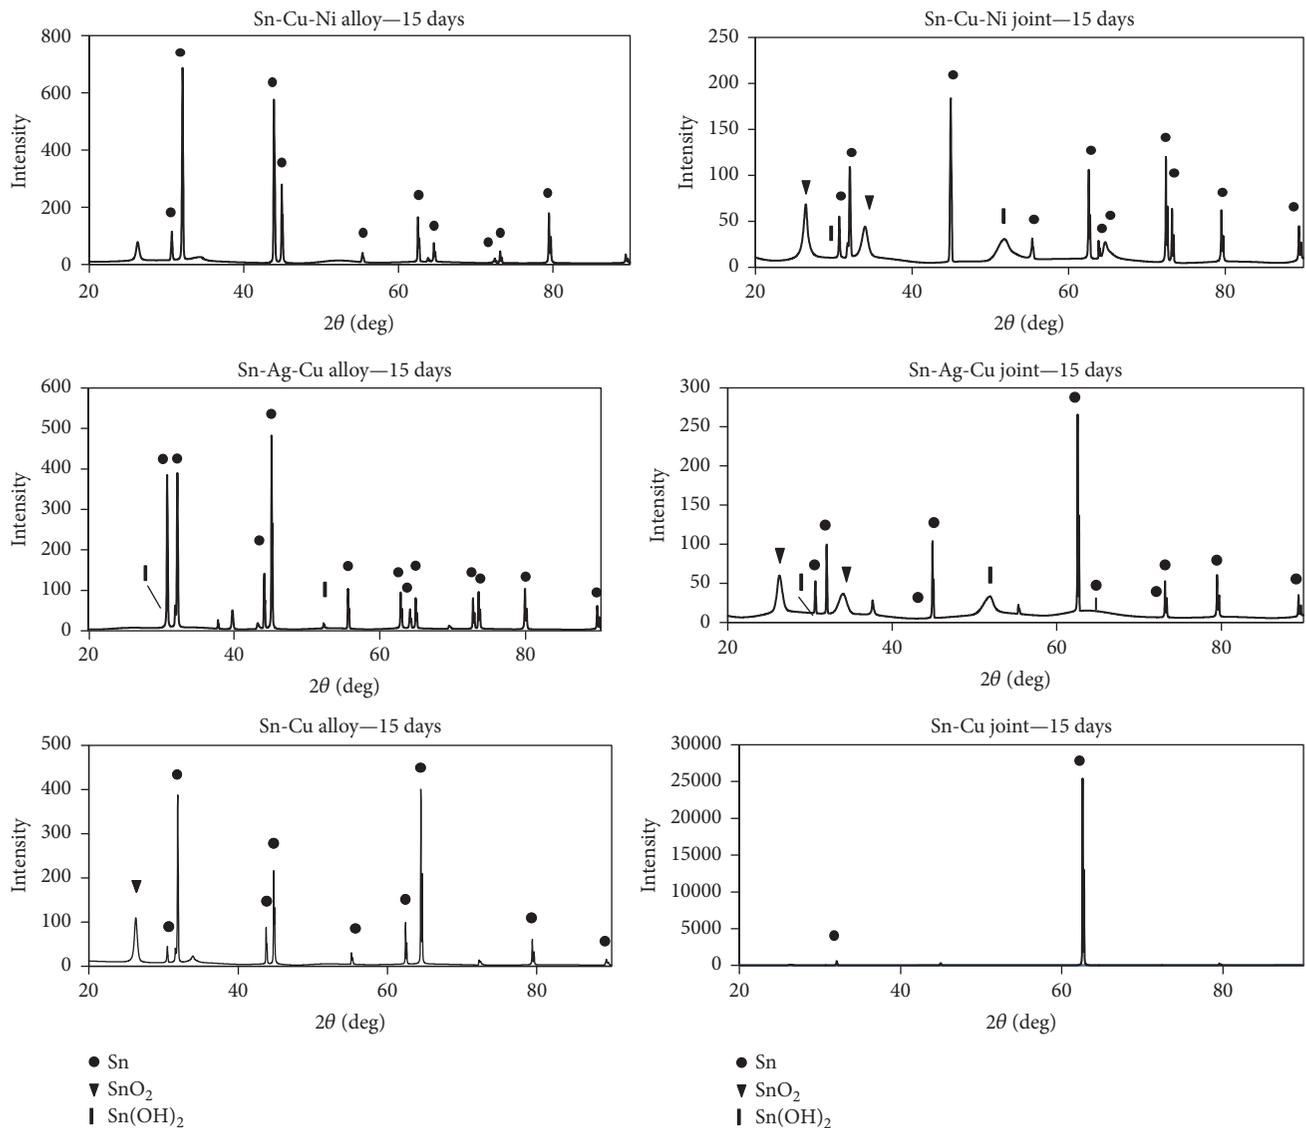
FIGURE 10: XRD patterns of surface product of Sn-Ag-Cu, Sn-Cu-Ni, and Sn-Cu solder alloy and joint after 15-day immersion in 3.5 wt.% NaCl solution.

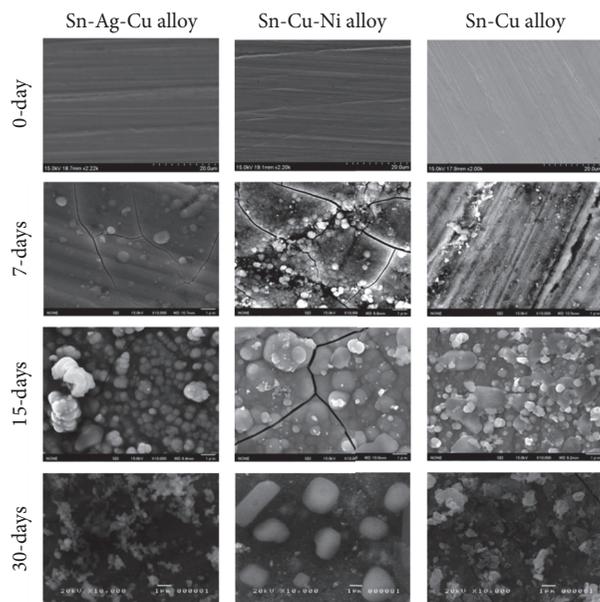
FIGURE 11: SEM image of lead-free solder alloy after 7, 15, and 30 days leaching measurement in 3.5 wt.% NaCl solution.

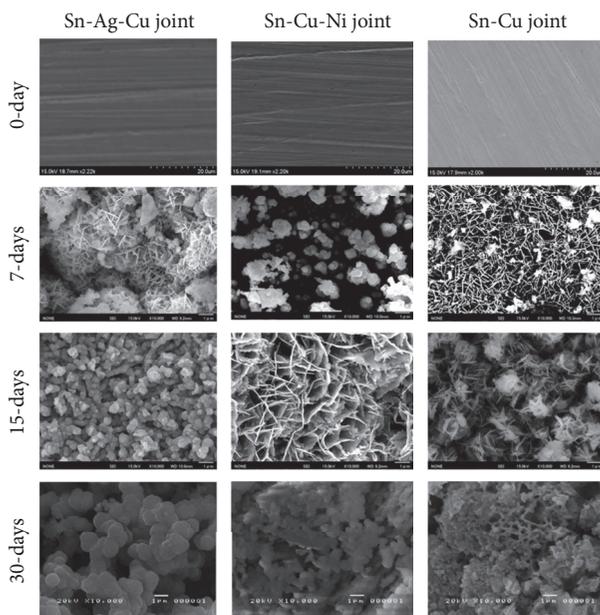
FIGURE 12: SEM image of lead-free solder joint after 7, 15, and 30 days leaching measurement in 3.5 wt.% NaCl solution.
