## Research Article

# Seismic Capacity Assessment of Confined Brick Masonry Building: An Experimental Approach

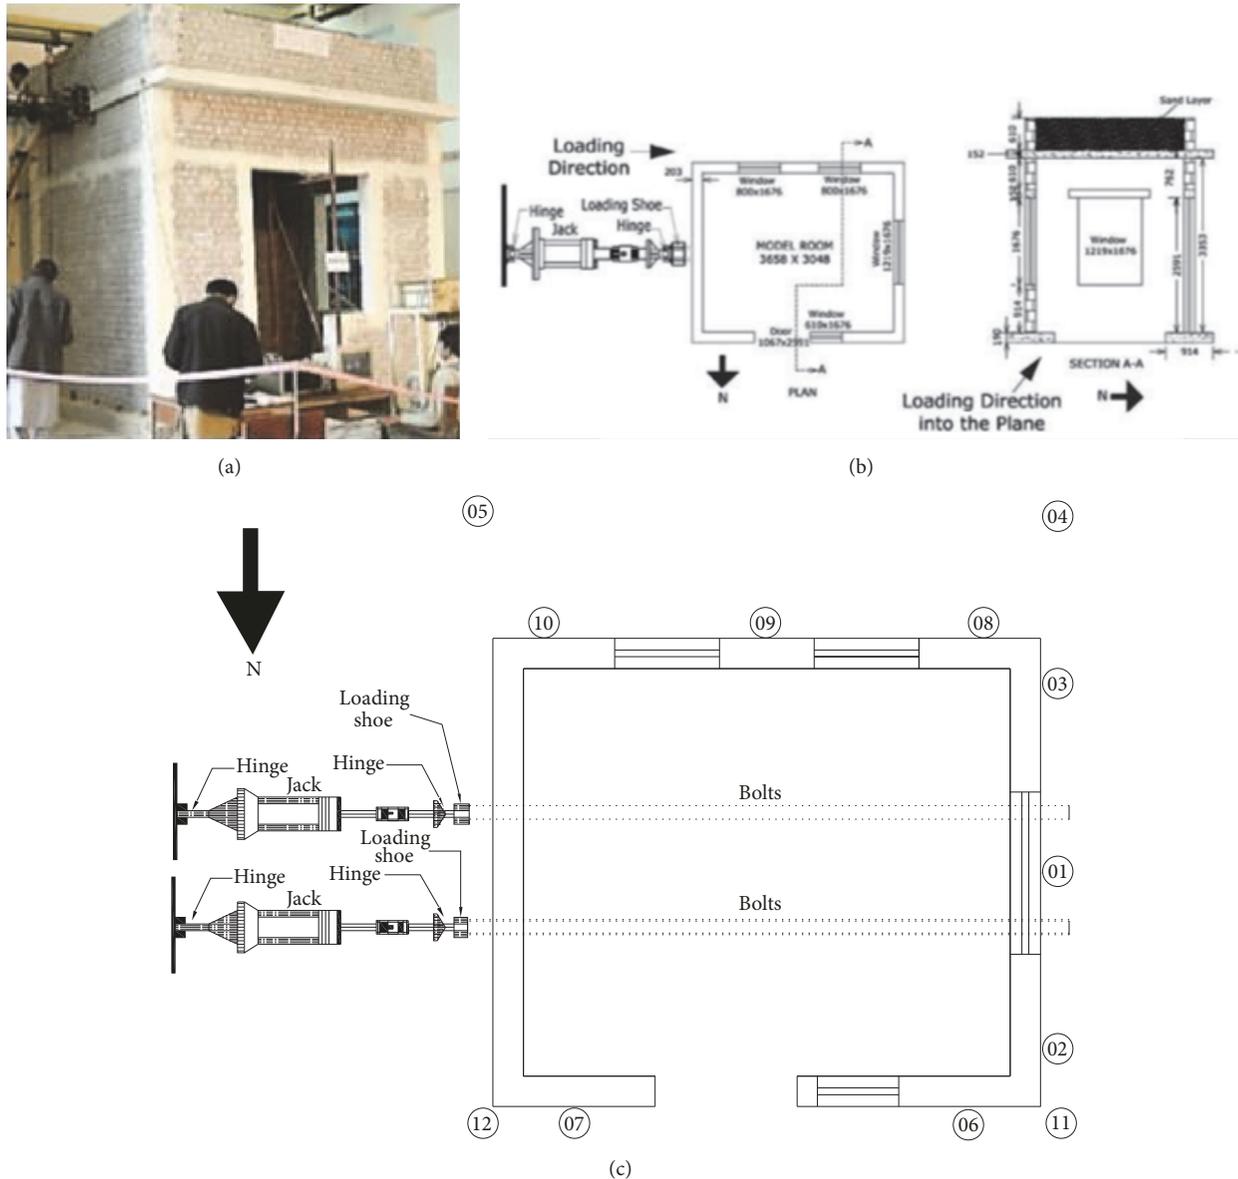
FIGURE 1: (a) A picture of the building model, (b) plan and elevation view details of full-scale building model, and (c) location of the hydraulic jacks in the tested building.

**2.1. Design and Construction of Building Model.** A full-scale model shown in Figure 1 was constructed for this study. The model resembles a typical interior room in a single story building in the local area. The model was constructed on the strong floor of the Earthquake Engineering Center at the University of Engineering and Technology Peshawar, Pakistan.

The interior dimensions of the room model were  $3048 \times 3658$  mm ( $10 \times 12$  ft) and 229 mm (9 inches) thick; walls were made using 1:5 cement-sand mortar with clay brick masonry in English bond pattern, which is the typical construction method in Pakistan. The brick dimensions were 216 mm  $\times$  102 mm  $\times$  70 mm. To avoid the formation of continuous

vertical joints bricks were laid in a staggered manner (see Figure 1(a)). The in-plane walls that were connected to the foundation and the roof slab mainly resisted the lateral forces. The confining elements provided the lateral confinement to the walls. Connection of walls with confining columns was achieved through tothing. The model building was constructed over a 305 mm (12 inches) thick reinforced concrete (RC) pad that was connected to the strong floor via bolts. 76.2 mm (3 in) tothing was spared in every layer of masonry at the four corners and around each opening of the room which was later filled with (1:2:4) concrete. The filling was done in 3 layers with sufficient rodding to achieve the compaction. Each confining tie column was reinforced with 4 #4 (12 mm-dia) bars tied by #3 (9.5 mm-dia) stirrups at 9" (229 mm) c/c. Lintel beams having a size of 152 mm  $\times$  229 mm (6  $\times$  9 in) were casted over all the openings. The beam was reinforced with 2 #4 (12 mm-dia) bars in tension and 2 #4 (12 mm-dia) bars as hangers and was tied by #3 (9.5 mm-dia) stirrups at 152 mm (6 in) c/c spacing. Reinforced concrete slab having a thickness of 152 mm (6 in)

was casted over the model. The slab was reinforced in both directions with #4 (12 mm-dia) bars spaced at 229 mm (9 in) center to center. 343 mm (13.5 in) thick masonry walls having a height of 762 mm (2.5 ft) were constructed over the slab that accounts for the dead load in vertical direction over the roof of the building from the adjacent parts of it. In order to take the effect of the roof treatment, a 381 mm (15 in) thick sand layer was spread over all the roof of the building. Lateral loading was applied through two hydraulic jacks that were fixed against the strong wall on the side of room model with no openings (see Figure 1(b)). To study the flange effect, a window was also provided in one of the out-of-plane walls.

**2.2. Test Setup and Testing Procedure.** The lateral loading was applied on the full-scale room model through two hydraulic jacks that were attached to the slab on the east side of building. The capacity of each loading jack was 200 kN (45 kips). This arrangement is shown in Figure 1. The model was fixed to the strong floor via posttensioning bolts.

In the push direction, bearing through the loading shoes was the means of applying the force to the building. For the pull direction, rods were placed above and below the slab starting from the out-of-plane east wall and ending at the out-of-plane west wall. Bolts were fastened at both ends to fix the rods at their position. The loading arrangement is shown in Figure 1(c).

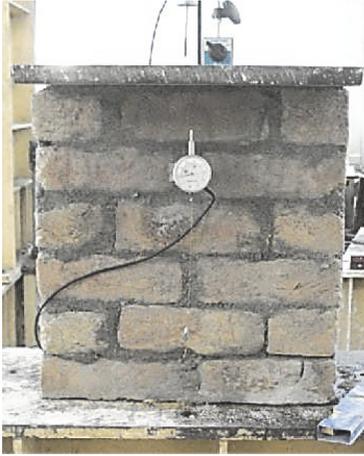
FIGURE 2: Compressive strength test of a masonry prism.

Compressive strength and modulus of elasticity of masonry were determined through test conducted on masonry prisms, 457 mm long  $\times$  457 mm high  $\times$  229 mm thick (18  $\times$  18  $\times$  9 inches) according to ASTM C1314 [2012], as shown in Figure 2. Tensile strength was determined from diagonal compression test on masonry prisms that were also 457 mm long  $\times$  457 mm high  $\times$  229 mm thick (18  $\times$  18  $\times$  9 inches), as shown in Figure 3. The low diagonal strength of the masonry indicated the weak bond between the mortar and the brick unit.

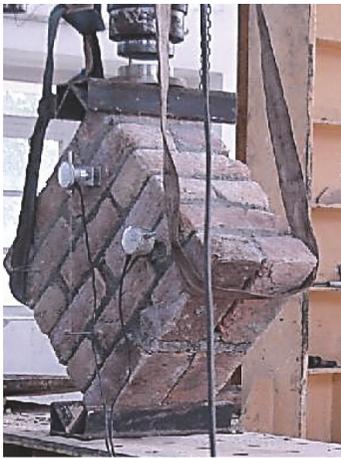
FIGURE 3: Diagonal compressive strength test of a masonry specimen.

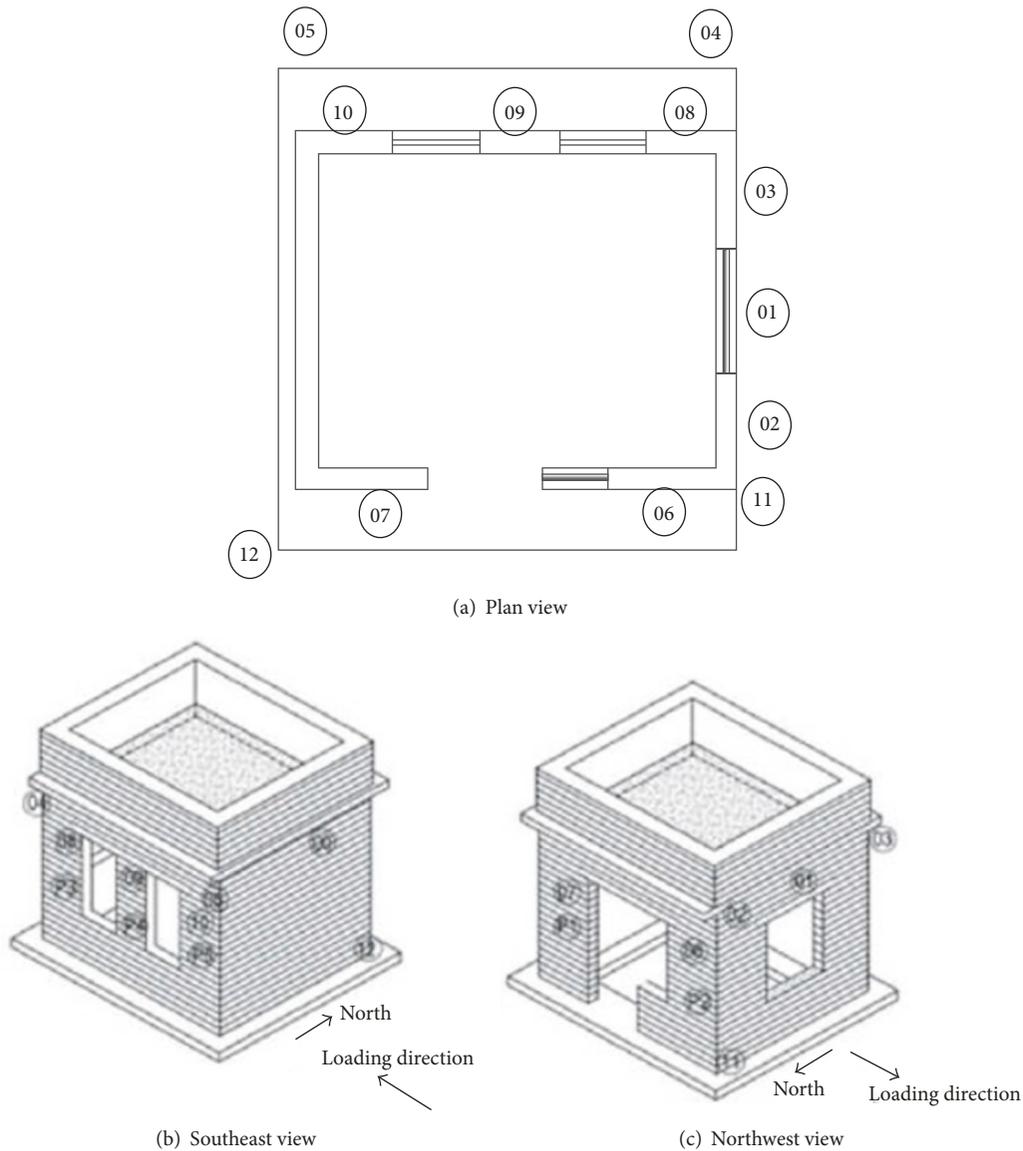
FIGURE 4: Location of LVDTs on the full-scale building model.

To measure displacements, 12 linear variable displacement transducers (LVDT) were used; the arrangement is presented in Figure 4. Gauge 01 was the control gauge, which was used to record the in-plane displacement at the middle center of the slab. Gauges 02–05 were used to measure the twisting of the structure. The displacement at the top of the piers was measured with gauges 06–10. Gauges 11 and 12 were used to determine the possible vertical displacement due to global rocking of the building.

The dead load stresses on the north wall (i.e., pier 01 and pier 02 according to Figure 4) and the south wall (i.e., pier 03, pier 04, and pier 05) were calculated as 0.14 and 0.12 MPa, respectively. The dead load values could be easily compared to material properties given in Table 1.

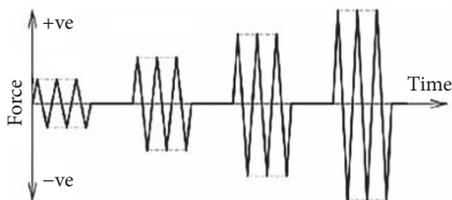
FIGURE 5: The pattern of quasistatic loading protocol.

The model was subjected to increasing reversed quasi-static loading cycles at the roof level with each cycle being repeated three times (see Figure 5). The test was performed

according to the force controlled environment. The test was started from the lateral load of 58.9 kN (6 tons) and it lasted at the load value of 258.96 kN (26 Tons). The load was amplified with an increment of 2 tons in each successive cycle, which makes ten load cycles. During the first load

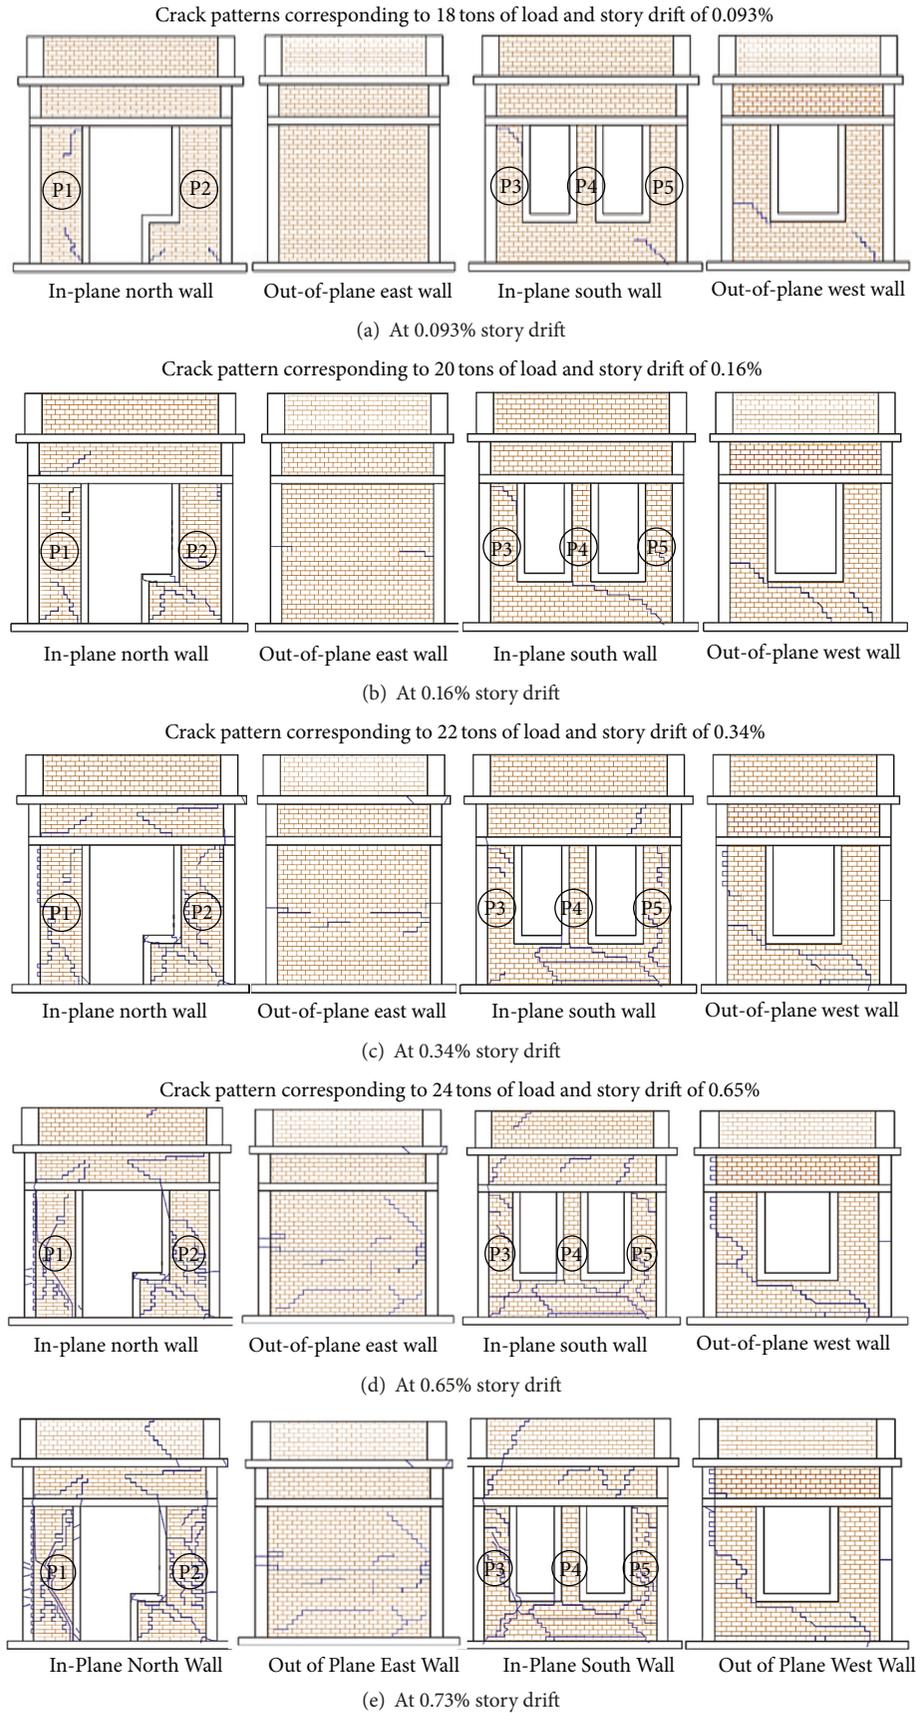
FIGURE 6: Crack patterns at different drift levels for the intact building (note: P stands for pier).

Story drift (%)	Damage description	Governing failure mode	Referenced figure
0.093	Diagonal hairline cracks at lintel level of P1, P2, P3 & P5	Shear	6(a)
0.16	Diagonal cracks passing through P1. At P2 & P5 diagonal cracks starting from the base and ending at the window	Rocking and vertical splitting	6(b)
0.34	Diagonal shear cracks at P1. Vertical cracks in P5	Shear and diagonal tension	6(c)
0.65	Scissor cracks over east wall	Mixed compression and shear	6(d)
0.73	Combination of vertical, horizontal, and radial cracks at the eastward wall	Global/local rocking and shear	6(e)

Figure 6 shows the crack patterns for the room model with increasing story drifts, and the qualitative summary for that is given in Table 2. During the first load cycle of 59.76 kN (6 tons) corresponding to the story drift of 0.0018% no crack was observed which shows that the model was strong enough to resist the applied load robustly without any crack propagation. Under load cycles from 79.68 to 139.44 kN (8 to 14 tons), no cracks were seen which shows the increased resistance of the brick masonry due to the confinement. Hence, it shows that confinement causes increase in the lateral load carrying capacity of the brick masonry building. The earthquake force is always indeterministic, so to simulate it with our testing facility the load was therefore been increased from 139.44 to 179.28 kN (14 to 18 tons) so that the cracks may be observed. At a force of 179.28 kN (18 tons) corresponding to a story drift of 0.093%, Diagonal hair line cracks appeared in the lower left corner of pier 2 and started propagating towards the lintel beam. Similar diagonal crack appeared in the upper right corner of pier 1 and started propagating towards the toe of pier 1. During the reverse cycle, diagonal hairline cracks started appearing at the lower right corner of pier 2 and started propagating upward and vice versa for pier 1. No crack appeared in pier 4 whereas diagonal cracks appeared in piers 3 and 5.

At a load of 199.2 kN (20 tons) corresponding to a story drift of 0.16%, hair line cracks appeared at the center of

pier 2 above the sill level which started propagating towards the lintel beam thereby showing that the cracks are of shear nature that exceeded the tensile strength of masonry. Moreover, such cracks likely appeared in the center of pier 2 and extended towards the tie columns.

At a load of 219.12 kN (22 tons) corresponding to a story drift of 0.34%, the diagonal shear cracks become wider and propagate through the lintel beam in pier 2. Cracks also started appearing in the right toe of pier 1 during the positive cycle and propagated upward. Similarly, during the reverse cycle, scissor like cracks appeared in pier 1. In the southern wall, the shear cracks also started appearing near the foundation pad and below the sill levels.

At a load of 258.96 kN (26 tons) corresponding to a story drift of 0.73%, both of the tie columns of the strong wall cracked at the middle because of flexure stresses. The cracks in pier 1 of the northern wall widened up to 3 inches, which makes it yielded showing the phenomenon of toe crushing. The diagonal shear cracks in pier 2 propagated through the slab such that the slab crumbled. The test was stopped and the crack pattern was then observed carefully. In Figures 7–12, stair stepped cracks and cracks passing through the solid bricks are seen at drift level of 0.73%.

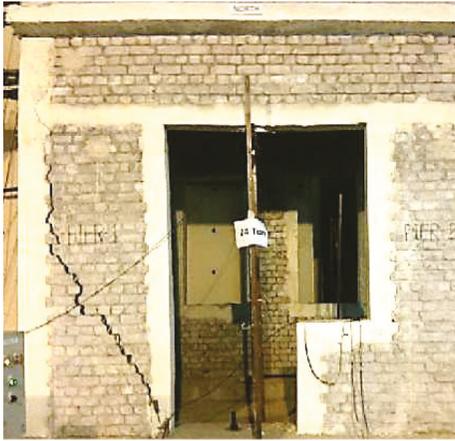
FIGURE 7: Diagonal shear cracks in pier 1 corresponding to story drift of 0.34%.

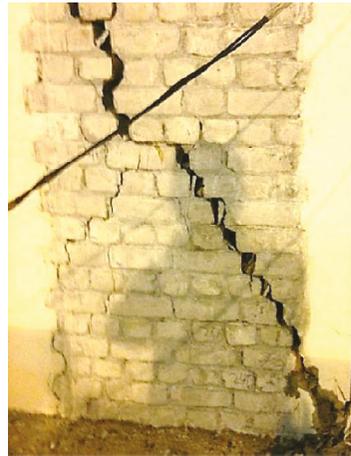
FIGURE 10: Cracking of toe in pier 1 corresponding to story drift of 0.73%.

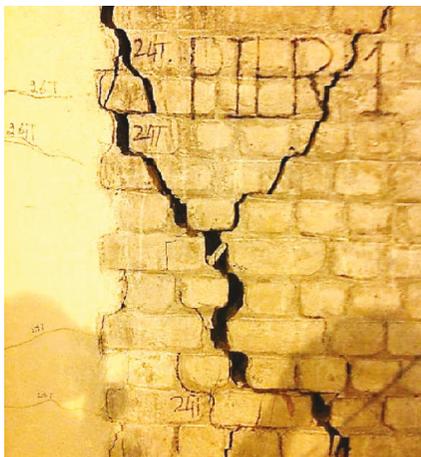
FIGURE 8: Diagonal shear cracks showing a scissor pattern corresponding to story drift of 0.73%.

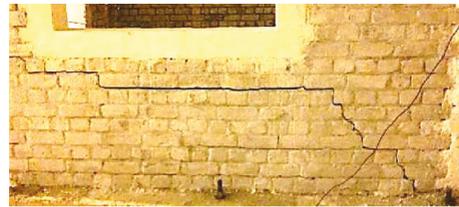
FIGURE 11: Combination of flexure and shear cracks in the out-of-plan wall corresponding to story drift of 0.65%.

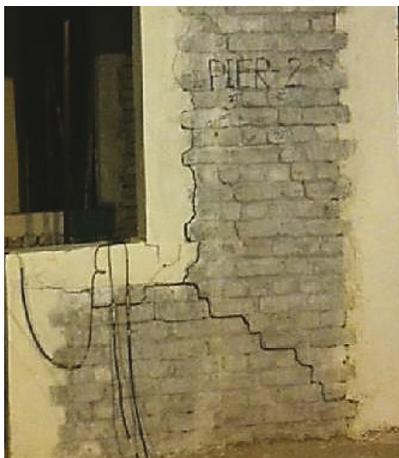
FIGURE 9: Diagonal shear cracks in pier 2 corresponding to story drift of 0.73%.

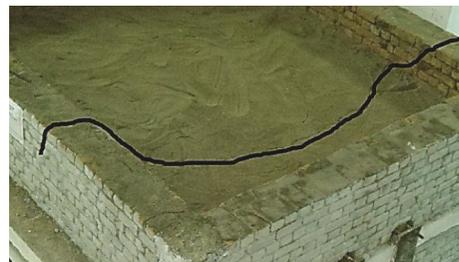
FIGURE 12: Line shows the crack appeared in the slab.

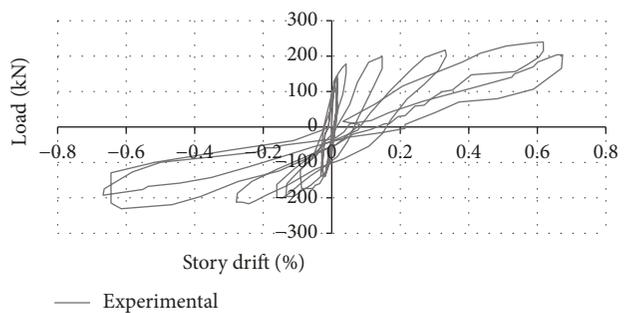
FIGURE 13: Hysteresis loop of CBM building.

Figures 13 and 14 show the force-deformation response of the CBM building for hysteresis and envelope curves, respectively, obtained from gauges 06–10. Story drift ratio defined as “the ratio of the lateral displacement of story to the height of story” is used here to indicate the lateral

deformation. As a sign convention, the push direction was taken as positive and vice versa. Envelop curves are drawn by joining the points of maximum positive and negative loads in each cycle. Tangent stiffness decreases with increasing displacements and became very small at 0.20% story drift. The structure reached its maximum resistance at 0.65% story drift, after which the strength degradation initiated at a slow pace. The gradual degradation of the structure began beyond the story drift of 0.65% of peak resistance. The test was stopped when the resistance decreased to 89% of the maximum loading corresponding to 0.70% story drift (200.7 kN).

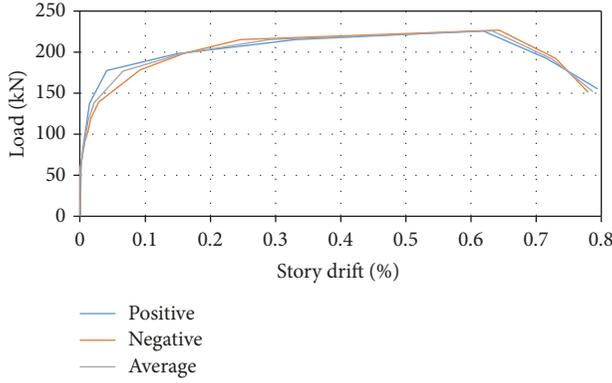
FIGURE 14: Envelop curves for CBM building.

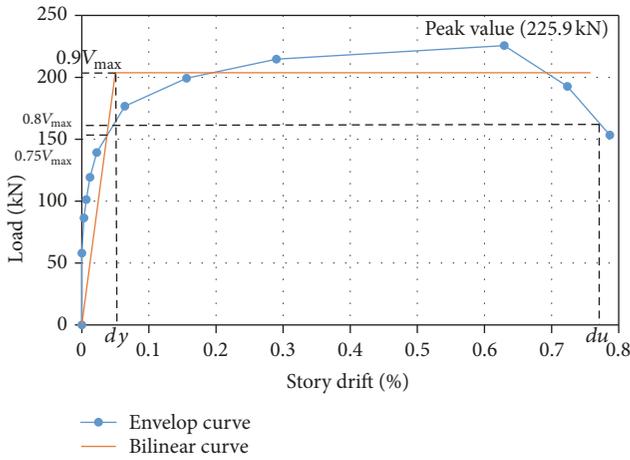
FIGURE 15: Bilinear curve of CBM building.

An idealized bilinear curve was made by the average of the force-deformation envelope curves in both the positive and negative directions. Based on equal energy principle, a method proposed by Magenes and Calvi [18] was used to develop an elastoplastic curve. From the average backbone curve shown in Figure 15, the maximum load,  $V_u$ , was approximated as  $V_u = 0.9V_{max}$ . The effective stiffness,  $K_{eff}$ , was taken as the ratio of  $0.75V_u$  to the corresponding displacement in the envelope curve. The yield displacement was then calculated as  $\Delta_y = V_u/K_{eff}$ . The ultimate displacement was taken at a point corresponding to  $0.8V_u$  in the envelope curve. The displacement ductility denoted by  $\mu_D$  was then

From Figure 15, the ultimate and yield story drifts for the room model were found to be 0.772% and 0.051%, respectively. The displacement ductility is thus found as  $0.772/0.051 = 15.13$ . Response modification factor,  $R$ , which can be defined as one of the seismic design parameters to consider nonlinear performance of building structures during strong earthquake and relying on this, many seismic design codes led to reduce loads. Similarly, for seismic design, it is important to estimate, maximum lateral displacement of structures due to sever earthquakes for several reasons. Seismic design provisions estimate the maximum roof and story drifts occurring in major earthquakes by amplifying the drifts obtained by elastic analysis with a displacement amplification factor  $C_d$ . Both the parameters are obtained from the following relations:

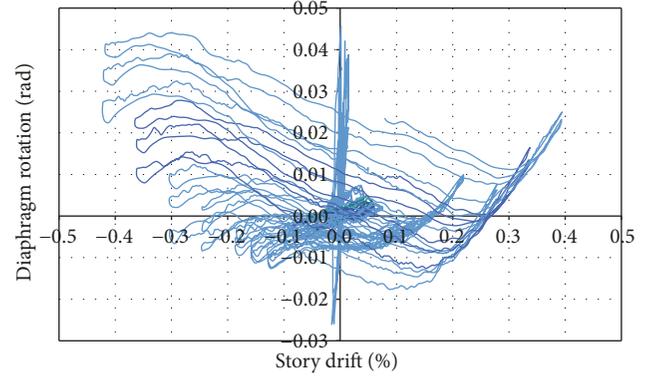
FIGURE 16: Effect of torsion produced in the form of diaphragm rotation in nonretrofitted block masonry building.

To avoid any torsion in the building, an attempt was made in design of model to keep the lateral stiffness of both in-plane walls the same. However, two out-of-plane gauges (numbers 04 and 05) were installed, to record any possible torsion. The diaphragm rotation was measured as the sum of the displacement recorded by these two gauges divided by the distance between them. The rotation as a function of story drift is shown in Figure 16. The maximum rotation was 0.0044 for the CBM building. Positive direction rotation was smaller than the negative direction. We see that the symmetrical conception of rigidity has succeeded. However, the increasing levels of asymmetry were associated with the increasing level of damage (due to unequal loss of rigidity in the walls), which resulted in torsional effects.
