Research Article

Quasi-Static Cyclic Test on a Concrete-Encased Frame-Reinforced Concrete Tube Building Model

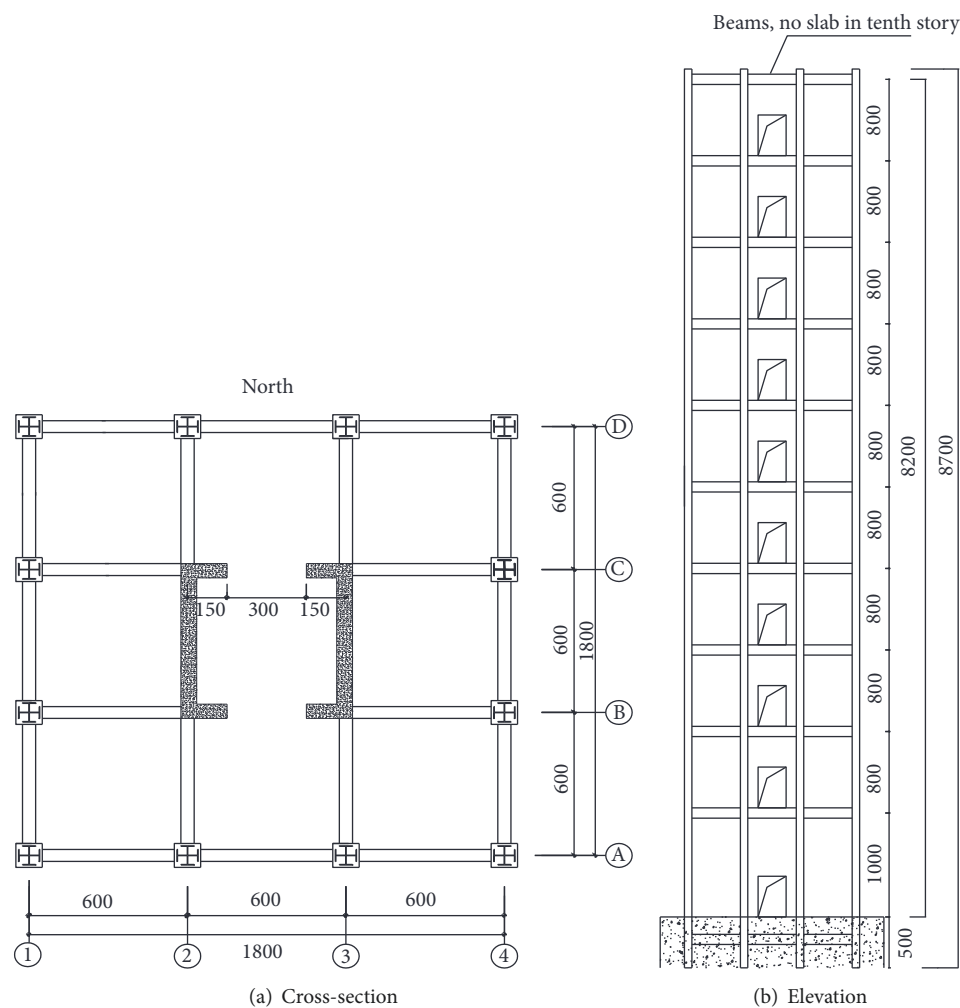
FIGURE 1: Dimensions of specimen (units: mm).

The frame is composed of CS columns and steel beams with I cross-section, while the core tube is made of reinforced concrete. Considering the laboratory conditions, a 1:5 reduced-scale model was constructed for the quasi-static tests. The model was 10 stories with square cross-sections, with 20 beams and 12 columns in each story. The total height of the model was 8700 mm. The depth of the foundation, the first story, and the rest of the stories were 500 mm, 1000 mm, and 800 mm, respectively. Two holes were arranged on each story for elevator doors. The details and dimensions of the specimen are shown in Figure 1. It should be mentioned that the selected span is small because of the limitation of laboratory conditions. Compared with typical building, the linear stiffness ratio of beams and floor system increases. The capacity of shear transferring between core tube and frame is enlarged. It may lead to less damage degree of beams and floor system.

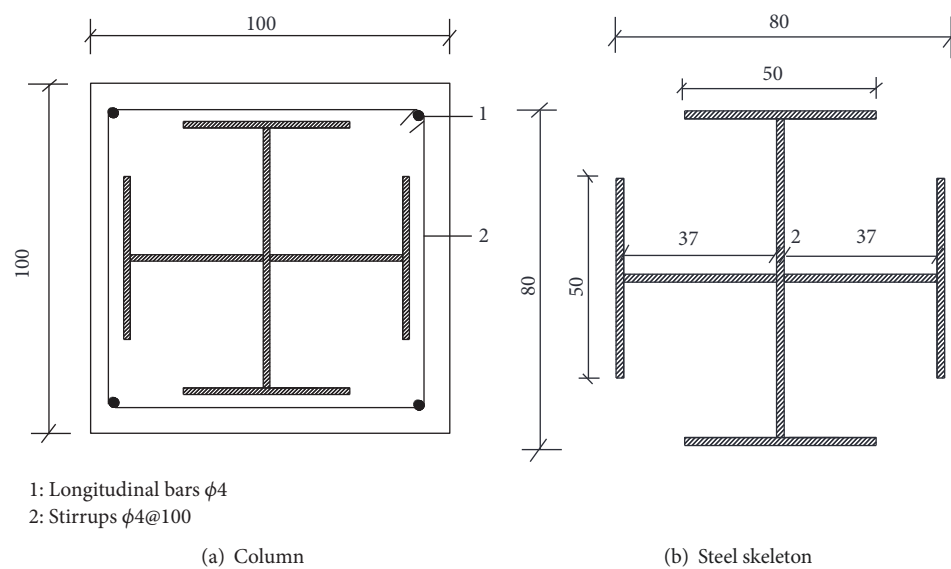
FIGURE 2: Configurations and skeleton of CS columns (units: mm).

2.2. Test Model Construction. The CS columns had a square cross-section of 100 mm × 100 mm. Figure 2 shows the configurations and skeleton of the CS columns. The cross-shaped structural steel used in the columns consisted of several hot-rolled steel plates. The steel plates were welded to create a cross-shaped steel section. Figure 3 shows the steel beams and configurations of beam-column joints. An I cross-section was adopted in the steel beams. The beams steel plates were welded to the columns steel skeleton.

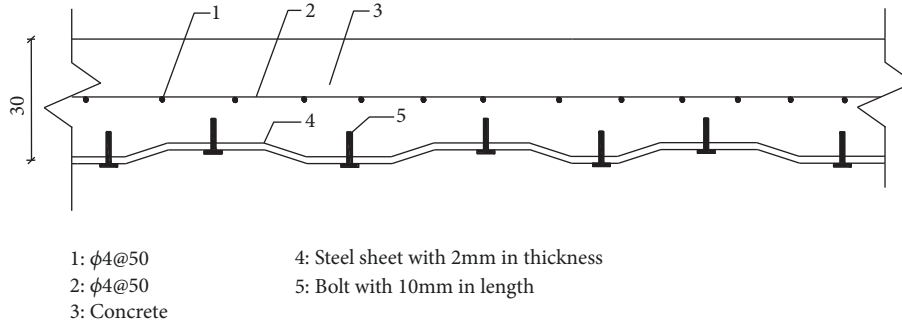
FIGURE 4: Composite slab system (units: mm).

The composite slab was adopted. The slab system was composed of thin steel plate, concrete, steel bar, and stud connectors. Single-layer mesh reinforcement is used, and 10 mm length stud connectors were welded to the steel plate to strengthen the bond between the steel plate and concrete. A

sectional view and details of the reinforcements are shown in Figure 4.

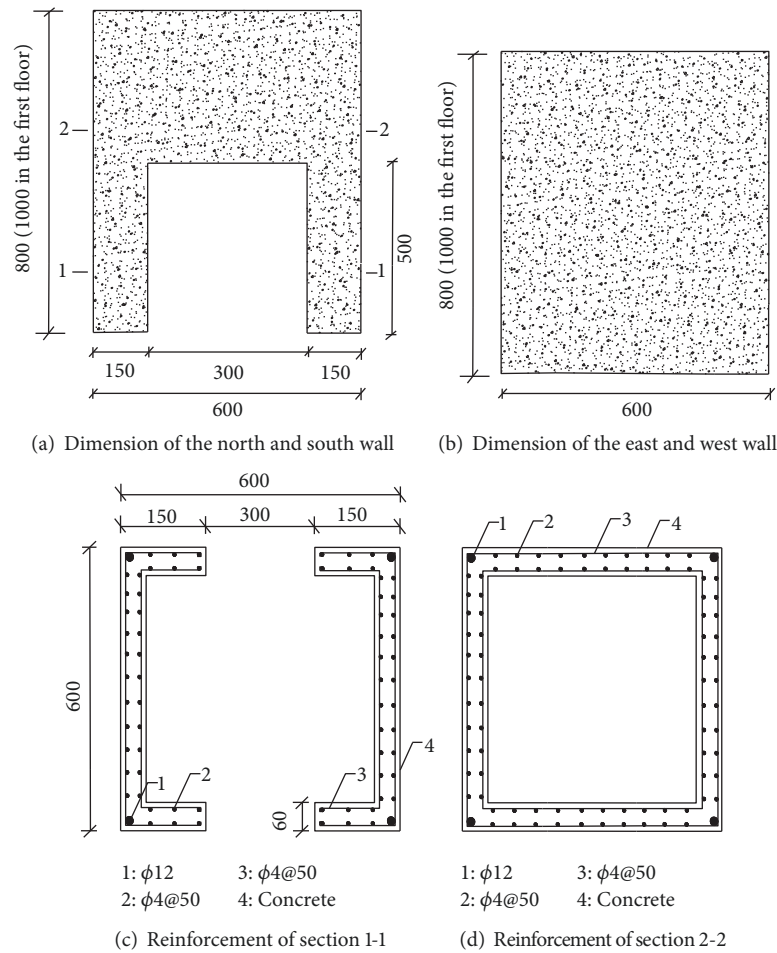
FIGURE 5: Detail of core tube (units: mm).

A square cross-section is used for the core tube, and the dimensions are shown in Figure 5. The thickness is 60 mm for the first two floors and 40 mm for the rest. Double-layer mesh reinforcing is arranged in the tube, including four 12mm diameter bars in the corners. For the actual structure, the cross-section indeed decreases along with the height. As the scale of specimen is reduced by similarity ratio, there is a small difference in dimension. For the convenience of construction, the using cross-section is identical.

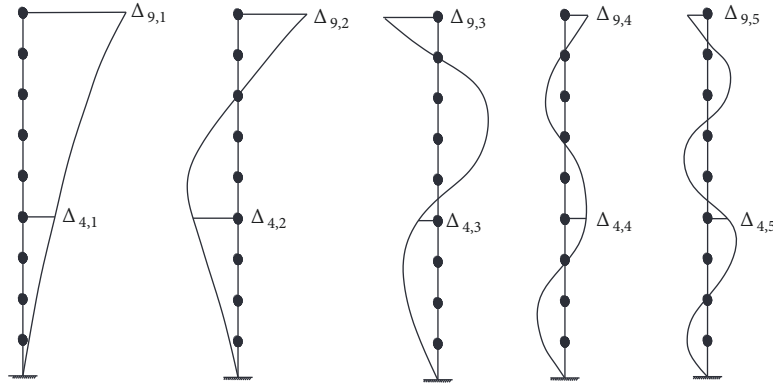
FIGURE 8: The first five mode shapes.

where Δ_9 and Δ_4 are the actual displacement applied on 9th and 4th floor; $\Delta_{9,i}$ and $\Delta_{4,i}$ are lateral displacement of i -th mode shape as shown in Figure 8; η_i is participation coefficients of i -th mode shapes.

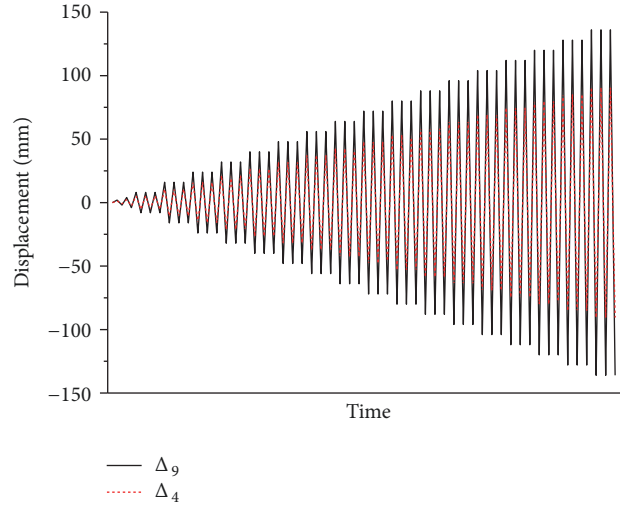
FIGURE 9: The history of loading program.

(3) The reverse cyclic loading applied by multipoint is proved to accurately consider the influence of higher mode shapes [19]. According to existing experimental equipment, two actuators were set up at the 4th- and 9th-floor slabs (see Figure 6). The displacement-controlled method was adopted, and Figure 8 shows the first five mode shapes. The amplitude of displacement is defined by (1) [29] and finally $\Delta_9/\Delta_4=1.5:1$. In the loading program, displacement increment at 9th floor is 8 mm per level, and three cycles are applied at each level as shown in Figure 9. Once the bearing capacity falls to 85% of the ultimate lateral load, or the specimen is unable to continue bearing axial forces, the test is regarded as finished.

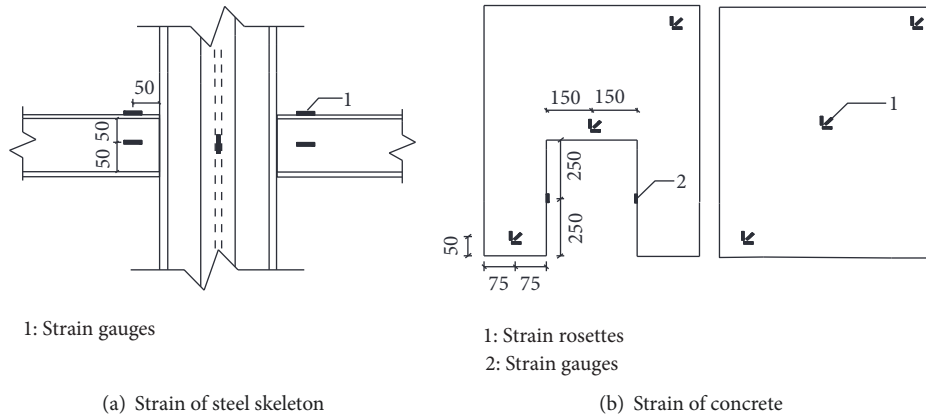
FIGURE 11: Arrangement of strain gauges and rosettes at the first and second floors (units: mm).

2.5. Instrumentation. The measuring points were defined to capture the overall response of the test model during loading as well as any local effects, such as CS columns and core tube yielding. Displacement sensors were mounted on the slabs of each story at the loading side. Due to the symmetry of cross-section, the components at 1st and 2nd floor in Figure 10(a) were selected for attaching strain gauges as shown in Figure 10(b), and the detail is shown in Figure 11.

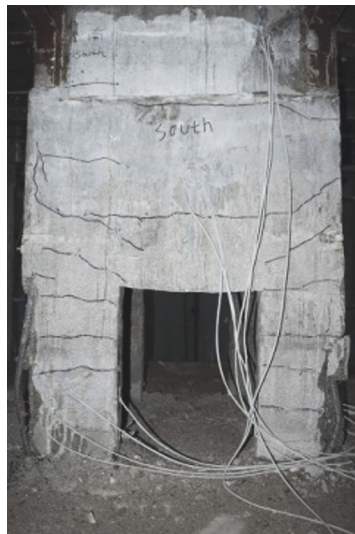
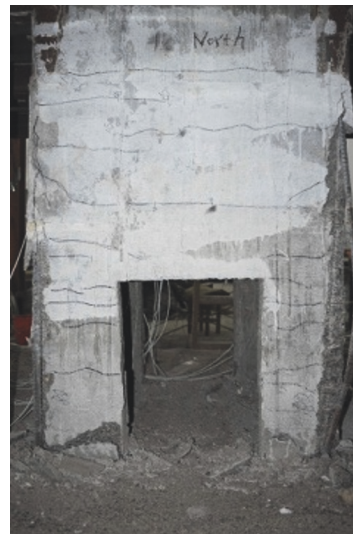
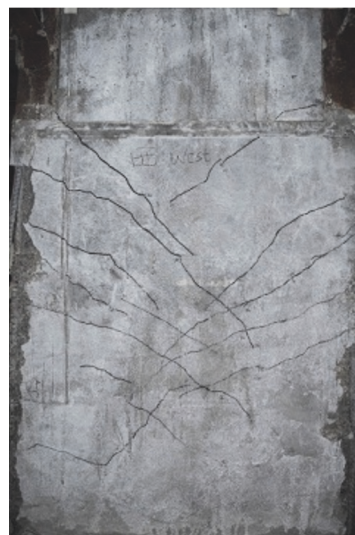
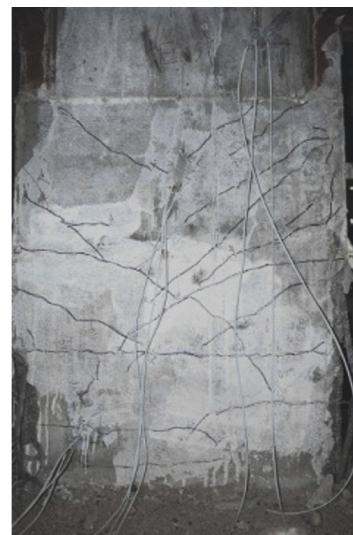
(a) The south wall

(b) The north wall

(c) The west wall

(d) The east wall

FIGURE 12: Cracks on core tube at the first floor.

Each component of the specimen exhibited various failure modes. The core tube exhibited relatively wide cracks and severe concrete crushing localized at the bottom. There were two types of cracks as shown in Figure 12; one was horizontal tension cracks, which mainly occurred on the north and south of core tube (perpendicular to the loading direction). Under the action of tension and compression, the concrete was seriously crushed, and the width of the cracks was approximately 10 mm (see Figures 12(a) and 12(b)). The other was oblique shear cracks, which mainly occurred on the west and east of core tube (parallel to the loading direction). Cracks gradually extended at 45° angle and eventually formed X-shaped intersecting cracks (see Figures 12(c) and 12(d)).

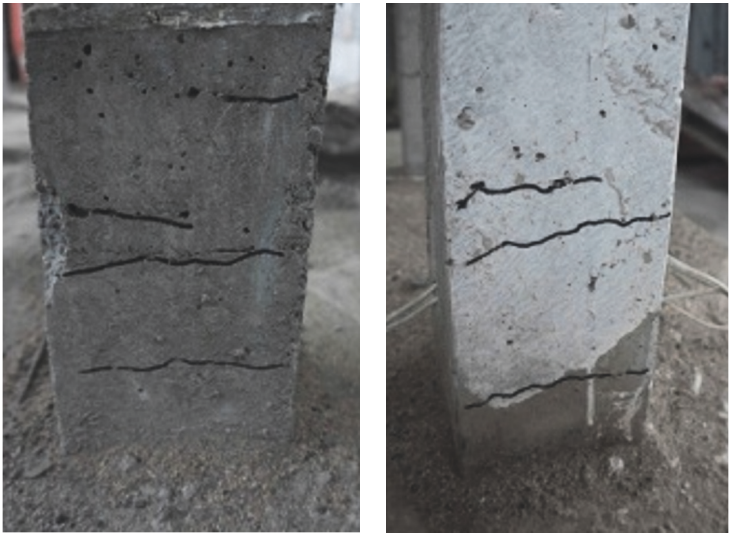
(a) The interior column (b) The corner column

FIGURE 13: Cracks on columns at the first floor.

Compared with the core tube, frame exhibited relatively few cracks as shown in Figures 13 and 14. Horizontal tension cracks occurred at the bottom of the column, with a small amount of concrete spalling. Shear cracks were observed in the joints particularly on the 1st and 2nd floors, which were accompanied by severe concrete crushing. The longitudinal reinforcements and steel skeleton were exposed and bent. As shown in Figure 15, horizontal cracks mainly occurred on the floor slabs. Concrete was crushed at the boundary between floor slabs and the core tube, and the steel plate was compressed and exhibited locally bulging.

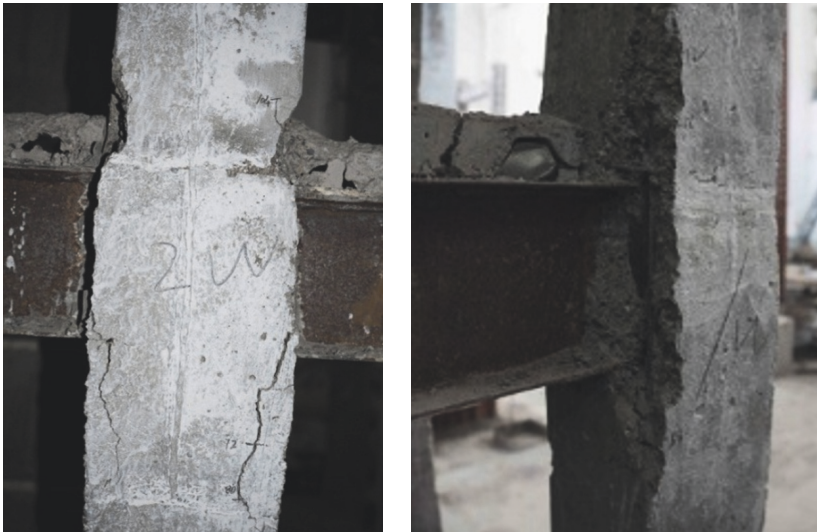
(a) The interior joint (b) The exterior joint

FIGURE 14: Cracks on joints at the second floor.

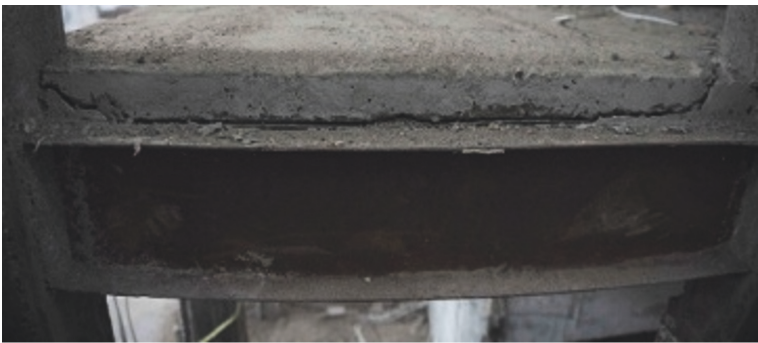
FIGURE 15: Cracks on slab at the second floor.

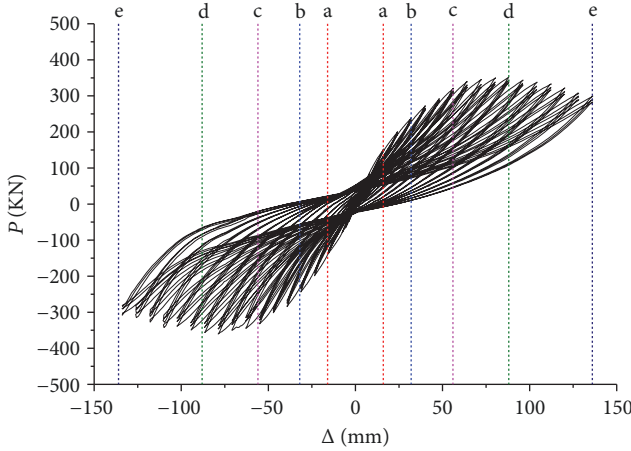
FIGURE 17: Hysteretic curve.

3.3. Hysteretic Curve. The hysteretic curve of the specimen indicates the relationship between base shear and top displacement. The hysteresis curve shape is between the spindle and the “S” form, as shown in Figure 17. The specimen generally exhibited three stages: yielding, ultimate, and failure stage. In the initial stage of loading, the specimen remains

The damage process of different components can be described as follows (zones a–e as shown in Figure 17): (a) when Δ_y was less than 16 mm, no damage occurred and the specimen was intact. Then minor damage occurred on the columns at first floor. (b) When Δ_y reached 32 mm, the core tube began to get damaged; however the columns did not develop further damage. (c) When Δ_y reached 56 mm, the core tube seriously got damaged; meanwhile the joints and floor slabs slightly got damaged. (d) When Δ_y reached 88 mm, the core tube failed and the damage degree of joints and slabs was aggravated. (e) When Δ_y reached 136 mm, the frame got into failure stage.

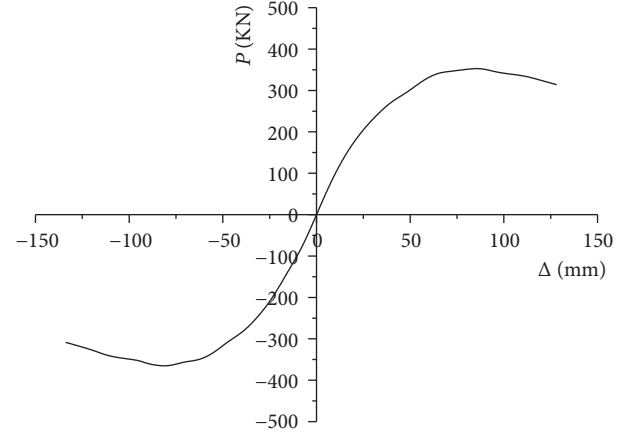
FIGURE 18: Skeleton curve.

3.4. Envelope Curve. The skeleton curve of the specimen is symmetrical in both positive and negative directions as shown in Figure 18. In order to confirm the yield and damage points, the equivalent energy method is adopted, as shown in Figure 19. A_1 and A_2 are the shaded areas. The loads and displacements at the yield point, limit point, and failure point are presented in Table 5, where P_y , Δ_y , P_{max} , Δ_{max} , P_u , and Δ_u are the loads and displacements at yielding, ultimate, and failure points, respectively.

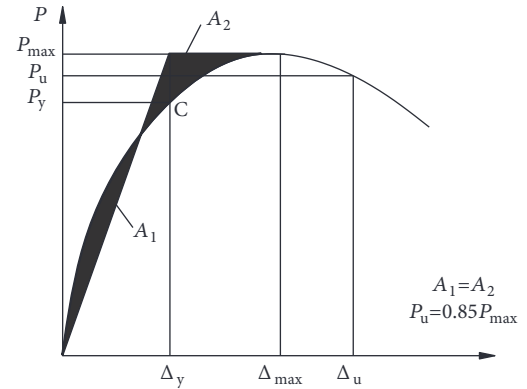
FIGURE 19: Equivalent energy method.

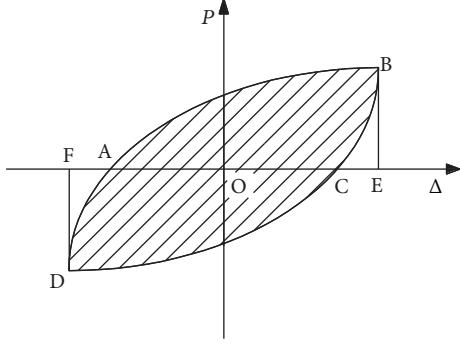
FIGURE 20: Hysteretic loop and energy dissipation capacity.

where Δ_u and Δ_y are parameters as described in Table 5, $S_{(\Delta ABC + \Delta CDA)}$ is the area of one hysteretic loop as shown in Figure 20, and $S_{(\Delta OBE + \Delta ODF)}$ is the total area of ΔOBE and ΔODF .

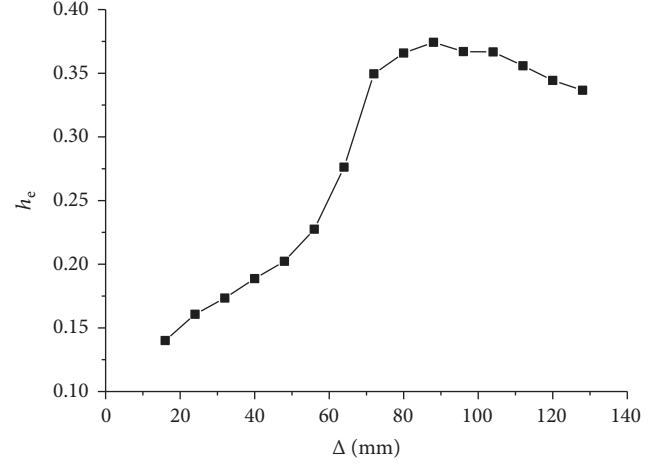
FIGURE 21: Energy dissipation capacity.

The displacement ductility coefficient μ is 4.27. The equivalent viscous coefficient h_e is shown in Figure 21, and the maximum value is 0.374 when Δ_g reaches 88 mm. It meets the requirement of $\mu \geq 3$ in Code for Seismic Design of Buildings (GB50011-2010). Compared with the results of other frames (L-shaped column composed of concrete-filled steel tubes frame [30]), the mentioned parameters are $\mu=3.31$ and $h_e=0.336$. It is proved that specimen for CS frame-RC core tube building allows larger inelastic deformation.

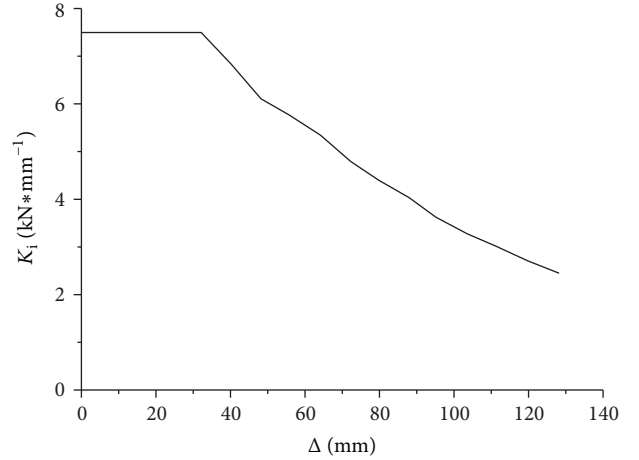
FIGURE 22: Degradation of stiffness.

The stiffness degradation is shown in Figure 22. It can be seen that the stiffness of the specimen remains constant in the initial stage, but it degenerates rapidly once the core tube damage. Platform segment shows the elastic stage of specimen, and the degradation reveals the cumulative damage of structure. Finally the stiffness degenerates for about 67.49%. Compared with the result of [30], in which stiffness degradation is 79.07%, CS frame-RC core tube buildings maintain larger stiffness even at failure stage.
