Research Article

Shaking Table Tests on Sliding Displacements of Loess Slope under Coupling Effect of Rainfall and Earthquake

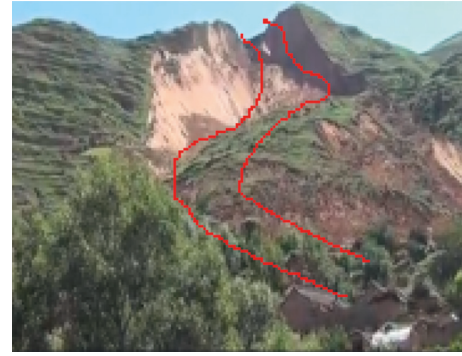
FIGURE 1: Loess landslide induced by the Min-Zhang Ms 6.6 earthquake.

The geological conditions of the landslides induced by M_{ZC}-Ms 6.6, shown as Figure 1, were analyzed. The prototype of the test model adopted one natural loess slope which lies in Shanzhidun Village, Lanzhou New District. The slope height is about 7 m, and the slope angle is about 20°. The soil is Malan loess (Q_3 loess), which is used to model the prototype for the test. The natural loess slope for five consecutive days of artificial rainfall test, including heavy, moderate, and light, and the total rainfall was about 684.5 mm. These results of the infiltration test showed that the maximum permeability depth of the slope was about 1290 mm and the minimum permeability depth was about 710 mm. The maximum humidity was 23%, and the minimum humidity was about 19% in the permeability area of the loess slope (detailed results will be published in another paper). Therefore, the test of the loess slope model adopted the results of the infiltration test in which the rainfall intensity was 15 mm/h and the total rainfall was 50 mm. The penetration depth of the slope surface was about 25 cm, and the moisture content was

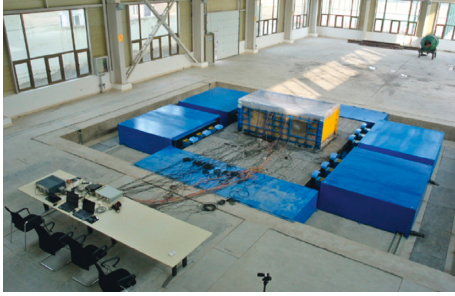
FIGURE 2: The large shaking table.

2.1. Introduction for the Large Shaking Table. The test adopted the large shaking table in the Lanzhou Institute of Seismology, China Earthquake Administration, as shown in Figure 2. The size is 4 m × 6 m, the maximum bearing capacity is 25 t, the maximum acceleration is 1.7 g, and the maximum speed is 1.5 m/s. Regular and irregular waves (including seismic waves and shock waves) can be input, and the range of effective frequency is 0.1 Hz~50 Hz. The test adopted a rigid sealed model box, whose inner box size is 2.8 m × 1.4 m × 1.8 m.

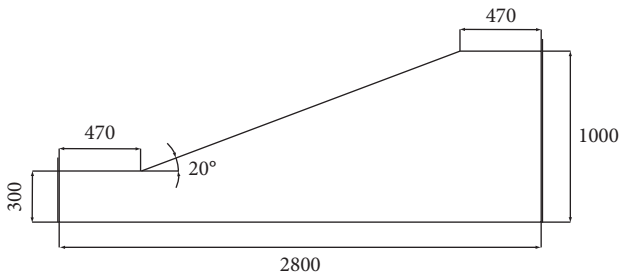
FIGURE 3: Size of the slope model.

2.2. The Size of Slope Model. The model is shown in Figure 3, and the width of the slope model is 1400 mm. Two layers of plastic foam plate (2 cm thick) were laid on the sides of the model to reduce the boundary effect along the direction of vibration.

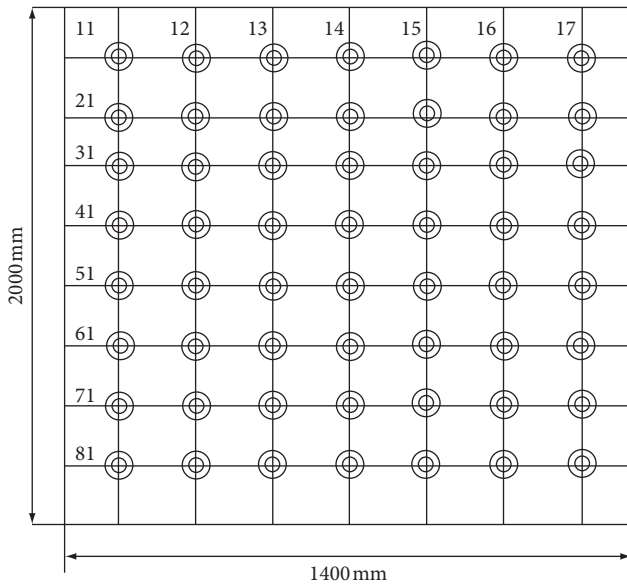
FIGURE 4: Layout of displacement measuring points for slope surface.

2.3. The Layout of Displacement Measuring Points for Loess Slope. The numbers of measuring points of the slope model are shown in Figure 4, which consists of 8 rows and 7 columns, total of 56 measuring points on the slope surface. The width of each column is 175 mm and the width of each row is about 222 mm.

4.1. The Monitoring Displacement of Loess Slope Model. The XTDIC displacement test system (optical measurement) of the Quanshi Software system (Shanghai) Co., Ltd., was adopted and the layout of the measuring point is shown in Figure 4. The displacement of loess slope was recorded under five operating conditions, which were loading waves of 600 gal, 700 gal, 800 gal, 976 gal, and 1300 gal, successively. The monitoring time of each input wave was about 50 s, and the instantaneous displacement of the measuring point in x , y , and z directions and the absolute displacement (namely, u_x , u_y , u_z , and u_a) can be recorded. Each operation was an independent testing process, it started at 0 s and ended at 50 s, and then the displacement would be retested in the next operation.

4.2. The Displacement Analysis of Loess Slope. The measurement point of the loess slope model (location of no. 76 measuring point in Figure 4) was studied because of the degree of macroscopic fracture and sliding distance on the

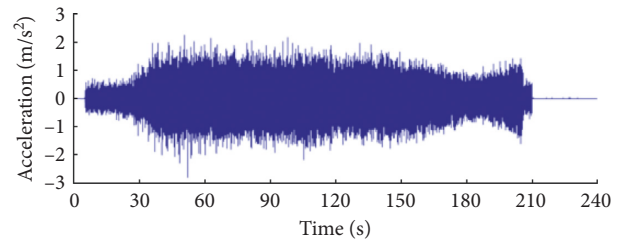
FIGURE 6: Sine wave.

2.6.1. *Sine Wave (3~50 Hz).* The sine wave was input by scanning frequency, and 20 gal (1 gal = 0.01 m/s²) sine wave was input to determine the natural frequency of the slope model. The time-history diagram of 200 gal sine wave acceleration is shown in Figure 6.

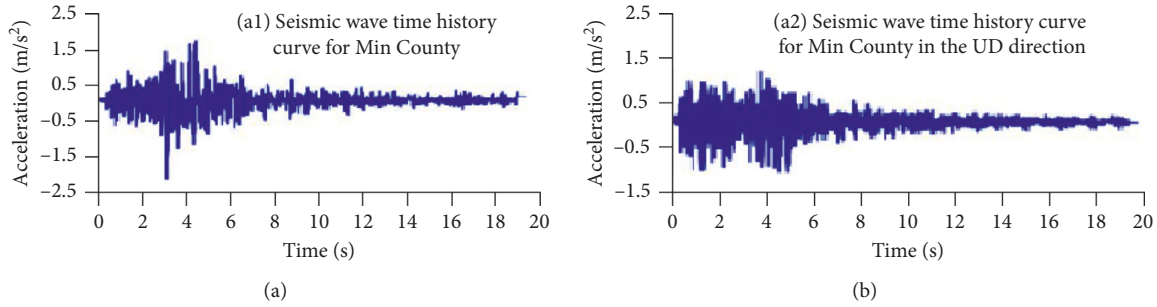
FIGURE 7: Seismic wave of Min County.

recorded in the strong ground motion station of Min County during the Min-Zhang Ms 6.6 earthquake on July 22, 2013. The wave consists of a vertical component and a horizontal component as shown in Figure 7.

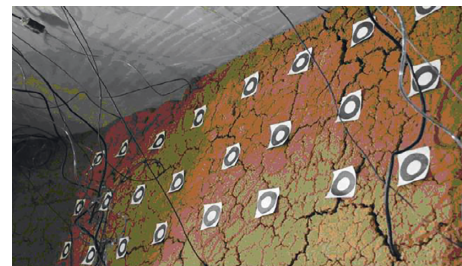
FIGURE 11: Loess slope surface at the 600 gal.

4.2.1. The Displacement of Loess Slope at the 600 gal. As the time of the seismic wave goes on, obvious cracks have appeared on the slope surface as shown in Figure 11. u_x , u_y , and u_z all are equal to 0 when the loading time is 0~23.6 s. However, u_x , u_y , and u_z are equal to 365.43 mm, -370.49 mm, and -2044.38 mm, respectively, when the loading time is 23.9 s and finally tends to be relatively constant. u_a is still equal to 0 under the loading wave condition. Figure 12 shows u_x , u_y , and u_z in 0~50 s.

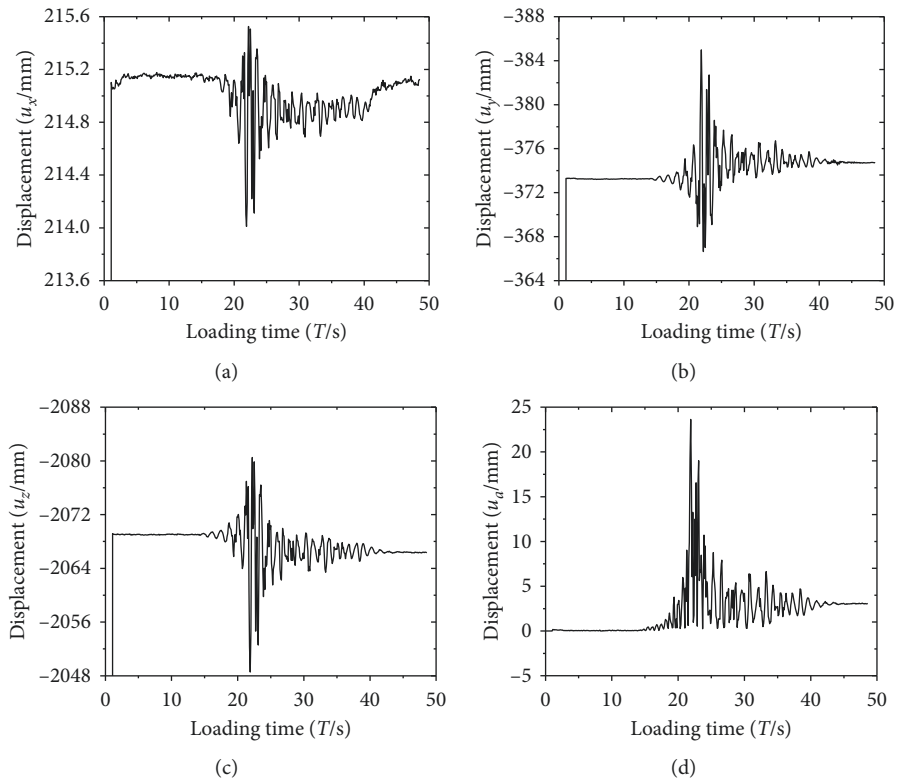
FIGURE 13: Variation of displacement with loading time.

4.2.2. The Displacement of Loess Slope at the 700 gal. u_x , u_y , u_z , and u_a are given at the 700 gal in Figure 13. As can be seen from the macroscopic picture, the cracks gradually increased and a rupture block appeared on the slope surface.

It can be seen from Figures 12–16 and 19–22 that all the maximum peak values of acceleration, u_x , u_y , u_z , and u_a appear during the loading time of 20–25s, where resonance might occur. u_z is far greater than u_x and u_y . As loading to 700 gal, u_x sharply reduces, $u_y > 0$, then appears to $u_a > 0$, and

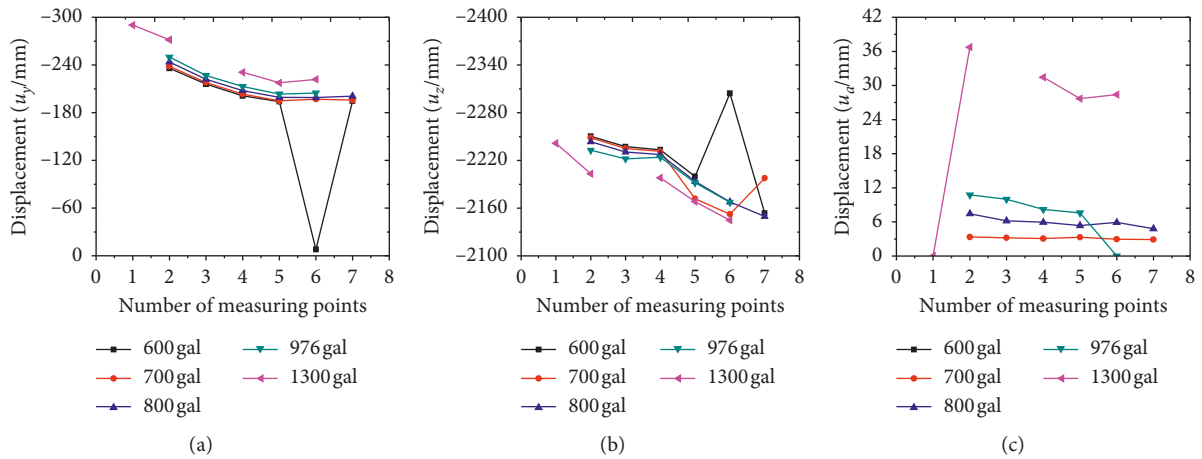
FIGURE 17: Variation of displacement with location.

4.3. Comparison of Displacement of Loess Slope in the Same Row. These measuring points (measuring points 1, 2, 3, 4, 5, 6, and 7 in Figure 17 refer to from no. 61 to no. 67 in Figure 4) were analyzed in order to study the position of the rupture slip on the slope surface. The values of all measuring points showed maximum displacement under the corresponding loading conditions. The displacement of no. 63 failed to read under the 1300 gal loading wave. The analysis of u_y , u_z , and u_a is given as presented in Figure 17.

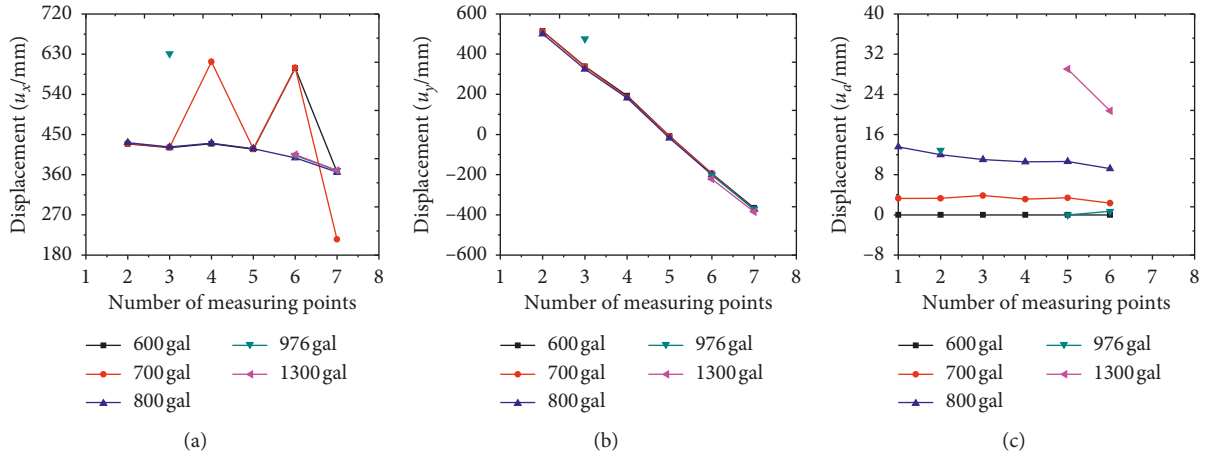
FIGURE 18: Variation of displacement with location.

4.4. Comparison of Displacement of Loess Slopes in the Same Column. With the same reason as above in Section 4.3, the measuring points in the sixth column were studied, and measuring points 1~8 referred to no. 16~no. 86 in Figure 4. The analysis of u_x , u_y , and u_a is given as shown in Figure 18.

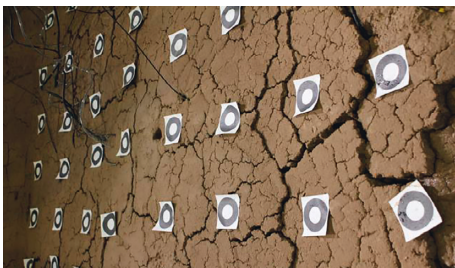
FIGURE 21: Loess slope surface at the 976 gal.

Figure 21 shows that the change of displacement in no. 66 is obviously different from the other; it indicates that the location is easily damaged, and the position is at first damaged from the image of loess slope model. u_z slowly increases as loading more than 600 gal. u_a sharply increases ($u_{amax} = 318$ mm) at the 1300 gal; it shows that the velocity of sliding blocks is far greater than the other, and the velocity of sliding blocks sharply increases with increase in loading intensity.

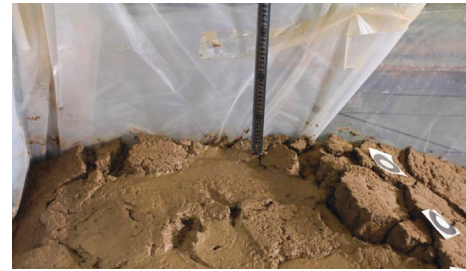
FIGURE 22: Loess slope surface at the 1300 gal.

Figure 22 shows that u_y reduces first and then increases from slope top to slope toe, and positive and negative changes of u_y indicate sliding blocks move along the curve. u_z gradually reduces from slope top to slope toe. The changes of u_y and u_z are very small for different loading waves. u_x sharply increases which indicates that sliding blocks appear on the slope surface.
