## Research Article

# A Control Method of Rock Burst for Dynamic Roadway Floor in Deep Mining Mine

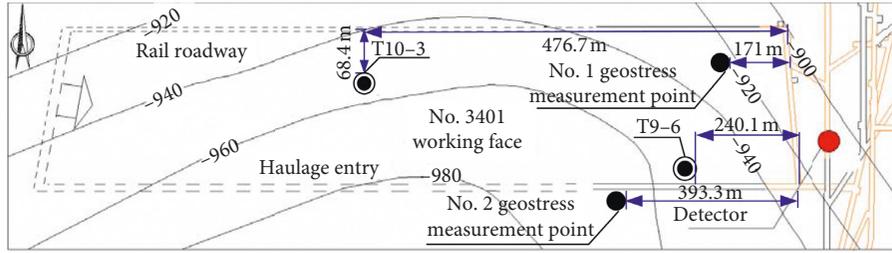
FIGURE 1: Layout of No. 3401 working face.

Figures 1 and 2 show that overall occurrence status of the No. 3 coal mine is controlled by the fold structure. The anticlinal structure greatly influences the No. 3 coal seam uplift, while the influence of synclinal structure is relatively small. The coal seam in the No. 3401 working face is greatly influenced by the anticline, and the geostress is large. Therefore, roadway excavation activity further increases the possibility of rock burst. Table 1 shows the results of a geostress test in the mining area.

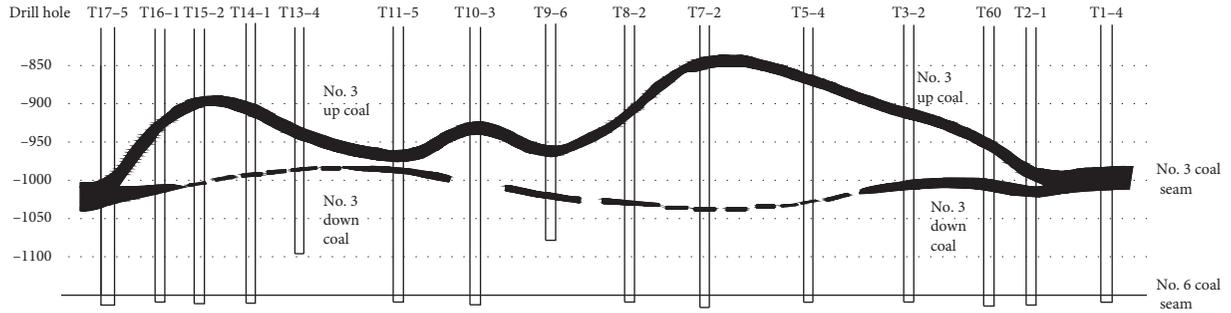
FIGURE 2: Macroscopic storage structure profile of No. 3 coal seam.

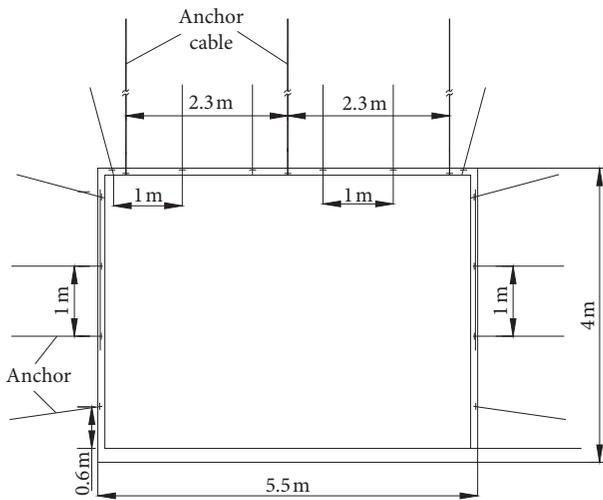
FIGURE 4: Layout of roadway support section.

The No. 3401 working face roadway haulage is a rectangular section. The roadway section width is 5.5 m, and the roadway height is 4.0 m.

Table 2 lists the roadway support parameters, while Figure 4 shows the roadway support section.

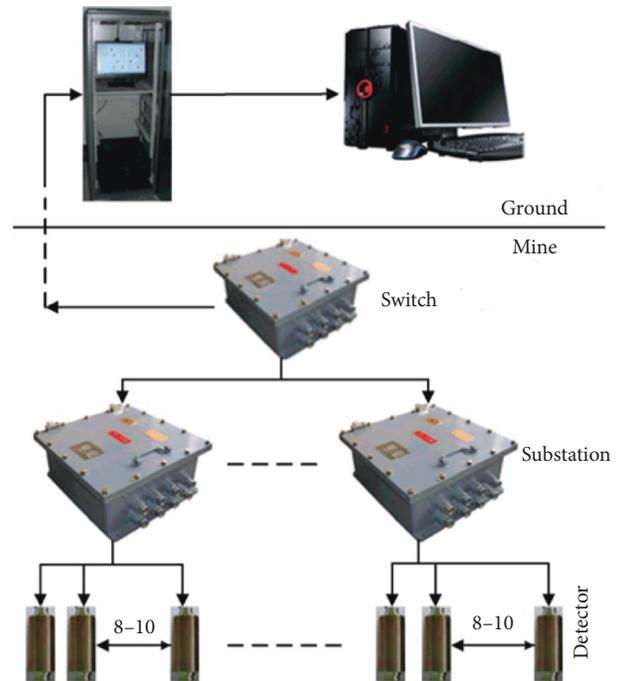
FIGURE 5: Microseismic monitoring system structure.

To monitor microseismic and rock burst events during the excavation, the high-precision SOS microseismic monitoring system was adopted in the mine. Figure 5 shows the structure of monitoring system, and Figure 6 shows the microseismic energy distribution of roadway during roadway haulage excavation.

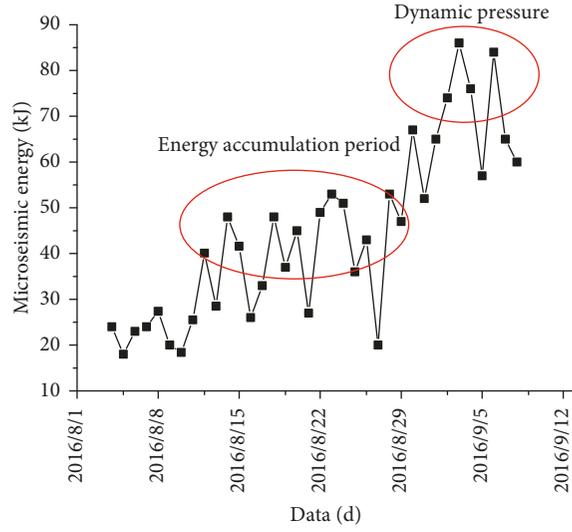
FIGURE 6: Microseismic energy distribution.

Figure 6 shows that during August 4 to 12, the early excavation stage for roadway was influenced by horizontal tectonic stress and excavation disturbance. Microseismic events occurred frequently, but relatively little energy was released; this was considered the energy accumulation period. During August 13 to 29, microseismic events were in the active stage and the significantly increased energy was released, with the roadway constantly advancing in the anticlinal axis. During August 30 to September 8, the energy released by microseismic events increased further and the roadway started exhibiting dynamic stress phenomenon when excavation reached 160 m. Three roadway floor rock burst events were recorded during this period. However, the

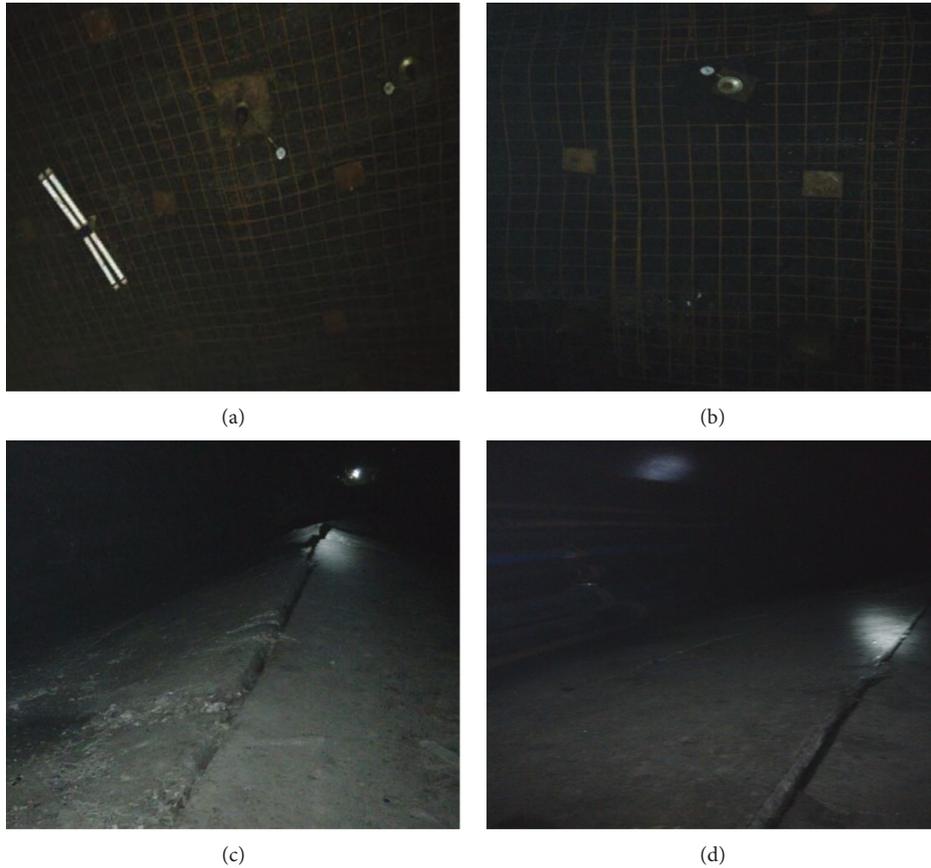
FIGURE 7: Deformation and failure of roadway-surrounding rock. (a) Roof. (b) Roadway side. (c) Floor. (d) Floor.

roadway roof and sidewalls had no obvious damage and maintained their integrity. Figure 7 shows the deformation and destruction of roadway-surrounding rock. These findings indicated the significance of studying roadway floor rock burst induced by mining disturbance, such as excavation disturbance and roof movement, to ensure mine safety.

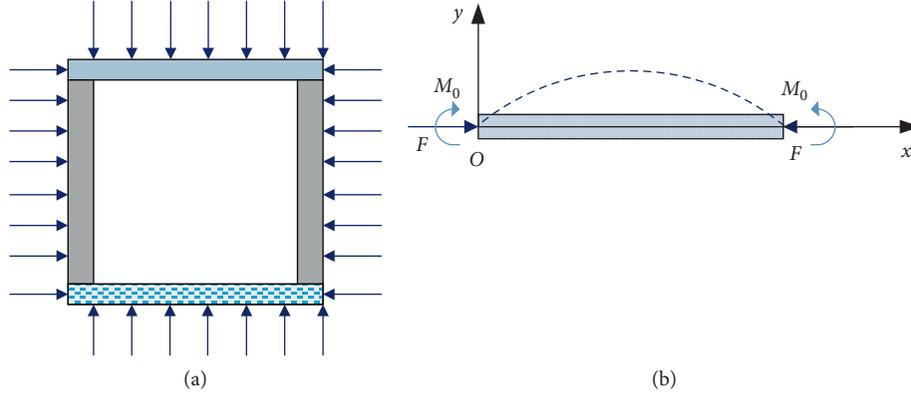
FIGURE 8: Simplified model of the roadway floor force. (a) Stress analysis of roadway-surrounding rock. (b) Stress analysis of floor deformation.

recorded as  $L$  with the unit length to analyze the stress, as shown in Figure 8(a). The stress analysis of floor deformation is shown in Figure 8(b).

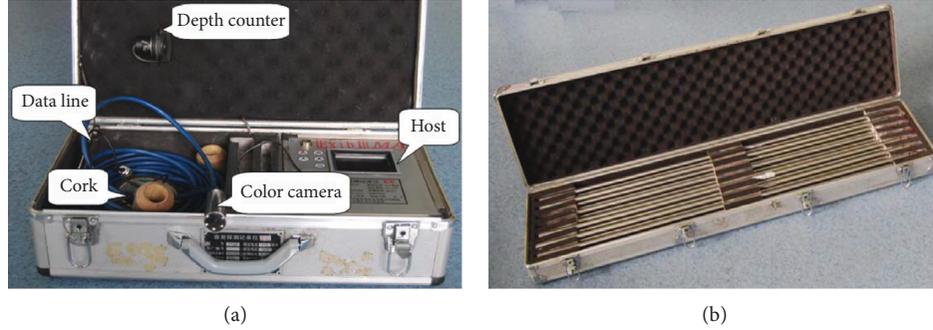
FIGURE 9: YTJ20 borehole detection recorder. (a) Detection recorder host. (b) Guide rod.

detection recorder was used to detect cracks and separation in the roadway-surrounding rock. The recorder uses a high-resolution color peeposcope and LCD display. It can work continuously for 12 hours, achieving real-time image display and recording and storage with small volume, light weight, and simple operation. The borehole detection recorder and its main parameters are as shown in Table 3 and Figure 9.

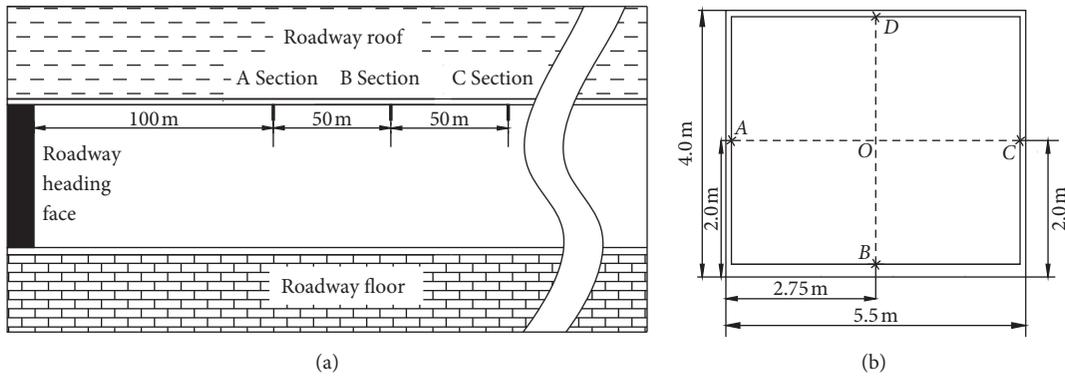
FIGURE 10: Schematic diagram of detection section site layout.

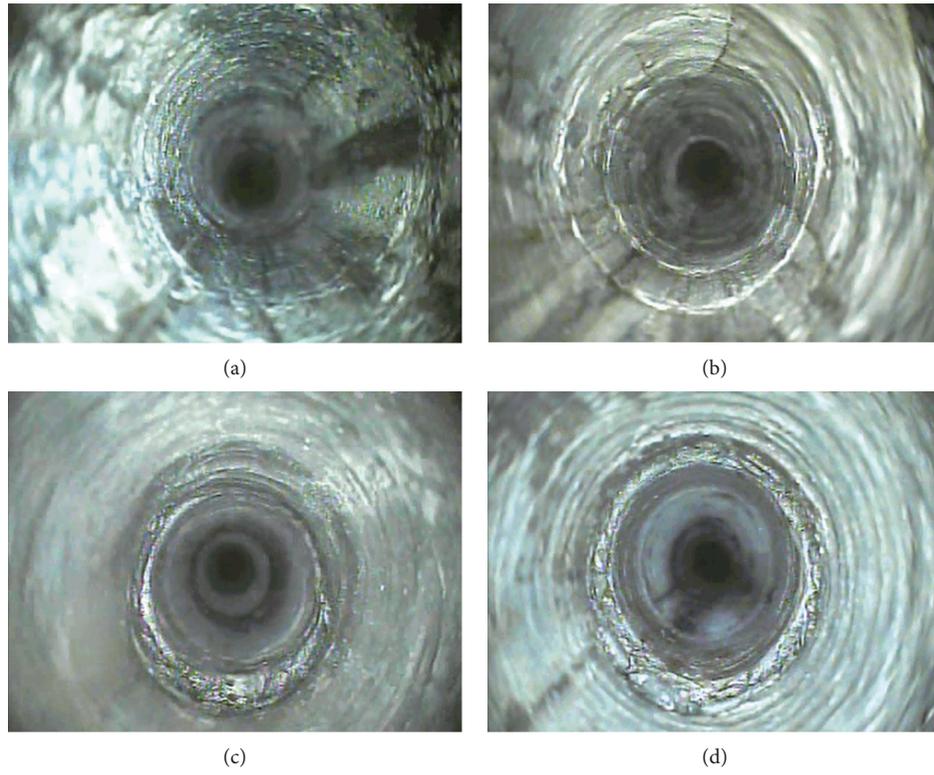
FIGURE 11: Video capture of the roof detection borehole. (a) Intact roof strata. (b) Fracture. (c) Crack. (d) Broken.

After the detection was completed, video capture of the roadway roof, sidewalls, and floor was extracted as shown in Figures 11–13.

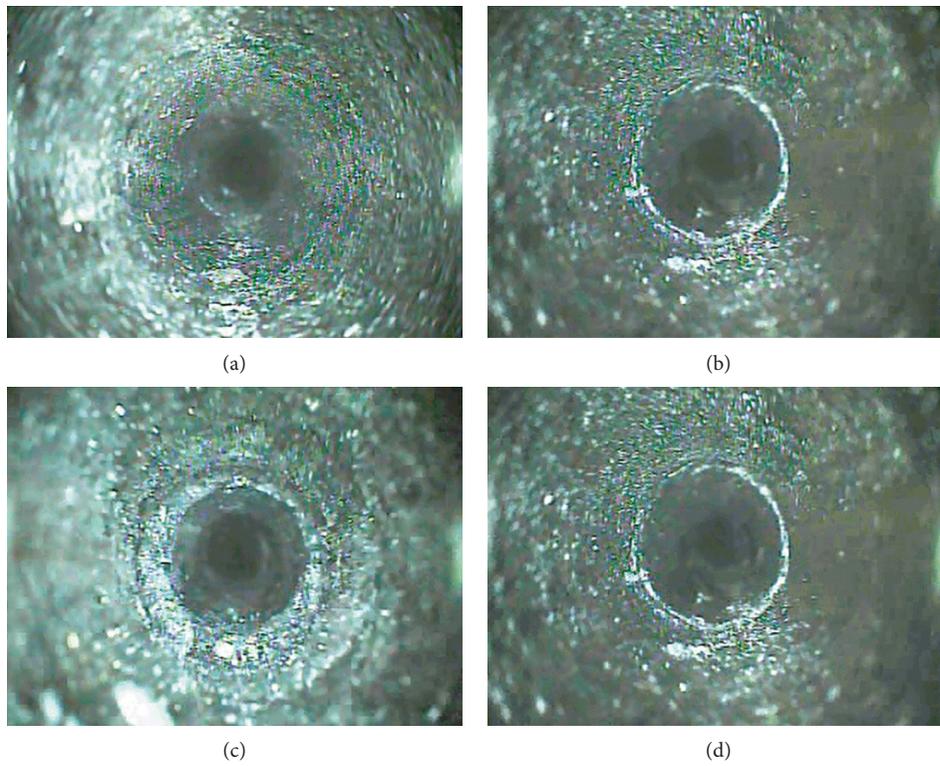
FIGURE 12: Video capture of the roadway side detection borehole. (a) Complete coal seam. (b) Fracture. (c) Crack. (d) Broken.

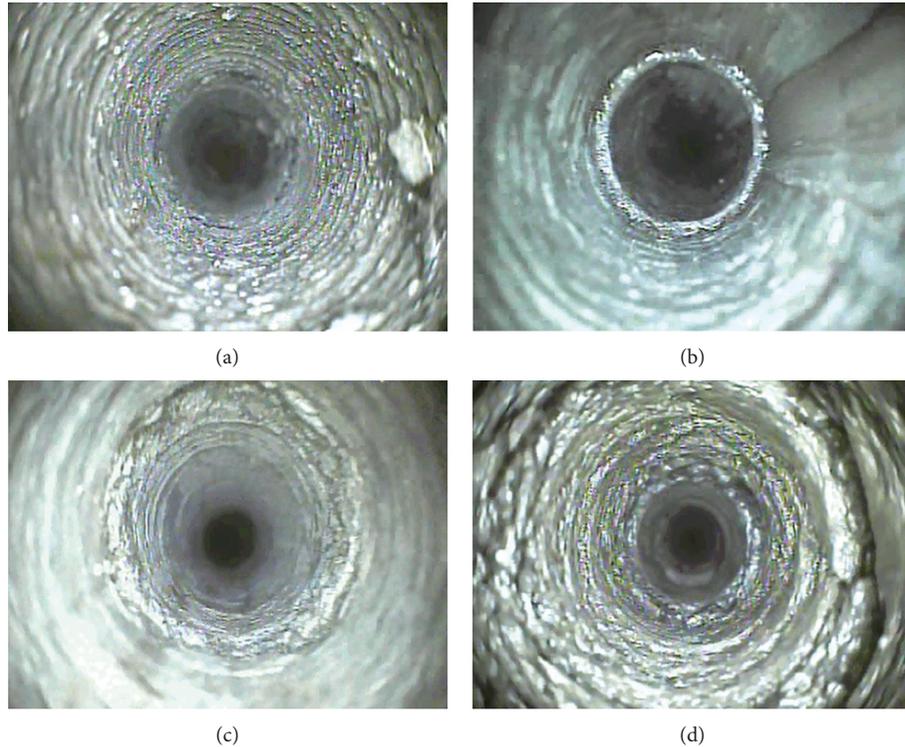
FIGURE 13: Video capture of the roadway floor detection borehole. (a) Complete floor rock stratum. (b) Fracture. (c) Crack. (d) Broken.

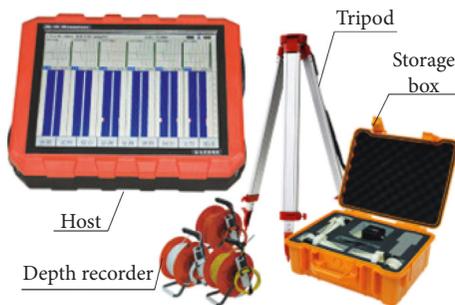
FIGURE 14: Mine ultrasonic transmitter.

By using the borehole recorder to detect destruction of roadway-surrounding rock, fracture distribution of the surrounding rock was analyzed. An ultrasound transmitter was used to detect failure destruction in the surrounding rock between adjacent boreholes. Main parameters of mine ultrasonic transmitter are shown in Table 5 and Figure 14. The transmitter-monitoring point was identical with the borehole point. Firstly, borehole detection was carried out. Secondly, transmitter detection was carried out without rearranging the measuring points. Finally, rupture of surrounding rock occurred along the borehole from the outside to inside. The fracture area between adjacent boreholes was connected by using a spline curve, and the area between fracture areas was regarded as the complete area, as shown in Figure 15.

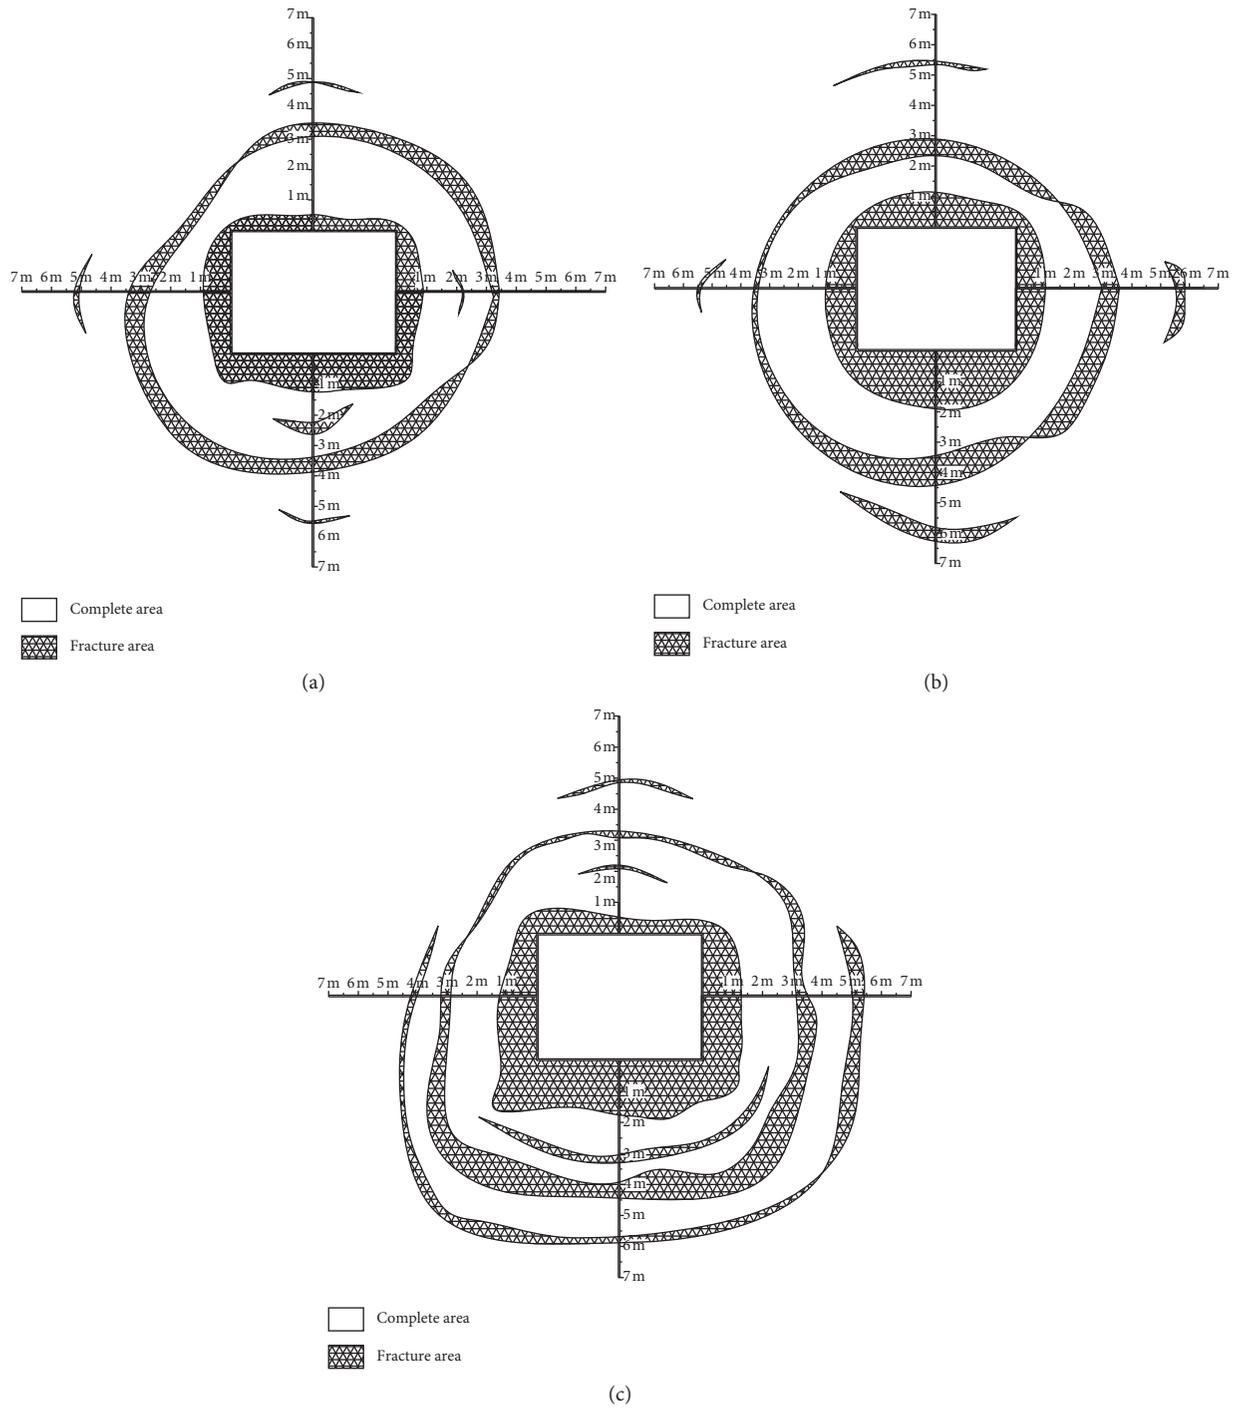
FIGURE 15: Fracture distribution of the roadway-surrounding rock. (a) A Section. (b) B Section. (c) C Section.

Figure 15 shows that the fracture area of roadway-surrounding rock gradually narrowed from its width along the borehole axis direction. The closer the detection section is to the anticline axis, the more serious the fracture in the surrounding rock. Sections A, B, and C in the roadway can be divided into two, two, and three fracture areas, respectively. Roadway-surrounding rock damage was most serious in the range of 1 m–2 m. The damage was mainly breakage and fracturing, and the scope was called the loose area. The second fracture circle was 3 m–4.5 m and mainly

consisted of cracks and fissures. Along the borehole, the third fracture circle was 5.5 m–6 m. Sections A and B had only a few cracks in the roadway-surrounding rock. In addition, the fracture distribution for roadway floor was more serious than the distribution for roadway roof and sidewalls based on comparison of the roadway-surrounding fracture.

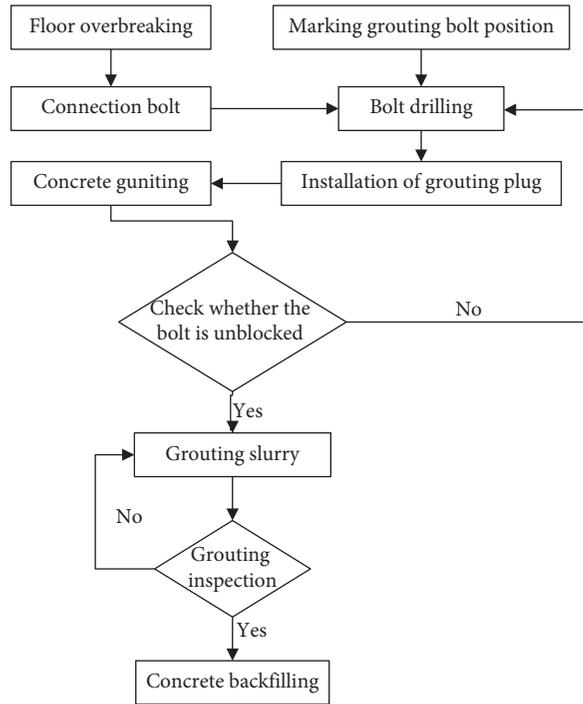
FIGURE 16: Construction flowchart of the roadway floor.

rock burst, while the support parameters for roadway roof and sidewalls remain unchanged. The support parameters optimization processes for the roadway are shown in Figures 16 and 17.

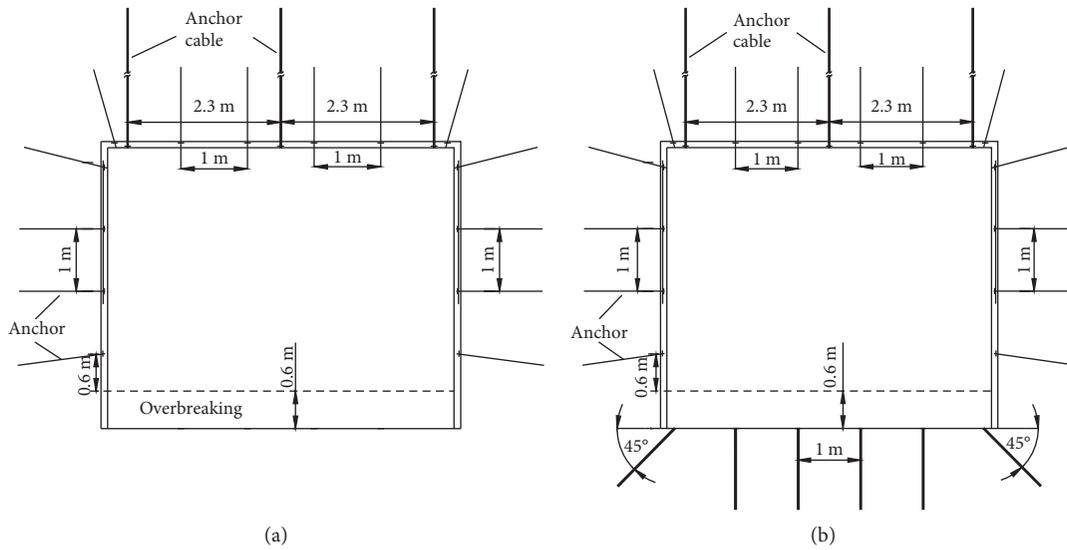
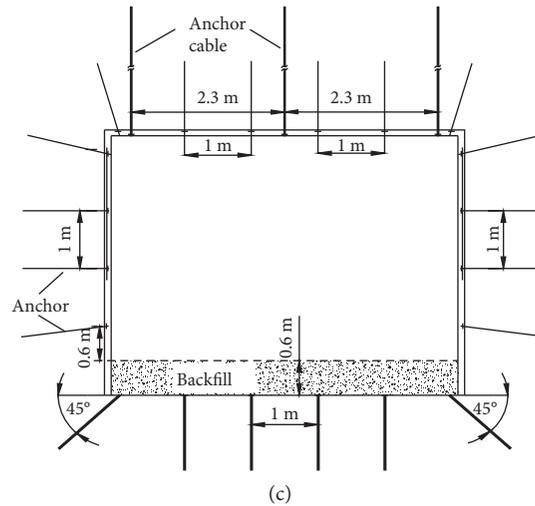
FIGURE 17: Roadway support parameter optimization design diagram. (a) Overbreaking. (b) Bolting and grouting (c) Backfill.

Concrete of strength grade C40 was used to backfill the overbreak portion of roadway floor, as shown in Figure 17(c).

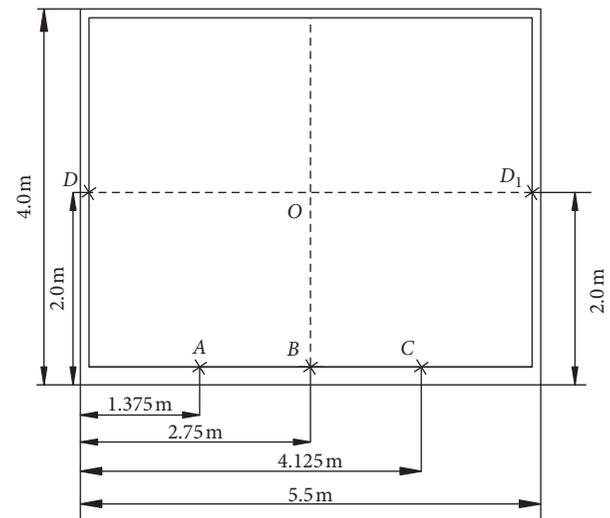
FIGURE 18: Monitoring point layout for the roadway surface.

point  $B$  was located at 2.75 from the floor to roadway side. Monitoring points  $D$  and  $D_1$  were located at 2.0 m from the roadway side to floor, as shown in Figure 18.

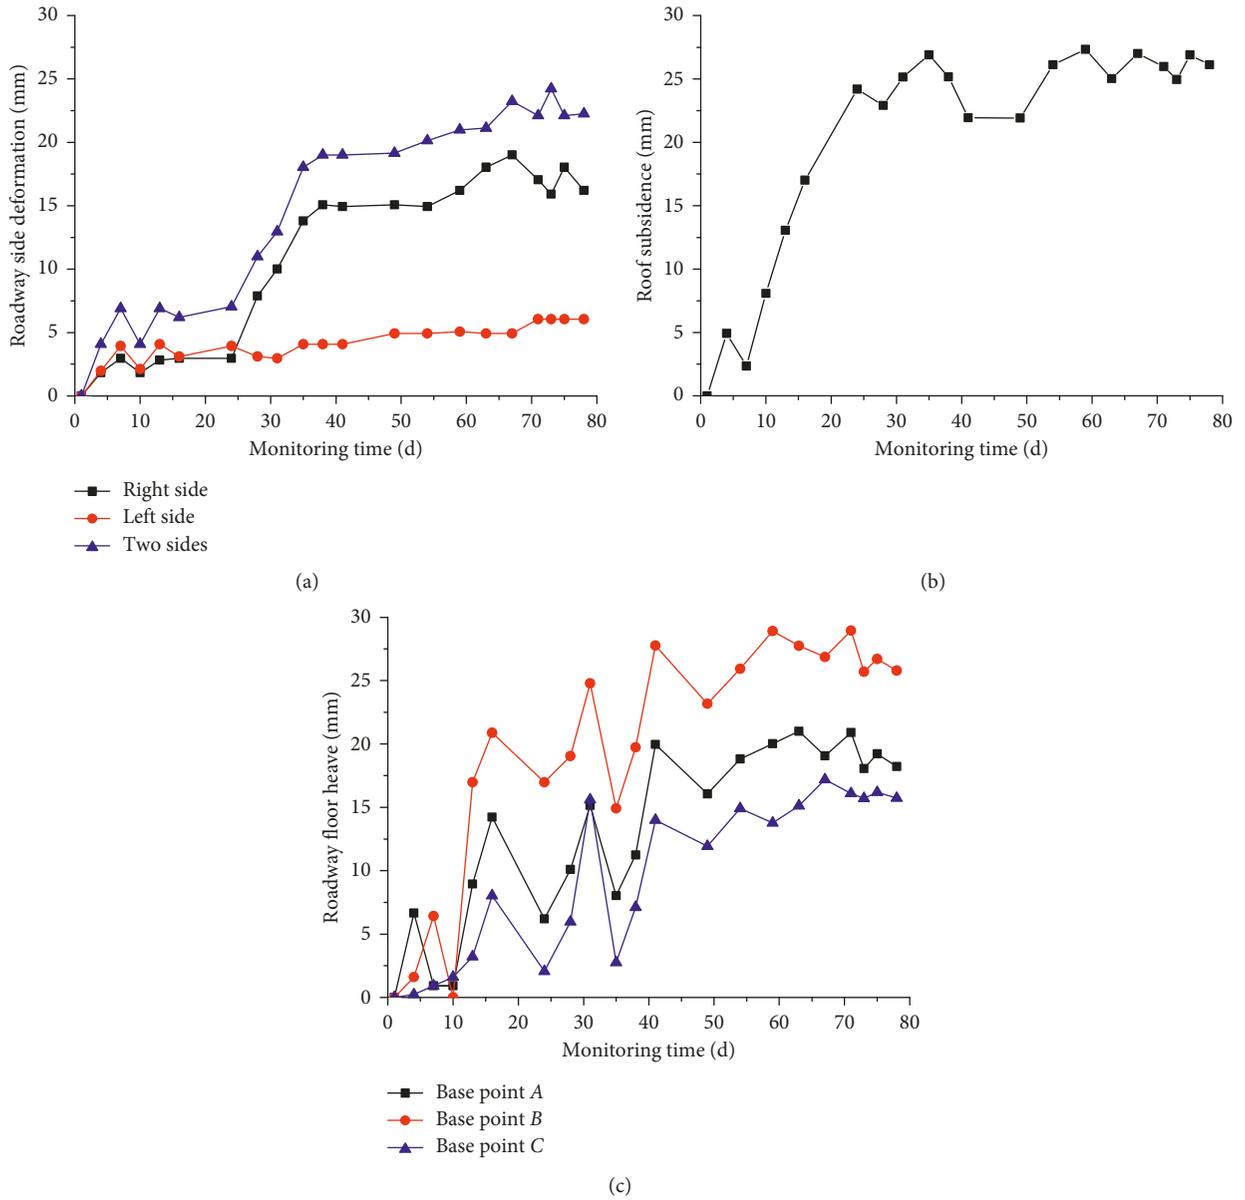
FIGURE 19: Displacement distribution curves of roadway-surrounding rock. (a) Roadway sides. (b) Roof. (c) Floor.

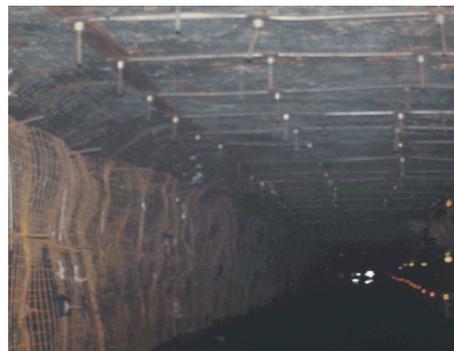
FIGURE 20: Roadway support parameters optimization effect.

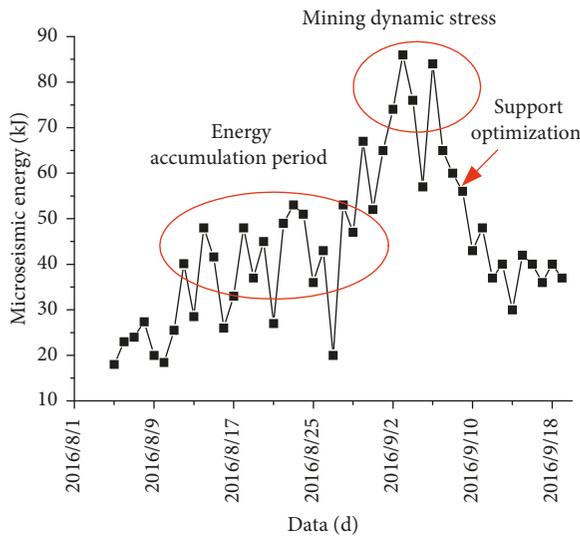
FIGURE 21: Distribution of roadway microseismic energy.
