Research Article

A Novel Experimental Technique to Simulate Shock Behaviour and Bursting Failure of Roadways

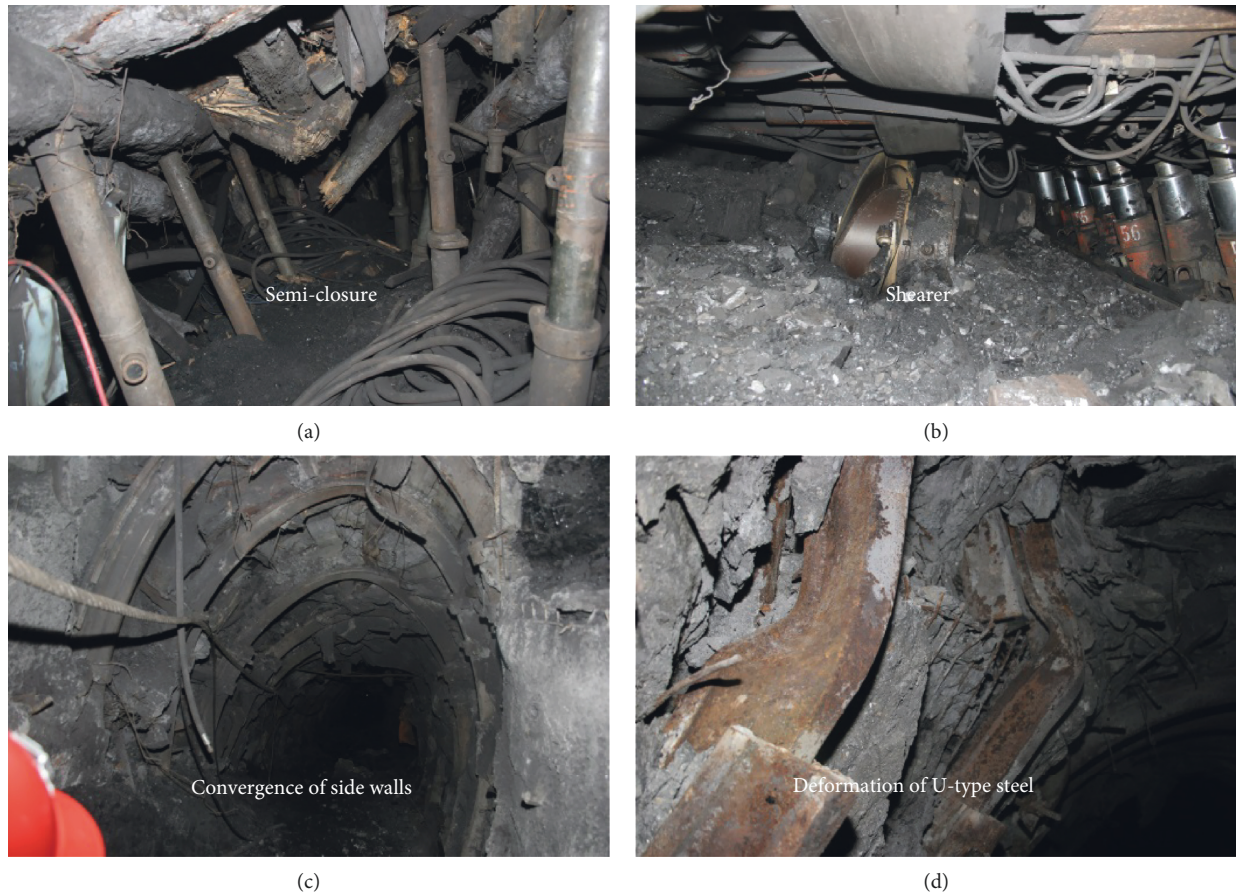
FIGURE 2: Photos of rockburst damage in Xing'an Coal Mine, roof subsidence and floor heave (a), coalface damage (b), convergence of two side walls (c), and damage of U-type steel (d).

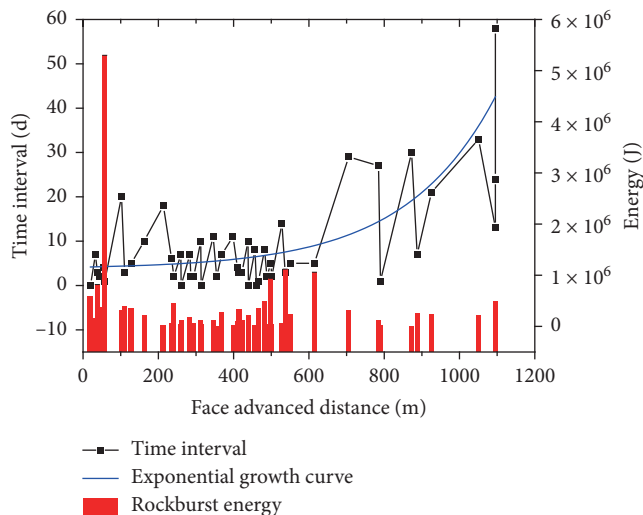
FIGURE 3: Time interval and the energy of rockbursts regarding the advanced distance of the coalface in Yanbei Coal Mine [7].

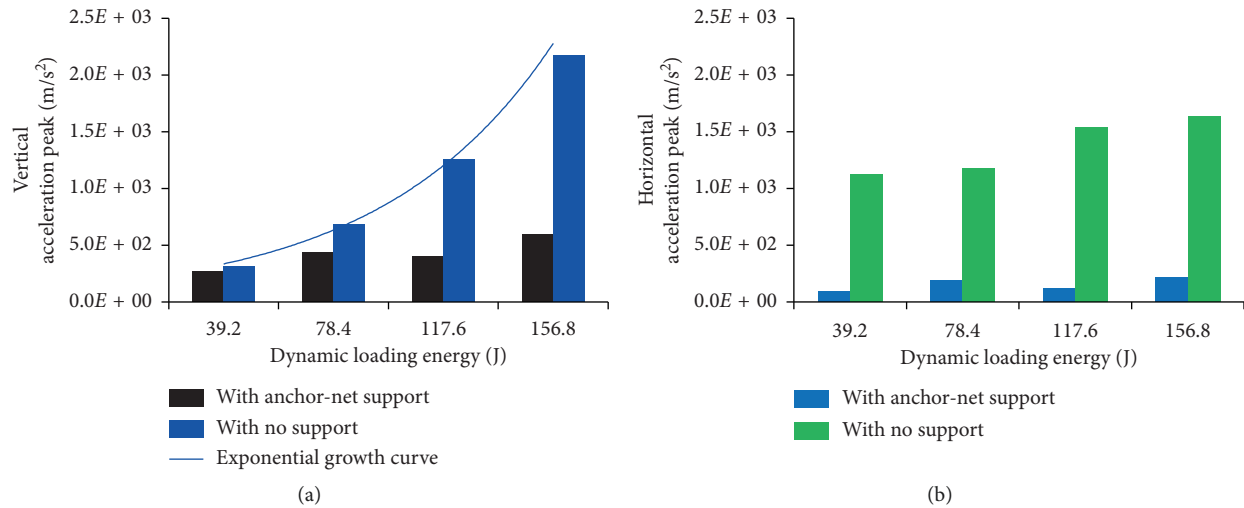
FIGURE 7: Variations of acceleration peaks in vertical (a) and horizontal (b) directions at different dynamic loading stages.

of roadway sections were recorded under different dynamic loads. Acceleration signals from the impact plate and the two roadway sections at different dynamic loading stages are demonstrated in Figures 6 and 7 depicts the changes in acceleration peak of roadway sections with and without the support under dynamic loads. When the lifting height of the drop hammer was increased, the vertical and horizontal acceleration amplitudes monitored by using two accelerometers on the impact plate gradually increased. Meanwhile, acceleration amplitudes of the two roadway sections also increased in vertical and horizontal directions. Significant differences appeared between acceleration signals measured in the two roadway sections with and without anchor-net support. This phenomenon showed that the anchor-net support could change the shock behaviour of the roadway under dynamic loads. That is, the acceleration amplitude of the roadway section without the support increased obviously with the increase of dynamic loading energy, while the acceleration amplitude of the roadway section with the anchor-net support had no obvious increase, especially in the horizontal direction. Under the first three dynamic loads, no failure occurred as the amplitude of shock acceleration of the modeled roadway increased. However, when acceleration amplitude increased to a certain level at the time of the fourth dynamic loading, the unsupported roadway section underwent a sudden failure process, whereas the roadway with anchor-net support displayed no failure. Both the vertical and horizontal acceleration peaks of the unsupported roadway section were higher under the fourth dynamic loading, manifesting the dynamic nature of the bursting failure event. However, the roadway section with the anchor support still had small acceleration peaks at that time. This meant that the shock resistance of the roadway was increased by the anchor-net support.

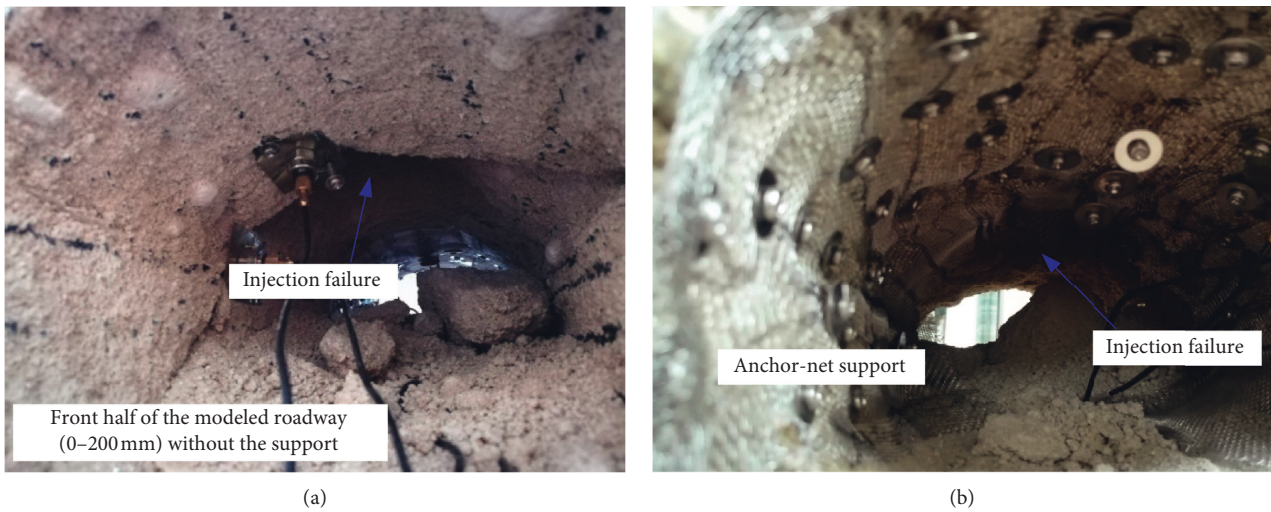
FIGURE 10: Surface scenes after bursting failure: (a) roadway section with no support, (b) roadway section with the anchor-net support, (c) large pit after the injection, (d) outline of the injection pit, and (e) bottom of the injection pit.

Rockburst represents a sudden failure behaviour of the whole roadway structure. The damage includes the surrounding rock and the support units. A GX-3 high-speed camera was used to capture the failure process of the modeled roadway. A few images captured from the video are presented in Figure 9. It is a sudden failure with no pre-announcement and pre-event dilatation before the resistance of the roadway was exceeded. During this ejection process, a large piece of fragments jetted out at a high speed with a crisp and loud sound. Figure 10 shows the surface scene after bursting failure. It can be observed that a deep pit was formed after the fragment ejection. Because dynamic stress waves had been generated both in vertical and horizontal directions by using the impact plate with a slant face, the axial of the fan-shaped pit had an angle above the vertical

(Figure 10(d)). In the tests, bursting failure only occurred in the unsupported roadway section. However, the roadway section with the anchor-net support was still in good condition. It can be concluded that the back roadway section with anchor-net support had higher shock resistance to dynamic loads. Hence, the resistance of the support is decisive for the occurrence of rockbursts in underground roadways (in view of different shock behaviour and bursting failure of roadway sections with and without the anchor-net support systems).
