# Pseudodynamic Testing of Buildings Retrofitted with External Steel Reinforced Concrete Frames to Increase Lateral Strength for Earthquake Damage Prevention

In this study, a new technique for seismic retrofitting via the attachment of an “external steel reinforced concrete frame” (ESRCF) system was developed to strengthen medium-to-low-rise reinforced concrete (RC) buildings. Two methods (bolting and welding) were developed to connect existing RC frames and external strengthening elements; these methods are technically and practically suited to various construction conditions. The retrofitting method developed in this study can be used to perform seismic strengthening construction, while residents continue to live within the building. The method is categorized as a “strength design approach” implemented via retrofitting, allowing the lateral ultimate load capacity of RC buildings, whose failure mode is shear, to be increased easily. Test specimens were designed based on an existing RC building in Korea lacking seismic data and then strengthened using the ESRCF system. Pseudodynamic and cyclic loading tests were conducted to verify the effects of seismic retrofitting. In total, fo

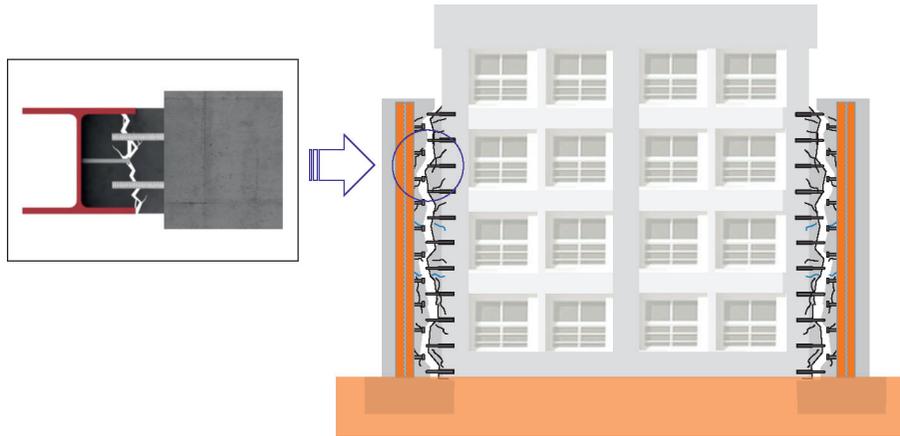
FIGURE 1: Drawbacks of the conventional chemical lap-splicing method (i.e., cracks in the concrete surface), which uses a steel rebar for connecting existing reinforced concrete (RC) frames to external strengthening elements.

The widely used chemical lap-splicing method, which employs steel reinforcing bars (rebar) to connect existing RC frames to external strengthening elements, inevitably leads to cracks in the concrete surface during an earthquake (Figure 1) due to insufficient ductility capacity of the joint concrete. This cracking prevents transmission of the earthquake load from the existing structure to the strengthening system; thus, successful seismic retrofitting is unlikely [7]. The ESRCF system was proposed to improve structural integrity compared with the conventional chemical lap-splicing method.

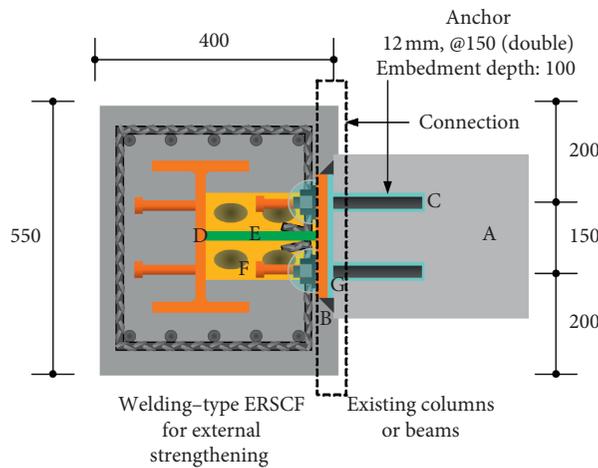
FIGURE 2: Detailed diagram of a connection element and technical details of the welded ESRCF strengthening system.

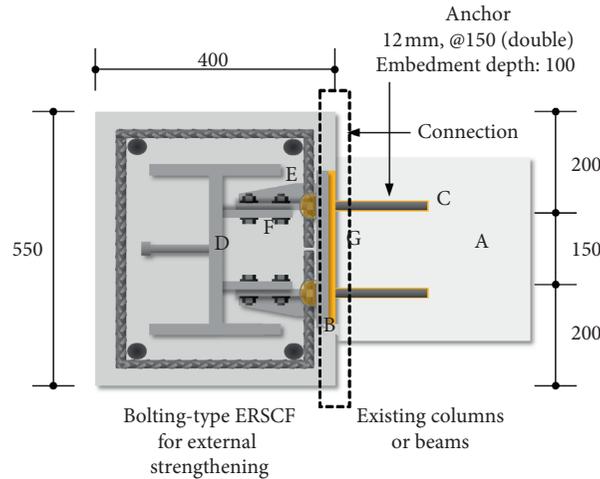
FIGURE 3: Detailed diagram of a connection element and technical details of the bolted ESRCF strengthening system.

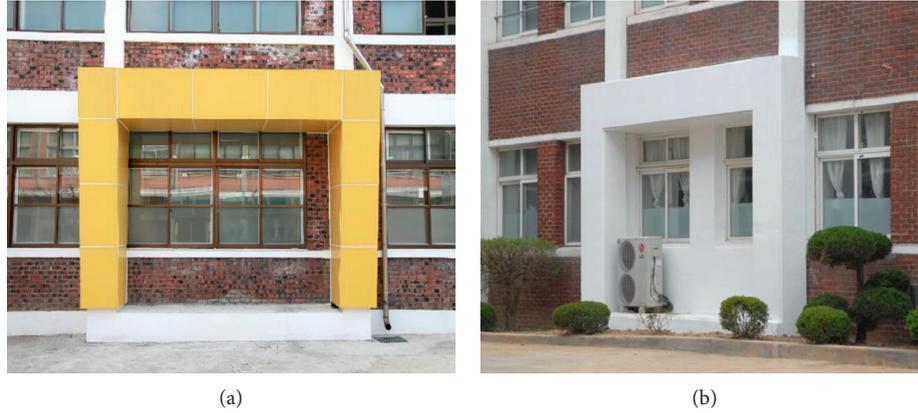
FIGURE 4: Postconstruction image of the external steel reinforced concrete frame (ESRCF) system.

*2.3. Postconstruction Image of the Proposed ESRCF System.* Figure 4 shows a postconstruction image of the proposed ESRCF system. The retrofitting method developed in this study can be implemented for seismic retrofitting construction, while residents continue to live within the building. The method represents a “strength design approach” implemented via retrofitting, to easily increase the ultimate lateral load capacity of RC buildings lacking seismic data, which have shear failure mode.

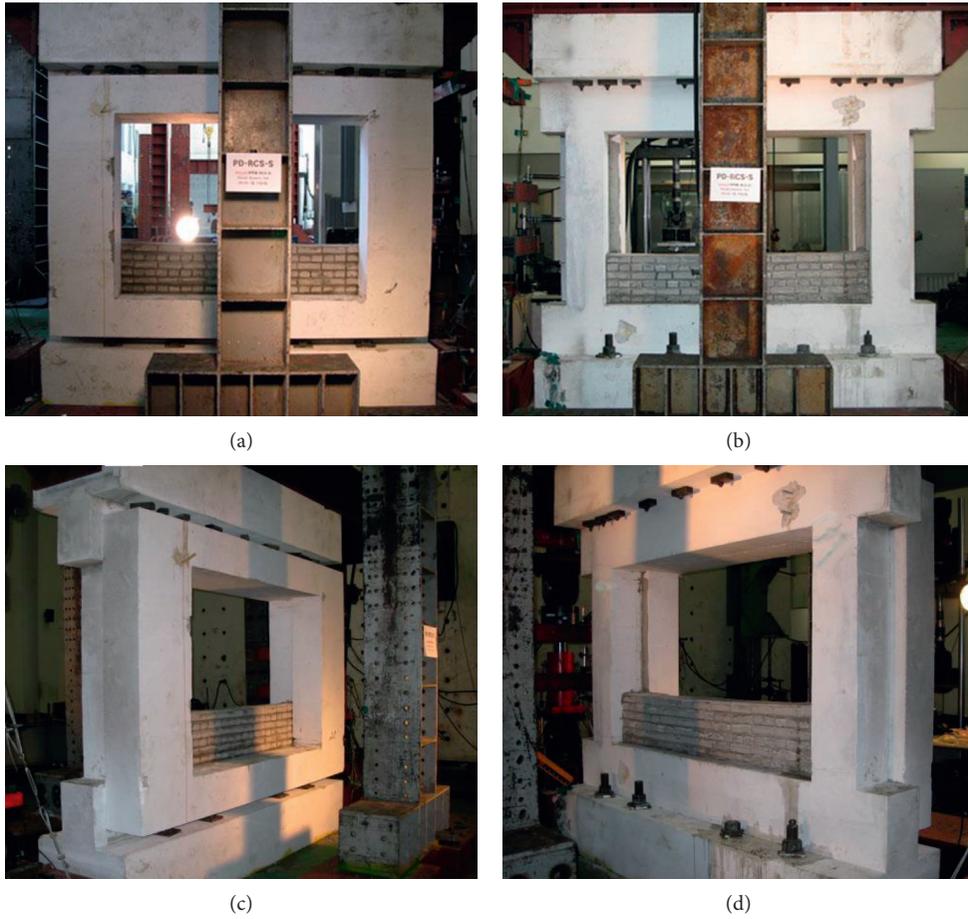
FIGURE 5: Detailed configuration of the test specimens strengthened with the ESRCF system. (a) Front view; (b) rear view; (c) front isometric view; and (d) rear isometric view.

The configurations of the scaled-down specimens are shown in Figures 5 and 6. The purpose of the tests was to verify the seismic strengthening effectiveness of the ESRCF system, in terms of maximum response strength, response displacement, degree of earthquake damage, and hysteresis in the lateral load-drift relationship, compared with the control specimen. Specimens consisting of columns and beams were designed according to the guidelines for load-carrying capacity of the JBDPA [6].

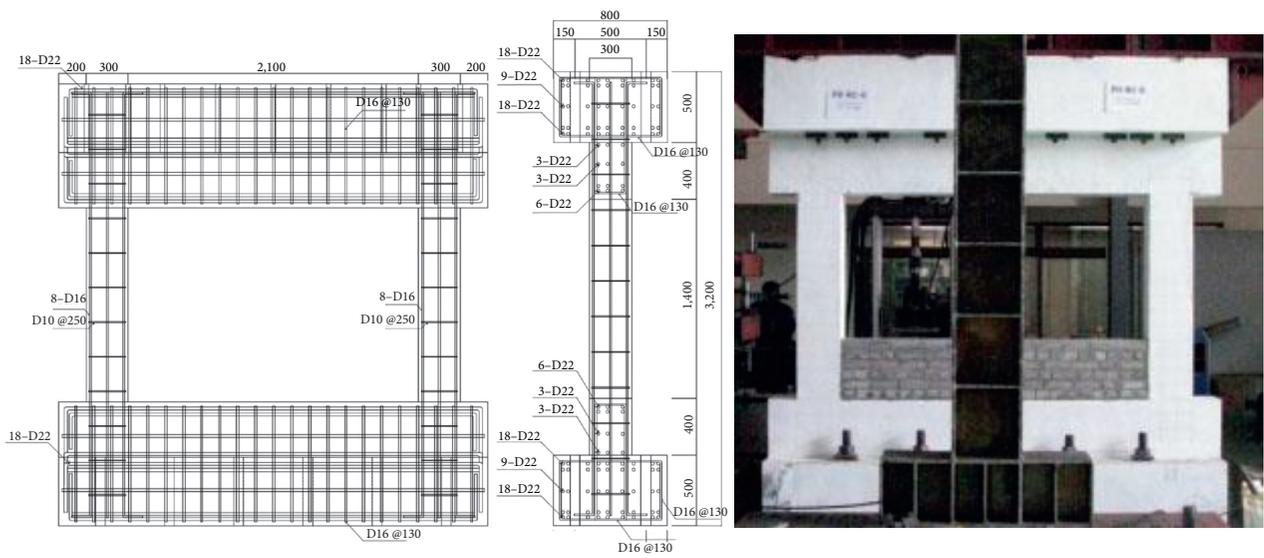
FIGURE 6: Detailed configuration of the control specimen.

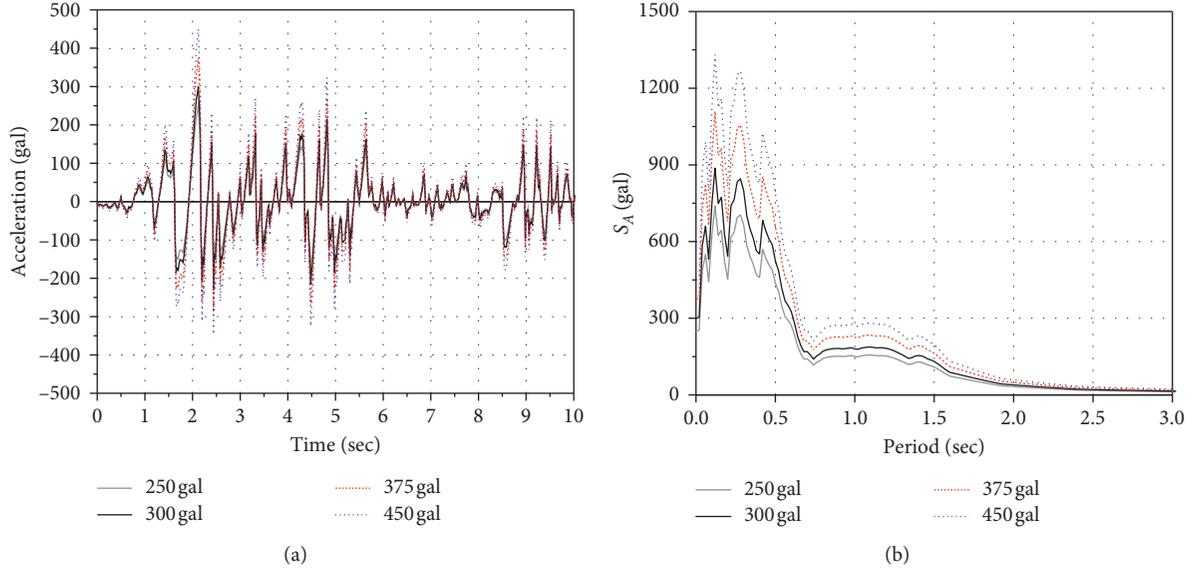
FIGURE 7: Ground motion accelerations used in the pseudodynamic test. (a) Time history records and (b) acceleration response spectrum.

which has been widely used to verify seismic performance in various building systems. The magnitude of ground motion was normalized to acceleration values of 250, 300, 375, and 450 gal. Figure 7 shows time history records of the normalized ground motion accelerations used in the pseudodynamic test, respectively, together with their acceleration response spectrum. The ground motion acceleration of 250 and 300 gal approximately corresponds to the seismic load in Zone-1 with  $S_D$ - and  $S_E$  soil conditions, under which two-thirds of the earthquake ground motion have a 2% probability of exceedance within 50 years (i.e., a 2,500-year return period), as specified by the KBC [4]. Ground motions of 375 and 450 gal were also used, to assess the seismic strengthening effectiveness of the ESRCF system in the context of a very strong earthquake, under which all earthquake ground motion has a 2% probability of exceedance within 50 years. Before the pseudodynamic test, a cyclic loading test was conducted to estimate the lateral load-drift relationship of an RC frame lacking seismic data (C-RC specimen).

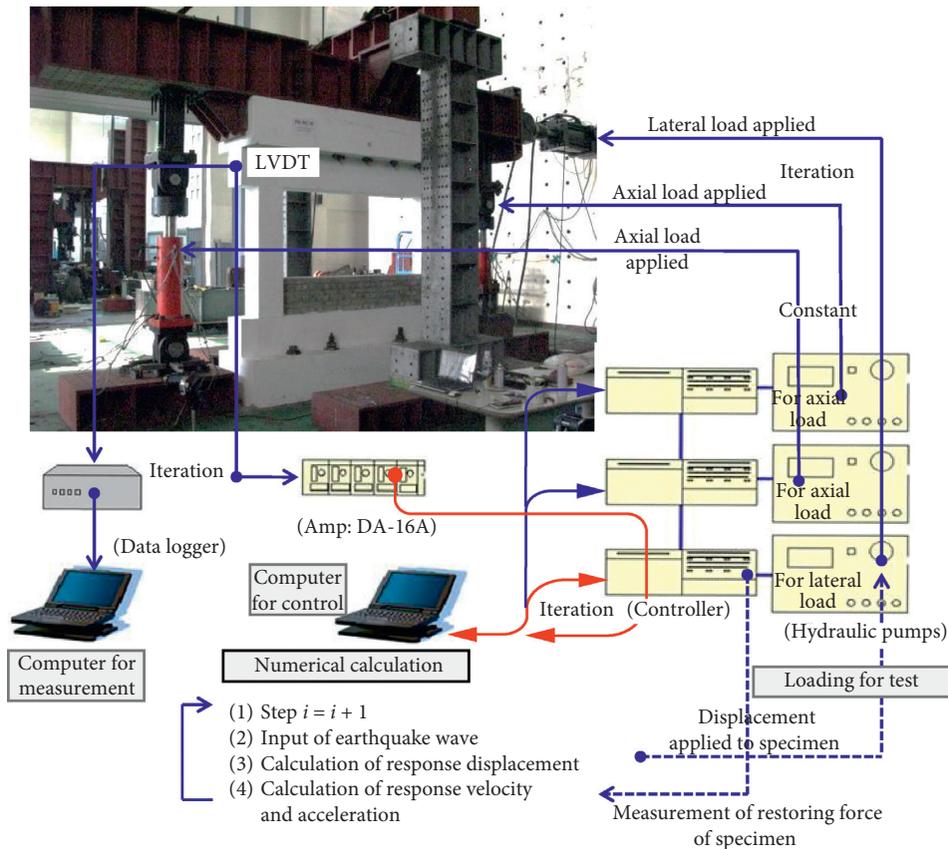
FIGURE 8: Simplified schematic diagram of the pseudodynamic testing system used in this study.

**3.4. Description of the Pseudodynamic Testing System Used in This Study.** A simplified schematic diagram of the pseudodynamic testing system used in this study is shown in Figure 8, together with the test configuration. The system can

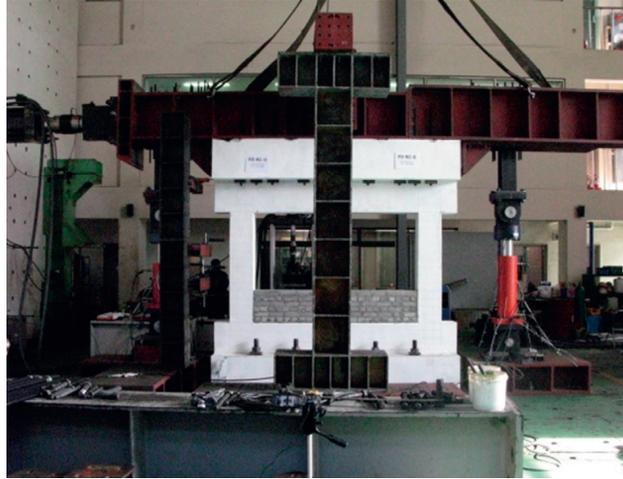
FIGURE 9: Test configuration.

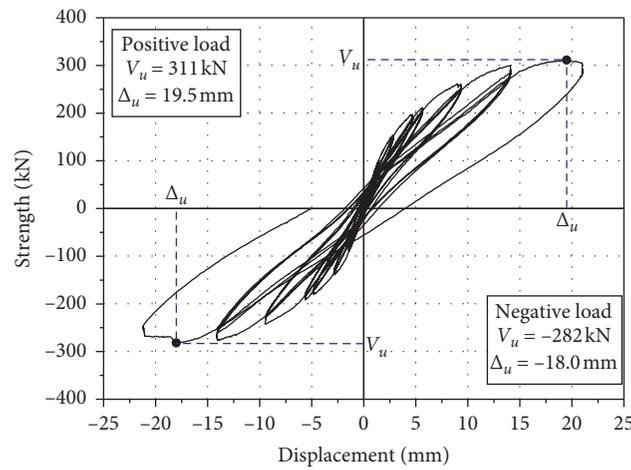
FIGURE 10: Lateral load-displacement curve for the C-RC specimen during the cyclic loading test.  $V_u$ : ultimate shear strength  $\Delta_u$ : displacement at the ultimate point.

nonstrengthened control C-RC specimen was a positive load of 311 kN, with lateral drift of 19.5 mm ( $R = 1.4\%$ ), and a negative load of  $-282$  kN was accompanied by lateral drift of 18.0 mm ( $R = 1.3\%$ ). At the ultimate state, the failure mode was shear, which represents useful information for determining the failure mechanisms of existing Korean RC buildings lacking seismic data. Figure 10 shows load-displacement curves for the C-RC control specimen during the cyclic loading test. Table 5 lists its mechanical characteristics, i.e., shear strength and displacement, under positive and negative loads.

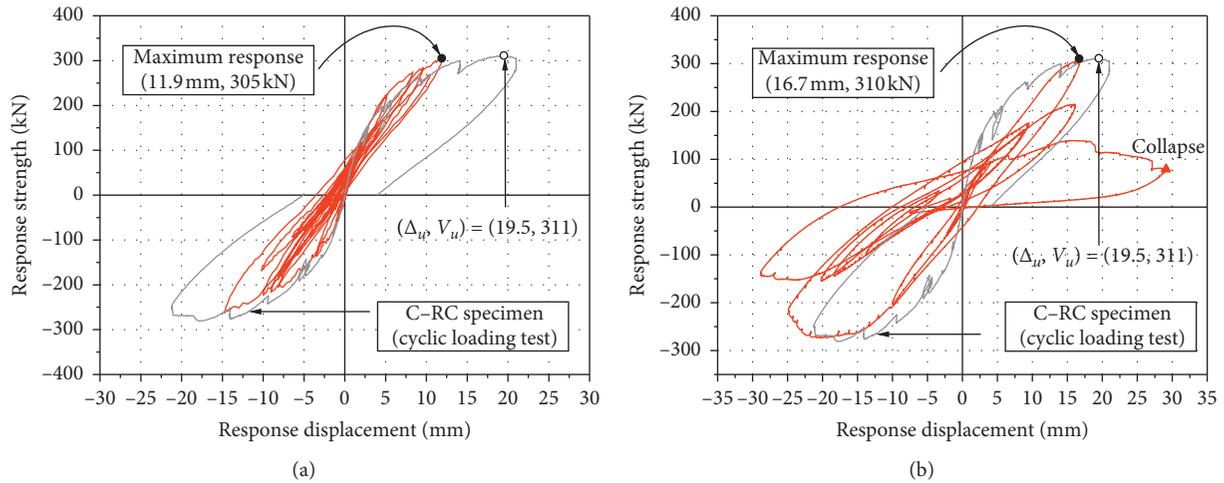
FIGURE 11: Lateral response load-displacement relationships for the control PD-RC specimen during pseudodynamic testing at (a) 250 gal and (b) 300 gal.

Figure 11 shows the lateral response load-displacement relationship of the PD-RC control specimen during the pseudodynamic test under the 250 and 300 gal NS ground motion recorded at El Centro during the 1940 Imperial Valley earthquake; this approximately corresponds to the seismic load in Zone-1 under  $S_D$  and  $S_E$  soil conditions, under which two-thirds of the earthquake ground motion have a 2% probability of exceedance within 50 years (2,500-year return period), as specified in the KBC [4]. The figure shows an envelope curve describing the lateral load-displacement relationship of the C-RC control specimen following the cyclic loading test.

The maximum earthquake response of the PD-RC control specimen for an earthquake ground motion of 250 gal was observed under a load of 305 kN with lateral displacement of 11.9 mm, which was classified as heavy earthquake damage according to the JBDPA [23]. For ground motion of 300 gal, the same control specimen showed a maximum response strength of 310 kN with lateral displacement of 16.7 mm, which is practically equivalent to drift; this is compared with the displacement at the ultimate point under positive load of 19.5 mm for the C-RC specimen

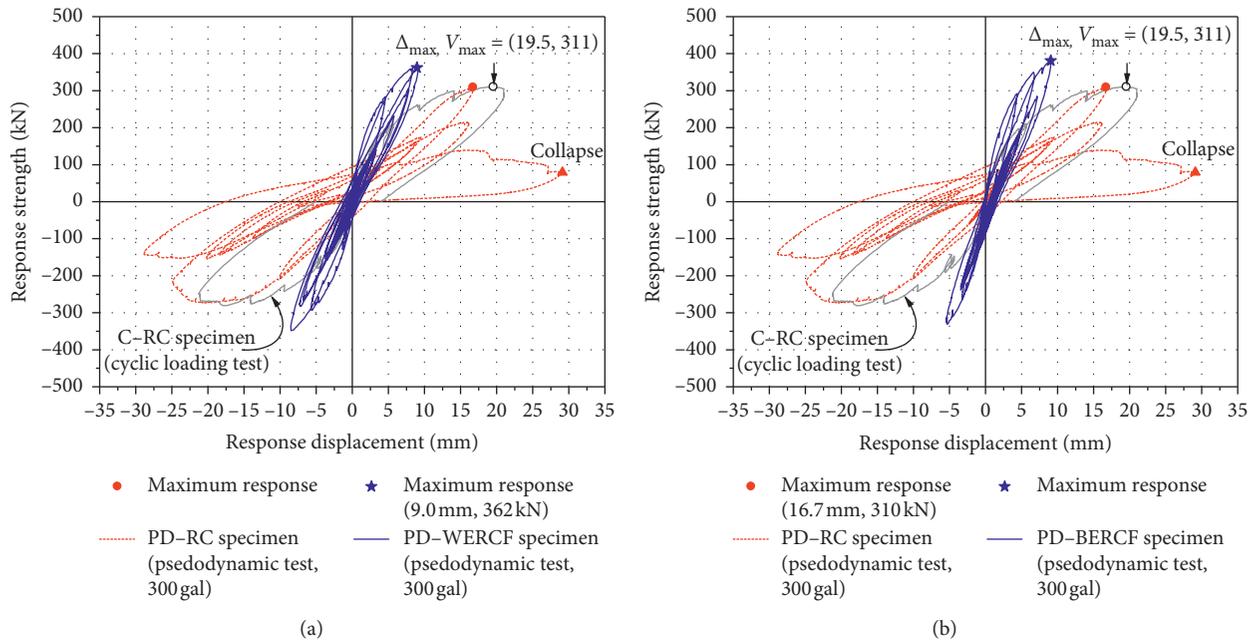
FIGURE 12: Lateral response load-displacement relationships for specimens strengthened with the ESRCF system during pseudodynamic testing at 300 gal. (a) PD-WERCF; (b) PD-BERCF.

Figures 12–14 show the lateral response load-displacement relationships of the PD-WERCF and PD-BERCF specimens during pseudodynamic testing at 300, 375, and 450 gal, respectively. We also used ground motion of 375 and 450 gal to assess the seismic strengthening effectiveness of

For an earthquake ground motion of 300 gal, the PD-WERCF specimen showed a maximum response strength of 362 kN with displacement of 9.0 mm, suffering slight damage in the form of minor flexural and shear cracks, whereas the PD-RC control specimen sustained shear collapse. The earthquake response behavior of, and degree of damage to, the PD-BERCF specimen strengthened with the bolted ESRCF system was similar to that of the PD-WERCF

specimen. The PD-BERCF specimen showed a maximum response strength of 381 kN with lateral displacement of 9.1 mm at 300 gal. Among the strengthened specimens, the strength ratio (Table 6) at the maximum response to 300 gal was 1.2-fold higher on average than that of the control PD-RC specimen.

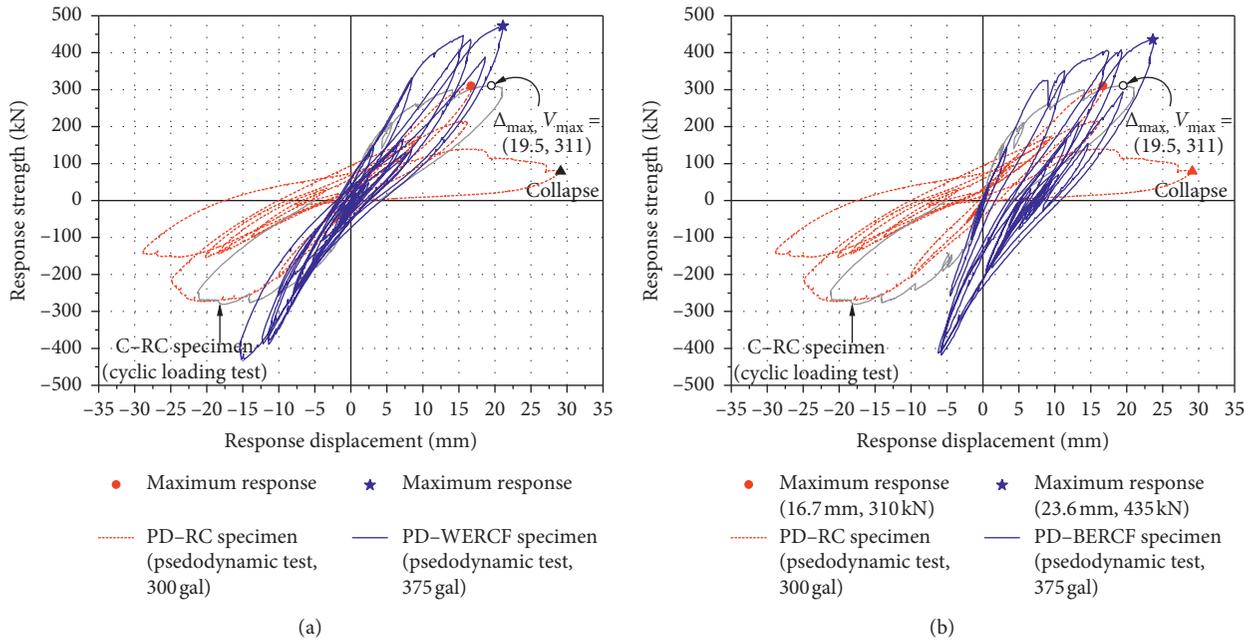
FIGURE 13: Lateral response load-displacement relationships for specimens strengthened with the ESRCF system during pseudodynamic testing at 375 gal. (a) PD-WERCF; (b) PD-BERCF.

Under severe earthquake ground motion (375 gal), the PD-WERCF specimen showed a maximum earthquake response at a load of 472 kN with lateral displacement of 21.1 mm; this was similar to that of the PD-BERCF specimen, with a load of 435 kN and lateral displacement of 23.6 mm. The strength ratio of the reinforced specimens at 375 gal was 1.45-fold higher than that of the control specimen. For both

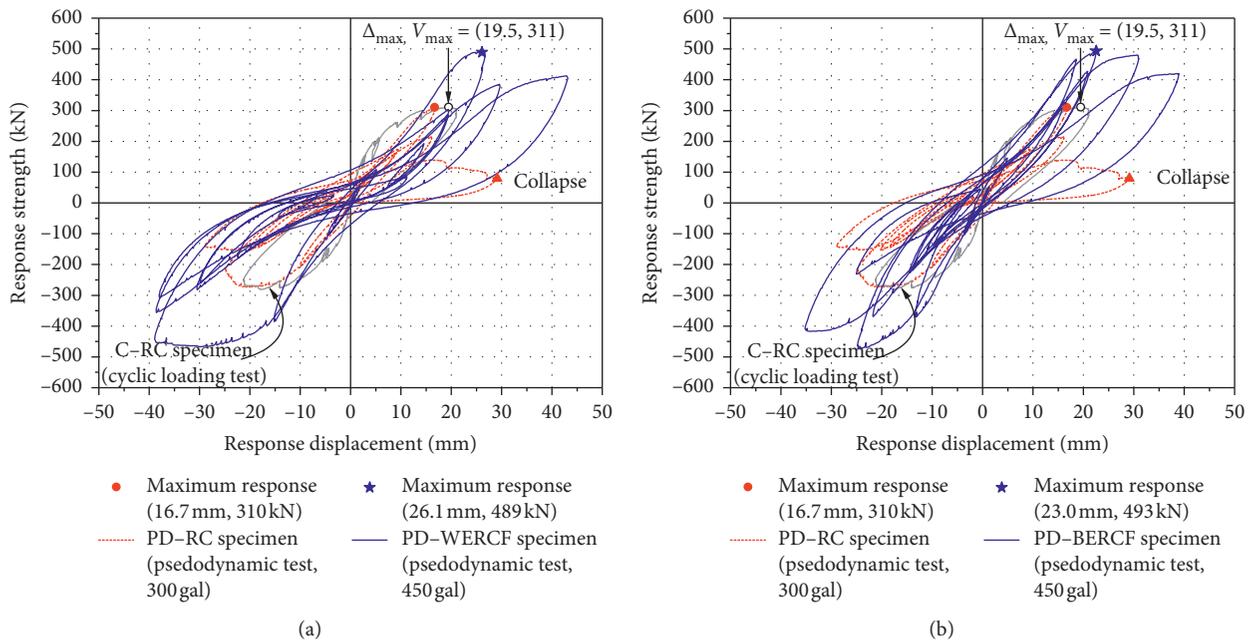
FIGURE 14: Lateral response load-displacement relationships for specimens strengthened with the ESRCF system during pseudodynamic testing at 450 gal. (a) PD-WERCF; (b) PD-BERCF.

specimens, earthquake damage was estimated as light. At the highest level of earthquake intensity (450 gal), the welded ESRCF strengthening system showed a maximum response strength of 489 kN with displacement of 26.1 mm, sustaining moderate damage according to the JBDPA [23] and Maeda et al. [11]. As observed in the welded ESRCF specimen, the bolted ESRCF specimen showed moderate damage, with shear cracks observed at a severe earthquake level of 450 gal

and a maximum response strength of 493 kN with displacement of 23 mm. Both the welded and bolted ESRCF systems showed fewer and thinner cracks, and no major peeling failure of the concrete cover was observed at 450 gal (unlike the control PD-RC specimen, which collapsed at 300 gal).

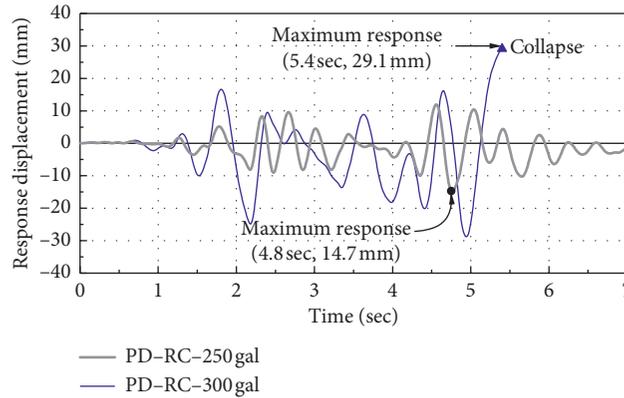
FIGURE 15: Response displacement-time history relationships of the PD-RC control specimen during pseudodynamic testing at 250 and 300 gal.

*4.2. Response Displacement-Time History Relationships and Maximum Response Displacement.* At 250 gal, the maximum response displacement of the PD-RC control specimen occurred at 4.8 s, with a lateral drift of 14.7 mm; heavy damage was observed. At 300 gal, the control PD-RC specimen showed a maximum response after 5.4 s with lateral displacement of 29.1 mm, resulting in shear collapse of both columns. Figure 15 shows the response displacement-time history relationships of the PD-RC control during pseudodynamic testing under the 250 and 300 gal NS ground motion recorded at El Centro during the 1940 Imperial Valley earthquake.

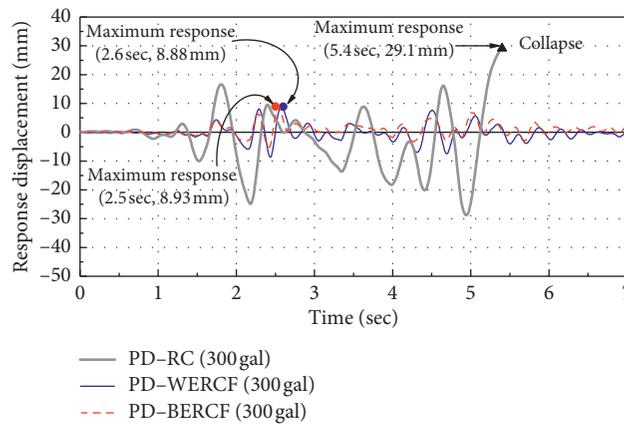
FIGURE 16: Response displacement-time history relationships of the control specimen and ESRCF-strengthened specimens during pseudodynamic testing at 300 gal.

The strengthened PD-WERCF specimen, on the other hand, suffered only slight damage, with a maximum response displacement of 8.9 mm at 2.6 s. The response displacement-time history of the PD-BERCF specimen strengthened using bolted ESRCF was very similar to that of the PD-WERCF specimen under the same earthquake intensity level. At 375 gal, the PD-WERCF specimen showed a maximum response displacement at 4.5 s, with a lateral drift of 23.5 mm, resulting in light damage; this result was similar to that of the PD-BERCF specimen, which showed a lateral drift of 20.9 mm after 4.6 s. At the highest level of earthquake intensity (450 gal), the PD-WERCF specimen strengthened with the welded ESRCF system showed a maximum response displacement of 43.0 mm at 5.3 s and suffered moderate damage. Similar to the response displacement-time history of the welded ESRCF specimen, the bolted ESRCF specimen showed moderate damage, with shear cracks occurring at 450 gal and a maximum response displacement of 38.6 mm after 5.2 s. Figures 16–18 compare response displacement-time history relationships between the PD-WERCF and PD-BERCF specimens during pseudodynamic testing at 300, 375, and 450 gal, respectively, as well as that of the PD-RC control specimen at 300 gal.

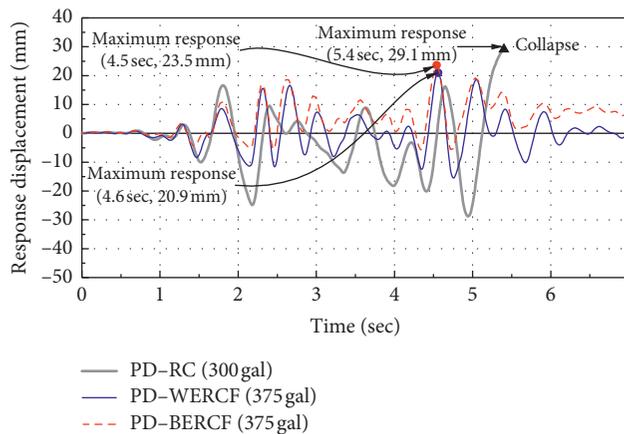
FIGURE 17: Response displacement-time history relationships of the control specimen and ESRCF-strengthened specimens during pseudodynamic testing at 375 gal.

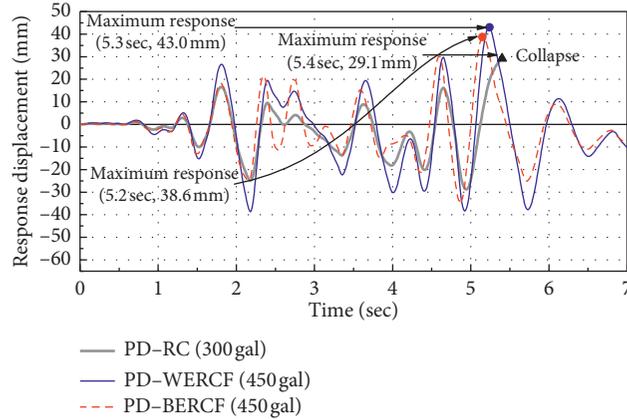
FIGURE 18: Response displacement-time history relationships of the control specimen and ESRCF-strengthened specimens during pseudodynamic testing at 450 gal.

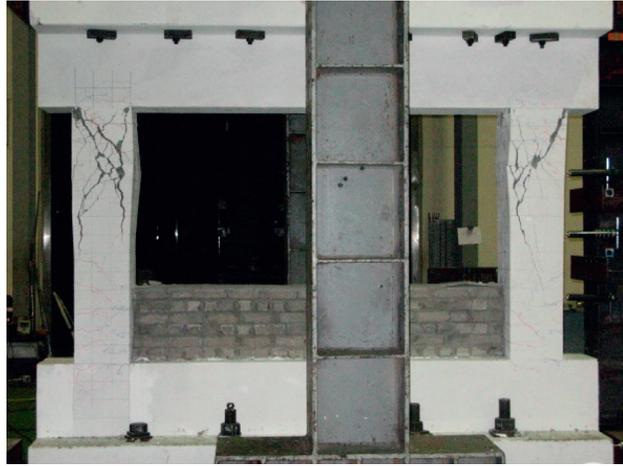
FIGURE 19: Cracks observed in the C-RC specimen during cyclic loading.

*4.3.1. Cyclic Loading Test of the Nonstrengthened Control Specimen (C-RC).* The control specimen was designed based on the frame of a typical Korean RC building [17] lacking seismic data, under the expectation that it would exhibit shear failure. The cyclic loading test was conducted on the C-RC specimen to investigate the hysteresis characteristics of the Korean RC frame lacking seismic data and to determine the variables for the pseudodynamic test. Figure 19 shows the crack patterns observed on the C-RC specimen following the final stages of the cyclic loading test.

The first crack occurred at a positive load of 39 kN, and a small flexural crack appeared in both the bottom and upper

column faces after three cycles during the third loading step ( $R = 0.2\%$ , 2.8 mm). Cracking was not observed in the center of the column. Flexural cracks extended into the middle of the column after step four. Following the seventh loading step ( $R = 0.5\%$ , 7 mm), at both positive (234 kN) and

negative (-211 kN) loads, shear cracks were observed at the top faces of the columns, and a number of diagonal shear cracks appeared, some of which were more than 3 mm wide. When the applied load reached 271 kN, at the ninth positive loading step ( $R = 1.0\%$ , 14 mm), additional shear

cracks were observed, with increasingly large widths. We observed peeling failure due to shear forces emanating from the concrete cover, likely due to insufficient shear confinement. Shear collapse occurred at the top of both columns following the application of a load of 302 kN, with a lateral drift of 21 mm ( $R = 1.5\%$ ). The maximum load capacity of the frame of the C-RC specimen was a positive load of 311 kN, with a lateral drift of 19.5 mm ( $R = 1.4\%$ ). The maximum positive load capacity (281 kN) was similar to the maximum negative load capacity, with a lateral drift of 18.2 mm.

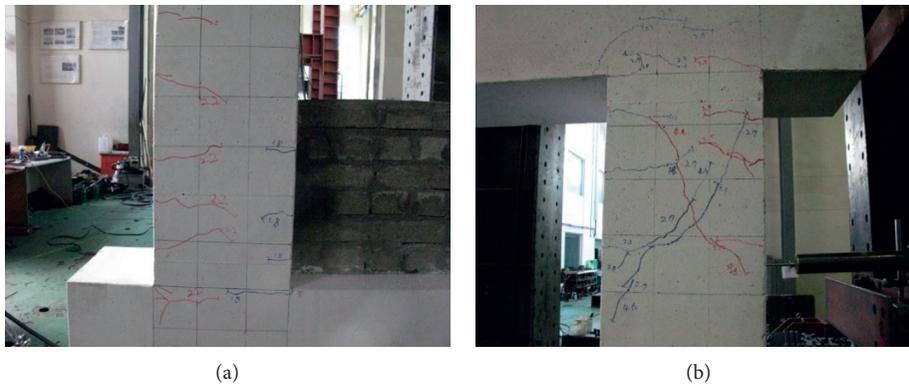
FIGURE 20: Cracks appeared in the PD-F specimen during pseudodynamic testing under earthquake ground motion of 250 gal, after (a) 2.2 s with lateral displacement of 7.2 mm and force of  $-166$  kN and (b) 4.8 s with lateral displacement of 13.6 mm and force of  $-212$  kN.

of 11.9 mm. The pseudodynamic test was performed for 7 s. Figure 20 shows the crack pattern observed in the PD-RC specimen during the pseudodynamic test, performed by applying earthquake ground motions of 250 gal (El Centro, NS).

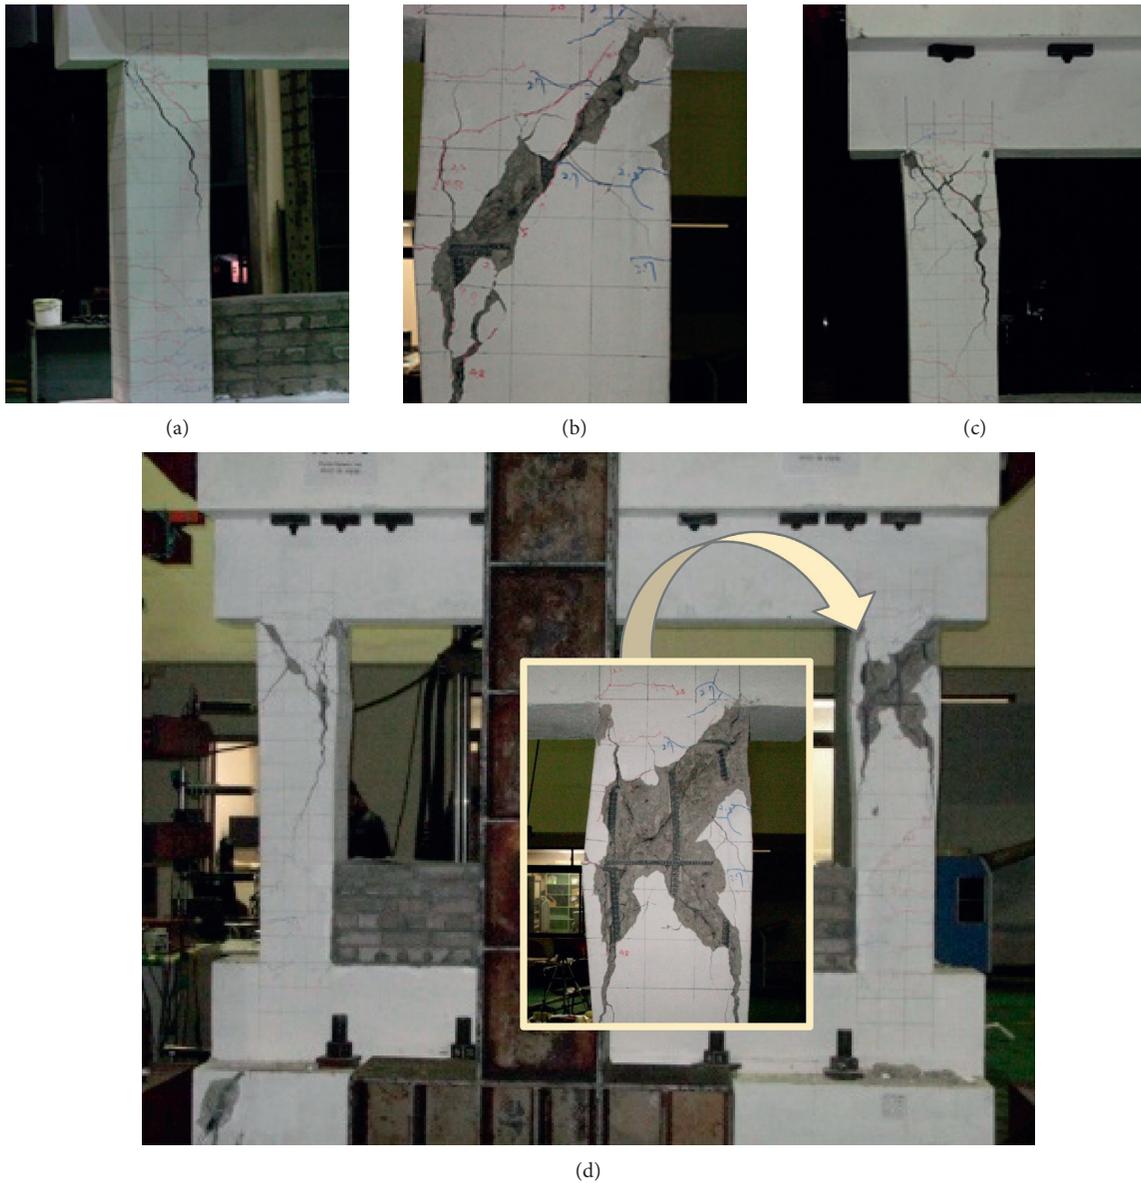
FIGURE 21: Cracks appeared in the PD-F specimen during pseudodynamic testing at 300 gal, after (a) 1.52 s with lateral displacement of 10 mm and force of  $-204$  kN, (b) 2.18 s with lateral displacement of 24.9 mm and force of  $-268$  kN, (c) 5.4 s with lateral displacement of 28.9 mm and force of 80 kN, and (d) during the final stage (7 s).

In the 300-gal earthquake ground motion test, after approximately 1.52 s, under a negative load of 204 kN with lateral displacement of 10.0 mm, large, visible shear cracks were observed on all faces of the columns. Shear cracks increased in number and extended in width after 1.8 s, with lateral displacement of 16.6 mm. After 2.18 s, with lateral displacement of 24.9 mm, we observed peeling failure due to earthquake shear forces from the concrete cover at the top faces of the columns. Shear collapse occurred at the tops of both columns within 5.4 s, following the application of a positive load of 80 kN, with lateral displacement of 28.9 mm. Figure 21 shows the crack pattern observed in the PD-RC specimen during the pseudodynamic test, performed by applying earthquake ground motions of 300 gal (El Centro, NS).

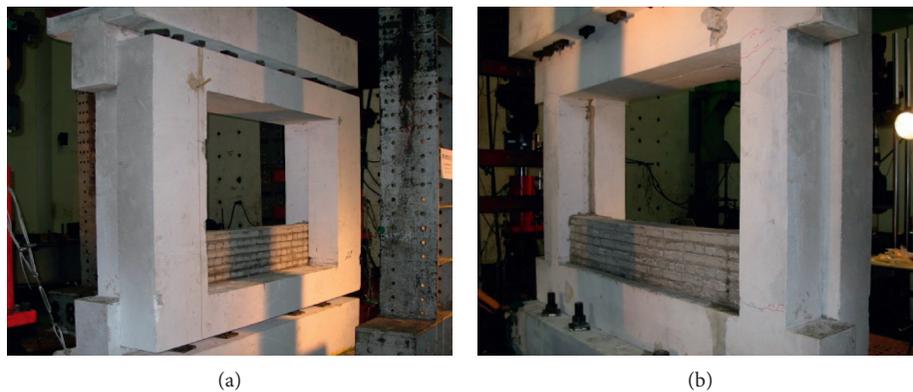
FIGURE 22: Cracks appeared in the PD-WESRCF specimen during pseudodynamic testing at 300 gal after (a) 4.5 s with lateral displacement of 7.32 mm and force of 320 kN, and (b) during the final stage (7 s).

For the 300-gal earthquake ground motion, a small flexural crack was observed in the upper faces of the columns within approximately 1.6 s, under a positive load of 250 kN with lateral displacement of 4.0 mm. Flexural cracks extended to the middle of the column after 2.28 s, with lateral positive displacement of 8.1 mm. However, the flexural crack remained small, and no shear cracks were observed; only one small flexural crack was noted under maximum ground motion, occurring at 2.57 s under a positive load of 404 kN with lateral displacement of 8.8 mm. After approximately 4.5 s, under a positive load of 320 kN with lateral displacement of 7.32 mm, diagonal shear cracks were observed at the top faces of the columns; however, they were very small, as shown in Figure 22(a). The PD-WESRCF specimen sustained light damage (slight shear and flexural cracks) at 300 gal, corresponding to the seismic load in Zone-1 under  $S_E$  soil conditions, as specified in the KBC [4]. The PD-RC control specimen collapsed following the development of large shear cracks. The welded ESRCF strengthening system

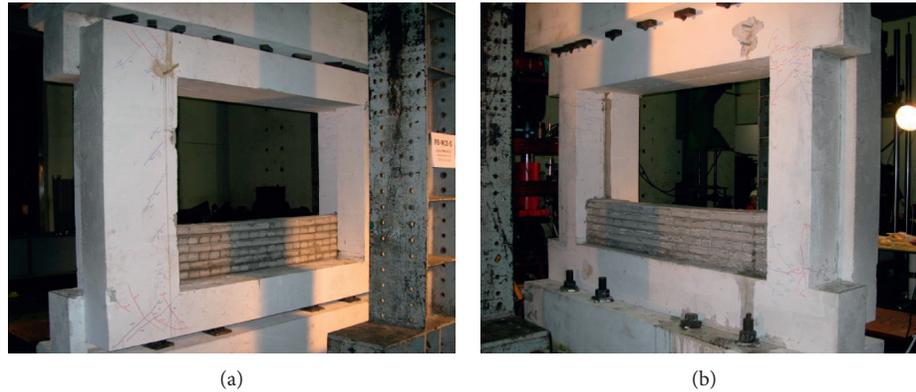
FIGURE 23: Cracks appeared in the PD-WESRCF specimen during pseudodynamic testing at 400 gal after (a) 4.5 s with lateral displacement of 19.6 mm and force of 489 kN, and (b) during the final stage (7 s).

With earthquake ground motion of 375 gal, after 1.77 s, under a positive load of 368 kN with lateral displacement of 8.6 mm, diagonal shear cracks were observed at the top and bottom faces of the columns. Shear cracks increased in number and extended to the middle of both columns after 4.5 s; however, the cracks remained small, with widths  $<1$  mm. In contrast, under severe earthquake ground motion (450 gal), under which all earthquake ground motion has with a 2% probability of exceedance within 50 years, visible shear cracks were observed on all faces of the columns, increasing in number and width ( $>2$  mm) after 2.16 s with lateral displacement of 33 mm (641 kN). Compared with the control PD-RC specimen, which collapsed at 300 gal, the cracks were fewer and thinner, and major peeling failure of the concrete cover was not observed. Thus, the reinforced PD-WESRCF specimen showed moderate damage (i.e., shear cracks) under a severe earthquake level of 450 gal; greater strength was observed in comparison with a non-strengthened control PD-RC specimen, in which major earthquake damage and shear failure were observed in both upper columns.

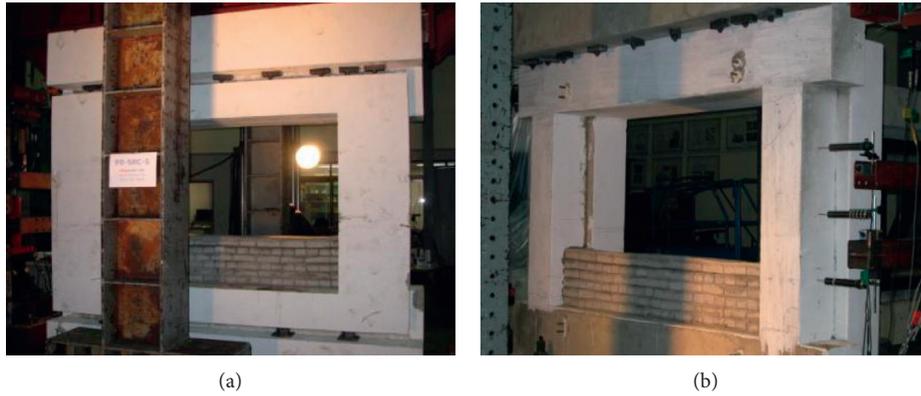
FIGURE 25: Cracks appeared in the PD-BESRCF specimen during pseudodynamic testing at 300 gal after (a) 2.55 s with lateral displacement of 8.9 mm and force of 381 kN, and (b) during the final stage (7 s).

At 300 gal, a small flexural crack was observed in the upper faces of the columns with lateral displacement of 3.9 mm at approximately 1.76 s. The flexural cracks extended to the middle of each column after 2.28 s, with lateral positive displacement of 6.6 mm. However, the flexural cracks remained small, and no shear cracks were observed. After approximately 2.55 s, under a positive load of 381 kN with lateral displacement of 8.9 mm, very slight diagonal shear cracks were observed at the top faces of the columns (Figure 25(a)).

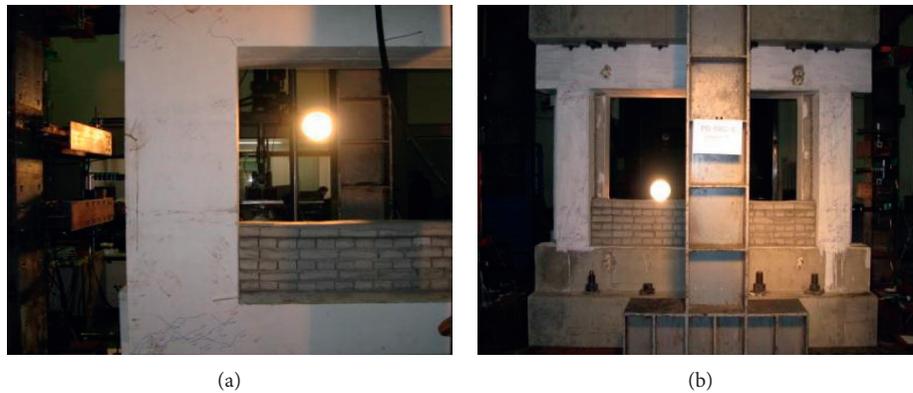
FIGURE 26: Cracks appeared in the PD-BESRCF specimen during pseudodynamic testing at 375 gal after (a) 2.65 s with lateral displacement of 19.1 mm and force of 401 kN, and (b) during the final stage (7 s).

With earthquake ground motion of 375 gal, after 2.17 s, under a negative load of 372 kN with lateral displacement of 5.2 mm, diagonal shear cracks were observed at the top and bottom faces of the columns. Shear cracks increased in number, extended to the middle of both columns after 2.65 s, and remained small ( $<1$  mm wide). The bolted ESRCF strengthening system proposed in this study showed good reinforcement effectiveness when subjected to the maximum earthquake ground motion considered in the KBC. Under severe earthquake ground motion (450 gal, Figure 27), visible shear cracks were observed on all faces of the columns, increasing in number and width ( $>2$  mm) after 2.2 s with lateral displacement of 26 mm. Compared with the control PD-RC specimen, which collapsed at 300 gal, the cracks were fewer and thinner, and no major peeling failure of the concrete cover was observed.

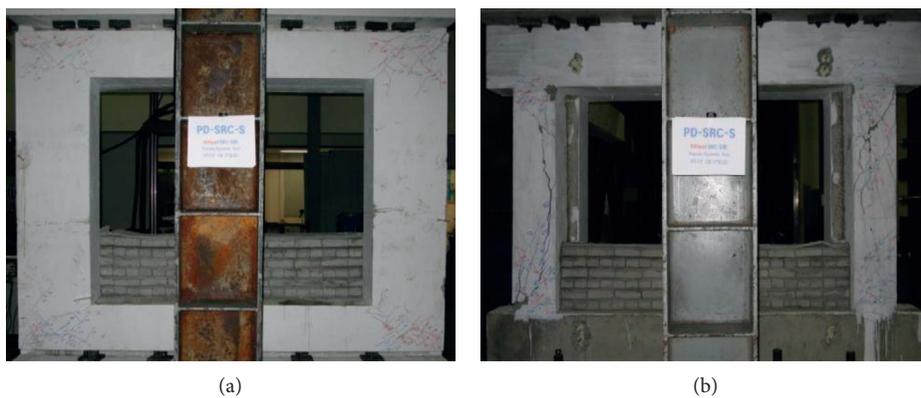
FIGURE 27: Cracks appeared in the PD-BESRCF specimen during pseudodynamic testing at 450 gal after (a) 1.5 s with lateral displacement of 13.5 mm and force of  $-372$  kN, and (b) during the final stage (7 s).

As observed for the welded ESRCF specimen, the reinforced PD-WESRCF specimen showed moderate damage, with shear cracks observed under severe earthquake ground motion (450 gal). Greater strength was noted compared with the nonstrengthened control PD-RC specimen, which showed major earthquake damage with shear failure in both upper columns.
