Research Article

Research on the Controlling Effect of NPR Cables for Anti-Dip Slope Based on the Numerical Simulation

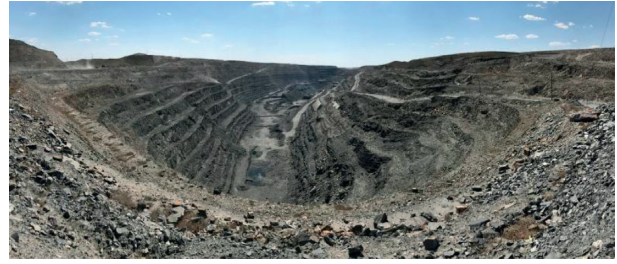
FIGURE 1: Overview of Changshanhao open-pit mine.

2.1. Geographical Characteristics. Changshanhao mine is located in Inner Mongolia province, and the elevation of study area is between 1550 and 1750 m (Figure 1). The mining area had wide temperature differences and scarce rainfall. The annual maximum temperature was 35~37°C, and rainfall period was mainly concentrated between July and September.

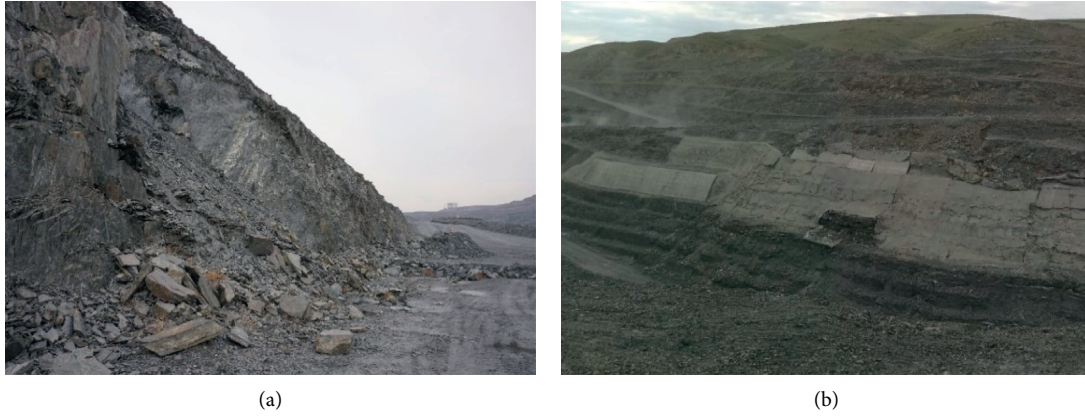
FIGURE 2: Instability failure of open-pit mine in current situation. (a) Collapse in mining area. (b) Re-instability of reinforced area.

2.3. Current Situation and Problems in Mining Area. With the increase of height of slope, the frequency of landslides became more frequent, while landslides of different scales occurred in many areas (Figure 2), which severely threatened the safety of open-pit mining operation. From the distribution of landslides, the southwest pit was concentrated at the northern side. At present, these landslide areas could be slightly controlled through local square cutting, platform widening, and stage height and slope angle reduction to maintain mining production. Although certain areas were strengthened with ordinary cables, the ordinary cables easily broke under the large deformation of slope. Moreover, large-scale landslides still occurred in the reinforcing area, which severely threatened the mine production safety (Figure 2(b)).

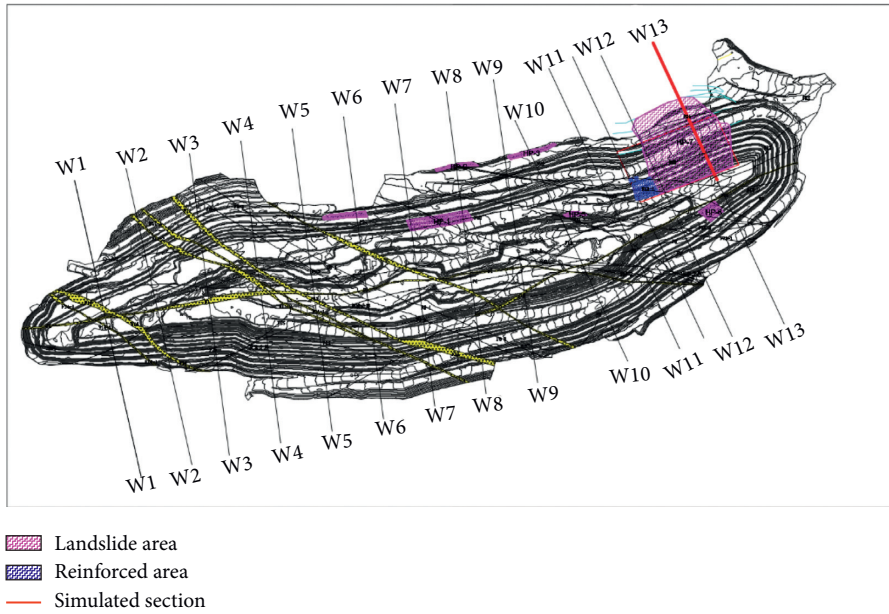
FIGURE 4: Position of selected calculation slope section in open-pit mine [20].

3.2.2. Stability Analysis of Slope Section in Current and Final Boundary Situations. Considering the distribution of rock strata and landslides area, the north and south sides of southwest pit were divided into 13 calculation sections along the main pit axis, and the slope stability of southwest pit was evaluated (Figure 4).

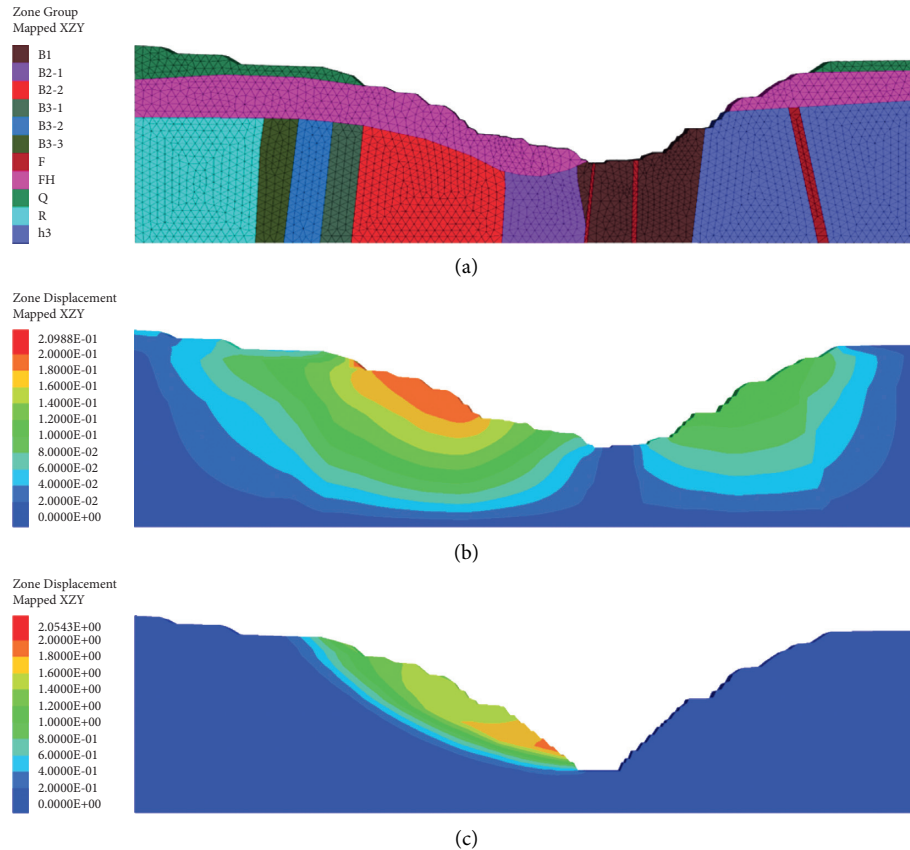
FIGURE 6: Calculated results of W8 slope section. (a) Section model of W8 slope. (b) Displacement of W8 slope section in current situation. (c) Displacement of W8 slope section in final boundary situation.

(2) W8 Slope Section Calculation Results. The W8 slope section was stable and in equilibrium. After excavation, instability failure occurs at the foot of northern side and potential large-scale landslide might occur, due to the slope foot instability (Figure 6).

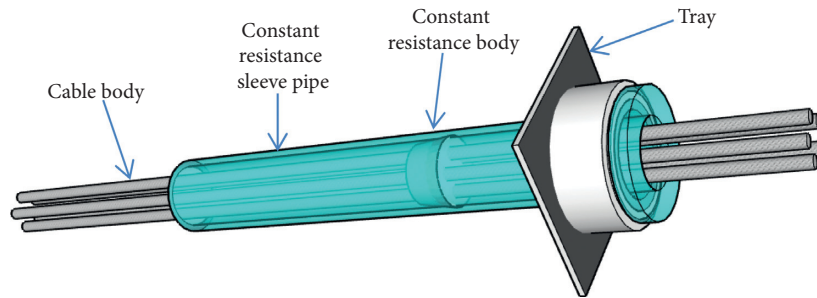
FIGURE 8: Structure diagram of NPR cable.

4.2. Control and Reinforcement Principle of NPR Cable. The cable is the main bearing body for slope protection and monitoring in open-pit mines worldwide. Currently, many energy-absorbing bolts, developed according to actual needs, could resist high deformation and failure of rock mass within a certain range, despite different energy-absorption characteristics through stretching, compression, and necking of a component, while these bolts do not have negative Poisson ratio performance, not really overcoming the necking breakage and support failure of cable. Considering the mechanical properties limitation of traditional cables, He (2010) developed a negative Poisson's ratio (NPR) cable with the properties of high constant resistance force and large elongation to control the large deformation of slope. Since the development of NPR cable, NPR cables have been successfully applied to the field stability monitoring and control of many open-pit slopes, producing significant results. NPR cable consists of a cable shank, connector, and constant resistance device (constant resistance body and sleeve), along with tray and nut. Figure 8 presents the structure of an NPR cable [21]. Constant resistance body is a standard cone, the constant resistance sleeve is a standard cylinder with uniform wall thickness, and the cable shank is a uniform diameter-equivalent pole. Constant resistance body and the sleeve together form a constant resistance device to provide a constant support resistance to the cable. The diameter of constant resistance body exceeds the

diameter of cable shank and is slightly larger than the inner diameter of the constant resistance sleeve. The working resistance of the cable might be produced between the sleeve and the cone, when an external load acts on the cable shank.

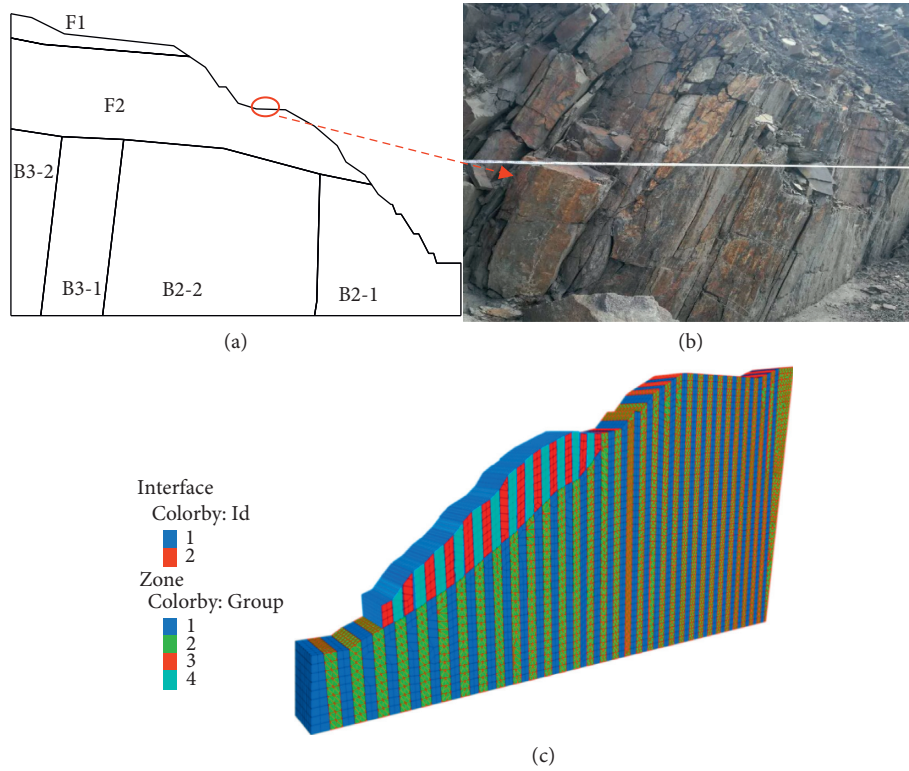
FIGURE 9: Calculation mode establishment of W13 slope section. (a) Morphology of W13 section. (b) Slope toppling failure. (c) Calculation model of W13 section.

The geophysical data demonstrated that the bending fracture surface depth was approximately 20 m. Due to finite difference principle limitations, the block element of FLAC3D software could not simulate the slope toppling failure form. Consequently, the interface element was used

to wrap the pseudo-destructive body, for the interaction between the destroying bodies to be realized through the interface. The lithology of the slope section could not be assigned according to the actual situation, due to the simplification of joints during modeling. In addition, the rock block strength in this area was relatively high, while the research results demonstrated that the sliding failure was mainly controlled by the joints. Therefore, the lithology could be assigned to a higher strength, while the structural plane could be assigned according to the actual strength. The corresponding numerical model is presented in Figure 9.
