Research Article

Seismic Fragility of Chinese Light-Gauge Steel Keel Gypsum Board Partition Walls

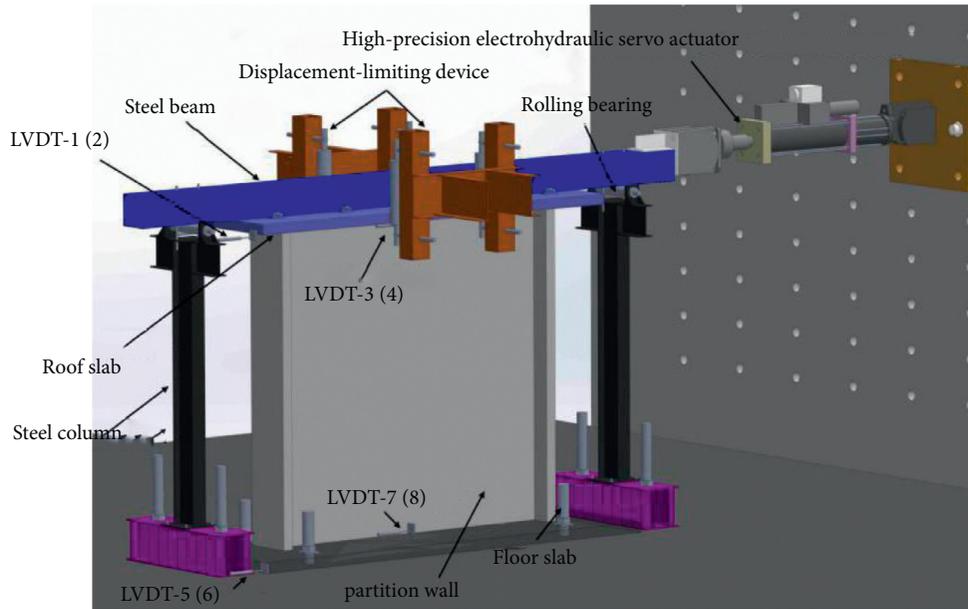
FIGURE 1: Loading apparatus.

2.1. Loading Apparatus. The tests were conducted in the structural laboratory of the Harbin Institute of Technology, with the aim to investigate seismic damage phenomena, failure mechanisms, and fragility of LSKGBPWs as well as

the effects of the partition wall-structure connection type on the performance and fragility. The partition wall is a self-supporting component that only bears its own weight. Therefore, it is necessary to design a test apparatus that is easy to load and does not affect the actual performance of the partition wall. The test apparatus includes a single-story steel frame, lateral displacement-limiting device, roof/floor concrete slab, and high-precision electrohydraulic servo actuator. There is no joint connection between the beam and the column of the steel frame, but a rolling is installed on the top of the column to support the steel beam. The reinforced concrete roof slab is fixed under the steel beam through the embedded parts, and the roof slab can be replaced during the test. Displacement-limiting devices are installed on both sides of the roof slab to ensure that the roof slab only moves in the horizontal loading direction. As the steel beam moves horizontally, it drives the roof slab to move in the same direction to load the partition wall. The floor slab is fixed on the ground by anchor bolts. The top and bottom parts of the partition wall are fixed to the roof slab and the floor slab, respectively. During the test, the lateral load is provided by the high-precision electrohydraulic servo actuator. The horizontal force transfer path is actuator → steel beam → roof slab → partition wall [23]. Figures 1 and 2 show the I-shaped partition wall specimen tested.

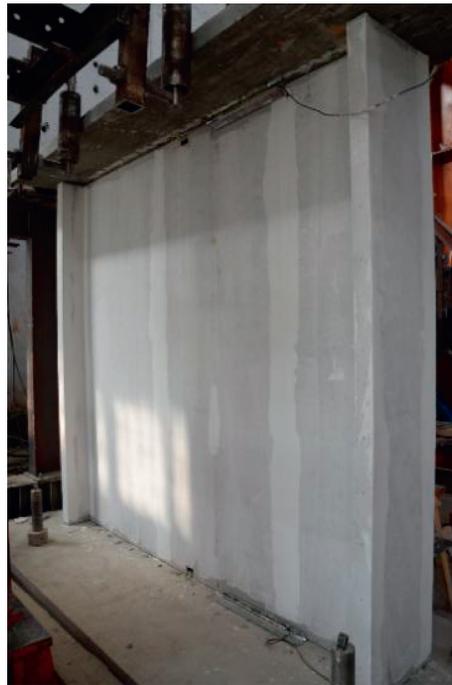
FIGURE 2: The specimen.

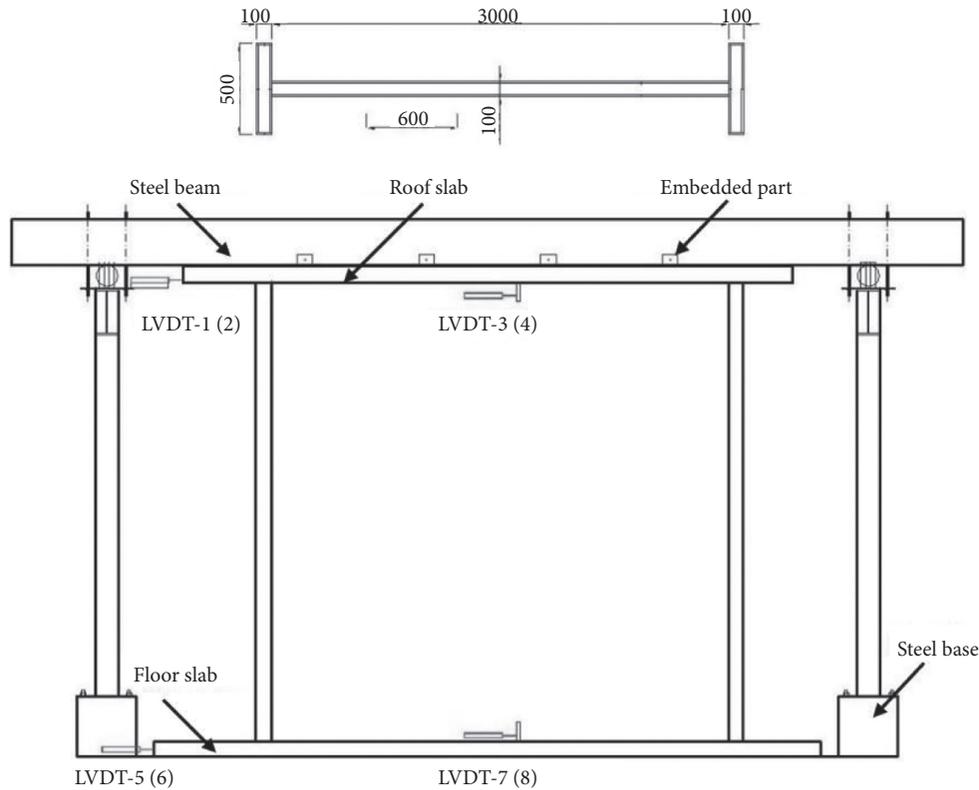
FIGURE 3: Section of the specimen design.

2.2. Test Specimens. In the tests, the lateral resistance performance of LSKGBPWs under horizontal low-cycle reciprocating load was investigated. Figure 3 shows the view of the LSKGBPW design, and the construction details of the partition wall connection are shown in Figure 4. Table 1 lists the parameters of the specimens. All specimens met the code in the Light-gauge Steel Keel Gypsum Board Partition Wall and Suspended Ceiling standard [24]. The variables considered in the selection of the wall configurations include the following:

- (1) The specimens were the independent I-shaped full-scale (1 : 1) partition walls with a height of 3 m and a span of 3 m, as the top and bottom tracks connect with roof slab and floor slab, respectively, as illustrated in Figure 2.
- (2) The detail of construction is illustrated in Figure 3.
- (3) The size of a single gypsum board is 3 m × 1.2 m × 12 mm according to Chinese code GB-T9775 (GB 2008).
- (4) The U-shape track connects with the roof and floor slabs by shot pins, shot pin-backing plate, and expansion bolt, as illustrated in Figure 4. The specimens were distinguished to five groups by the connection types as listed in Table 1.
- (5) The size of U-shape track is 75 mm × 35 mm × 0.55 mm, as the size of C-shape steel stud is 73.5 mm × 45 mm × 0.55 mm as listed in Table 1.
- (6) The U-shape track connects with the C-shape steel stud by self-tapping screw spacing 600 mm. The

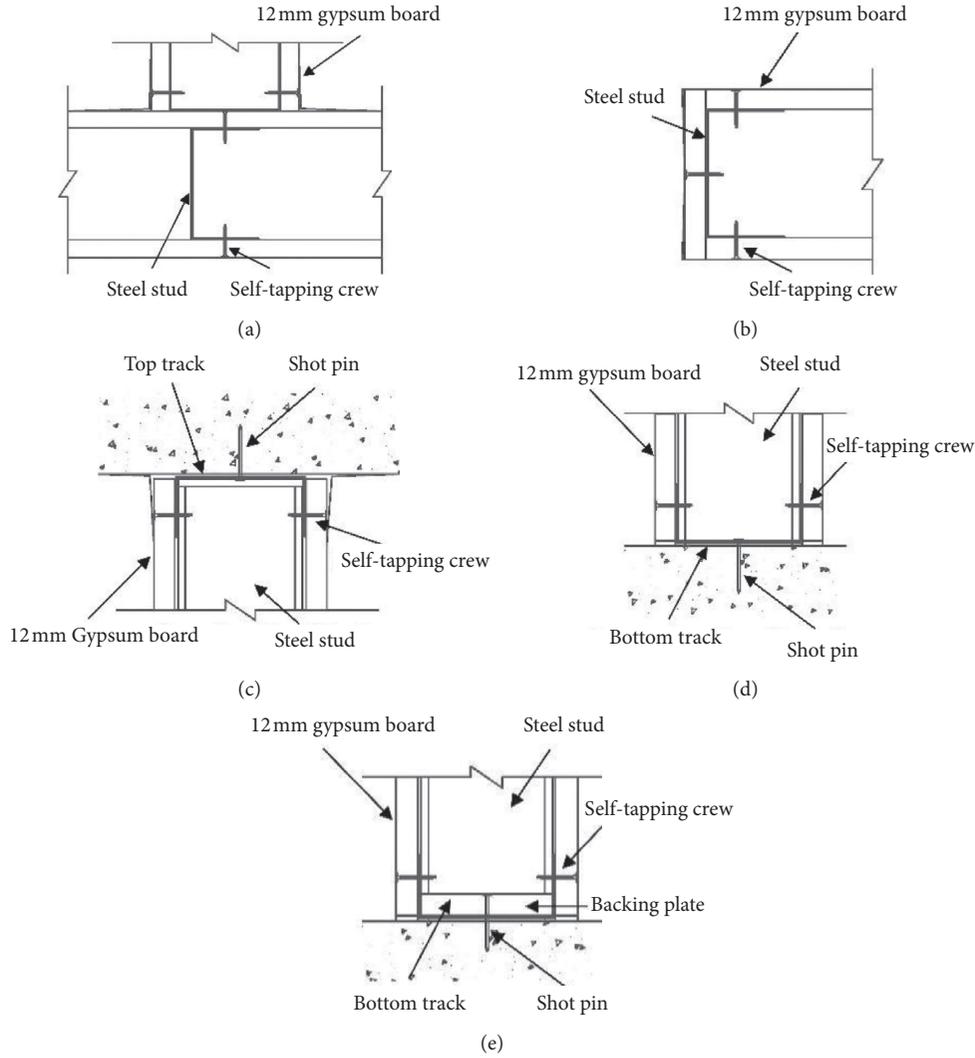
FIGURE 4: Detail of construction (a) T joint. (b) The edge joint. (c) The top track joint. (d) The bottom track joint. (e) The bottom track joint with backing plate.

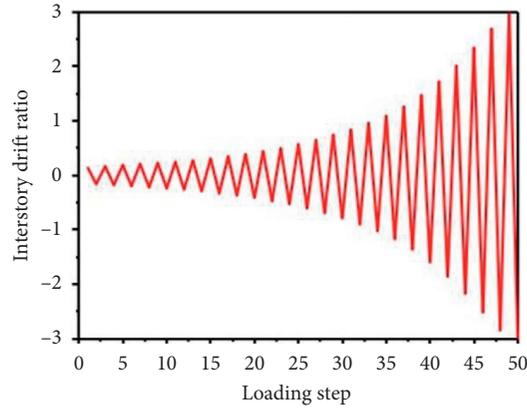
FIGURE 5: Loading regime.

The loading regime was based on that proposed by Retamales et al, which was developed specifically to assess the fragility of nonstructural components that are sensitive to interstory drift [25]. In the method, the predicted interstory drift demand of nonstructural specimens is described by using a set of closed-form equations that should simultaneously satisfy the following conditions: (1) the ground response spectrum should be matched; (2) the target

interstory drift ratio should be applied to the specimen; and (3) the number of story movement cycles applied to the specimen should be the same as that in actual seismic records. The displacement record generated based on this loading regime is shown in Figure 5. The LSKGBPW has a relatively low lateral stiffness, and its damage process is sensitive to the interstory drift ratio. This loading regime is characterized by many steps and small increments per step and can record in detail the variation processes of the interstory drift ratio and failure of the specimens, satisfying the needs of fragility research. The loading regime uses displacement control throughout the entire process with the minimum displacement increment of 0.5 mm. As loading progresses, the displacement increment per step increases gradually. In the tests, displacement sensors are placed in the middle of the reinforced concrete roof and floor to measure the displacement and calculate the interstory drift ratio.

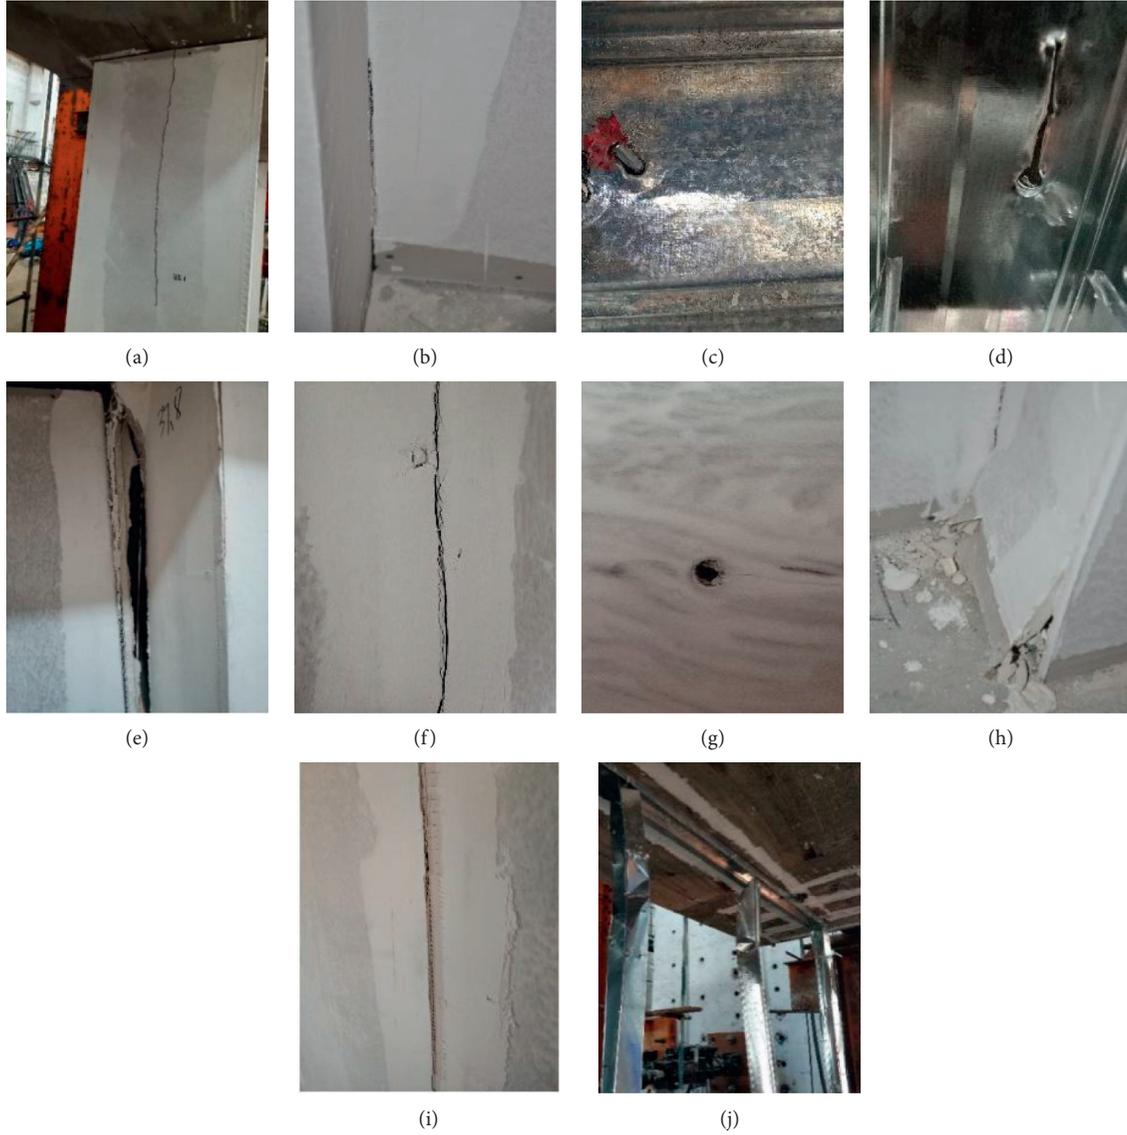
FIGURE 6: . Damage phenomena. (a) Crack of the gypsum boards in the transverse wall. (b) Crack at the internal corner. (c) Loosening of a shot pin. (d) Tearing of the track at the shot pin connection. (e) Separation of the transverse wall from the longitudinal wall. (f) Crack at the connection of the gypsum boards of the longitudinal wall. (g) Pulling out self-tapping screw in the gypsum board. (h) Crushing of the gypsum board. (i) Separation of the gypsum board from the steel stud. (j) Severe buckling of the steel stud.

2.4. Experimental Results. The damage characteristics of the LSKGBPW are described in detail in Table 2 and Figure 6. The damage processes and characteristics of groups A, B, and C are similar, reflecting the influence of the shot pin distance, while those of groups C, D, and E reflect the effect of the connection type on the damage phenomena.

Group	Number of specimens	Connection type	Connection distance (mm)	Damage phenomena
A	3	Shot pin	600	Cracks in the gypsum boards of the transverse walls on both sides, Figure 6(a); cracks in the internal corner, Figure 6(b); loose, dislodged, sheared shot pins at the connection, Figure 6(c); tearing of the track, Figure 6(d); separation of the transverse and longitudinal wall, Figure 6(e).
B	3	Shot pin	400	Cracks in the gypsum boards of the transverse walls on both sides; cracks in the internal corner; loosening, dislodging, and shearing off of the shot pins at the connection; tearing of the track; separation of the transverse and longitudinal walls; cracking between the gypsum boards of the longitudinal wall, Figure 6(f).
C	3	Shot pin	200	Cracks appearing in the transverse walls on both sides, cracks in the internal corner, cracks between the gypsum boards of the longitudinal wall, loosening and dislodging of the self-tapping screws between the gypsum board and the keel, Figure 6(g), local crushing of the gypsum boards, Figure 6(h), local separation of the gypsum board and keel, Figure 6(i), severe local buckling of the steel stud, Figure 6(j).

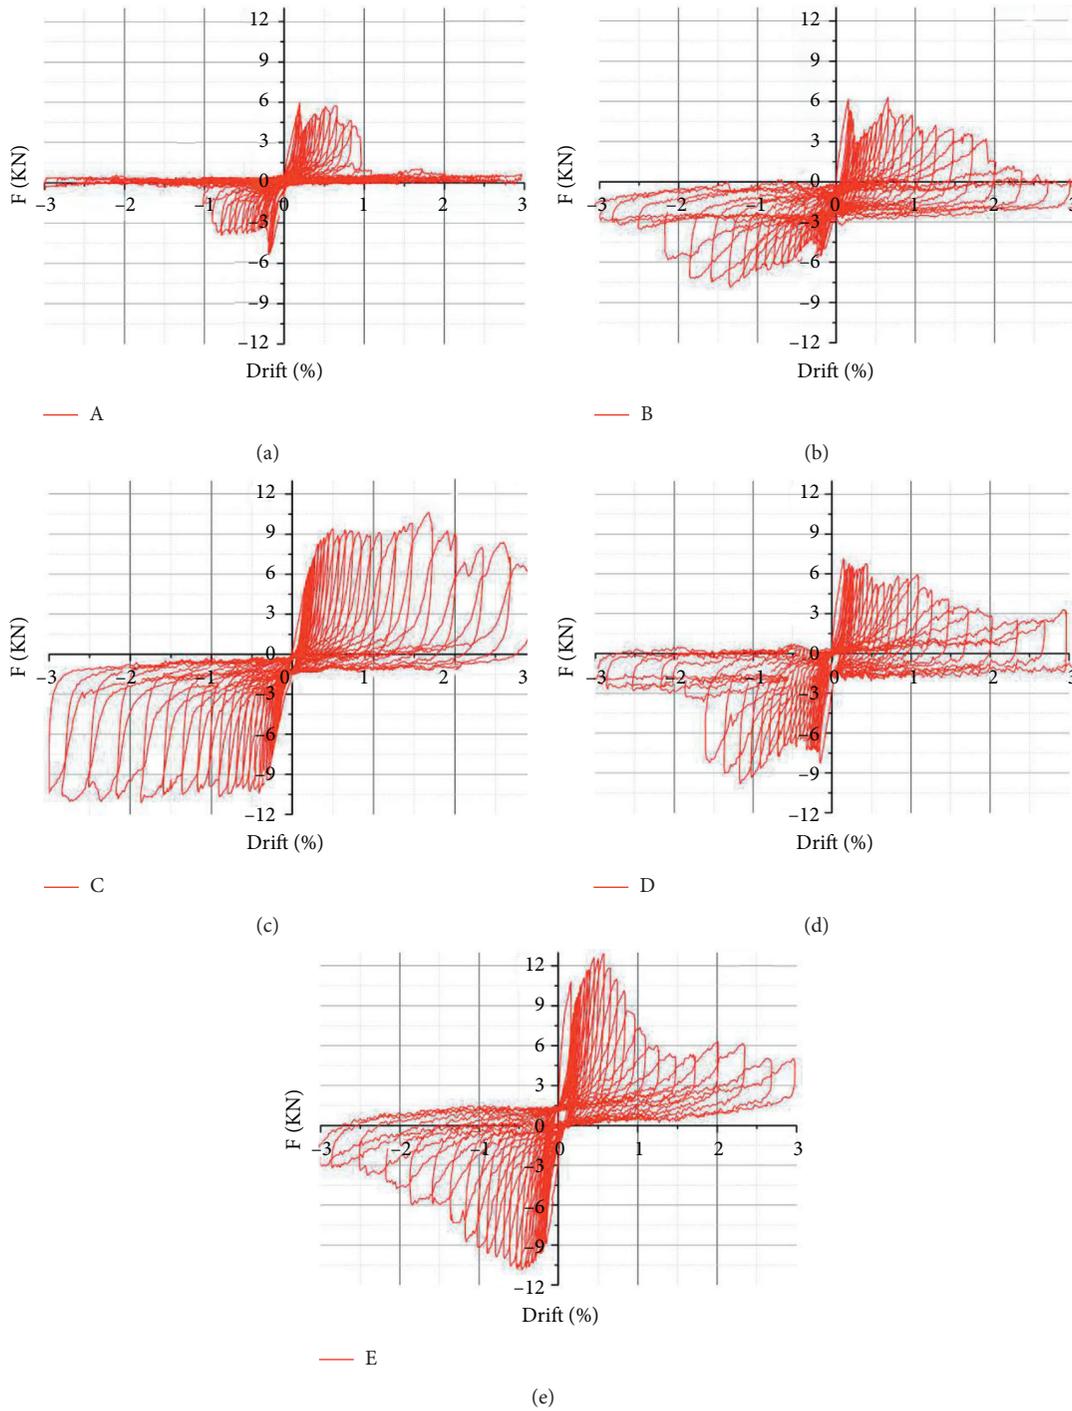
FIGURE 7: Hysteresis behaviors of specimens. (a) Specimen in group A. (b) Specimen in group B. (c) Specimen in group C. (d) Specimen in group D. (e) Specimen in group E.

Based on the damage characteristics of groups A, B, and C, it is found that, when the distance between shot pins was small, the damage on the partition wall-structure connection was delayed under the same load. Figures 7(a)~7(c) show the hysteresis loops observed for specimen in group A

to C, respectively. Then, according to the damage characteristics of the specimens in group D, the backing plate strengthened the local track and could prevent it from tearing effectively. However, the damage to the partition wall-structure connection was dominated by shearing of the shot pins after adding the backing plates, while the partition wall-structure connection was affected by both the strength of the track and the strength of the shot pins. Therefore, the backing plate could not strengthen the partition wall-structure effectively, and the damage phenomena of the specimens in group D were similar to groups A, B, and C. Figure 7(d) shows the hysteresis loops observed for specimen in group D.

In group E, first, the self-tapping screws at the edge of gypsum board were loosened. Then, the gypsum boards at the corner were crushed, and the self-tapping screws were loosened and pulled out severely. Crack occurred at the connection of two gypsum boards on the longitudinal wall. Finally, the steel stud buckled severely, or the gypsum boards were separated from each other on the longitudinal wall, and the specimen was failed. Compared to other specimens, the specimens of group E did not show any damage on the partition wall-structure connection, due to the strong expansion bolt, but the more self-tapping screws loosened or were pulled out, and the steel stud buckled. The damage phenomena of group E were different from other specimens, showing that strengthening the partition wall-structure connection could change the damage phenomena of the partition wall. Figure 7(e) shows the hysteresis loops observed for specimen in group E.

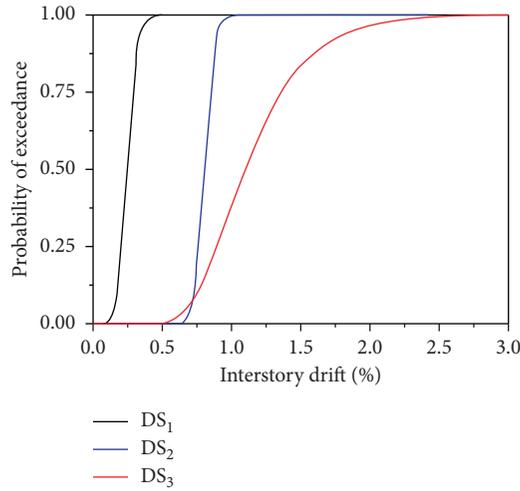
FIGURE 8: Fragility curves for group A.

where $j = 1, 2,$ and 3 denote the three damage states of a specimen, i represents the i th specimen in a group of specimens for fragility analysis, r_i^j denotes the interstory drift ratio that triggers the j th damage state of the i th specimen, and M is the number of specimens in a group of specimens for fragility analysis, where $M = 3$ in this study. The fragility curves are shown in Figures 8–12.

The fragility curves DS₂ and DS₃ are crossing in groups A, B, and D. The fragility curve is calculated by cumulative

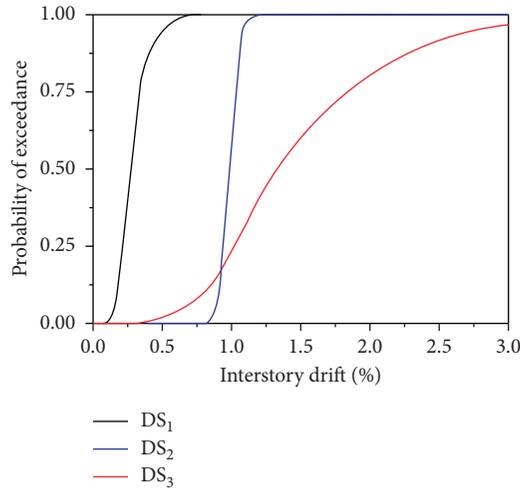
FIGURE 9: Fragility curves for group B.

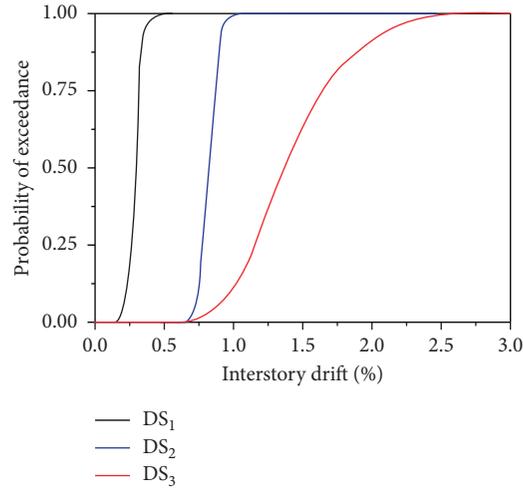
FIGURE 10: Fragility curves for group C.

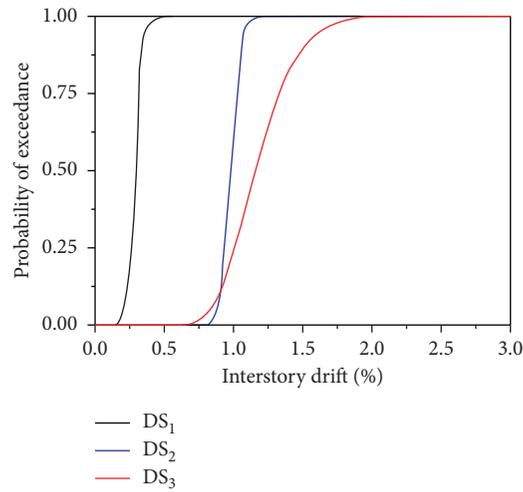
FIGURE 11: Fragility curves for group D.

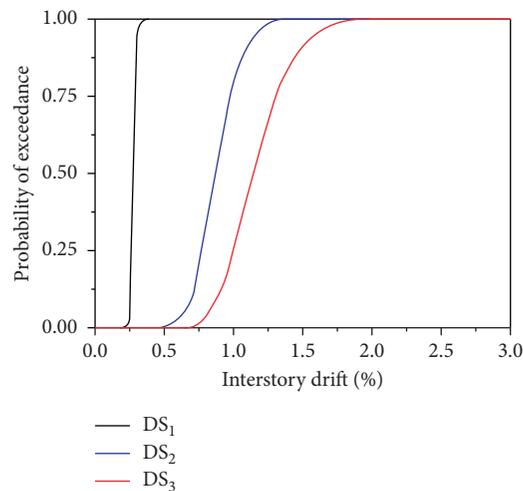
FIGURE 12: Fragility curves for group E.
