## Research Article

# Dynamic Characterization of a Reinforcement Rammed Wall for the Earthen Ruins

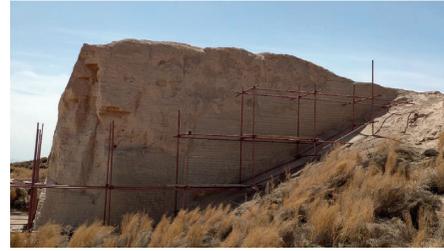
FIGURE 1: The reinforced site wall.

The experimental work depicted in the paper followed an elementary investigation on a reinforcement rammed wall located in the Suoyang ancient city (Guazhou, China), under which actual conditions indicated that it has been strengthened and in order to avoid the loss of an ancient cultural architecture (Figure 1). We are all known that the currently conditions are the result of the restoration process against the other walls in the ancient city. While, there are ruins of the wall at different degrees of erosion damage. As the government departments pay more and more attention to the protection of cultural relics, strengthened cultural relics are processing. The wall is trapezoidal in cross section with two sides of about 6.5 m and 4.2 m; it is 10 m tall and the thickness of the rammed layer is 0.1 m. The top surface of the site is roughly terrace-shaped. Simplifying the actual situation can allow us to gain Figure 2. A trebling method is revealed combining an accurate aerial survey based on pictures processing, vibration testing, and FEM.

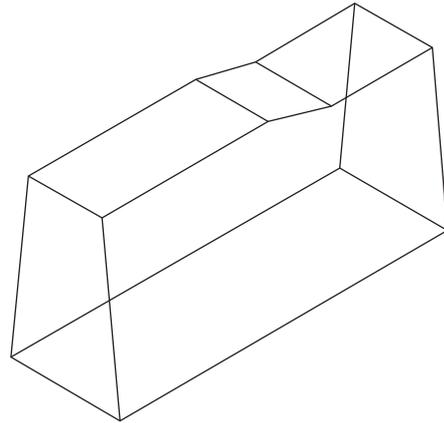
FIGURE 2: The simplified model of the wall.

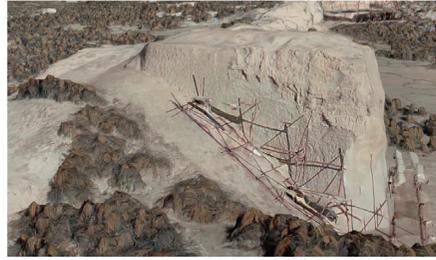
FIGURE 3: The reinforced wall in Suoyang city: virtual 3D model.

The configuration used in the experiment can be epitomized into four stages: operation planning, data acquisition, data processing, and postprocessing representations. A considerable number of superimposed pictures can be obtained from the drone flight. It is commonly believed that the complete layout of the whole structure, the plan view, the one elevation, and the lower side of the wall could be generated from the datasets. Plotting the range of the flight on the remote controller, the target level of accuracy depended on the flight altitude, and as such, we must adjust the flight height. The flight was carried out using a Phantom 4 manufactured by DJI, which flew at an altitude of 80 m. Reducing the height can improve the accuracy, but it would greatly increase the cost of image processing. Thus, we need to take the height into account for processing costs. The flight range is the continuous walls in the east of Suoyang ancient city, and the object to be studied in the paper is a part

of it. Therefore, it is necessary to intercept from them (Figure 3).

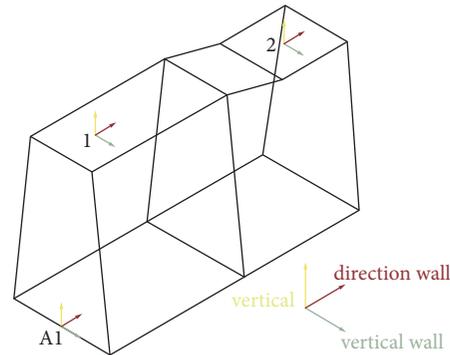
FIGURE 4: The sensors' arrangements in the wall.

*3.1. Experimental Procedures and Methods.* The dynamic response of the reinforced wall has been measured by using nine uniaxial accelerometers. The INV 3060S intelligent signal acquisition and processing system developed by COINV were selected as the experimental equipment, and the 941 B vibration pick-ups developed by Institute of Engineering Mechanics CEA were selected as the sensors. The sensitivity of the sensor was 23 V-s/m. The 9 sensors were divided into three groups; each group has 3 sensors in which the two horizontal and one vertical direction were measured, respectively. Placing three sets of vibration pick-ups in three positions for the purpose of the identification of vertical, horizontal, and torsional vibration modes, the sensors' arrangement is reported in Figure 4. There are three experiments in the testing methodology, each recording 300 s time series with a sample rate of 204.8 Hertz. Three sets of vibration pick-ups were named as A1, 1, and 2. The one point of A1 has been installed in the bottom of the wall as a reference system for the analysis, and the others were placed on the top of the wall. Each point has three arrows

representing the three directions in which it is measured (Figure 4). It should be noted that the red arrow is the direction wall, the green arrow is the vertical wall, and the yellow arrow is the vertical.

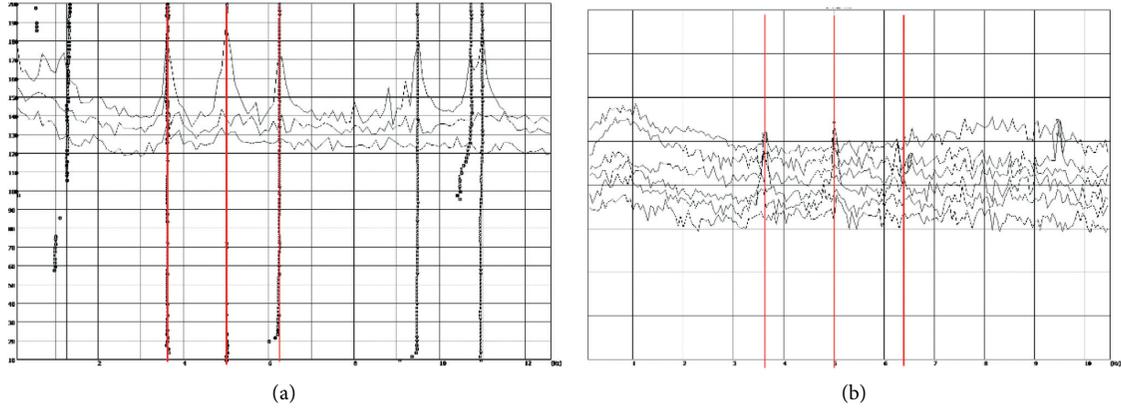
FIGURE 5: The pictures with two different techniques. (a) Stability diagram for SSI. (b) Singular value for EFDD.

**3.2. Data Processing: SSI and EFDD.** The data obtained from the sensors were processed by the stochastic subspace identification (SSI) algorithm in the time domain and the enhanced frequency domain decomposition (EFDD) method for identifying the modal parameters [21, 22]. Since the power spectral density spectrum estimated from the raw velocity data and the corresponding references [23, 24], the range of the frequencies should be below 10 Hertz. The ambient vibration data were processed to a cut-off frequency of 10 Hertz. Natural frequencies and vibration modes of the reinforced wall were estimated by using the SSI and EFDD. Figures 5(a) and 5(b) show the stability diagram for the SSI and the singular values of the spectral matrices of the testing for the EFDD, respectively.

The paper identified the frequencies and modes of the first-three orders (Figure 6). As shown in Figure 5, the frequencies identified by the stability diagram obtained by the SSI method and the singular values obtained by the EFDD method are basically the same (Table 1).

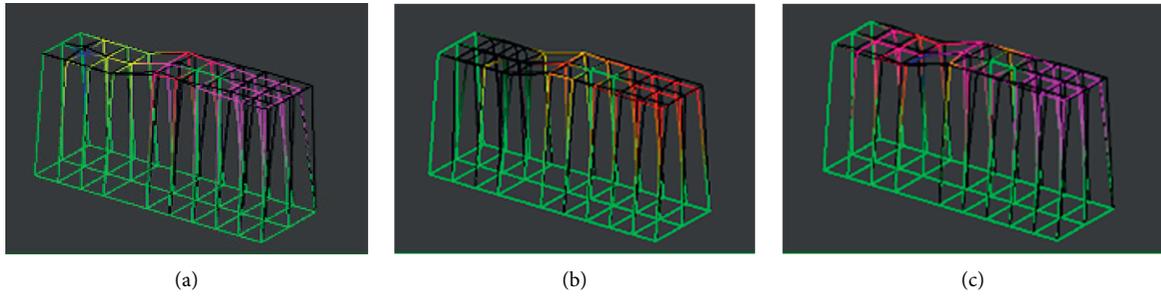
FIGURE 6: Experimental frequencies and vibration modes. (a) First-order transverse bending,  $f_1 = 3.626$  Hz, and damp = 0.861%. (b) Second-order left and right torsion,  $f_2 = 5.018$  Hz, and damp = 0.416%. (c) Third-order vertical bending,  $f_3 = 6.372$  Hz, and damp = 1.876%.

Modes (#)	SSI		EFDD		Mean	
	Freq (Hz)	Damp (%)	Freq (Hz)	Damp (%)	Freq (Hz)	Damp (%)
1	3.629	1.19	3.624	0.532	3.626	0.861
2	5.012	0.82	5.024	0.012	5.018	0.416
3	6.251	1.52	6.493	2.232	6.372	1.876

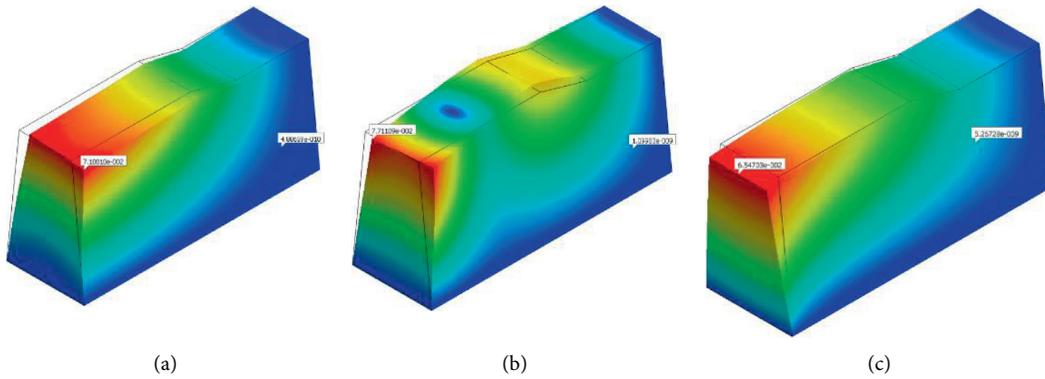
FIGURE 7: Numerical frequencies and vibration modes. (a) First-order transverse bending,  $f_{1FEM} = 3.34$  Hz, (b) second-order left and right torsion,  $f_{2FEM} = 5.417$  Hz, and (c) third-order vertical bending,  $f_{3FEM} = 6.098$  Hz.

modes in the vertical direction were not identified. In fact, there are higher order torsional modes in the vertical direction, as evidenced by the FEM results. The 3D model

obtained from the UAV flight was applied to be built as accurate as possible. Because the modelling built in the paper is regular, there are some slight differences in details from

the actual one, such as the existence of a partial gap at the top of the wall which is neglected in the finite element model. More importantly, the wall is more nonuniform and non-homogeneous on account of the effects of historical and natural disasters. This could explain the discrepancies between the experimental and FEM analyses.
