## Research Article

# Study on Energy Dissipation Characteristics and Damage Law of Backfill under Cyclic Impact

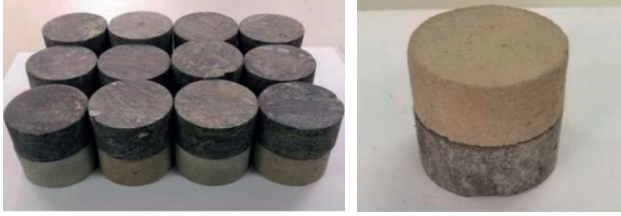
FIGURE 1: DM-CTB.

**2.2.3. Test Scheme.** In this impact test, the combined specimens DM and CTB were, respectively, used as the incident end and the transmission end [38–40]. The impact pressure (replaced by  $I_p$ ) was selected as 0.2 MPa and 0.24 MPa. Five cycles of impact tests were carried out on DM-CTB<sub>1:4</sub> and DM-CTB<sub>1:6</sub> specimens to simulate the cumulative damage and failure effect of multiple blasting stopping on adjacent cemented backfill.

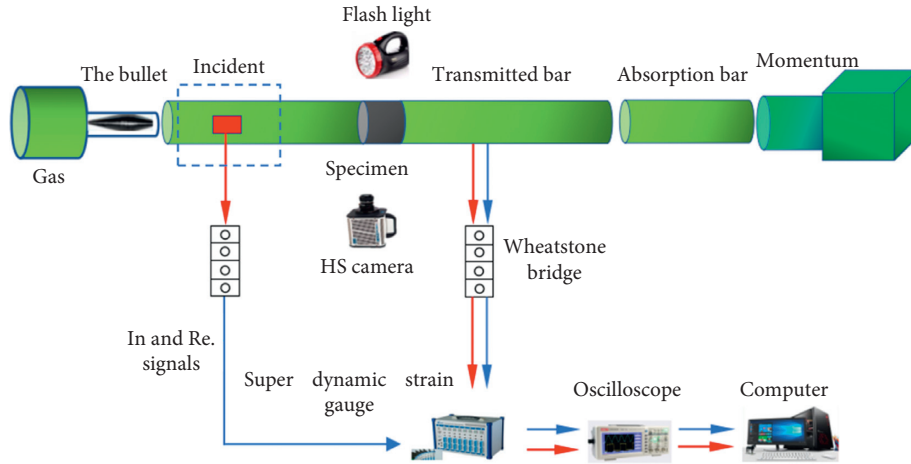
FIGURE 2: SHPB test device.

**2.2.1. Experimental Equipment.** In this research, the test was carried out using the SHPB (split-Hopkinson pressure bar) pressure rod separator in the Rock Mechanics Laboratory of Kunming University of Science and Technology, as shown in Figure 2. The main components include power wheel drive, elastic compression bar, damping absorption, signal collection, data storage, and processing. The elastic pressure rod is made of 40 Cr high-strength alloy steel, its diameter of is 50 mm, the elastic modulus is 210 GPa, and the density is 7810 kg/m<sup>3</sup>; the p-wave velocity is 5100 m/s.

**2.2.2. Experimental Principle.** In the SHPB test, there are two basic assumptions, including the one-dimensional stress wave propagation and stress uniformity. The “three-wave method” [37] was used to process the collected strain wave signal. The stress  $\sigma(t)$ , strain  $\varepsilon(t)$ , and strain rate  $\dot{\varepsilon}(t)$  can be expressed as

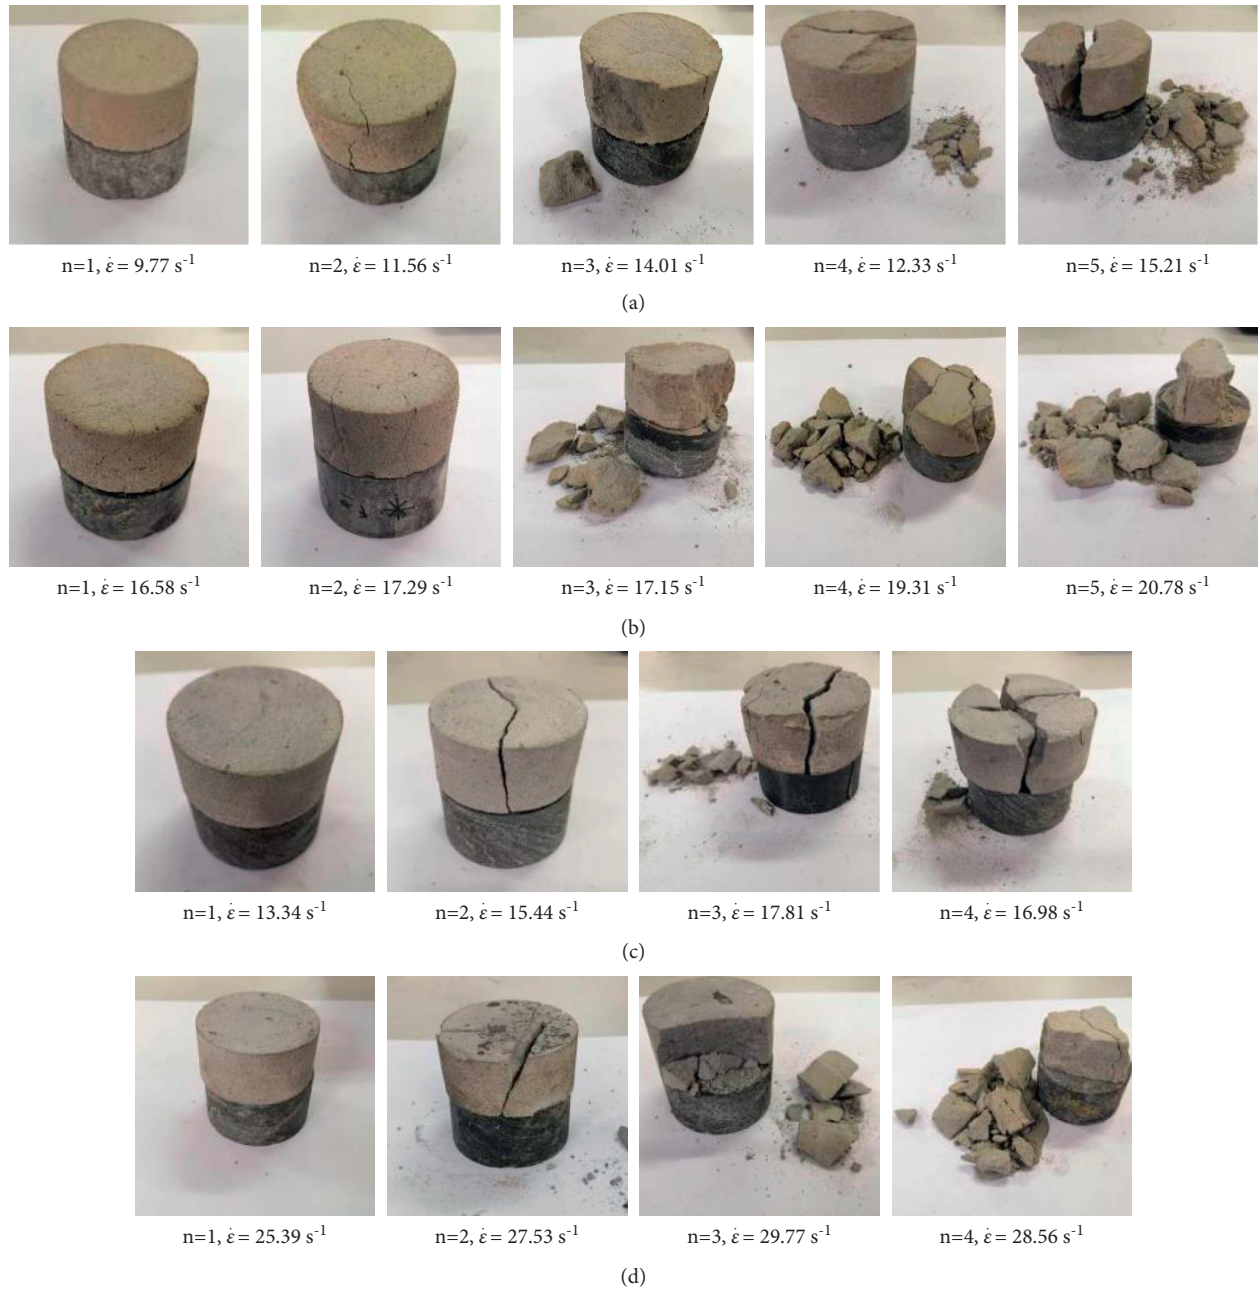
FIGURE 5: Combination of specimen failure pattern impact process. (a)  $I_p = 0.2 \text{ MPa}$ , DM-CTB<sub>1:4</sub>. (b)  $I_p = 0.24 \text{ MPa}$ , DM-CTB<sub>1:4</sub>. (c)  $I_p = 0.2 \text{ MPa}$ , DM-CTB<sub>1:6</sub>. (d)  $I_p = 0.24 \text{ MPa}$ , DM-CTB<sub>1:6</sub>.

**4.1. Failure Modes of Composite Specimens under Cyclic Impact.** It can be seen from Figure 5(a) that under the condition of  $I_p=0.2$  MPa, DM-CTB<sub>1:4</sub> did not show obvious failure when  $n=1$ ; when  $n=2$ , CTB<sub>1:4</sub> began to produce transverse cracks; when  $n=3$ , it started to flake at the edges; when  $n=4$ , CTB<sub>1:4</sub> showed shear failure; when  $n=5$ , CTB<sub>1:4</sub> showed failure instability and partial crushing. With the increase of the number of cyclic loading, the fragmentation degree of CTB<sub>1:4</sub> increased and the fragmentation size decreased; however, according to the shape of fragments, the fracture surfaces are mainly parallel to the length direction of sample CTB<sub>1:4</sub>, and most of them are transverse tensile failures. When  $I_p=0.2$  MPa, DM-CTB<sub>1:6</sub> showed tensile failure accompanied by edge breakage; the reason is that at the end of the transmission bar, cracks and fracture zones appeared in CTB under the effect of impact loading. Under the action of axial impact compression. The fracture area is prone to stress concentration, and there is reflective stretching between the interfaces. The filling body near the end of the transmission rod is more likely to be broken.

After cyclic impact loading, by comparing Figure 5(a) with Figure 5(b), it can be seen that in DM-CTB<sub>1:4</sub> combined specimen, the deformation failure of CTB is faster than that of  $I_p=0.24$  MPa when  $I_p=0.24$  MPa. By comparing Figure 5(c) with Figure 5(d), it can be known that when  $I_p=0.24$  MPa, the CTB exhibited larger deformation and more obvious failure. As shown in Figures 5(a)–5(d), under the same impact pressure, the CTB part in DM-CTB<sub>1:6</sub> showed a higher degree of tensile and shear failure, indicating that the overall strength of DM-CTB with a small ratio is weak. The springback deformation of DM-CTB<sub>1:6</sub> aggravated the deformation failure of the lower part of the specimen and weakened the stability of the skeleton structure. According to Figure 5, when DM-CTB<sub>1:6</sub> was damaged, DM-CTB<sub>1:4</sub> was still in the elastic deformation

stage with no cracks or some internal microcracks produced, and the plastic deformation was incomplete. Moreover, the impact of low strain rate had a certain “reinforcing” effect on the specimen structure, and its impact resistance and deformation resistance were improved in the short term.

In conclusion, under the action of cyclic impact load, both ends of DM-CTB showed an end effect, which leads to stress concentration; at the same time, compression zones are formed at both ends of DM-CTB, resulting in cracks being parallel to the axial direction. With the increase of compressive stress, a potential shear failure surface is formed, and some cracks of the filling body in DM-CTB will

further be expanded, finally forming a macroscopic failure surface. In the shear failure surface area, CTB samples will fall off due to the impact and exhibit compression shear failure. However, CTB will lose its bearing capacity and break into many small pieces when the dynamic load strength exceeds the residual strength of CTB.

For the same ratio, under the cyclic impact, the larger the impact pressure is, the more obvious the deformation failure of DM-CTB is. Under the same impact pressure, CTB in DM-CTB with a low ratio is more serious, and the mass of fragments increases accompanied by fine powder. The failure mode is mainly crushing failure, but the DM part is

nearly not broken accompanied by transverse deformation on the end face of the DM part of the transmission end. Only a few parts of DM show tensile cracks. With the increase of  $I_p$  of impact pressure, the development of tensile cracks in the DM part deepens, but in general, the crack development is not obvious.
