Research Article

Occurrence Mechanism of Roof-Fall Accidents in Large-Section Coal Seam Roadways and Related Support Design for Bayangaole Coal Mine, China

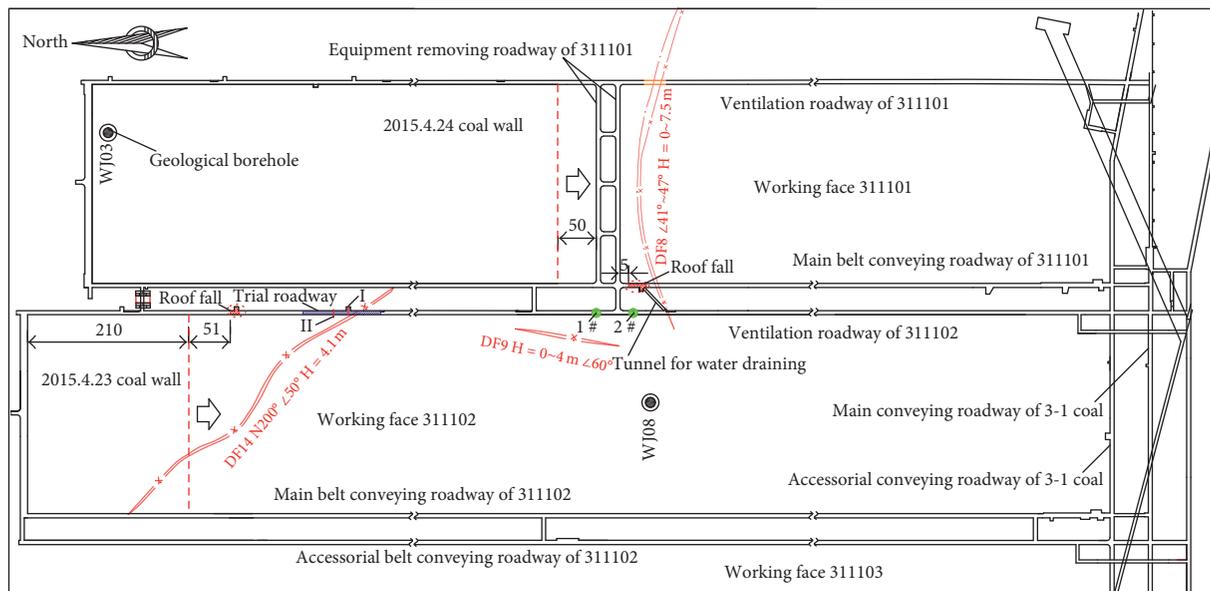
At about 8:00, April 23, 2015, when number 311102 working face was advanced to 210 m, the anchor cables in ventilation roadway were fractured, and roof stratum 51–62 m in front of the working face fell (i.e., the position filled with red grid lines shown in Figure 3). The roadway where the roof fell had a length of approximately 12 m, the maximum fall height of the roof was almost 5.0 m, and the section of the roadway with the fall height over 1.5 m was approximately 6 m in length. At about 0:44, April 24, 2015, when number 311101 working face was advanced to 50 m away from the withdraw roadway, the anchor cables in the main belt conveyor roadway were fractured, and the roof strata 5–21 m in front of the withdraw roadway fell (i.e., the position filled with red graticule lines shown in Figure 3). The roadway where the roof fell was approximately 16 m in

length, the maximum fall height also exceeded 5.0 m, and the section of the roadway with the fall height over 1.5 m was approximately 9.0 m in length. The fallen rocks pressed the belt conveyor, thus stopping the production in the working face. As also shown in Figure 3, two equipment caverns with a width of 5.0 m, a height of 3.8 m, and a depth of 5.0 m were set at the roof-fall positions in both the belt conveyor roadway of number 311101 working face and ventilation roadway of number 311102 working face. Apparently, the roadway span near the caves increased significantly, providing advantageous conditions for the fracture and falling of roadway roof. Figure 5 shows the pictures of roof-fall scenes in the ventilation roadway of number 311103 working face. To increase the supporting intensity of roadway roof and avoid the second roof-fall accident, single hydraulic props and steel i-beams were added after the first roof-fall accident. Sudden roof-fall accidents in the roadway severely threatened the physical health of underground miners and affected the safe and regular production in mines. Therefore, it is very important to investigate the causes and mechanisms of roadway roof-fall accidents in depth, improve the supporting scheme for surrounding rocks, and optimize the supporting parameters to avoid the reoccurrence of roof-fall accidents.

FIGURE 3: Illustration of the arrangement in numbers 311101 and 311102 working faces of Bayangaole coal mine.

As shown in Figure 3, two caverns with an identical depth of 5.0 m existed at the roof-fall positions in the main belt conveyor roadway of number 311101 working face and the ventilation roadway of number 311102 working face. The existence of caverns on the sides of roadway increased the span of roof coal seam, and the span of roof coal seam where the cavern was located can be written as follows:

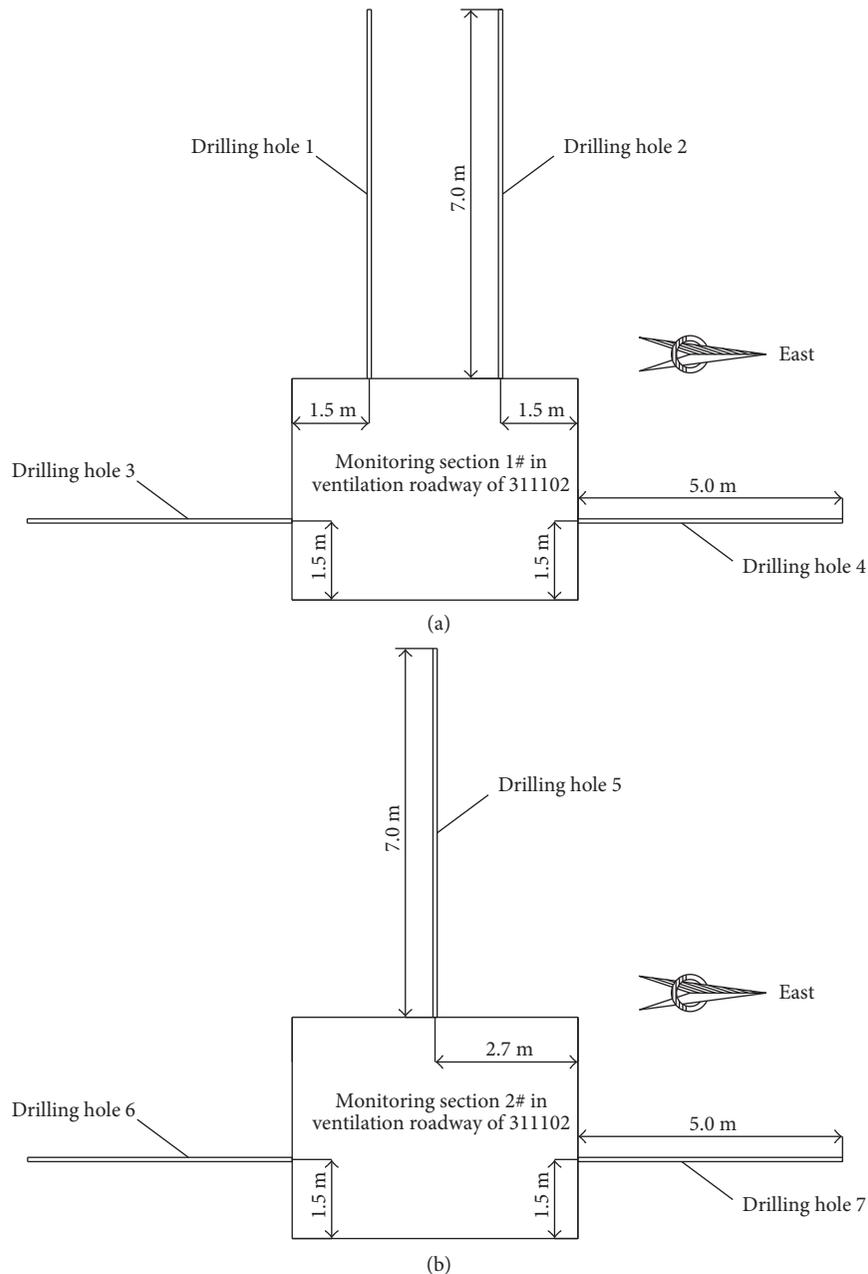
fracture characteristics of surrounding rocks in the ventilation roadway of number 311102 working face. During the detection, two monitoring sections were arranged as marked by green dots in Figure 3 on which a total of seven detection drilling holes were arranged. Specifically, four holes were arranged on monitoring section 1, while three holes were arranged on monitoring section 2. Figure 7 shows the arrangement of each detection hole on the section and related parameters.

FIGURE 7: Arrangement of drilling holes on two monitoring sections and related drilling parameter settings. (a) Monitoring section 1 and (b) monitoring section 2.

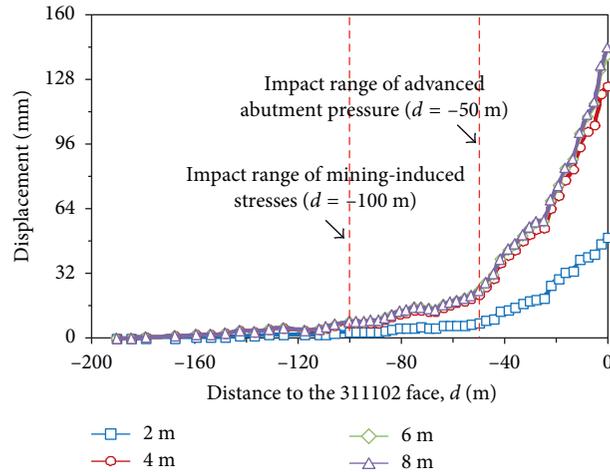
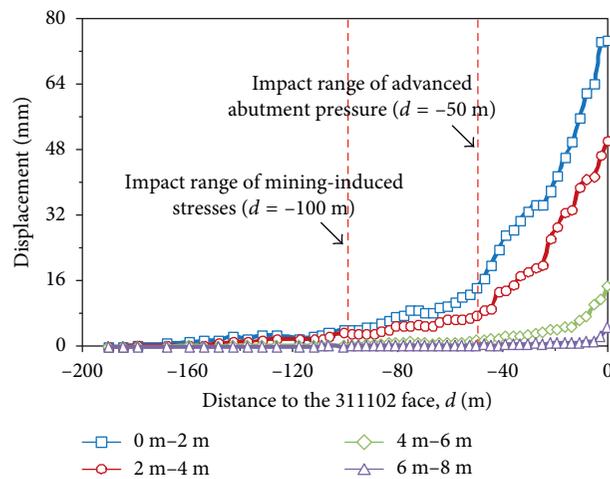
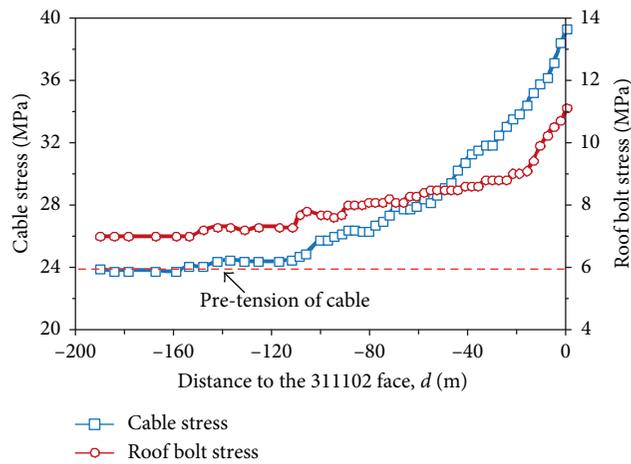
As the displacement of the shallow stratum (within a range of 0–4 m above the roof) increased gradually, stresses on the bolt at both sections I and II increased, indicating that a bolt with full-length anchorage can effectively suppress the displacement of a shallow stratum on the roof. The stress on roof anchor cable also increased with the increase in roof displacement and reached the maximum when the working face moved to the measuring point. The maximum stresses on roof anchor cables on sections I and II were 39.3 MPa and 52.5 MPa, respectively. According to the forced area of the stressmeter, the forces on the anchor cables were 275 kN and 365 kN, respectively, far smaller than the anchor cable's tensile load limit. This indicates that the used anchor cable was reasonable.

FIGURE 14: Monitoring results of roof displacement and stress on anchor cable (bolt) at section I. (a) Monitoring results of roof displacement, (b) displacements of roof stratum at different depths, and (c) monitoring results of stress on anchor cable (bolt).
