Research Article

An Investigation of Damage Mechanism Induced by Earthquake in a Plate Girder Bridge Based on Seismic Response Analysis: Case Study of Tawarayama Bridge under the 2016 Kumamoto Earthquake

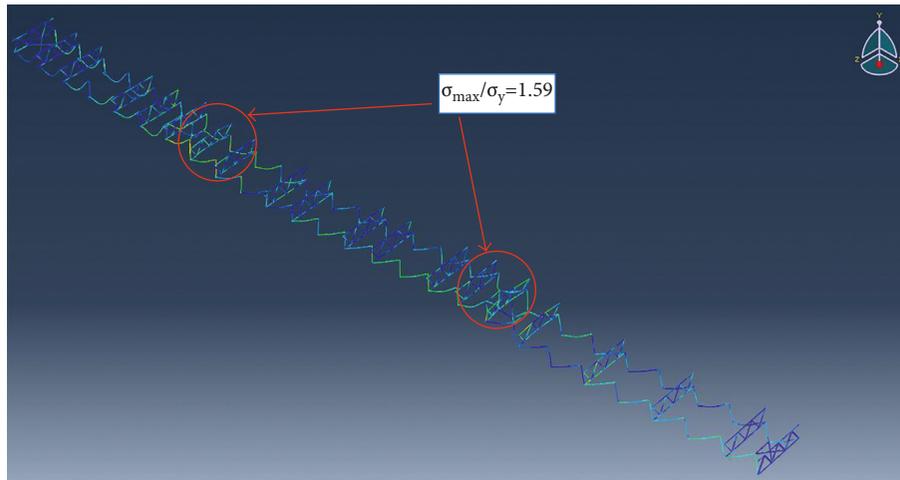
FIGURE 29: Members with the maximum σ/σ_y value.

6.1. Stress States in the Lateral Bracing Members. The stress states of all lateral bracing members for all five cases are presented in this section. The locations of all bracings are shown in Figure 28, and the stress states and maximum stress locations are shown in Figure 29.

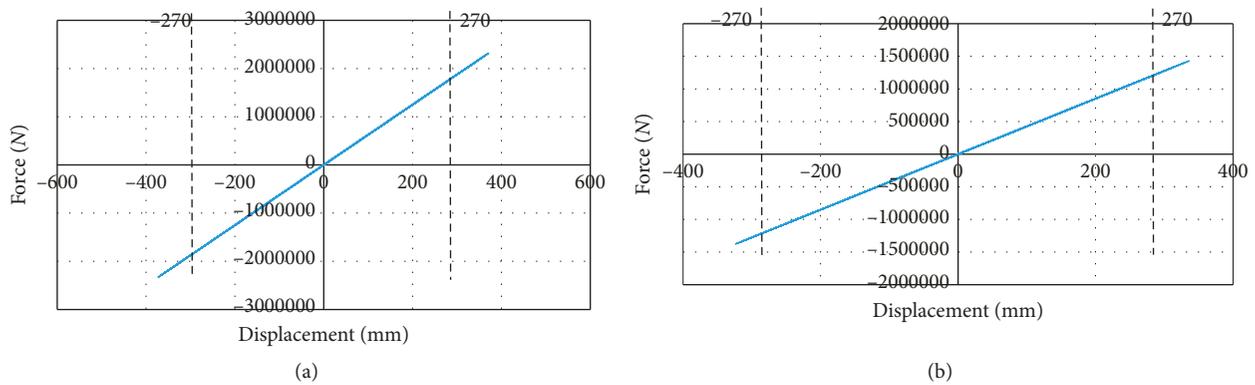
FIGURE 31: Force-displacement curves for the spring at pier 2.

used as rubber bearings in the bridge. Springs were installed at 16 locations (four for each pier and abutment) between the girder and piers/abutments, which are shown in Figure 30. Figure 31 presents the load-displacement relationship curves of a spring at P2 under the undamped condition in both longitudinal and transverse directions. The dotted lines in the figure show the theoretical displacement criteria of spring elements.

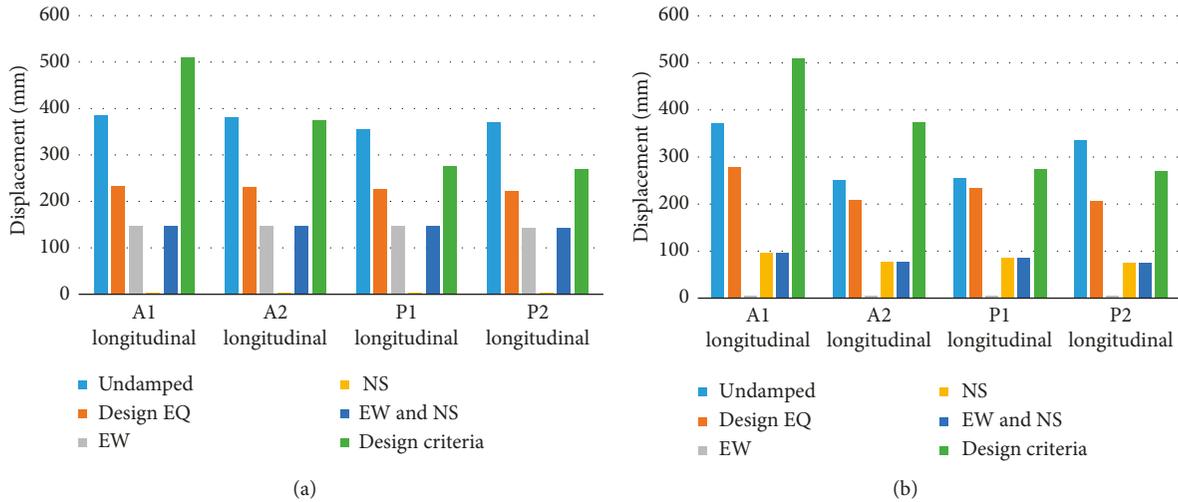
FIGURE 32: Spring displacement of the spring in each abutment and pier for all cases: (a) longitudinal direction and (b) transverse direction.

The displacement of all springs in all cases except in the undamped case was within their displacement criteria. In the undamped case, the displacement of springs at A2, P1, and P2 in the longitudinal direction and that of P2 in the transverse direction exceed the displacement criteria. The maximum displacement of springs occurred between 25.5 s and 26.8 s, which is close to the time when the maximum acceleration occurred.

displacement criteria in both longitudinal and transverse directions may be the reason why one of the rubber bearings at the P2 pier fell down. The displacements of springs in the longitudinal and transverse directions for all cases are shown in Figure 32.

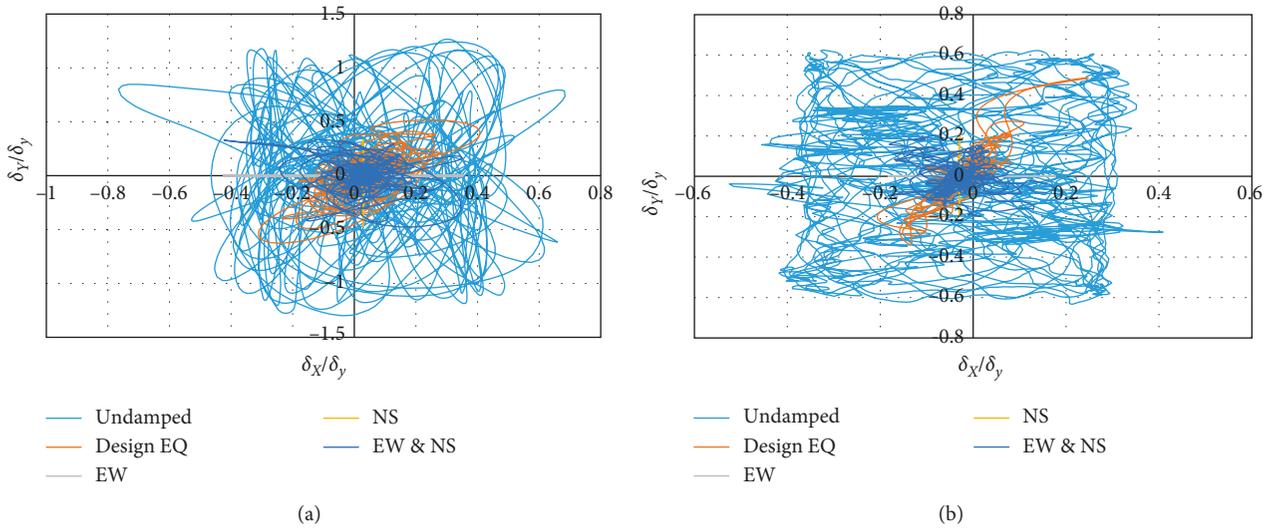
FIGURE 33: Trajectory curve for (a) pier 1 and (b) pier 2.

6.3. *Trajectory Curve of Piers.* The trajectory curves of piers were established in order to determine their response during the earthquake. These curves are shown in Figure 33. Among the five cases, the undamped case is more dominant, followed by the design earthquake one. It is clear that the displacements in the EW (longitudinal) and NS (transverse) directions are only dominant in their respective direction for both P1 and P2. The undamped displacements of both piers are more dominant in the

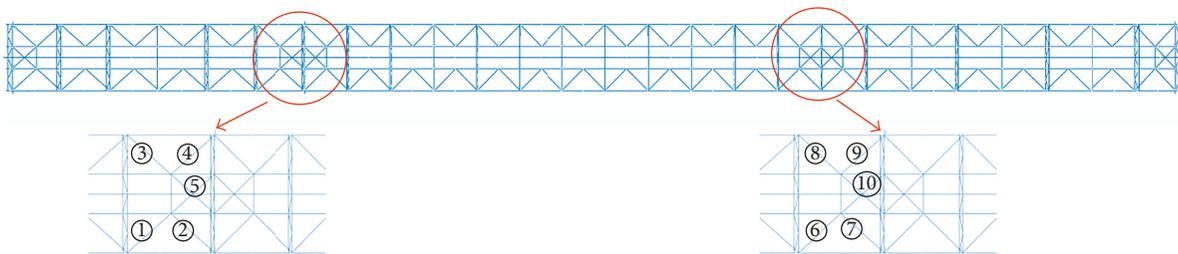
FIGURE 34: Locations of the buckled lower bracing members.

6.4. Behavior of Lower Lateral Bracings. The time history displacement response curves and force-displacement curves of some lower lateral bracing members were plotted in order to understand the behavior of lower lateral bracing members. The stresses of some of these members exceeded the maximum stresses, leading to hardening. Hence, some members exhibited an elastoplastic behavior, whereas some exhibited an elastic behavior only. Among the ten selected members shown in Figure 34, eight members buckled in the undamped case, five buckled in

the design EQ, and two each buckled in the EW and the EW and NS cases. In the NS case, no member buckled. Figure 35 shows that the members around P2 have a greater tendency to buckle, especially under the damped condition.
