Research Article

Mechanism and Control of Cable Breakage in a Roadway with Thick Top Coal in a Rockburst Mine

Cable breakage occurred frequently in the No. 3 roadway in Xingcun coal mine of Shandong Tian'an Mining Group CO., Ltd., during the roadway excavation. The paper aims at addressing the cause and solution of the case of general rockburst (rockburst phenomenon). Firstly, based on the analysis of stress and elastic energy evolution law of surrounding rock and stress state of cable, cable breakage mechanism was revealed. After that, grouting technology and parameters of cable breakage control were designed and applied in the No. 3 roadway. The research results can provide certain theoretical and practical value for mine pressure control of roadway, especially in rockburst mines.

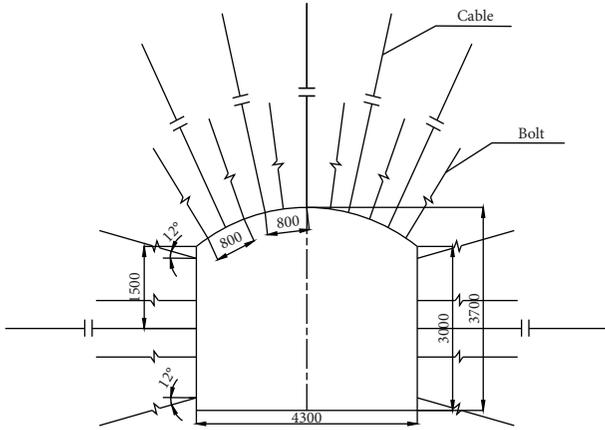
In the recent roadway excavation project, cable breakage occurred in the No. 3 exploration roadway in the seventh mining area of the Xingcun coal mine. The roadway adopted a straight wall circular arch section with 4300 mm width, 3000 mm straight wall height, and 700 mm circular arch height (Figure 1). Because it was driven along the floor of the coal seam, its roof was reserved with about 4.8 m top coal.

FIGURE 1: Section size and support parameters of No. 3 exploration roadway (unit: mm).

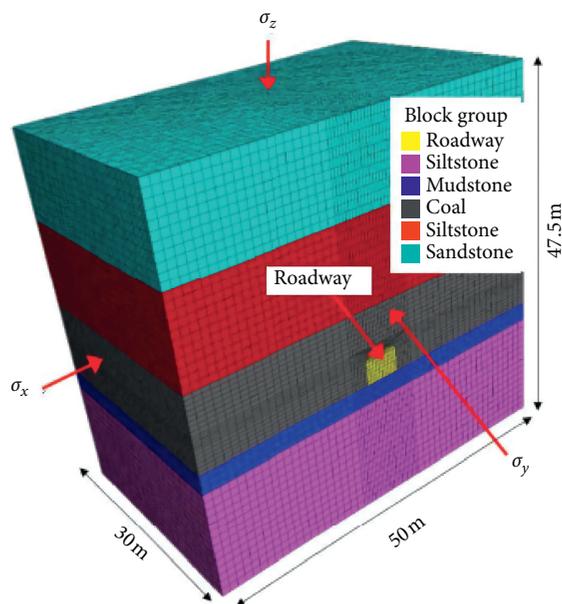
A three-dimensional numerical simulation model of the No. 3 roadway was established using FLAC3D software (Figure 4). The horizontal width, strike length, and vertical height of the model were $X \times Y \times Z = 50 \text{ m} \times 30 \text{ m} \times 47.5 \text{ m}$. For the accuracy of calculation, the grids of adjacent roadways were densely divided, and other grids were relatively sparse. The total number of nodes was 226,414 and the total number of units was 214,800. The front, rear, left, right, and top surfaces of the model used a stress boundary, and initial ground stresses (Table 1) were applied on the surfaces. The bottom surface used displacement boundaries. The

FIGURE 4: Three-dimensional numerical simulation model of the No. 3 roadway.

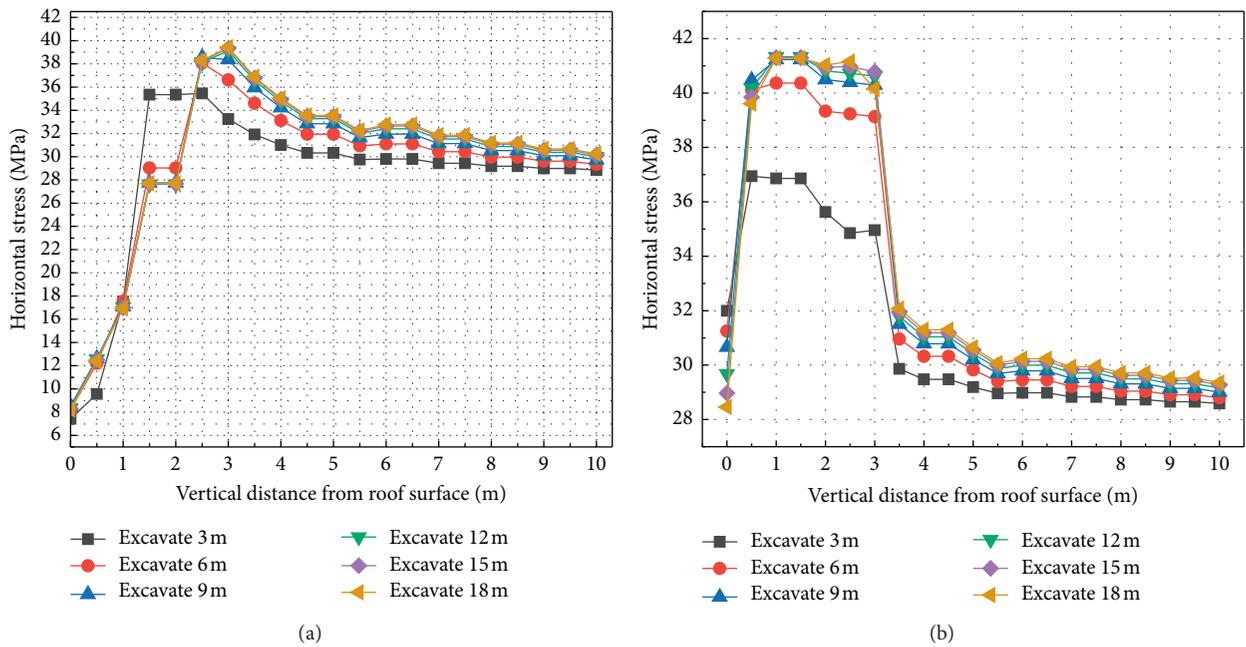
4.1.1. Comparison of Horizontal Stress Evolution. The mechanical parameters of the top coal and the rock with grouting were set larger than that without grouting in the numerical simulation model shown in Figure 4. Figure 9 was a comparison of the calculation results of horizontal stress

FIGURE 9: Horizontal stress evolution under different excavation distance without and with surrounding rock grouting. (a) Without surrounding rock grouting. (b) With surrounding rock grouting.

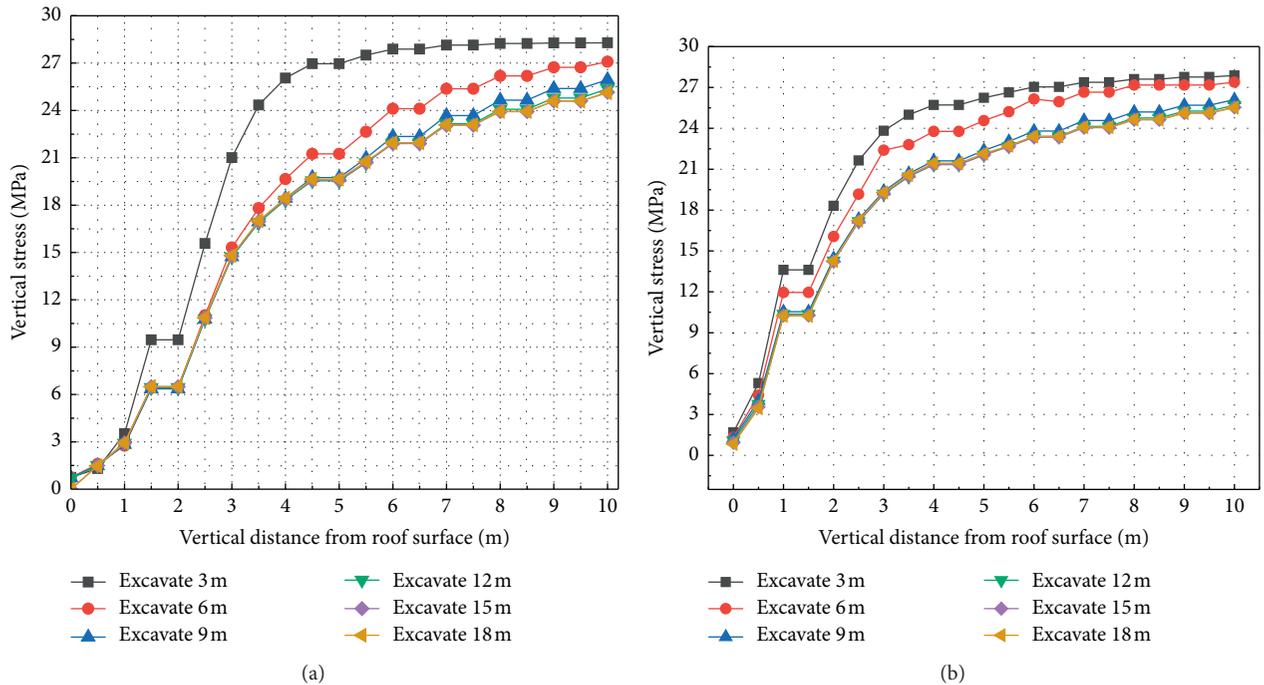
4.1.2. Comparison of Vertical Stress Evolution. Figure 10 shows a comparison of the calculation results of vertical stress evolution. Whether it was grouted or not, as the roadway excavation continues, the vertical stress within 10 m above the roof surface gradually decreased as a whole. But compared to that without surrounding rock grouting, the vertical stress drops evenly within the range of 3 m~4 m of roof after surrounding rock grouting, and there was no instantaneous sharp drop in the vertical stress. Another aspect, regardless of whether there is surrounding rock grouting or not, as the roadway excavation continues, the vertical stress of the surrounding rock within 1 m above the roof surface was gradually decreasing, but there was no situation that the vertical stress tended to be of very low value without surrounding rock grouting. For example, at the part 1 m deep of the top coal, the vertical stress without

surrounding rock grouting was about 3 MPa, and the vertical stress was at 9 MPa after surrounding rock grouting.

FIGURE 10: Vertical stress evolution under different excavation distance without and with surrounding rock grouting. (a) Without surrounding rock grouting. (b) With surrounding rock grouting.

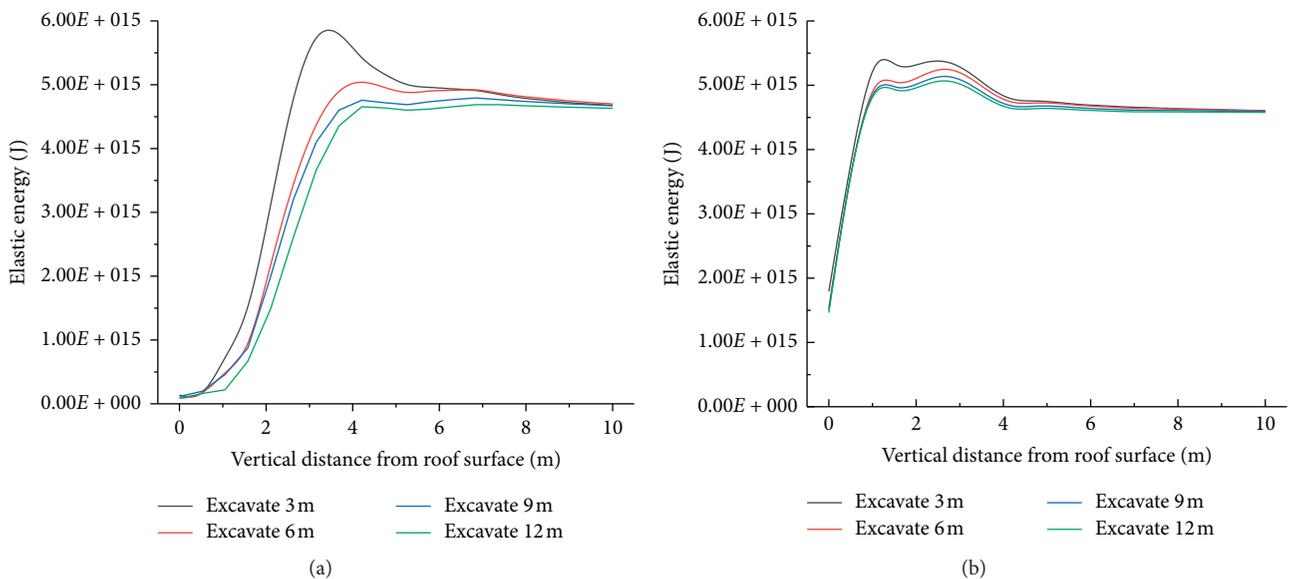
4.1.3. Comparison of Elastic Energy Evolution. Figure 11 was a comparison of the calculation results of the elastic energy. When the roadway surrounding rock was not grouted, as the roadway excavation, the elastic energy of the surrounding rock within 1 m of the shallow part of the roof tended to

zero, and a large amount of elastic energy accumulated within 3 m~4 m of the roof. After the surrounding rock was reinforced by grouting, although the surrounding rock energy was dissipated within 1 m of the shallow part of the roof, the elastic energy dissipation in this range was less compared to that without surrounding rock grouting. In addition, the elastic energy distribution of the surrounding rock was even within the range of 1.8 m~3 m of the roof, and the peak value was reduced compared to that without

FIGURE 11: Elastic energy evolution under different excavation distance without and with surrounding rock grouting. (a) Without surrounding rock grouting. (b) With surrounding rock grouting.

surrounding rock. As the roadway excavation, the degree of the elastic energy dissipation in this range was smaller and even than that without surrounding rock grouting.

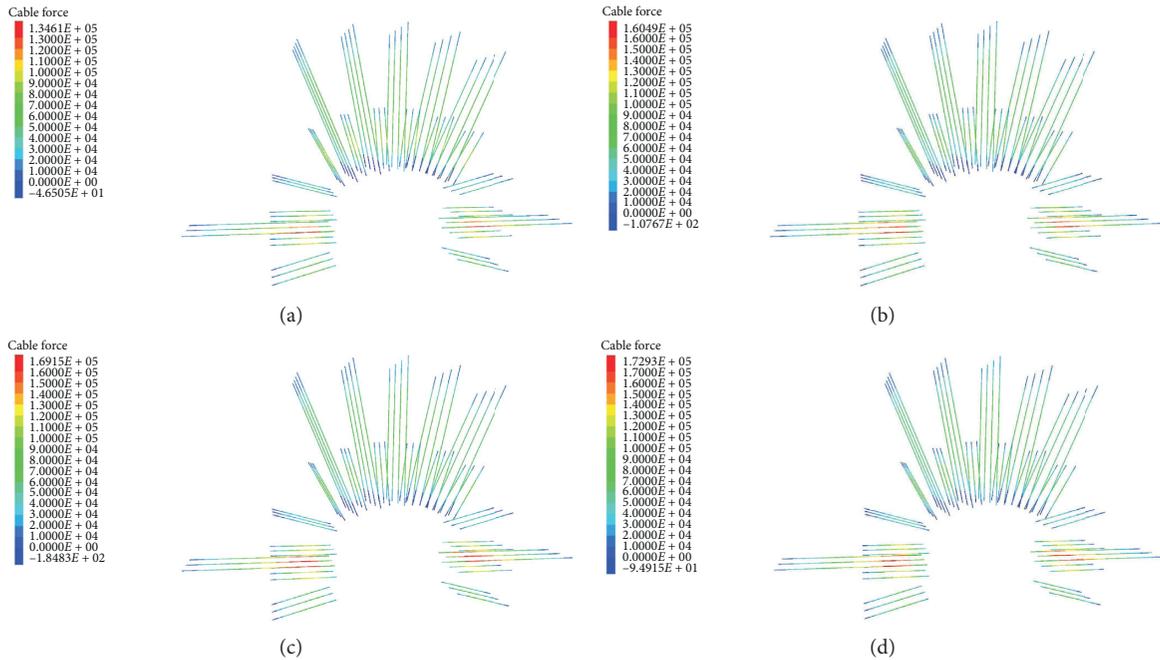
- (1) After the surrounding rock was grouted, the cable was uniformly stressed in the middle, and there was no axial force concentration, and the value was smaller than that without surrounding rock grouting.

FIGURE 12: Cable stress distribution under different excavation distance with surrounding rock grouting. (a) Excavate 3 m. (b) Excavate 6 m. (c) Excavate 9 m. (d) Excavate 12 m.

(2) After the surrounding rock was grouted, the cables with larger axial force were rib cables, but the maximal axial stress value of the rib cables was still smaller than that without surrounding rock grouting.

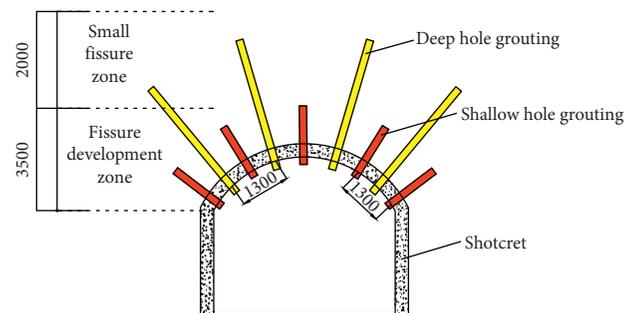
FIGURE 13: Schematic diagram of grouting hole design (unit: mm).

4.2.2. Grouting Hole Design. The reasonable design of surrounding rock grouting holes can effectively shorten the work, reduce the number of grouting materials, and increase the utilization rate of the grout. The grouting method of the No. 3 roadway used a combination of shallow hole grouting and deep hole grouting (Figure 13). The length of the shallow hole grouting pipe was 2600 mm (in the range of the fissure development zone), the radius was 15 mm, and the spacing and row spacing were 1300 mm. The length of the deep hole grouting pipe was 4800 mm (in the range of the small fissure zone), the radius was 10 mm, and the spacing and row spacing were 1300 mm.

4.2.3. Grouting Pressure. The pressure selected for surrounding rock grouting was to ensure that the grout can penetrate the fissures of the surrounding rock, but the grouting pressure should not be too high or too small [33]. If the grouting pressure was too high, problems such as roof falling will easily occur. If the grouting pressure was too small, the grout cannot be diffused in the surrounding rock due to insufficient power, and the grouting cannot achieve the expected effect of reinforcement. So the shallow hole grouting of the surrounding rock of the No. 3 roadway used 1 MPa grouting pressure, and the deep hole grouting used 1.5 MPa grouting pressure.

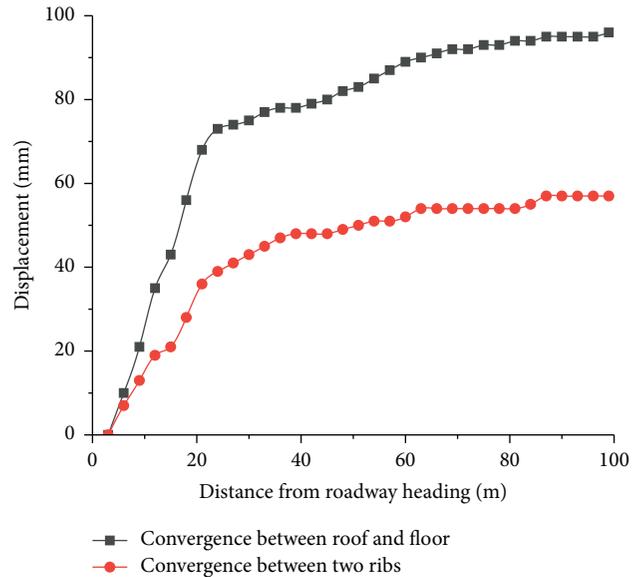
In the early stage of roadway excavation, the surface displacement of the surrounding rock near the heading of the roadway changes quickly. When the excavation distance was about 20 m from the heading, the surface displacement of the roadway started to converge stably. The convergence displacement of the two ribs was stabilized at about 53 mm, and the convergence displacement of the roof and floor was stabilized at about 97 mm (Figure 14). The deformation of the roadway was small.

FIGURE 14: Convergence displacement of roadway surrounding rock surface in the No. 3 roadway.

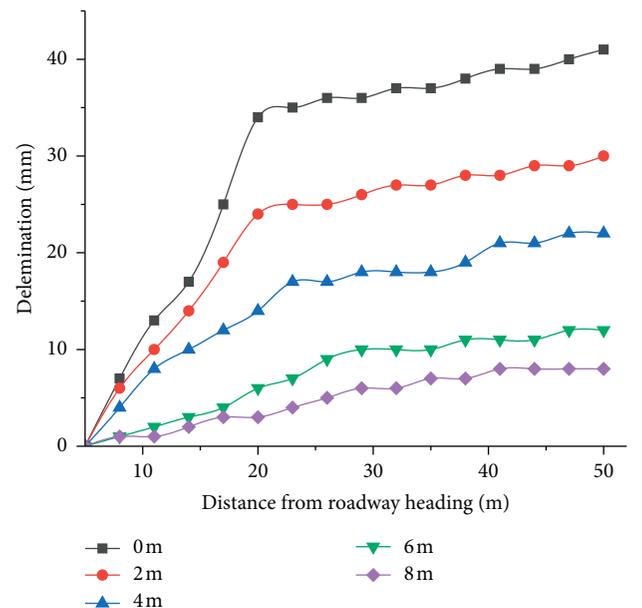
In order to check the integrity of the surrounding rock of the roadway after grouting, deep base point displacement meters were used to monitor the displacement of the surrounding rock of the roadway at different depths. The first measuring point was arranged at a distance of 5 m from the heading of the roadway, and the next measuring point was arranged every 20 m of the roadway. There were 3 measuring points in total, and the average value of the displacement value of the same depth measured by each measuring point was regarded as the final result. Figure 15 showed that when the measuring point was close to the heading, the displacement of each depth of the roof of the roadway increased faster and finally stabilized gradually. According to the data, the amount of separation in the deep part of the surrounding rock of the roadway was smaller, and the shallow part was slightly larger. But after a certain period of time, they all tend to be stable, and the maximum displacement was on the surface of the roadway. The maximum displacement of the roof was 38 mm.

FIGURE 15: Displacement of surrounding rock at different depth in the No. 3 roadway.

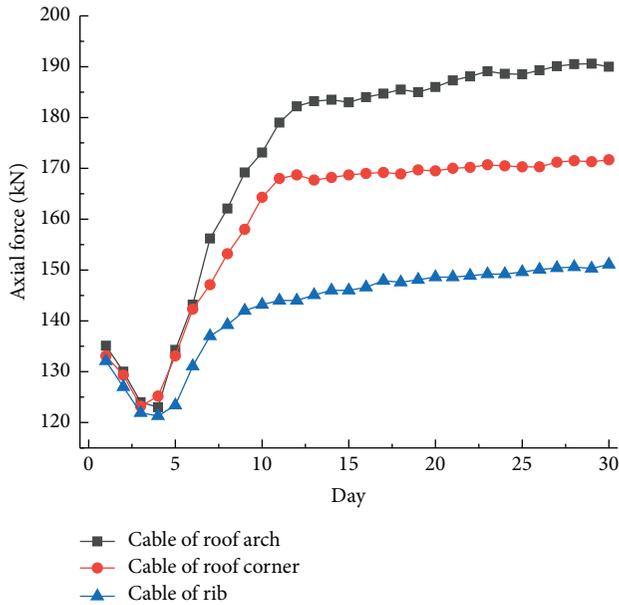
For the monitoring of the force of cable, the force of each part of the cable decreased first, then increased, and then stabilized (Figure 16). The axial force of the cable on the roof arch was the largest, and the maximum was 190.6 kN. The axial force of cable at the corner of the roadway was the next, and the maximum was 171.5 kN, and the anchoring force of the cable at the rib was the smallest, and the maximum was 151 kN. The axial force value of all the cable did not exceed the ultimate strength of the cable. More importantly, there was no cable breakage.

FIGURE 16: Axial force of the cable in the No. 3 roadway.
