Exposure Factors Influence Stone Deterioration by Crystallization of Soluble Salts

To perform this studio we focus on the stone obtained from the Church of *Santos Juanes* in Valencia. The Church of *Santos Juanes* is situated, within its enclave, in the historic centre of Valencia, in an area delimited by and known as the *Barrio del Mercat* (market neighborhood). The group of dwellings in this quarter, as with many others that form part of the city, are characterized by belonging to, and forming part of, the urban history of the city of Valencia [1].

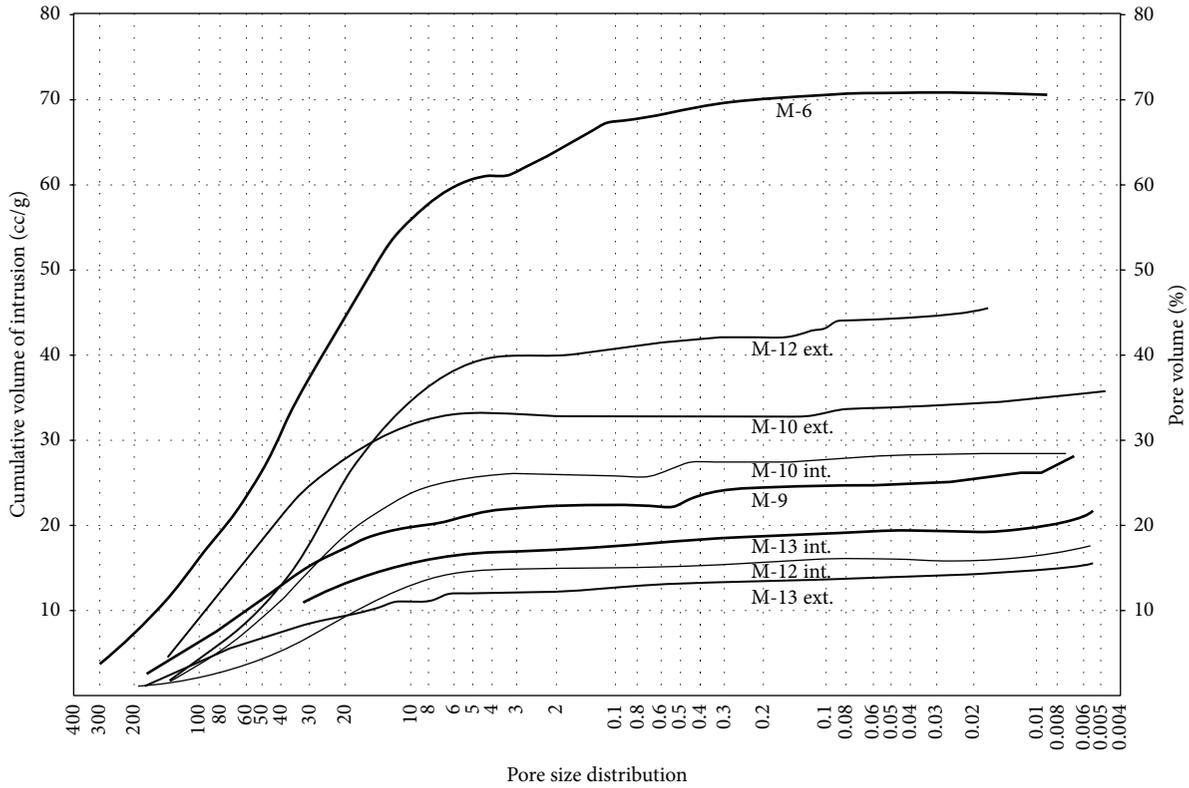
Figure 3 shows the main samples M-9, M-13, and M-12 correspond to parts of the building that historically belong to the second most important building period of the temple. The values are similar when comparing the volume of open

FIGURE 3: Graphical representation of pore diameter.

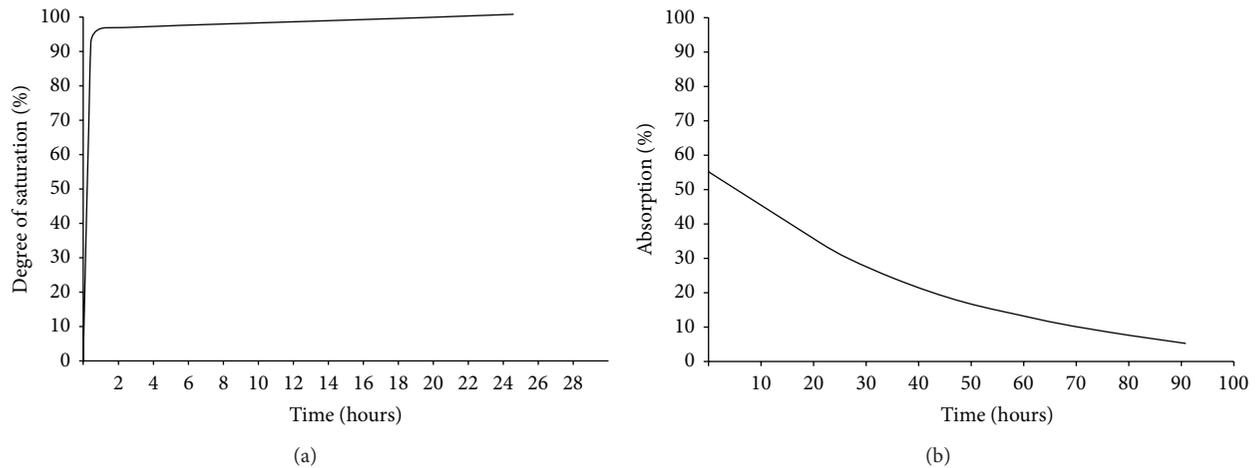
FIGURE 4: Absorption (a) and desorption (b) curves.

We also checked the water saturation and effusion capacity of the material, plotting their corresponding curves, which confirm that we are dealing with a highly porous rock and that the drying of the surface is slow and diffuse caused by the flow of water to its interior (Figure 4). The stone has high connectivity and variations in pore size or interpore connections. The absorption curves for these rocks could be broken down into two straight lines exhibiting a gradual change of slope between the initial and final phase [10].

desorption curve (Figure 4) showed that rock underwent slow, on the whole, evaporation where moisture was retained inside the pore system longer. Salts crystallization can occur if the solution is saturated or supersaturated [5]; therefore, it is possible that the concentration is constant and the temperature decreases, the solution reaches the saturation condition, and a low crystallization occurs. If evaporation occurs at a constant temperature, the concentration of the solution increases rapidly at the end of the capillaries and saturation is reached. The most common is that the combination of decreased temperature and increased concentration of the solution occur simultaneously.

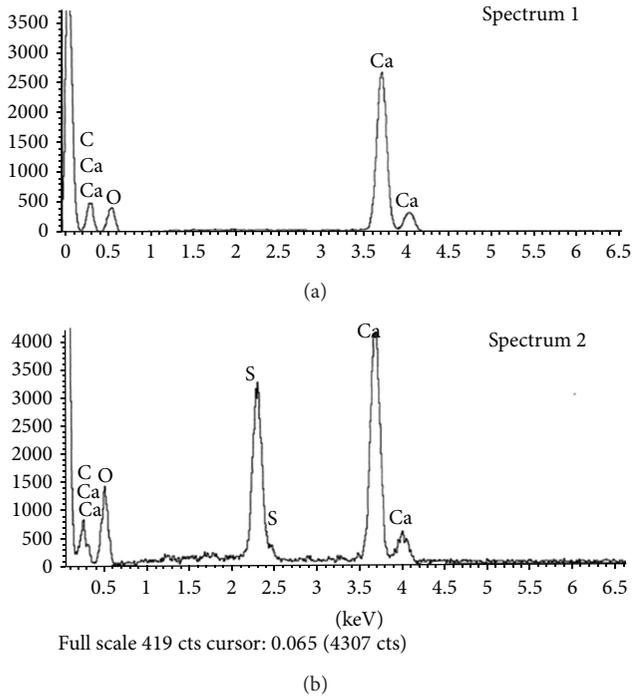
FIGURE 5: X-ray diffraction analysis.

spectroscopy (SEM-EDX) to characterize the salt mixture with surface damage. Analysis of the fresh, altered, and mainly physical-chemical meteorized samples has been compared by X-ray diffraction. Sulfur peak presence has been observed in monument samples. Pb and Na presence in some samples are sporadic anomalies due to samples spatial orientation in front of gas emulsions from combustion and saline seaside environment; an example is shown in Figure 5 and Table 4.
