Failure Analysis on 42CrMo Steel Bolt Fracture

The bolt is a fastening of the wind generator, with specification model of M30 × 435. The manufacturing process is described as follows: raw materials → fracturing materials → forging blanks → rough finish → heat treating → longitudinal mechanical property test → flaw detection → finish machining → finished products. When the bolt was installed and used, the customer found bolt fracture during routing inspection.

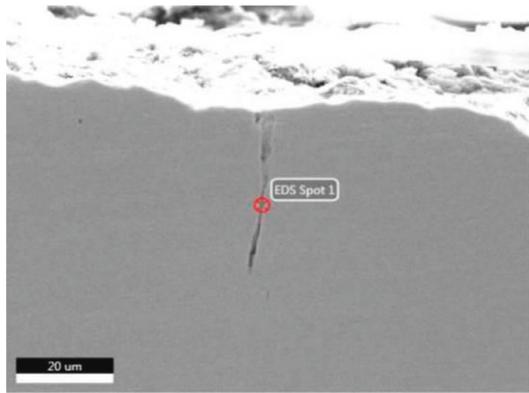
2.5. Microscopic Observation of Fracture Origin. Cut the bolt at the fracture origin area longitudinally and grind it. Under the metalloscope, many small cracks extending from the fracture to the matrix can be observed. The deepest crack depth measures 0.10 mm, with the morphology shown in Figure 10. Under magnified observation, the cracks are filled with gray products (Figure 11). Concentratedly distributed manganese sulfide inclusions are found near the fracture origin (Figure 12). Many manganese sulfide inclusions are also observed in the matrix.

It can be seen from the above microscopic results that the deepest crack depth in the fracture source region is 0.10 mm, and the crack initiation phase is 0.05–0.08 mm in the engineering. It is known that the deepest crack in the fracture source region has crossed the crack initiation stage to reach the crack. During the expansion phase, the presence of cracks causes stress and strain concentration on the surface of the bolt, forming a fatigue source at the crack and accelerating the initiation and propagation of fatigue cracks. There is carbon depletion at the source of the fracture, the

FIGURE 10: Micromorphology of small cracks.
