# FAILURE MECHANISMS THAT CAUSE HIGH ELECTRICAL LEAKAGE IN MULTILAYER CERAMIC CAPACITORS

HIROFUMI IKEO, SANPEI SAKAMOTO, KEN SATO<sup>†</sup>, HISAKAZU NISHIURA<sup>†</sup>, and KATSUHIRO OHNO<sup>‡</sup>

*Kita-Itami Works, Mitsubishi Electric Corporation, Itami, Japan 664*

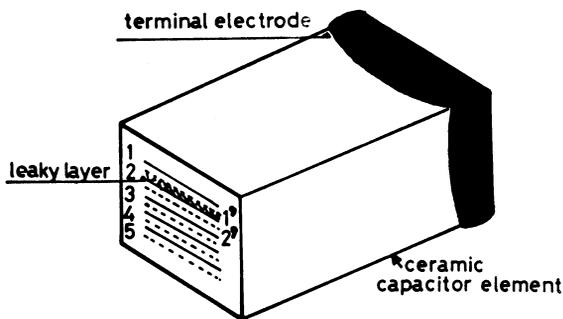
FIGURE 6 Procedure to clarify leakage layer (in this case leakage layer is between 1' and 2).

First step: After confirming that there was no leakage on the ceramic surface, the individual inner electrodes were isolated by removing one of the outer electrodes. The leaky ceramic layer was determined by measuring the resistance between each isolated electrode and the other outer electrode as shown schematically in Figure 6.

Second step: The ceramic was planed down parallel to the inner electrode plate by sand paper or sand/air abrasion, until the dielectric layer between the electrodes (1 and 1' - in Figure 6) appeared. One of the inner electrode plates across the dielectric layer was then exposed by using a narrow beam sand/air abrasion system and afterwards the outer electrode which had been removed by the first step was reconnected using silver paste. Careful removal of the electrode plate a

- 1-5 : Isolated inner electrodes (formerly, connected to leftward terminal)
- 1'-2' : Opposite electrodes (dotted line)

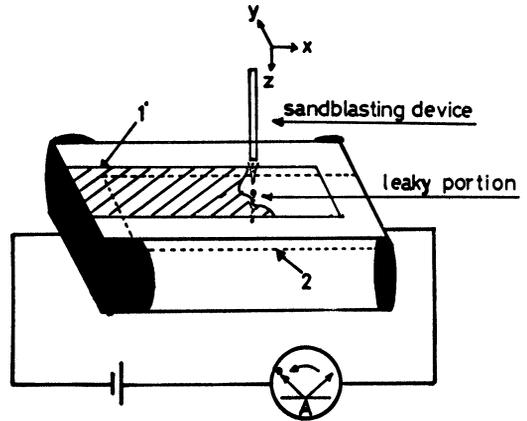
FIGURE 7 Procedure to clarify macroscopically leaky portion of capacitor.

little at a time, whilst watching the current across the dielectric, was performed until the observed resistance suddenly became infinite. This location, just before the resistance became infinite, is the macroscopic high leakage portion of the dielectric (as shown schematically in Figure 7).
