Research Article

Numerical and Experimental Failure Analysis of Carbon Fiber-Reinforced Polymer-Based Pyrotechnic Separation Device

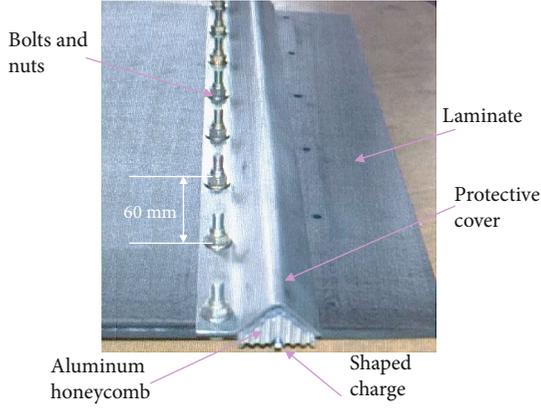
FIGURE 2: Cutting test of the composites separation device.

2.1. Cutting Tests for Composites Separation Device. The cutting test of CFRP separation device is illustrated in Figure 2.

The laminate is made of bismaleimide resin-based CFRPs, formed into a stack in the specified fiber direction with heating and curing process. The lay-up is $[[45/-45/0/45/0/90/-45]_2][0/30/-30/60/-60/0]$ according to the loading requirements and aerospace environment. The thickness of the laminate is 5.1 mm and the cutting thickness is 3 mm. The left and right boundaries of the laminate are clamped by two thick steel plates. The shaped charge is made of lead, and the V-shape structure is adopted for an ideal jet shape, jet velocity, and penetration depth. The shaped charge is attached to the surface of the laminate. In order to improve the cutting capacity, explosives with high detonation pressure (Hexogen) are selected and the density of explosive is 2.8-3.0 g/m. The test adopts single point initiation and linear cutting. The protective structure consists of a protective cover and a buffer structure. The protective cover is made of iron and the buffer structure is made of aluminum honeycomb materia.

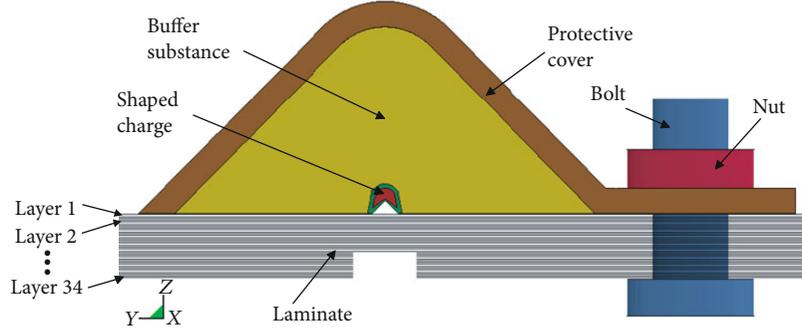
FIGURE 3: FEA model of the composites separation device.

2.2.1. FEA Model. All simulations were performed on the platform of a commercial FEM package of LS-DYNA [14, 15]. The FEA model of composites separation device is shown in Figure 3. The model includes a laminate, air, aluminum honeycomb, protective cover, bolts, nuts, and shaped charge made up of explosives, outer case, and shaped charge liner. The amount of explosives set in the numerical model is 3.1 g/m, which is consistent with the experiment. Lagrange arithmetic modeling was adopted to describe the deformation and damage of protective cover, bolts, nuts, aluminum honeycomb, and laminates. ALE method can handle large deformation problems under detonation shocks and was used to model the deformation of air, explosives, and shaped charge. The lay-up of the laminate is the same as that in the cutting test introduced in Section 2.1. The laminate has 34 layers and the thickness of each layer is 0.15 mm. Considering the linear cutting of the laminate, the cutting width of the FEA model is 15 mm. The laminate is completely constrained at both ends in all directions. The front and back of the

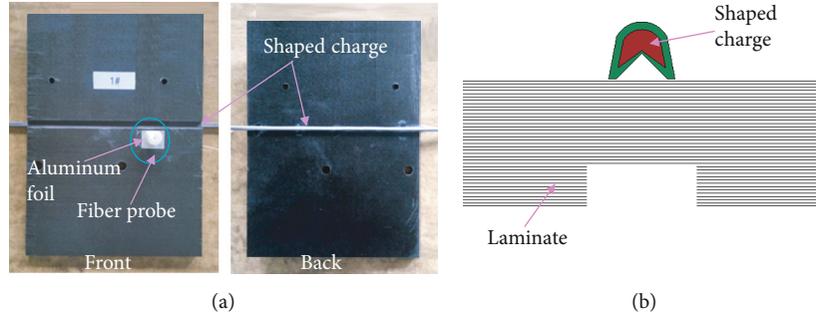
FIGURE 4: Cutting test and FEA model. (a) Cutting test for model verification [16]. (b) FEA model for verification.

2.2.3. Model Validation. To ensure the method validity of CFRPs' cutting simulation and rationality of the cutting model, use the simple cutting test result to validate the simulation model. The entire structure consists of a shaped charge and a laminate illustrated in Figure 4(a) [16]. In this validation test, the amount of explosive is about 3.85 g/m. The rationality of the numerical simulation model was validated by the comparison between the velocities of the feature points on the modeling laminate with the cutting tests. A test method with Displacement Interferometer System for Any Reflector (DISAR) was carried out. The FEA model for vali-

ation is shown in Figure 4(b). The amount of explosives is 3.9 g/m, which is consistent with the validation experiment. The size, ply, and thickness of laminates are all the same with the cutting test for model verification.

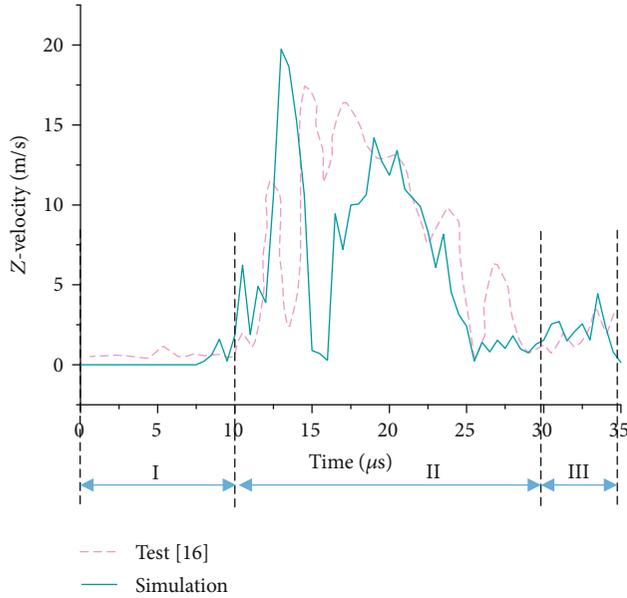
FIGURE 5: Velocity curves of the feature point of laminates.

According to the cutting test, the velocity recorded by DISAR method is positive. Therefore, the data obtained by simulation are processed in absolute value. Because the accuracy of the test may be affected by the warping of laminates and the adhesion degree of aluminum foil after cutting, this paper only compares the cutting velocity in 35 μ s, and velocity curve is shown in Figure 5. The result curve can be divided into three stages: (i) jet formation process; (ii) the cutting stage of the feature point position; and (iii) the cutting completion stage of feature point position. From the curve, the velocity is zero in the process of jet formation (stage i). In the second stage, the laminate is cut and the velocity is severe due to the propagation of stress wave. After the position of feature points on laminate is separated, the velocity of the laminate approaches zero in both the cutting test and simulation (stage iii). The maximum velocity obtained by the simulation model is 19.73 m/s, which is 12.9% higher than the results obtained by the test (17.48 m/s). The volatility of shock wave can cause errors in the dynamic cutting simulation, while the numerical model can reproduce the experimental outcomes in a reasonable range, which proves the rationality of the simulation model.

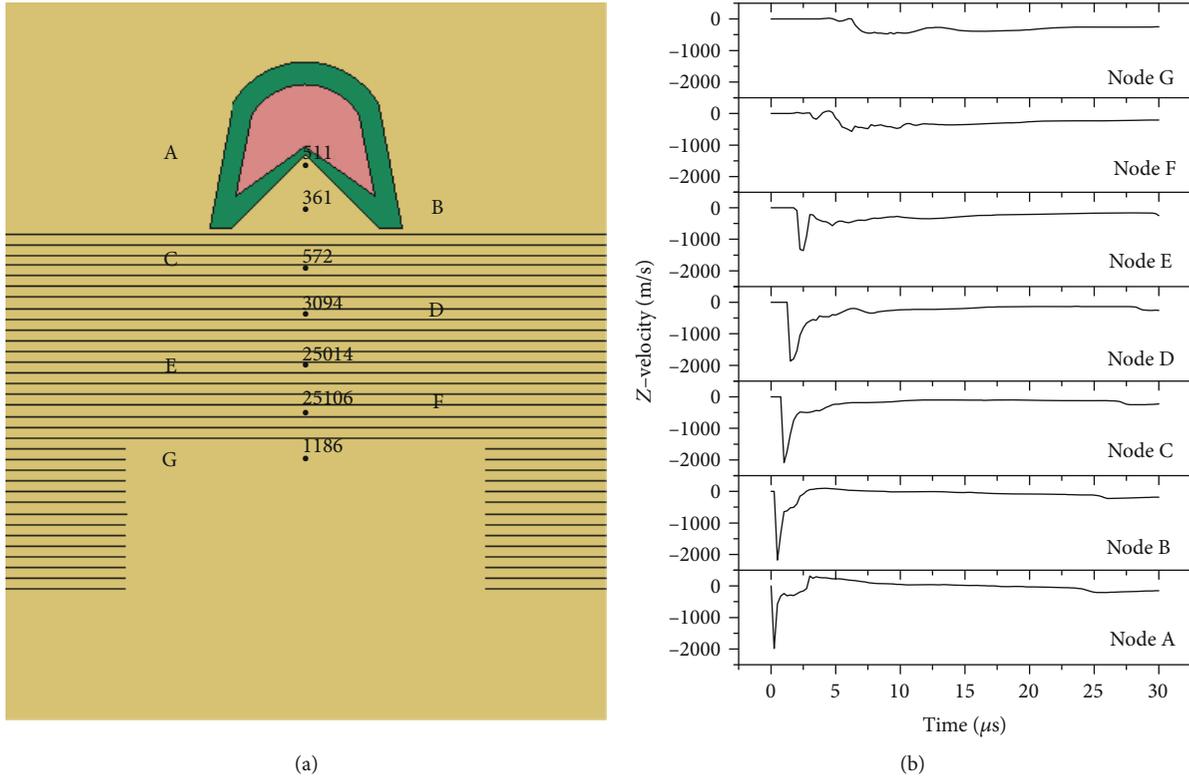
FIGURE 11: Jet velocity. (a) Location of the velocity observation nodes. (b) Velocity curves of observation nodes.

3.3.2. *Change of Jet Velocity during the Cutting Process.* The jet velocity is an important factor for the failure analysis of CFRPs, and several observation nodes on the outermost elements are studied during the cutting process as shown in

Figure 11(a). Figure 11(b) shows the change of *z*-direction velocity at observation nodes. Firstly, when the jet arrives at node A, the velocity is up to 1985.07 m/s. The jet velocity at node B is almost 2176.54 m/s. At about $t = 3.0 \mu s$, the velocity at node A and node B shows positive *z*-direction value which is caused by the reflections of the detonation created after contacting with the laminate surface. Nodes C, D, E, and F

are located in the laminate region. As the hindering effect of the laminate, the velocity of these nodes is decreasing. The maximum velocity of nodes C, D, E, and F is 2088, 1863.09, 1356.16, and 568.03 m/s, respectively. It is found that the velocity curve of node E obviously decreases and then continues to increase at about $t = 3.25 \mu s$, which is because of the inconsistent or broken phenomenon of the jet during continuous movement. For node F, the hindering effect of the laminate is becoming more and more obvious and the maximum velocity is 74% lower than the velocity at node B. Node G is located on the outside of the laminate. The jet still has a certain velocity after it penetrates the 5.1 mm laminate and finally reaches 471.77 m/s. Since the jet velocity has been greatly reduced after the jet has penetrated the laminate, the maximum velocity at node G does not happen at the time of the original arrival of the jet but it is at the arrival of the subsequent jet.
