# Multidisciplinary Approach to a Recovery Plan of Historical Buildings

**Luciana Orlando**

*Dipartimento di Ingegneria Civile, Edile e Ambientale, Sapienza Università di Roma, Via Eudossiana 18, 00184 Roma, Italy*

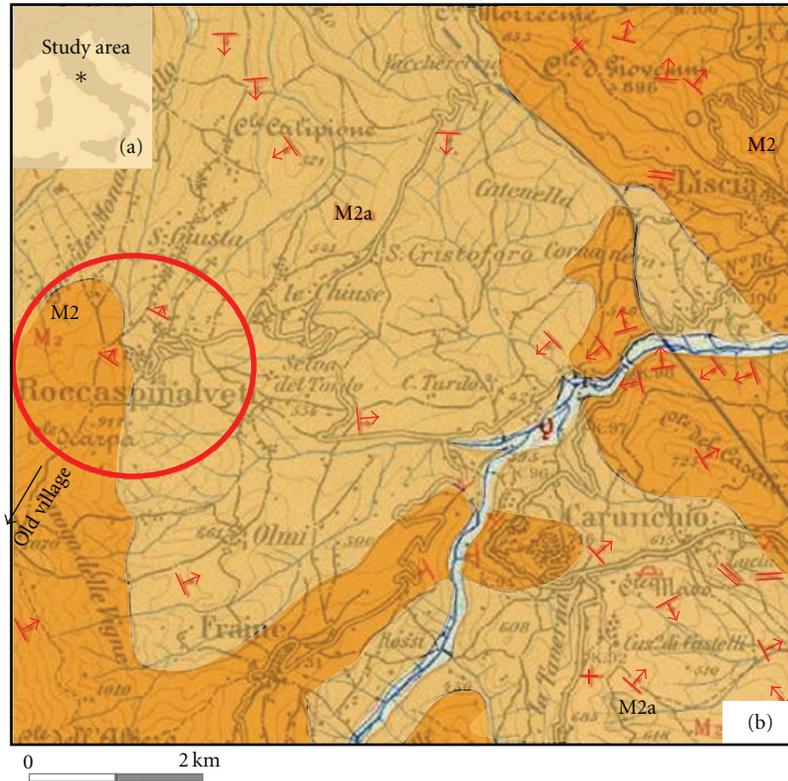
FIGURE 1: Study area location (a). The geological map (b) shows two outcropping formations *Miocene in age*: a flysch complex formed by a succession of calcareous sandstone, dense marl, clayey-marl-clay strata (M2), and a complex formed by a succession of clayey-sand and marl strata (M2a). The red arrows indicate the faults and the black arrow indicates the location of the old village 3 km from the present one.

The geological map (Figure 1(b)) shows that the village is located across two formations of *Miocene* age: a flysch complex formed by a sequence of calcareous sandstone, dense marl, clayey-marl-clay strata (M2) and a complex formed by a sequence of clayey-sand and marl strata (M2a). Such sequences can be over 100 m thick.

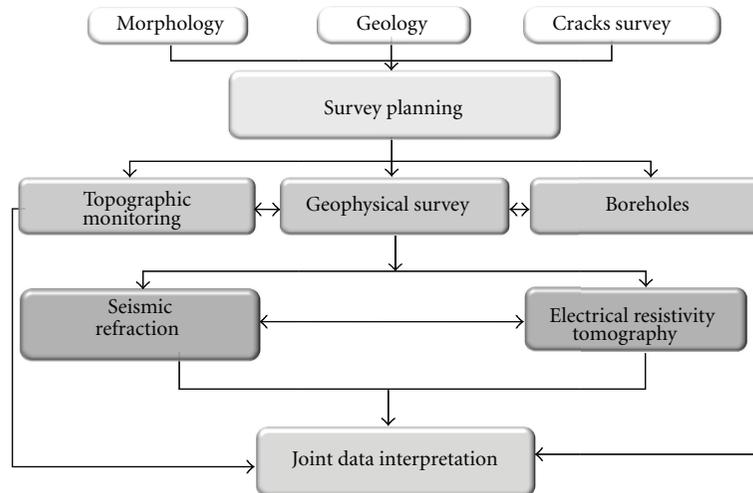
FIGURE 3: Flow chart of the surveys performed in the study area.

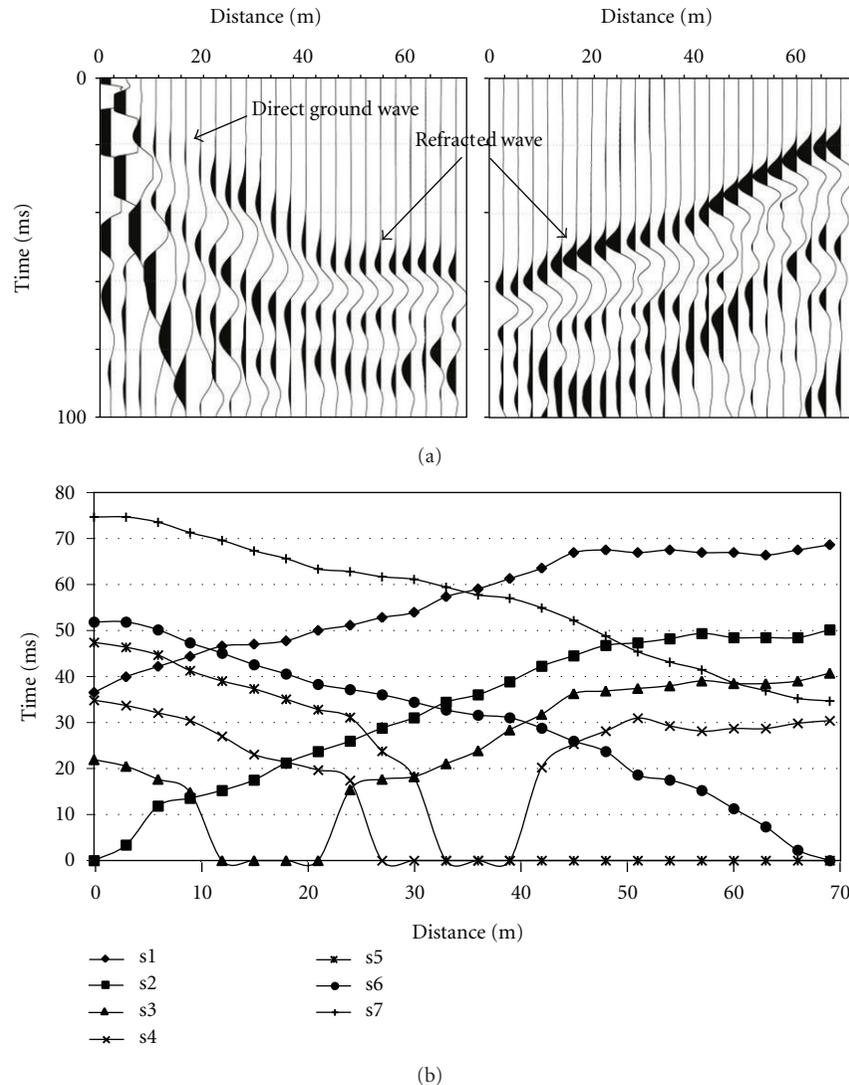
FIGURE 6: (a) Shots, s1 and s6, of seismic refraction line 8. (b) First arrivals of line 8.

The first arrivals were picked by hand and rechecked several times to improve accuracy. In Figure 6(a), shots s2 and s7 of line 8 are shown. The most important problem encountered was due to the direct wave that, for some shots, travelled through the road concrete.

The first arrivals were used (see an example in Figure 6(b)) for the calculation of P wave velocities and delay times. The former were used to draw the seismic refraction stratigraphy (Figures 7(a), 7(c), 7(e), and 8(a)).
