Research Article

A Systematic Approach to Identify Sources of Abnormal Interior Noise for a High-Speed Train

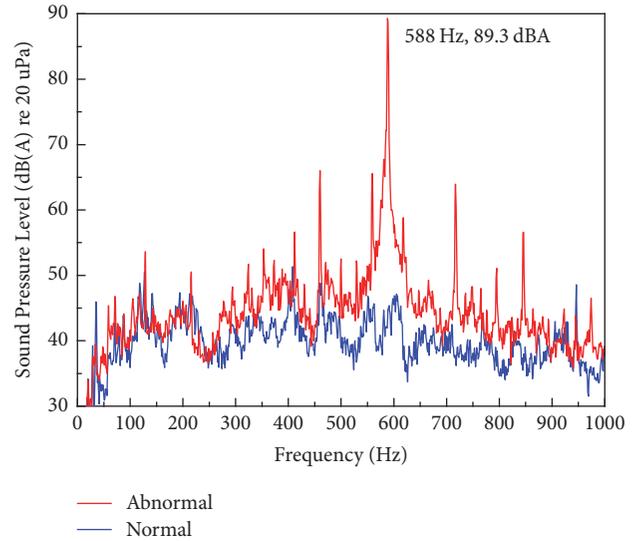
FIGURE 2: Normal noise (blue) and abnormal noise (red).

As the term “abnormal interior noise” indicates, the noise issue must be easily noticed by non-NVH professionals such as passengers and train staff, perceived as unusual in terms of loudness and characteristics, and felt to be annoying. Figure 2 gives an example which can be classified as “abnormal interior noise.”

Two noises shown in Figure 2 were measured, respectively, in two coaches of the same design. The red one is called “abnormal interior noise” since it has a dominant single frequency peak which represents a very high overall Sound Pressure Level (SPL). The most effective approach to identify the root cause of abnormal noise is performing well planned measurements on the train running at the same condition as that when the noise issue was observed, combined with proper data analysis. In general, the following procedure should be excised.

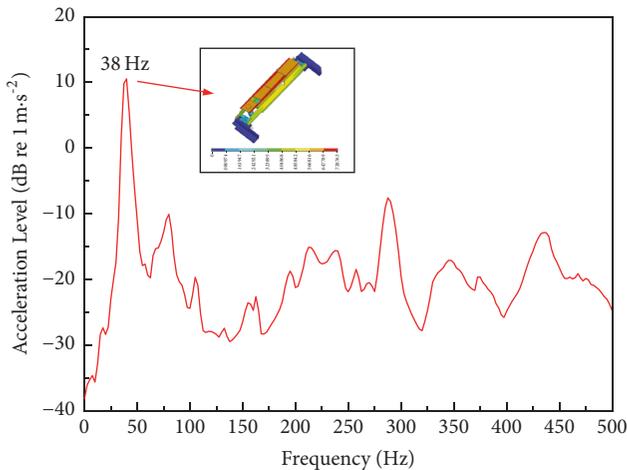
FIGURE 4: Frequency spectra of acceleration of the door switch.

For example, (1) abnormal noise is generated by the door switch assembly as indicated in Figures 3 and 4. The noise/vibration is at a single frequency which is related to train speed. The noise is radiated by the structural resonance of the door switch assembly which is in turn excited by the first order of the wheel out-of-round wear at 380 km/h. (2) Abnormal interior noise occurred at the ends of a coach [18] at a single frequency as indicated in Figures 5 and 6. The problematic frequency is related to train speed. The root cause is the sleeper passing of the train at 250 km/h which excites one of the acoustic modes at the coach end through vibrations of the floor and the sidewall. (3) Abnormal interior noise occurred in a driver's cab of a high-speed train as indicated in Figure 7. It is of broadband and the problematic frequencies are independent of train speed. The source is related to the air-conditioning and the generated noise propagates into the interior via airflow in the ducts.

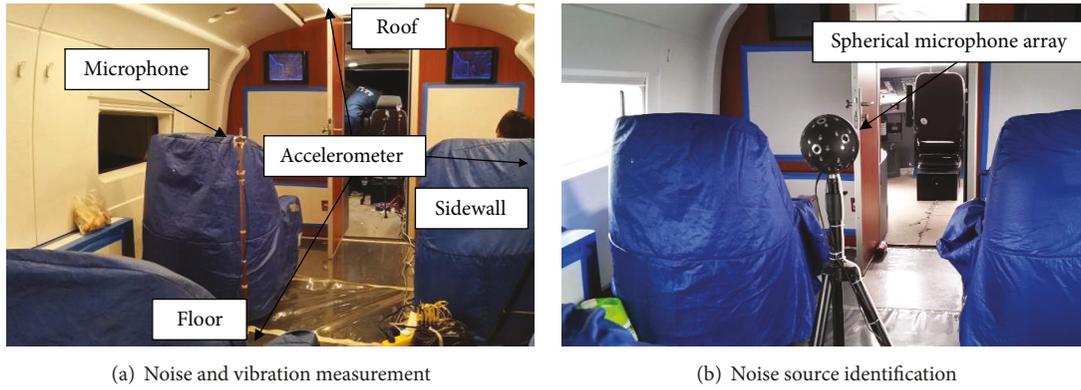
FIGURE 10: Test photographs of noise and vibration in the VIP cabins.

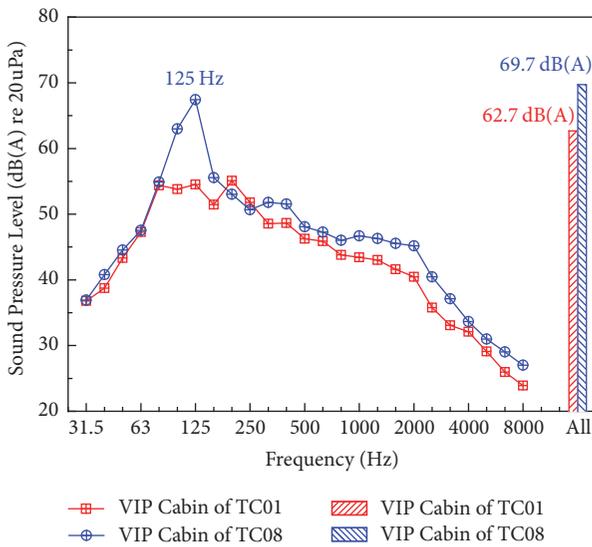
3.3. Frequency Contribution Analysis. Figure 11 shows the measured interior noise results from the microphone, overall level, and frequency spectrum in 1/3 octave bands, of the two VIP cabins when the train is running at 250 km/h. It can be seen that the overall SPL of TC01 is 62.7 dB(A), while that of TC08 is 69.7 dB(A), 7 dB(A) higher. It is also seen that noise in TC08 has the highest peak at 125 Hz, about 13 dB(A) higher than that of TC01 at the same center frequency.

FIGURE 11: Noise test results in the two VIP cabins.

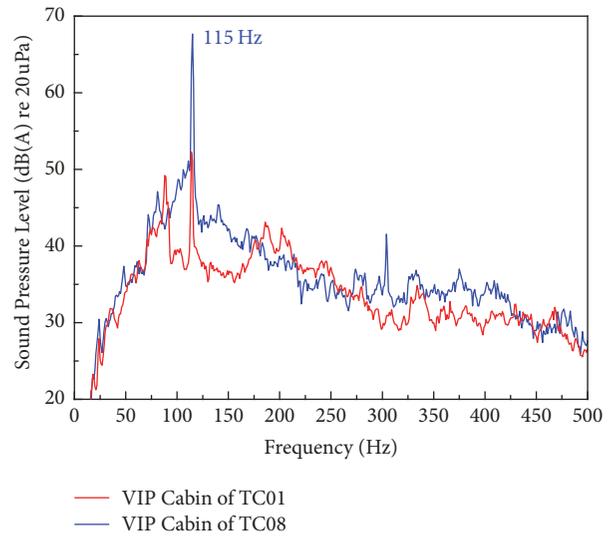
FIGURE 13: Narrow band frequency spectra of noises in the two VIP cabins.

Figure 13 further shows the narrow band frequency spectra of noises in the VIP cabins of TC01 and TC08. For TC08, the highest peak is at 115 Hz. Although a peak is also present at this frequency for TC01, its value is 17 dB(A) lower. Moreover, noise levels from 100 Hz to 170 Hz in TC08 are higher than those in TC01.

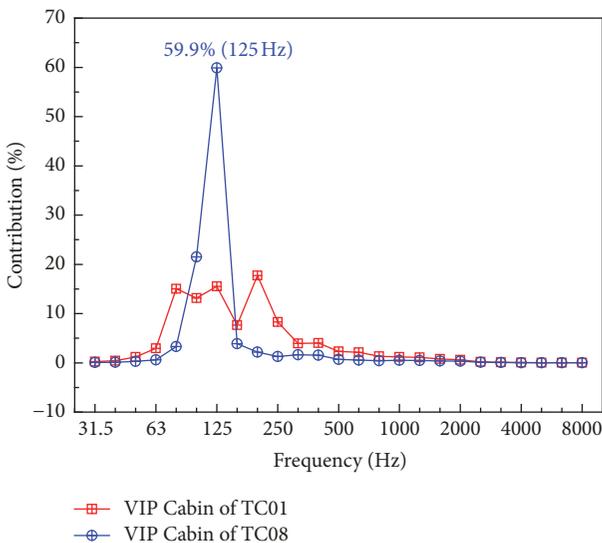
FIGURE 12: Noise contribution in 1/3 octave bands.

From Figure 12, noise contribution ratio of the 1/3 octave band centered at 125 Hz in TC08 is 59.9%. It also can be seen that the second highest noise contribution ratio is from the 1/3 octave band centered at 100 Hz, but only 21.5%. Contributions from other 1/3 octave bands are all below 5%. However, the frequency characteristics are quite different for TC01. For this cabin, the 1/3 octave bands centered at 80 Hz, 100 Hz, 125 Hz, and 200 Hz are main contributors, but each is between 15% and 20%. Therefore, it can be concluded that noise in the 1/3 octave band centered at 125 Hz is critical to the overall SPL in TC08.

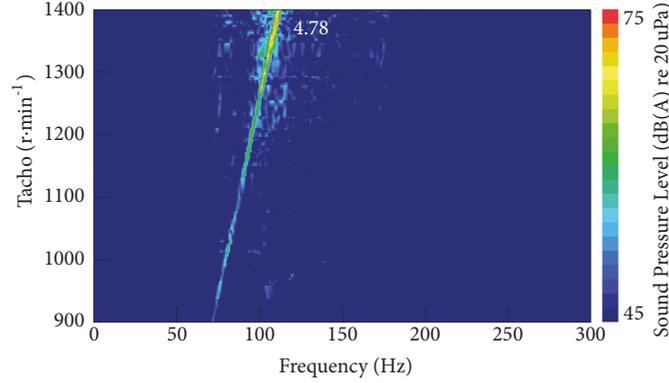
FIGURE 14: Noise order spectrum of the VIP cabin in TC08.

At this point, it can be concluded that TC08 is noisy which is caused by a much higher component at the sleeper passing frequency.

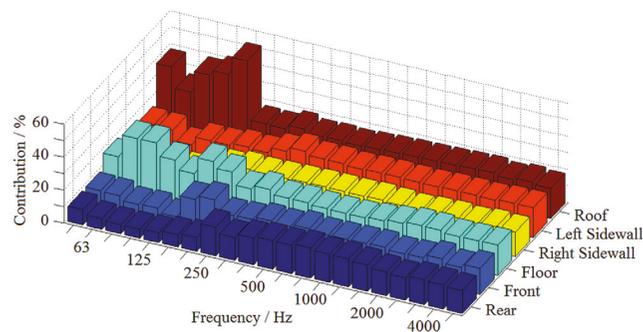
Figure 17 shows the noise area contributions in different 1/3 octave bands in TC08. It can be seen that contributions of the roof, the left sidewall, the right sidewall, the floor, the front, and the rear in each band are similar to each other for bands with frequency centered above 200 Hz. However, in 1/3 octave bands centered from 50 Hz to 125 Hz, noise contribution of the roof is much higher than those of other areas except at 63 Hz of the floor. Especially in 1/3 octave band centered at 125 Hz, which is the peak value band, noise contribution ratio of the roof is 53%. However, the second highest contribution ratio is only 19% from the floor. As a result, the roof plays a decisive role in the total noise of TC08.

FIGURE 17: Area contributions of TC08 in different 1/3 octave bands.

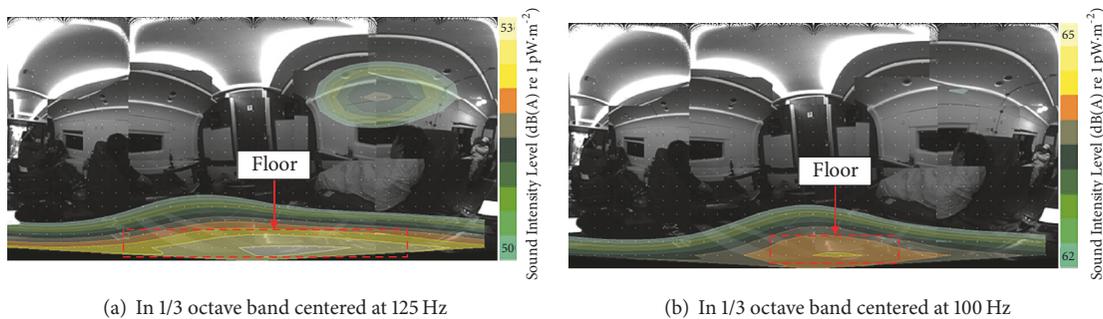
Figure 18 shows area contribution results for TC01 with the train speed being 240 km/h. Since we only have one spherical array system and there are some other testes in the other coaches of the high-speed train, when identified noise source in TC01 the speed is limited to 240 km/h. Figure 18(a) shows the noise distribution in the 1/3 octave band centered at 125 Hz, and Figure 18(b) indicates that at 100 Hz. From Figure 18, the maximum contributors in TC01 for the 1/3

FIGURE 18: Area contribution results of the VIP cabin in TC01.

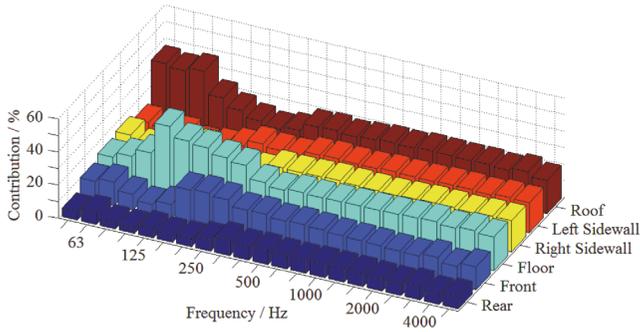
Figure 19 shows the noise area contributions in different 1/3 octave bands in TC01. It can be seen that in 1/3 octave bands centered from 100 Hz to 250 Hz, contributions from the floor are the highest, followed by the front and the roof.

FIGURE 19: Area contributions of TC01 in different 1/3 octave bands.

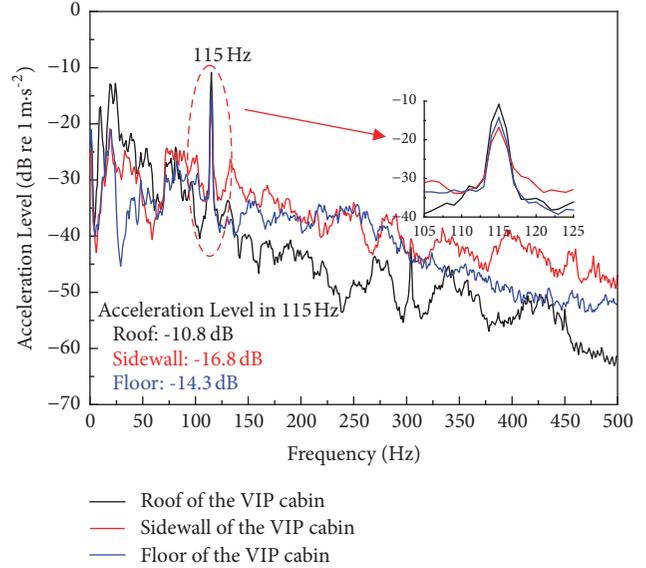
FIGURE 21: Narrow band frequency spectra of accelerations in TC08.

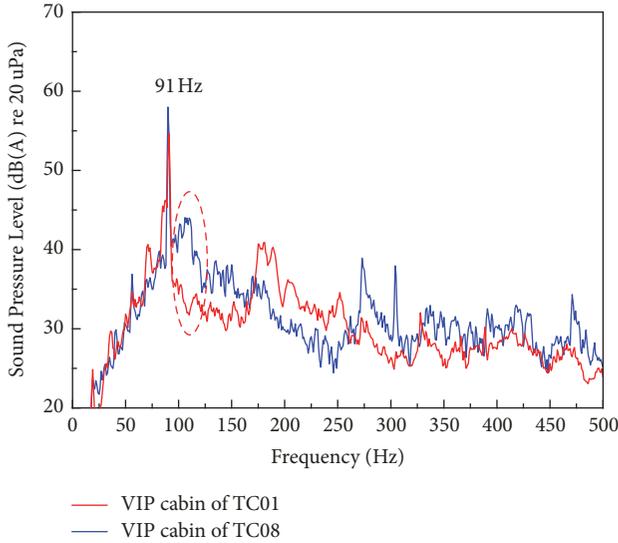
Figure 23 indicates that the highest peak frequency is 91 Hz which is the sleeper passing frequency at 200 km/h. At this frequency, as indicated from Figures 24–26, the acceleration levels of the roof, the sidewall, and the floor of TC08 are much lower than those of TC01. However, from 91 Hz to 125 Hz, the noise SPL of TC08 is still higher than that of TC01, or least similar. If the sound is purely from panel radiations, then at 91 Hz, SPL in TC08 should have been much lower than that in TC01.

Thus, sound leakage and scattering can be assumed behind the red area. Why at 200 km/h, the leaked sound pressure does not excite strong vibration for the roof panel may be explained to be that the sound pressure is not high enough to exceed other excitation mechanisms. However, at 250 km/h, as wheel/rail noise and vibration generated by

FIGURE 23: Narrow band frequency spectra of noises in the two VIP cabins.

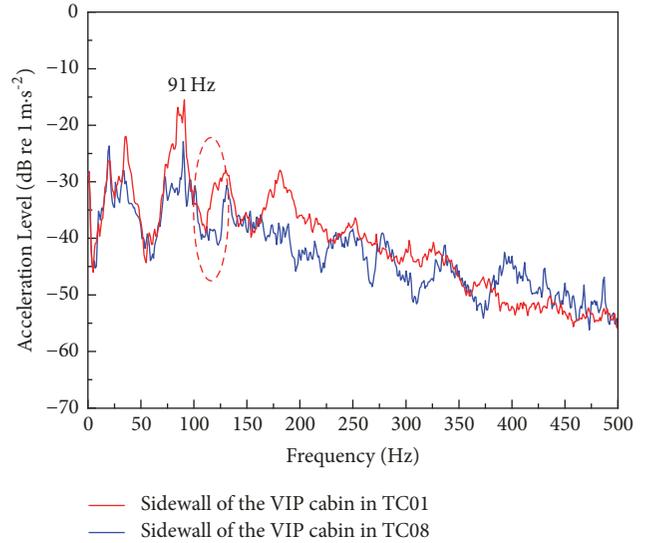
FIGURE 25: Narrow band frequency spectra of acceleration of the sidewalls.

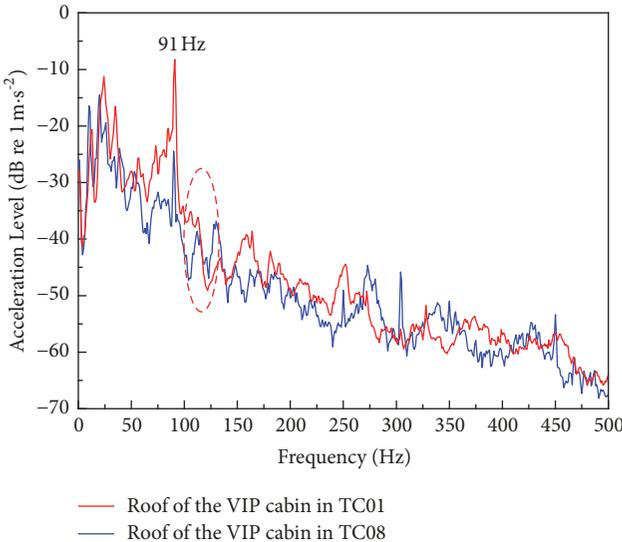
FIGURE 24: Narrow band frequency spectra of acceleration of the roofs.

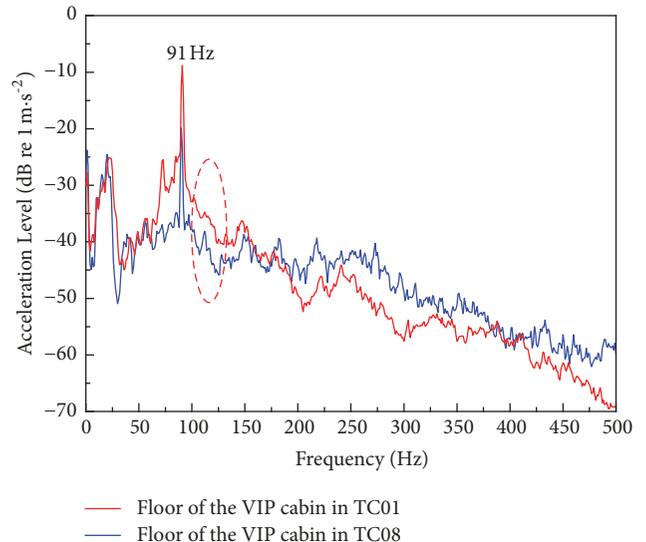
FIGURE 26: Narrow band frequency spectra of acceleration of the floors.
