# Physicochemical and Vibration Analysis of Christmas Tree Four-Way Flange Failure under Fracturing Process

When a wellhead gas production tree in a certain oilfield block fracturing completed 12 layers and 22 layers and then the bottom-up discharge operation was performed, the Wellhead four-way suddenly suffered erosion failure. This is the seventh failure of this operation. In order to obtain the cause of failure, the chemical analysis, hardness testing, tensile property testing, and finite element structural dynamic analysis are used to analyze the failure of the cross connection. The results of physical and chemical analysis show that the chemical composition, hardness, and tensile properties of the failed parts meet the requirements of the standard, not the problem of the material of the work piece. Due to the high-frequency vibration generated by the three-phase fluid in the pipeline during the discharge process, different types of vibration and deformation of the four-way valve and the valve body occur. The dimensions of the on-site structural parts were measured, and the bolt sizes were found to be different. A finite element model was established based on the measured dat

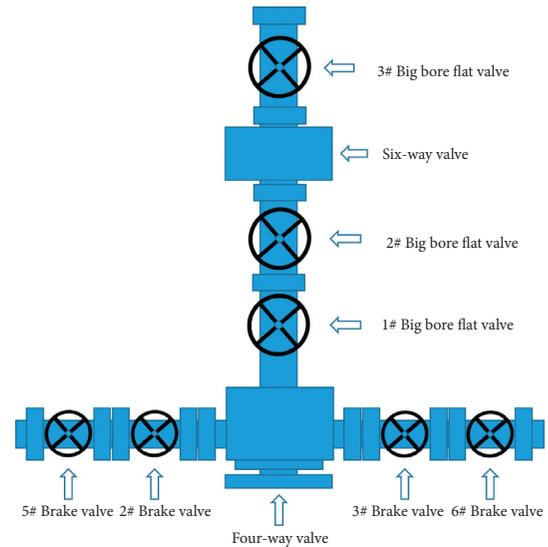
When the gas production tree of an oil field company was injecting gas from the bottom to top, a puncture occurred at the connection between the wellhead big cross and No. 3 valve. Figure 1 below is a schematic diagram of the wellhead

FIGURE 1: Schematic diagram of wellhead installation of gas production tree.
