## Research Article

# An Experimental Study of Thermal Fatigue on ASTM A 213 Grade T-23 Steel Tube

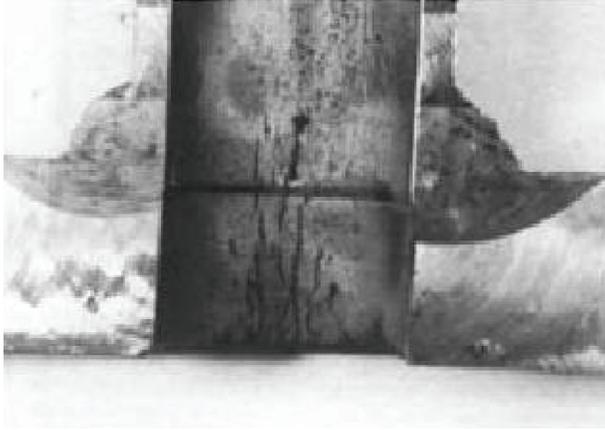
T23 tubes are widely used in pressure part applications in boiler fired by fossil fuels and also in heat recovery steam generators. The creep-rupture properties of grades T22 and T23 have been compared for the temperature range of 500–650°C and the results show that grade T23 has a temperature advantage of approximately 50°C over grade T22. Thermal fatigue is a form of failure that occurs in components subject to alternate heating and cooling. Under thermal fatigue, crack can initiate, propagate, and eventually failure occurs. The reason for cracking is due to the temperature change in the material that induces thermal expansion (or contraction). If surrounding material or external constraints hinder this expansion, thermal stresses arise. These cyclic thermal stresses cause fatigue similar to that of mechanical stresses. This type of failures usually occurs in power industries where turbulent mixing of fluids causes quick thermal transients in boiler heat exchanger tubes as shown in Figure 1 [1].

FIGURE 1: Sample piece of economizer inlet header showing crack in header hole and tube connector [1].

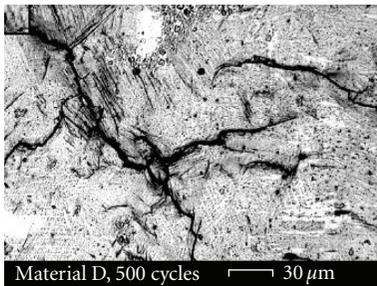
FIGURE 2: Microcracks [2].

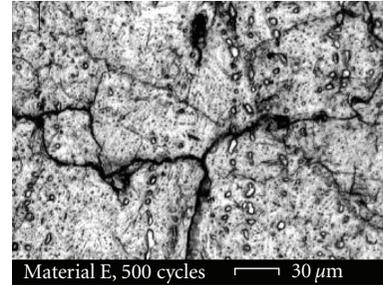
FIGURE 3: Mosaic-like network which is a typical thermal fatigue crack [2].

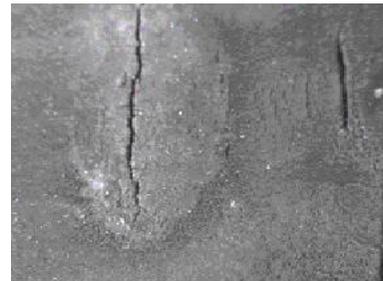
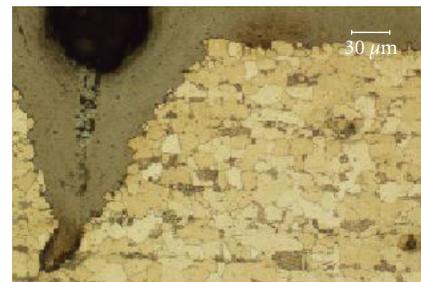
(a) Visual examination of microcracks [6]

(b) Microcracks observed using optical microscopy [6]

FIGURE 4: Microcracks obtained in the failed sample.

close resemblance with cracks observed in the received failed tubes are shown in Figures 4(a) and 4(b).

Similar type of failure has occurred in this work, which indicates the crack developed is due to the thermal fatigue. Shibli and Starr [11] discussed the new high-strength martensitic steel T91 issues and compared some of the perceived benefits with the actual plant experience under creep-thermal fatigue conditions. They suggested that for thin section components, the use of the T91 or other 9Cr martensitic steel tubing is not recommended due to their high level of steam side oxidation and other related oxide characteristics. Brown [12] developed a hybrid method using finite-element method to analyse the creep-fatigue life of boiler components. The developed method provides sufficient conservatism while still maintaining economically designed components for combined cycle gas-fired stations subject to rapid start up and cooling transients. The work also suggests the use of the finite-element method for thermal, stress-analysis aids in the correlation between operational events, and damage mechanisms. King and Riley [7] discussed about their recent experience in the condition assessment of boiler header components used in fossil-fired power plants. The work mentions many hurdles that may happen in boilers including internal borehole and ligament cracking and external tube connector weld cracking during operation as shown in Figures 5 and 6.

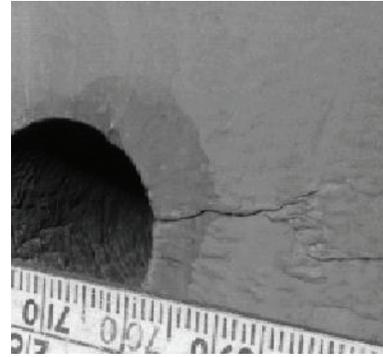
FIGURE 5: Closeup view of inside surface header sample piece showing cracking [7].

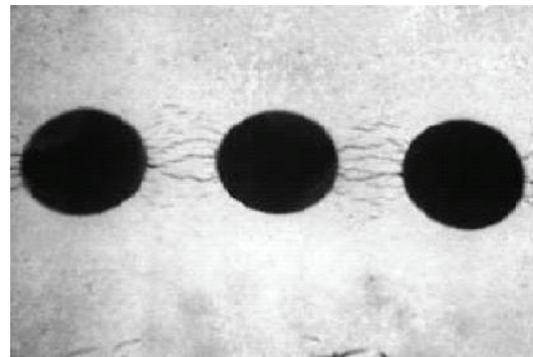
FIGURE 6: Inside surface of economizer inlet of header showing circumferential ligament field and borehole cracking [7].

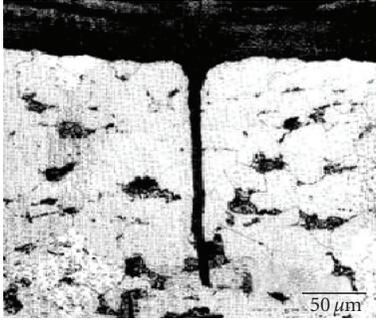
using induction coil and quenching rig for reproducing high-temperature cracks found in coal-fired boiler tubes as shown in Figure 7. They proposed that the crack initiation is by an intergranular surface corrosion/thermal stress interaction mechanism and environmentally assisted thermal fatigue crack propagation as shown in Figure 8.

FIGURE 8: Microcracks obtained by Smith et al. [8].

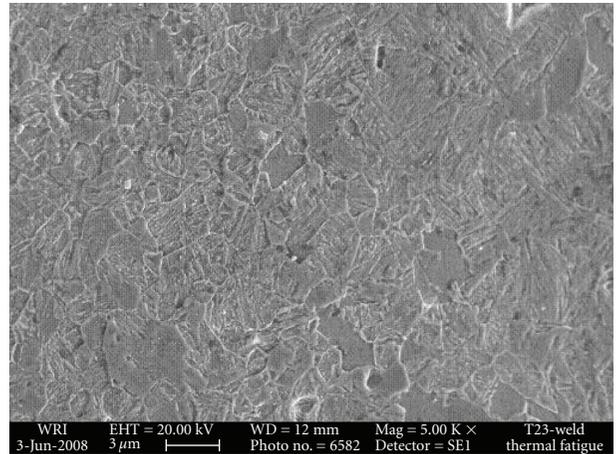
FIGURE 32: Unaffected weld tube structure.

**3.6.2. Defect Surface on Failed Weld Tube.** Figure 32 shows the microstructure taken in an unaffected region of the failed weld tube. The defects present in the failed weld tube are shown in Figures 33(a) and 33(b). From Figure 33, the cracks are developed from the outer surface of the tube and propagate towards the inner surface. Similarly, it travels in the circumference of the tube-heated region. When compared to the base crack, the size of the crack obtained in the weld is large. Mosaic-like crack formation is observed when it is magnified as shown in Figures 34(a) and 34(b) which is a typical thermal fatigue crack. From Figures 33(a) and 33(b), the initial crack width is large, when it moves towards the inner surface, the crack growth rate increases due to the temperature difference and rate of cooling. Due to these reasons, cracks are developed.
