Review Article

Geotechnical Distinction of Landslides Induced by Near-Field Earthquakes in Niigata, Japan

Hirofumi Toyota and Susumu Takada

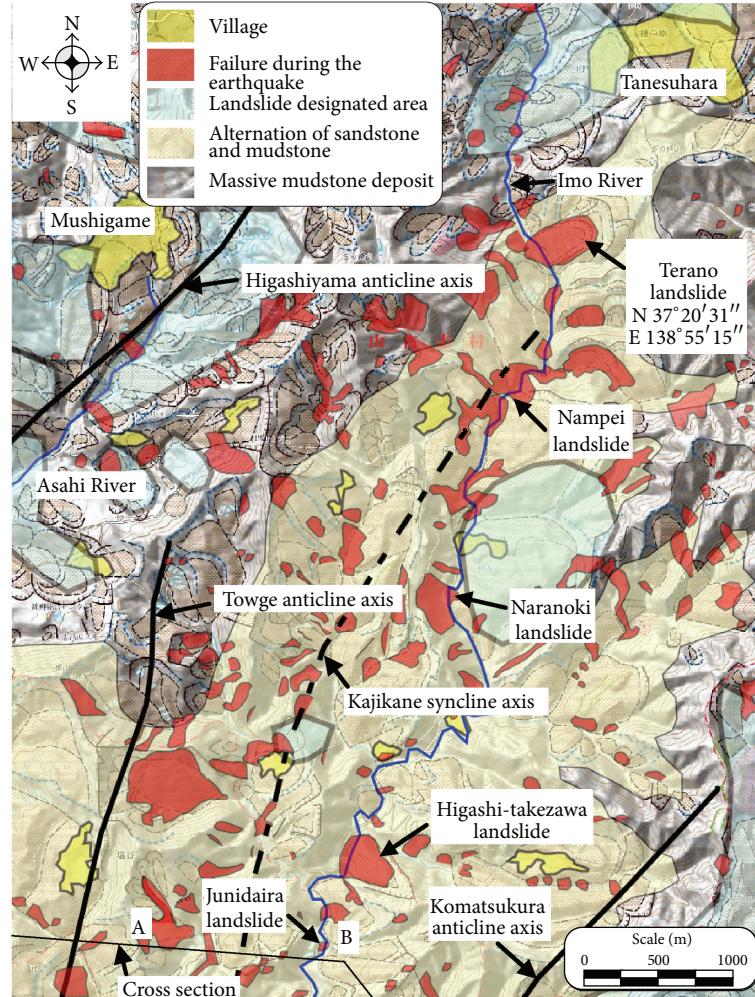
FIGURE 4: Landslide distribution and geological map around Yamakoshi area during Mid-Niigata Earthquake (provided by NIED and JST).

alternating sandstone and massive mudstone, designated as Kawaguchi and Wanatsu deposits. Alternation of sandstone and mudstone is distributed mainly along the Imo River, except in its upper course. As presented in Figure 4, more numerous landslides occurred during earthquakes in areas with alternated layers of sandstone and mudstone than in areas with massive mudstone deposits. This finding implies that sandy natural slopes are more fragile than clayey natural slopes during earthquakes. However, landslide-designated

areas, in which landslides are induced by snowmelt waters, are distributed mainly in the massive mudstone deposits. Moreover, the notable geological features of this region are syncline and anticline structures. They form a complex topography in which synclinal axes and anticlinal axes are arranged with a short interval (Figure 4). For that reason, peculiarly cuesta topography is apparent in this region. Fragile and weak slopes are therefore formed easily. In addition, the river scours the riverbed and the slope toe. Thereby, the slope becomes unstable. For those reasons, it is considered that numerous landslides occurred during the earthquake.

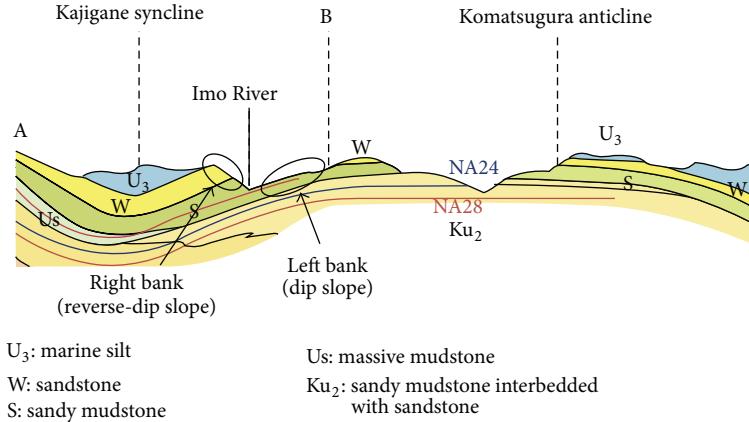
FIGURE 5: Geological cross section of the south of Yamakoshi area published by the National Institute of Advanced Industrial Science and Technology (AIST).

Figure 5 depicts a geological cross section of the area south of Yamakoshi area (Junidaira) published by the National Institute of Advanced Industrial Science and Technology (AIST). The location of this sampled geological profile is presented in Figure 4. Sandstone (W) and sandy mudstone (S, Ku₂) are distributed widely around the Imo River. This representative folded mountain area is composed of syncline and anticline. Geological cross sections clarify that a dip slope is apparent on the left bank of the Imo River. A reverse-dip slope is apparent on the right bank of the river. Peculiar slope failures occurred at the right and left banks of the Imo

River. Surface failures occurred frequently at the right bank having reverse-dip slope strata, whereas problematical large landslides occurred occasionally at the left bank, which is a dip gentle slope.

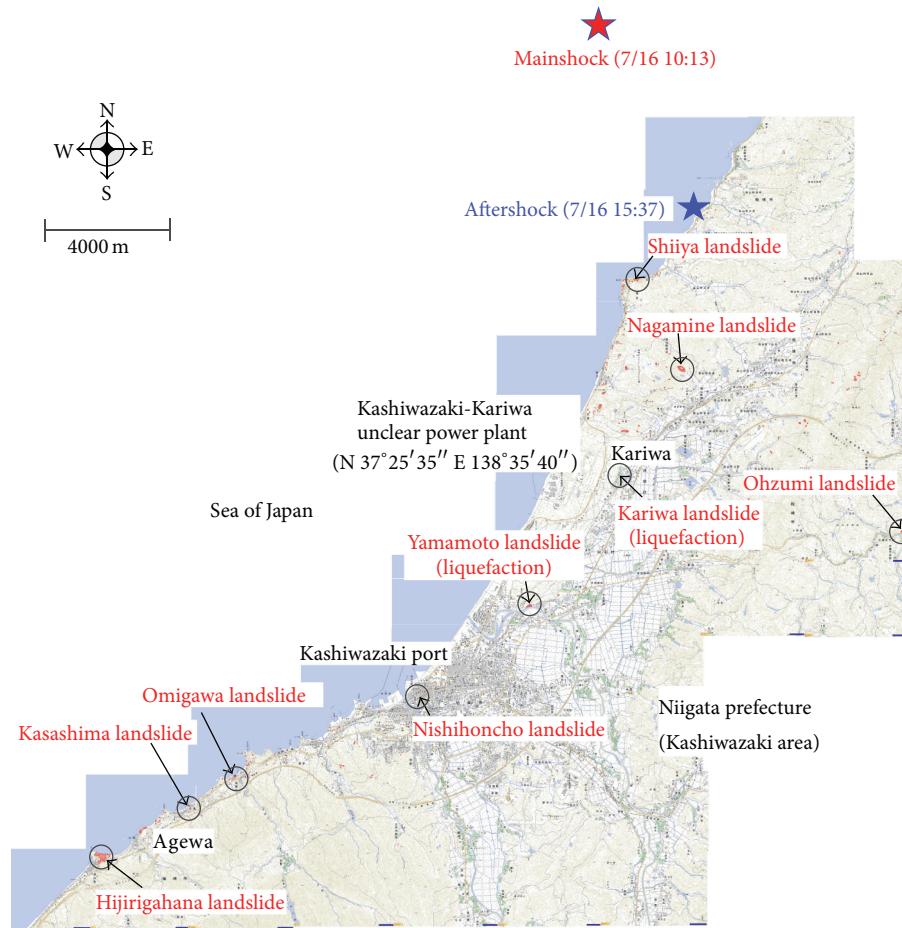
FIGURE 6: Landslide locations during the Mid-Niigata Offshore Earthquake (provided by GSI).

3.2. Mid-Niigata Offshore Earthquake. According to a report of the Ministry of Land, Infrastructure, Transport and Tourism (MLIT) given on 6 August 2007, 108 slope failures occurred during the Mid-Niigata Offshore Earthquake. The main slope failure sites are concentrated in the steep slope of coastal terrace from Shiyya to Hijirigahana, which is about 25 km distant, as shown in Figure 6. Although almost all slides were surface collapses, large mass movements rarely occurred in inland areas as described in Toyota and Onoue [13] because the earthquake occurred not under a mountainous area but under an offshore area. The fault extended from the epicentre to the south. However, the landslides are much fewer than the more than 3,000 which occurred during the Mid-Niigata Earthquake, despite the similarity of the earthquakes.

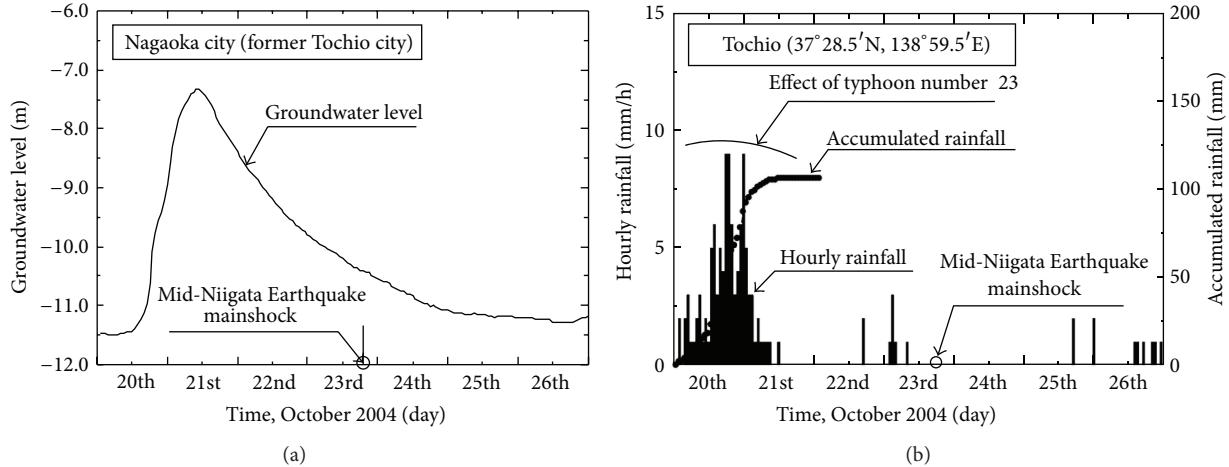
FIGURE 9: (a) Groundwater level and (b) rainfall during 20–26 October 2004.

Rainfall from typhoon number 23 occurred on 20 October 2004. The accumulated rainfall reached 100 mm in this area (Figure 9). The groundwater level rose quickly about 4 m with the rainfall. This area is inferred to include many catchment areas because the elevated groundwater levels descend gradually over a few days. The rise in the groundwater table induced by the typhoon had dropped by about 3 m in Tochio by the time of the Mid-Niigata Earthquake. It is apparent that this area still contained more water during the Mid-Niigata Earthquake than it did under ordinary conditions.

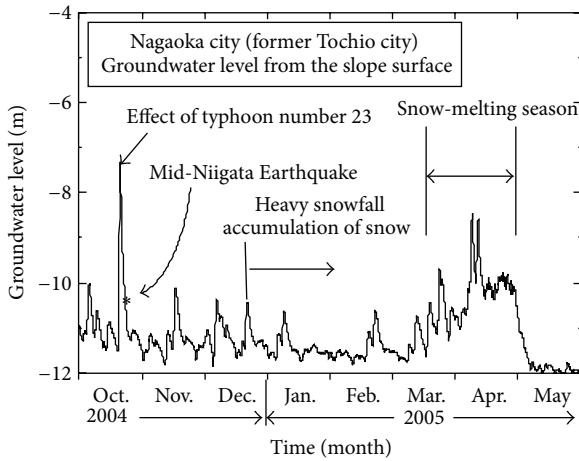
FIGURE 10: Groundwater level fluctuation.

Groundwater level fluctuation (October 2004–May 2005) is shown in Figure 10. The groundwater level at three days before the Mid-Niigata Earthquake was the highest in the displayed period of time. The snow season starts from mid-December. The total amount of snowfall reached 699 cm at Nagaoka during that winter. Snow melting accelerates from March with the coming of spring. The groundwater level increases during the snow-melting season because of soaking of snow water and suddenly drops after snow melting (in May), as shown in Figure 10. For that reason, tertiary type landslides have occurred frequently in this area in April and

May: the snow-melting season. Therefore, it was feared that the slope damaged by the Mid-Niigata Earthquake starts moving again. Observations were continued during and after the snow season.
