Shear Stress Analysis and Crack Prevention Measures for a Concrete-Face Rockfill Dam, Advanced Construction of a First-Stage Face Slab, and a First-Stage Face Slab in Advanced Reservoir Water Storage

Kongzhong Hu, Jiankang Chen

College of Water Resource & Hydropower, Sichuan University, Chengdu 610065, Sichuan, China

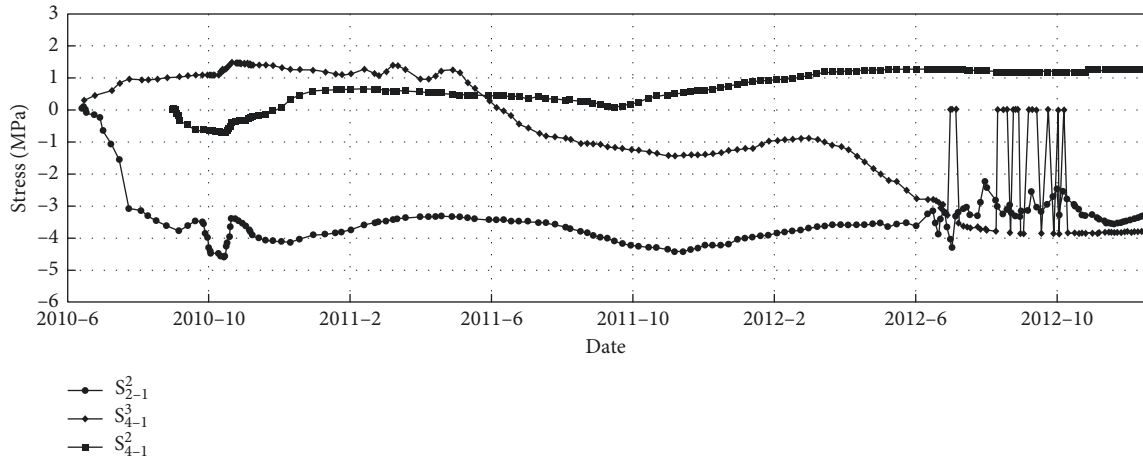
data indicated that data from the concrete-face rebar and from biaxial and triaxial strain meters were normal. Data from the concrete-face strain meter were normal, and the maximum strain was 600 $\mu\epsilon$. However, the rebar horizontal and vertical stresses at the 3255 m elevation showed clear variations when the water level rose during phase II, stage II. The corresponding time series are shown in Figures 7 and 8.

FIGURE 7: Rebar horizontal stress time series at the 3255 m elevation.

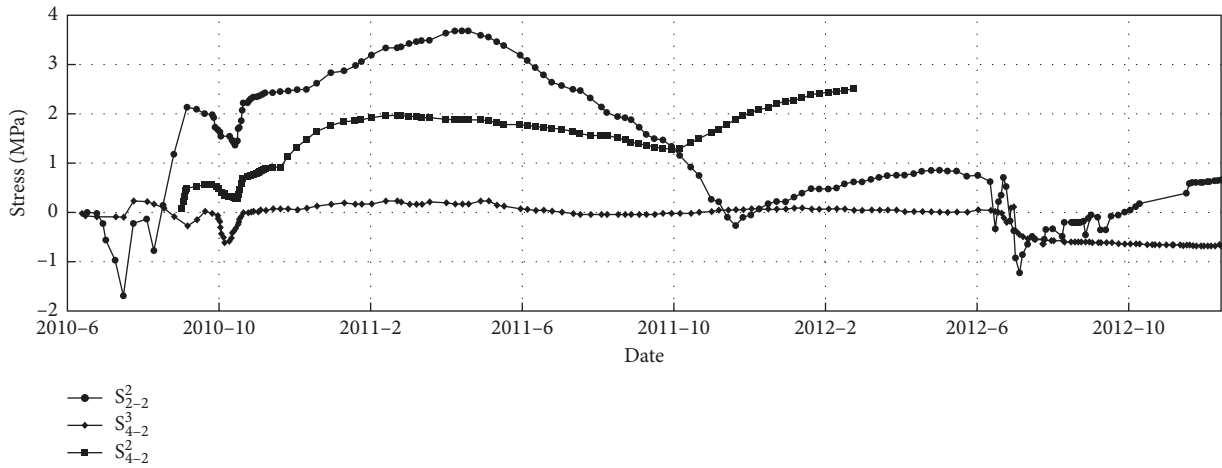
FIGURE 8: Rebar vertical stress time series at the 3255 m elevation.

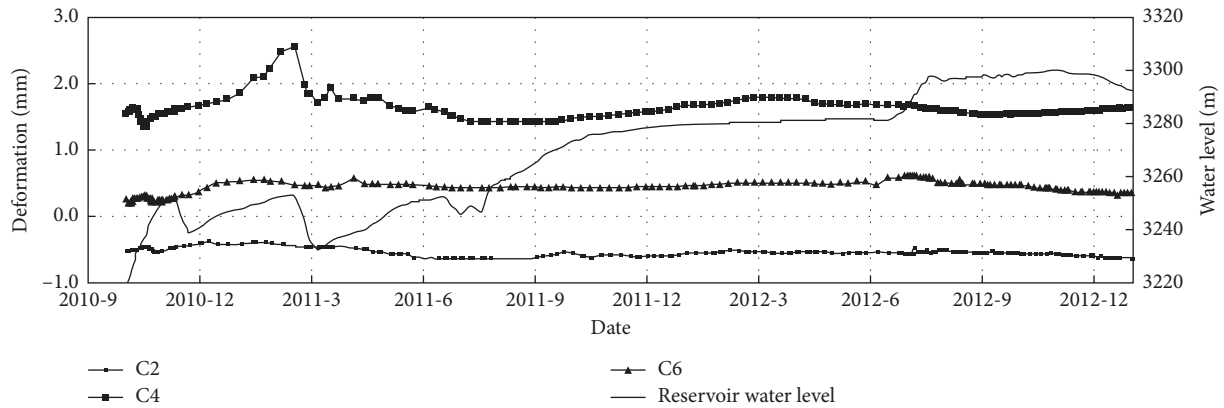
4.3. Dam-Body Separation. Void meters on the concrete face were deployed mainly at elevations of 3255 m and 3283 m. The data from the void meter at the 3255 m elevation showed no marked separation. Due to the reservoir water level, significant changes were recorded by the void meter at the 3283 m elevation. In particular, during the phase II, stage II reservoir impoundment, a significant, abrupt change coincided in time with an abrupt change detected by the rebar meter at the 3255 m elevation. Time series of the monitoring data are shown in Figures 9 and 10.

FIGURE 9: Void deformation time series at the 3255 m elevation.

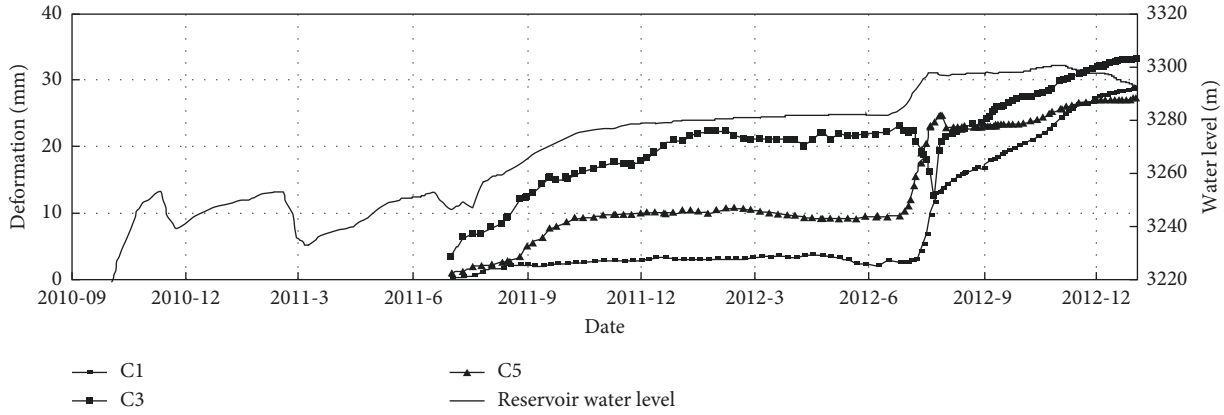
FIGURE 10: Void deformation time series at the 3283 m elevation.

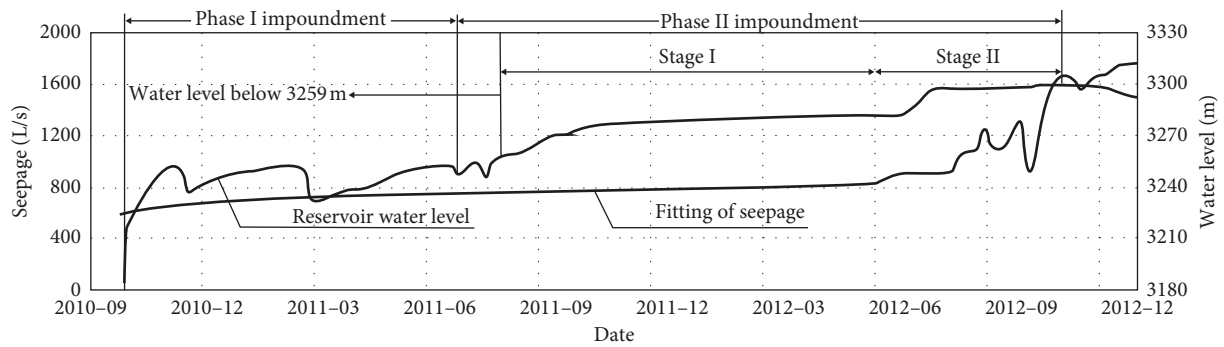
4.4. Dam-Body Seepage. Phase I impoundment occurred on September 28, 2010. As the water level rose, significant seepage of approximately 600–700 L/s from bedrock fractures in the slope toe behind the dam occurred. By June 15, 2012, the reservoir water level had risen to 3281.25 m, and the seepage measured 900 L/s. By November 18, 2012, the water level had risen to 3298.64 m, and the seepage measured 1645 L/s. At the beginning of 2013, the seepage reached 2000 L/s, and the seepage measured at the weir during the phase II, stage II reservoir impoundment showed a trend of significant increase. Variations in the seepage measured at the weir are shown in Figure 11.

temporary construction joints between the other concrete faces of phases I and II. Analysis suggests that the main cause of the sudden increase in seepage measured at the weir after August 2012 was that water flowed downstream through this seepage channel in the dam body.

FIGURE 11: Variations in seepage measured at the weir.

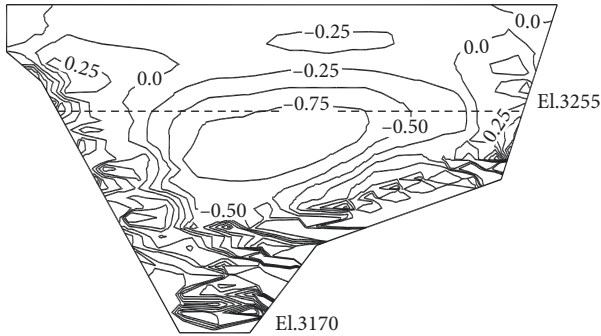
Based on the finite element results of three scenes, apart from scene 1 (Figure 15), during the rise of the reservoir water level, the slab of the staged construction shows a different degree of shearing stress at 3255 m. If there is no water storage for upstream prior to the second-stage slab pouring, then the first-stage slab bears only the stress caused by filling the upper portion of the dam. When the reservoir water storage reaches 3283 m, the maximum shear stress of the slab at 3255 m is approximately -1.89 MPa, and the range is limited (Figure 16). However, if the reservoir stores water according to scene 3, then the first-stage slab is not only affected by the stress from the filling of the upper dam but also subjected to the upstream water load, resulting in large shear stress at an elevation of 3255 m. When the reservoir water level rises to 3283 m, the maximum shear stress at an elevation of 3255 m is approximately -2.33 MPa, and there is a second shear stress region in the vicinity of 3243 m in elevation, and its maximum value is approximately -1.84 MPa. The upper and lower shear stress regions form an “I” shape (Figures 17–19). This calculation result is similar to that of the first-stage slab crack shape of Shuibuya.

FIGURE 15: Shear stress in the concrete face under condition 1 with the water level at 3283 m (units: MPa).

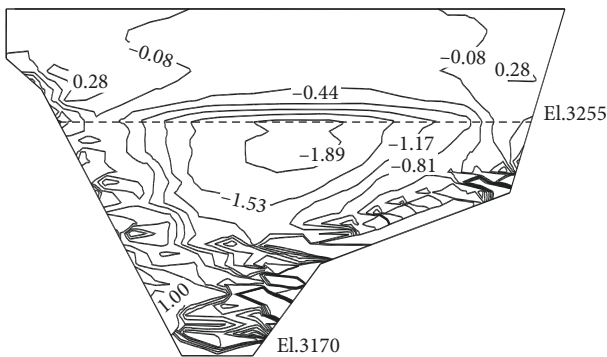
FIGURE 16: Shear stress in the concrete face under condition 2 with the water level at 3283 m (units: MPa).

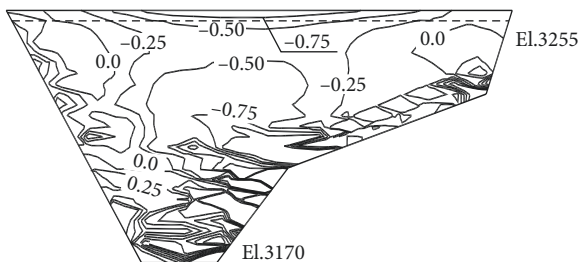
Figure 17 shows the shear stress in the concrete face in phase I on February 10, 2011, when the dam filling reached its maximum.

FIGURE 17: Shear stress in the concrete face under condition 3 with the water level at 3255 m (units: MPa).

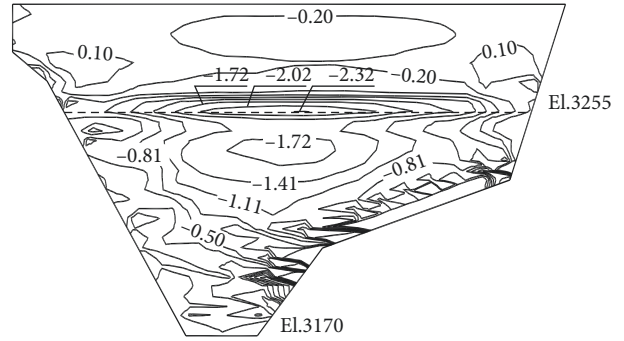
FIGURE 18: Shear stress in the concrete face under condition 3 with the water level at 3283 m (units: MPa).
