Rethinking the Water Leak Incident of Tunnel LUO09 to Prepare for a Challenging Future

Wen-Chieh Cheng

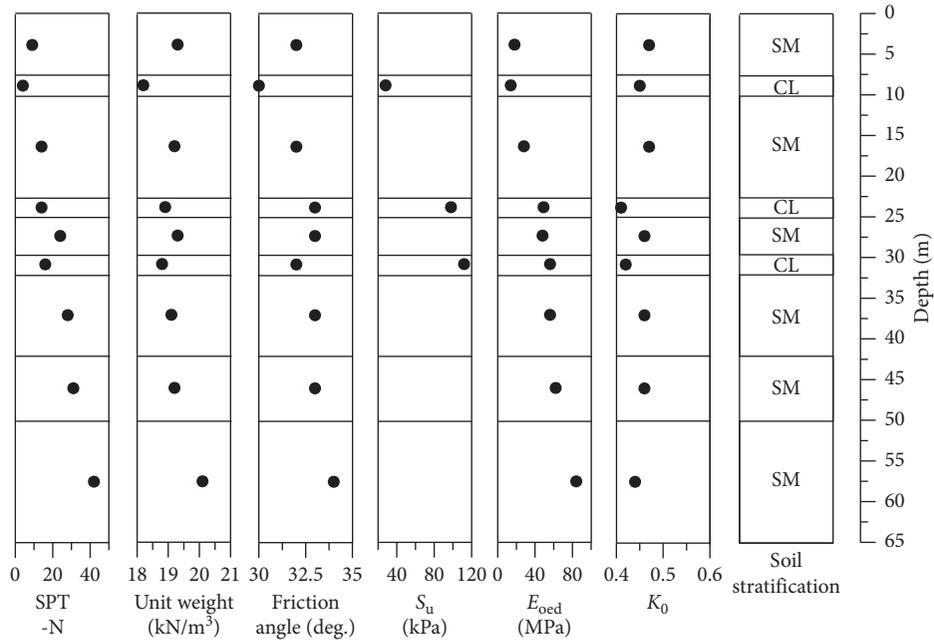
2.1. Background. Two 837 m long, 6.1 m wide parallel tunnels LUO09 were excavated using the shield tunnelling method. A 6.24 m diameter earth pressure balance (EPB) shield was responsible for tunnel boring operations. Their ends are linked to the stations O7 and O8 of the Kaohsiung metro system, and a cross passage with a middle sump pit at 32.6 m depth was built for safety purpose. Several boreholes that penetrate through a 42 m thick alternating layer of soft clay and silty sand and into a more than 30 m thick silty gravel were installed providing a detailed description of the field geological conditions (Figure 1). The groundwater level was at 5–6 m depths below the ground surface.

FIGURE 1: Soil properties profile. CL = silty clay; SM = silty sand; S_u = undrained shear strength; K₀ = earth pressure coefficient at rest; E_{oed} = elastic modulus from oedometer test.

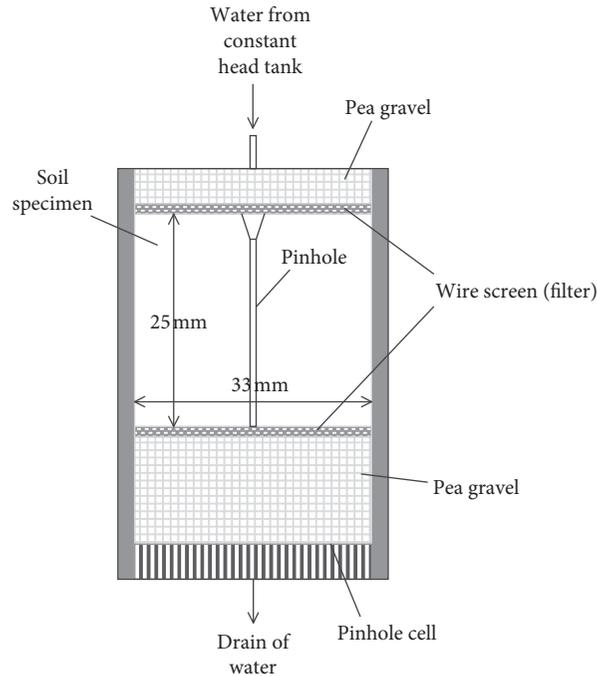
FIGURE 8: Pinhole test apparatus for assessing the dispersion and consequent erodibility of the local sandy silt.

erosion. It may be conclusively mentioned that the seepage-prone weak zones and high hydraulic gradient initiated the water leak incident and that water from the two undermined water mains transferred the Kaohsiung silt into more flowable debris and its nonplastic nature aggravated the collapse even further. Despite an apparent inadequacy in dealing with similar incident in other sites, the local sandy silt was found to be prone to the piping at deep depths under large hydraulic gradients, and the two undermined water mains enhanced its
