Finite Element and Vulnerability Analyses of a Building Failure due to Landslide in Kaithakunda, Kerala, India

Rajkumar Andrewwinner¹ and Sembulichampalayam Sennimalai Chandrasekaran

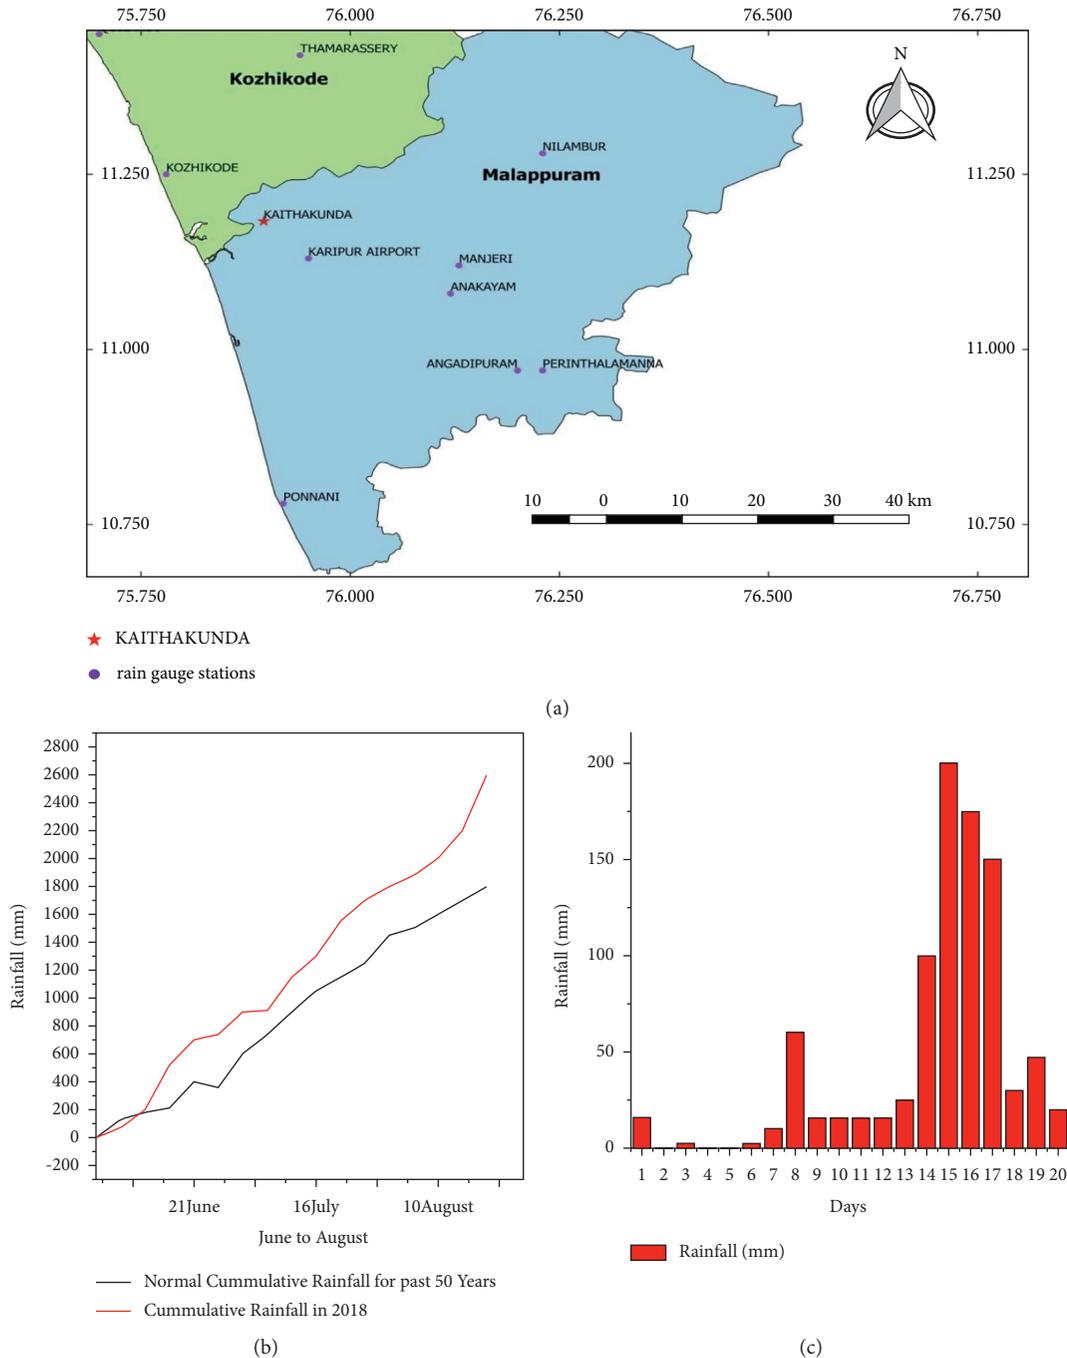
The modelling and properties of soil and the method of analysis were already discussed in the previous section. Infiltration analysis was carried out to study the effect of slope on the building. The rainfall data were used for infiltration in surface groundwater flow boundary conditions. The rainfall data obtained from the Indian Meteorological Department (IMD) are shown in Figures 4(b) and 4(c). The analysis was carried out in three stages. The first stage considered continuous rainfall of low intensity (cumulative rainfall of 1770 mm) from June to July 2018. The second stage considered intense rainfall from the 1st of August to the 14th of August 2018. The rainfall recorded during the second stage (August 1–14) is 2800 mm. Since the failure of the slope was observed on August 16, the third stage of analysis was carried out by considering the rainfall that occurred on the 15th and 16th of August with a very high intensity of 187.5 mm/day (Figure 4(b)).

FIGURE 4: Rainfall data. (a) Rain gauge stations near Kaithakunda. (b) Cumulative rainfall for south-west monsoon 2018 (after IMD 2018). (c) Daily rainfall recorded at Karipur airport in August 2018 (after IMD 2018).

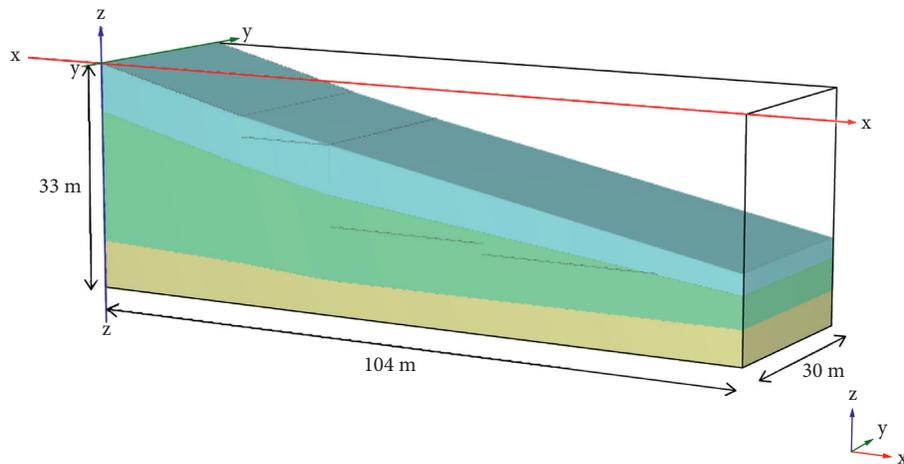
5.1. Analysis of the Original Slope. To understand the behaviour of the natural slope, the analysis is carried out on a model of the original slope. Figure 6 shows the model of the original slope with two layers of soil and one layer of rock. Slope with dimensions of 104 m length, 30 m width, and 33 m height is considered in the analysis. The properties of soil and rock are presented in Table 1. The soil is modelled as 10-node tetrahedral elements. The soil is modelled as Mohr-Coulomb elastic perfectly plastic model [32]. The hydraulic boundary condition (X, Y),

FIGURE 6: Finite element representation of the original slope geometry.

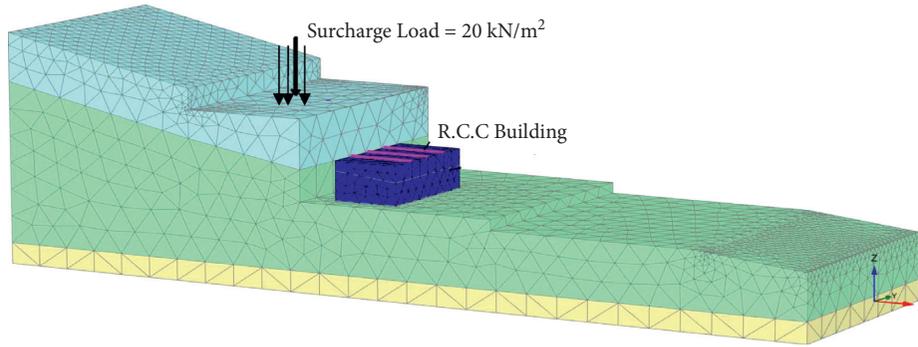
5.3. Analysis of Vertical Cut. Finite element analysis of the site condition that existed before failure (Figure 3(b)) is carried out to evaluate the mechanism of failure. Figure 7 shows the geometry of the model before slope failure. It shows the vertical cut in the slope and the building located very close to it. The structure is a single-storey building with load-bearing walls. The building is modelled as a plate element. Beam elements are used to transfer the load from the roof to the plates (load-bearing walls) (Figure 7). The foundation of the building is considered as a plate element to transfer the load to the soil. The plate and beam elements are modelled with a unit weight of Reinforced Cement Concrete (RCC). The width and length of the building are taken as 8 m

FIGURE 7: The geometry of the model existing site condition before failure.

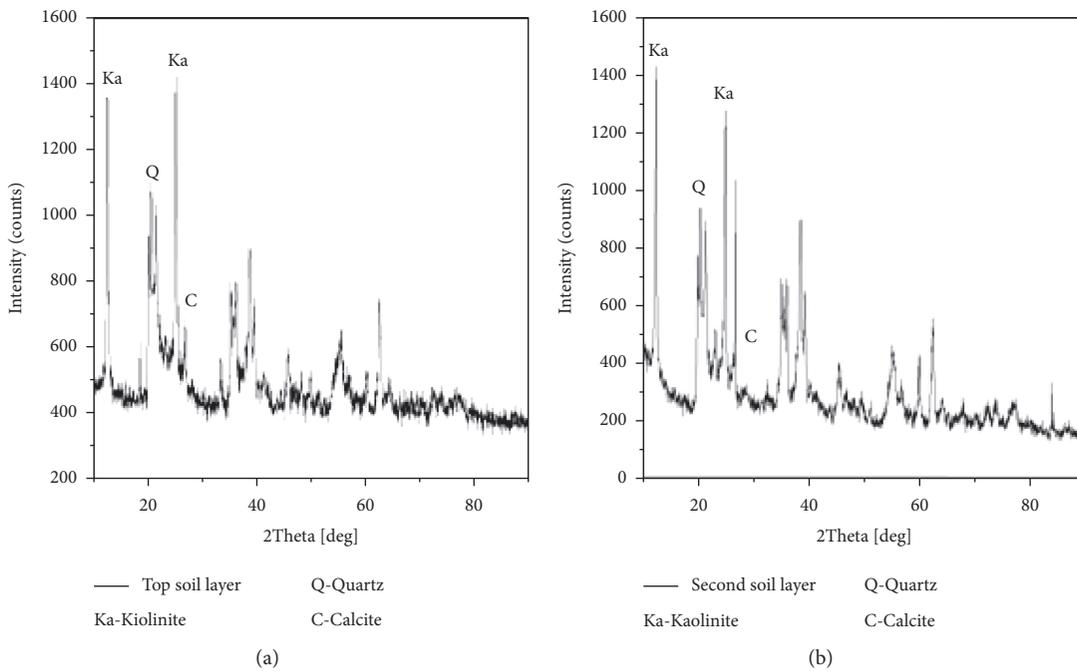
FIGURE 8: X-ray diffraction pattern for (a) the topsoil layer and (b) the bottom soil layer.

7.1.1. Weathering Characteristics. Figure 10 depicts FE-SEM images of both layers of soil. Figure 10(a) indicates that the topsoil layer was governed by silt/clay size clusters with voids on the soil particle surface and a highly porous structure due to the high weathering. The degree of weathering reduces with the increase in depth as the presence of clay minerals and pore volume decreases (Figure 10(b)). The FE-SEM images of both soil layers show the presence of kaolinite clay mineral with many pores in it, which is well supported by EDX and XRD analysis, as shown in Figures 8 and 11. EDX and XRD results indicate the presence of kaolinite clay mineral ($\text{Al}_2\text{Si}_2\text{O}_5(\text{OH})_4$) along with quartz and calcium carbonate (CaCO_3) in the topsoil (Figures 8(a) and 10(a)) [61, 62]. The presence of calcium carbonate in the soil indicates the weathering process in the soil [62, 63]. The second layer of soil has a very less amount of kaolinite clay due to the incomplete weathering process (weathering degree-VI according to [64]) in the soil [63, 65] (Figures 8(b) and 11(b)).

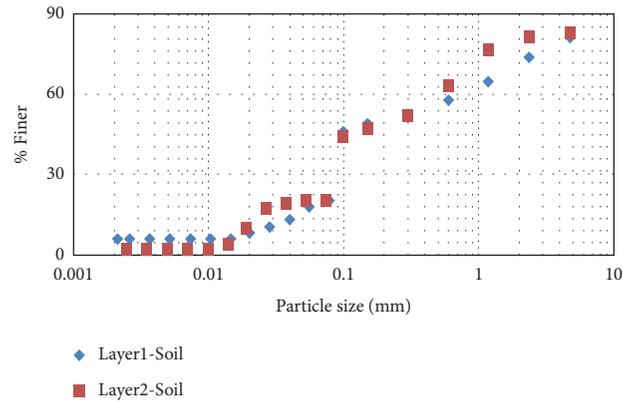
7.1. Properties of Soil. The particle size distribution curve for the soil samples is shown in Figure 9. Properties of soil evaluated from lab tests are presented in Table 1. Both soils are identified as silty sand (SM) as per USCS classification [58]. Hydraulic conductivity of the soil sample is evaluated as per the Indian Standard Code [59] and the permeability values for both the soil samples are in the range of 10^{-7} to 10^{-8} m/s. The Proctor compaction test is carried out to determine the maximum dry density of the soil. Consolidated drained (CD) direct shear tests on the soil samples are conducted as per [60]. The effective shear strength parameters obtained from the tests are presented in Table 1.

FIGURE 9: Particle size distribution curve.

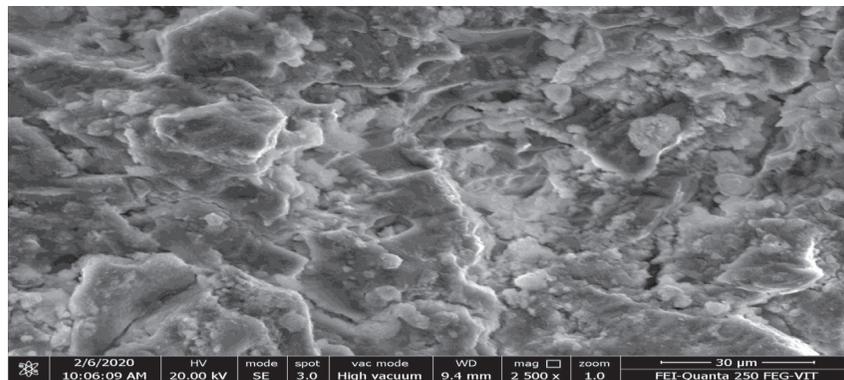
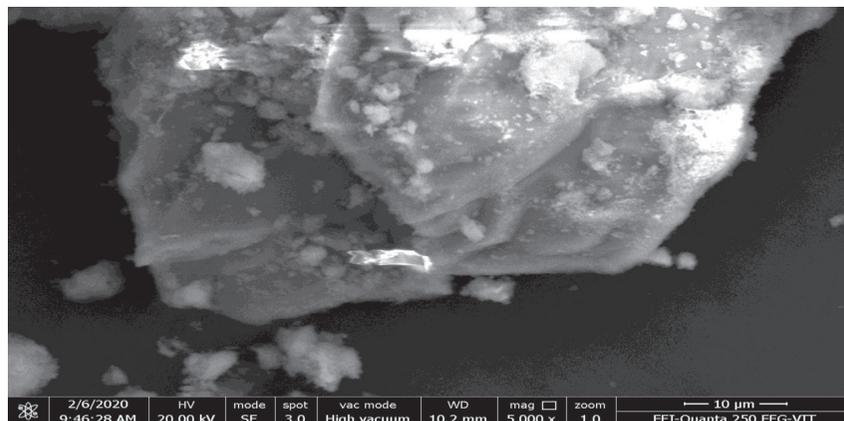
FIGURE 10: FE-SEM images of (a) topsoil and (b) second-layer soil.

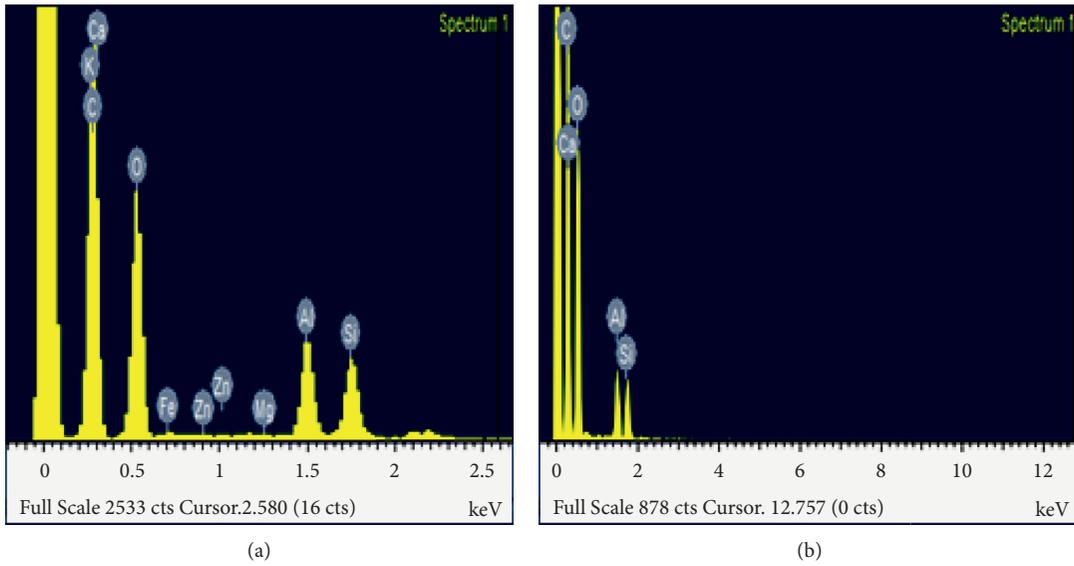
FIGURE 11: Energy-dispersive X-ray spectrum. (a) The topsoil layer and (b) the bottom soil layer.
